# Preliminary Ecological Appraisal and Roost Assessment

Stanford End Farmhouse, Barge Lane, Reading, RG7 1SY

10 July 2024, updated 01 February 2025

This report is prepared to inform a planning application with the Wokingham Borough Council. The proposal is described as:  
The full renovation of the farmhouse and adjoining barns to create one dwelling.

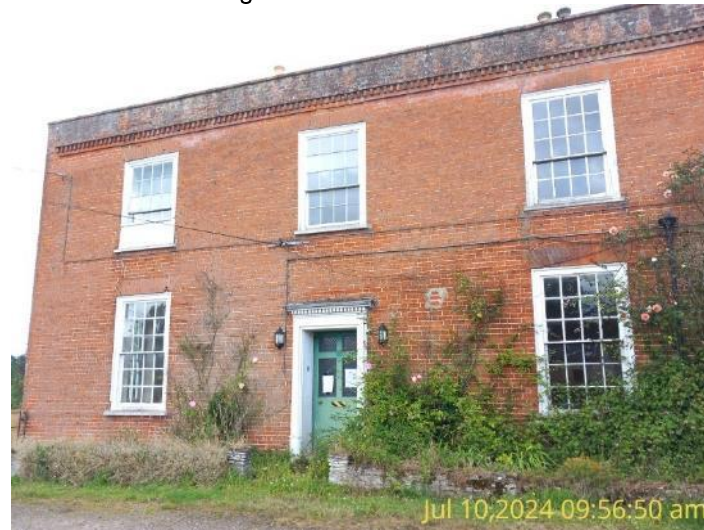
Figure 1: B1 – Northeast elevation.

B1 is a grade two listed building, it is a two-storey, brick-built building (Figure 1). The brickwork around the building appears in poor condition with gaps and cracks present in which bats can roost. The building has a multi-pitched and hipped roof, clad in clay roof tiles. The roof tiles are in poor condition, with many raised tiles under which bats could roost. The doors and window frames are of timber construction, and there are several gaps in between the frames and the brickwork which could be utilised by crevice dwelling bats. There are two chimneys located on B1. There are gaps in the tiles at the base of the chimneys which may provide ingress points into the loft void. There is a single storey side extension of B1 (see Appendix 5). The roof is in poor condition and has many raised tiles suitable for roosting bats.

Given the number of features identified on the property and the presence of excellent bat habitat around the site, as well as the bat droppings located within the loft, it is assessed that B1 provides **high** habitat value for roosting bats.

| | <p><b>Three</b> bat emergence/re-entry surveys are required on B1 during the active bat season (May – September) to confirm presence/likely-absence of bats roosting in or on the building. These survey visits should be completed during the optimal survey period mid-May to August inclusive. The survey visits should be at least three weeks apart.</p> <p>Sub-optimal: early May and September. Would require greater justification of timing e.g., weather conditions, known local bat activity.</p> <p>One of the surveys could be a dawn re-entry survey, or all three can be at dusk if supported by night vision aids (NVA).</p> <p><b>Four</b> surveyors are required to provide full coverage of the building's elevations to look for emerging/re-entering bats. An infrared camera should also be employed as part of the survey to see where any specific roost locations are located. Lighting mitigation may be required based on the outcome of the night bat survey(s).</p> <p>If any bat roosts are confirmed from this survey schedule, a bat license would be required to demolish the buildings as it would involve the destruction of roosts. This is applied for with the help of a class 2 licensed bat ecologist after planning permission is granted, but before commencement of works.</p> <p>An EPSL application to Natural England will be required. The EPSL application requires that all surveys have been undertaken within the most recent active bat season and planning permission must have been granted and all relevant wildlife-related conditions have been discharged prior to submission.</p> <p><b>Foraging and commuting habitat</b><br/>No further surveys are required.</p> <p><b>Artificial lighting</b><br/>A low impact lighting strategy will be adopted for the site during post-development which outlines the areas of the site that will be retained as dark corridors. Parameters can be found on the Bat Conservation Trust website:<br/><a href="https://www.bats.org.uk/our-work/buildings-planning-and-development/lighting-2">https://www.bats.org.uk/our-work/buildings-planning-and-development/lighting-2</a></p> <p><b>Suggested biodiversity enhancements</b><br/>Enhancements are dependent on the outcome of further surveys.</p> |

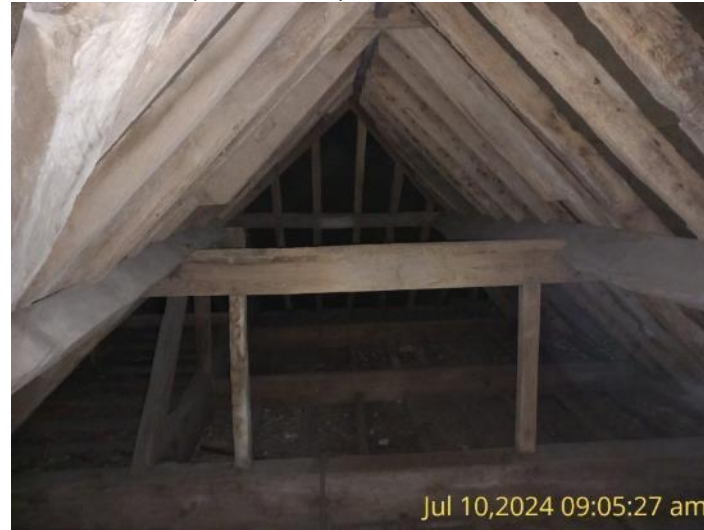
Figure 2: L1 – Loft space within the interior of B1.

*Loft Space 1 - L1 (Figure 2)*

It is constructed from original timber beams, including the ridge beam, rafters and purlins. The beams may provide roosting sites for void-dwelling bats. The roof is lined with bitumen felt which is in moderate condition with no tears, however gaps are present at the ridgeline. The floor of the loft is lined with mineral wool insulation and timber boards are in place. Daylight can be seen from within the loft through gaps in the bitumen felt, around the chimneys and at the top of the brick walls. The internal abiotic recordings at the time of the survey were 18.6°C and 86% relative humidity. The approximate loft dimensions were 12m long x 9m wide x 2m high. Approximately 100 droppings were located within the loft space, noticed along the joists and caught in cobwebs (see Appendix 5). B1 is a confirmed roost for a brown long eared maternity roost and common pipistrelle maternity roost (Arbtech Consulting Ltd, 2022).

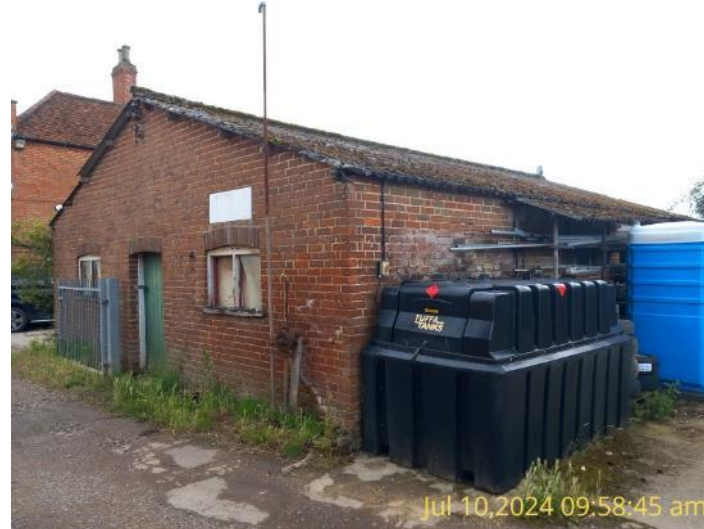
Figure 2: B2 – North elevation.

B2 is a one-storey brick-built semi-detached outbuilding with a pitched and gabled roof clad in corrugated asbestos roofing. The roof sheeting appears in good condition with no raised sections visible for roosting bats to utilise. The window and door frames are of timber construction and are tight-fitting to the brickwork. There are no suitable gaps for roosting bats to utilise. The interior of B2 is open with a vaulted ceiling and there is no separate loft space. The roof structure is comprised of metal beams. The roof is single-skinned and unlined. The building is not insulated and has large doors, reducing the suitability for bats as temperature and humidity would fluctuate rapidly.

Given the absence of features identified on the property, it is assessed that B2 provides **negligible** habitat value for roosting bats.

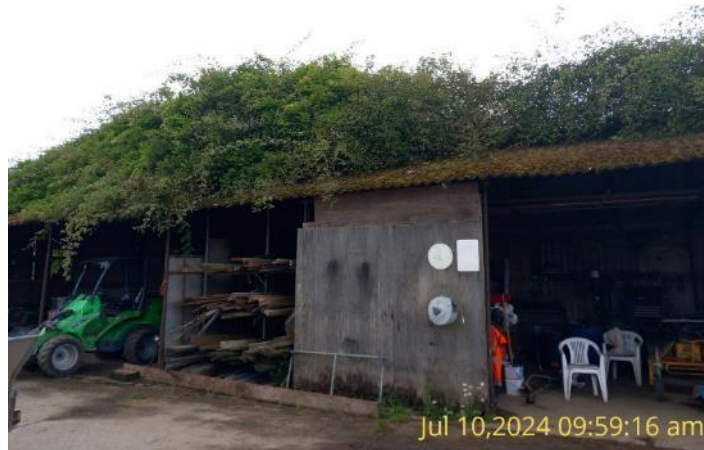
Figure 3: B3 – North elevation.

B3 is a one-storey metal framed outbuilding with a pitched and gabled roof comprised of corrugated asbestos sheeting. The sheeting is in moderate condition. The eastern elevation is entirely open, with no doors or windows, allowing birds and bats to enter freely. However, this also reduces the stability of the interior conditions and reduces the likelihood of bats roosting, as temperature and humidity will fluctuate rapidly. There is also abundant daylight within B3. The roof is not lined, and the back of the sheeting is exposed. The building has a vaulted ceiling and no separate loft space. There is significant vegetative growth on the roof of the building which could be used by nesting birds.

Given the absence of features identified on the property, it is assessed that B3 provides **negligible** habitat value for roosting bats.

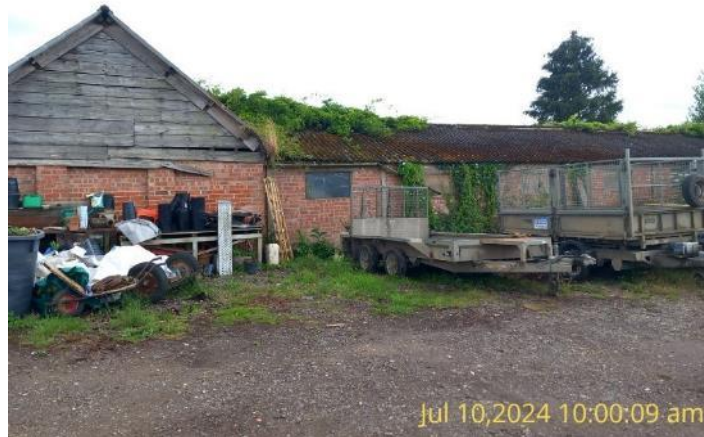
Figure 4: B4 – Northwest elevation.

B4 is a one-storey brick-built semi-detached outbuilding with a pitched and gabled roof clad in plastic composite roof tiles and asbestos corrugated roof sheeting. The roofing appears in good condition, with no raised sections under which bats could roost. The windows and doors are timber framed and are in good condition with no gaps around them in which bats could roost. The gable ends are clad in timber panelling which is in good condition, there are no warped boards or gaps suitable for bats. The interior of the building is open, and the ceiling is vaulted, with no separate loft space. The building is single skinned and is extremely light and prone to temperature fluctuations, reducing the suitability for bats.

Given the absence of features identified on the property, it is assessed that B4 provides **negligible** habitat value for roosting bats.

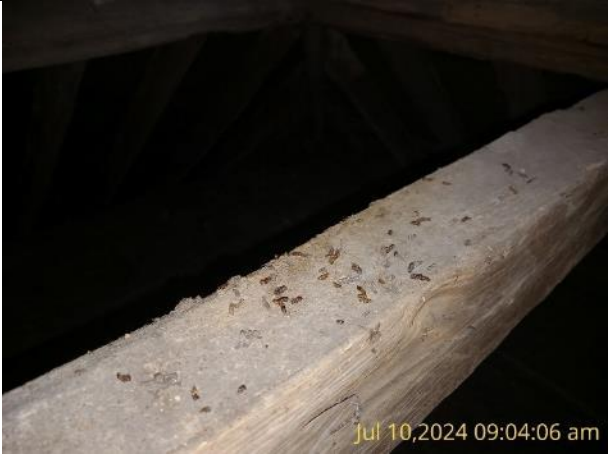
| Photograph | Description |
|---|---|
| | <p style="text-align: center;"><b>L1</b></p> <p><b>Droppings found on a beam within the loft space within the interior of B1.</b></p> <p><b>Approximately 100 droppings in total were seen within the loft space.</b></p> |

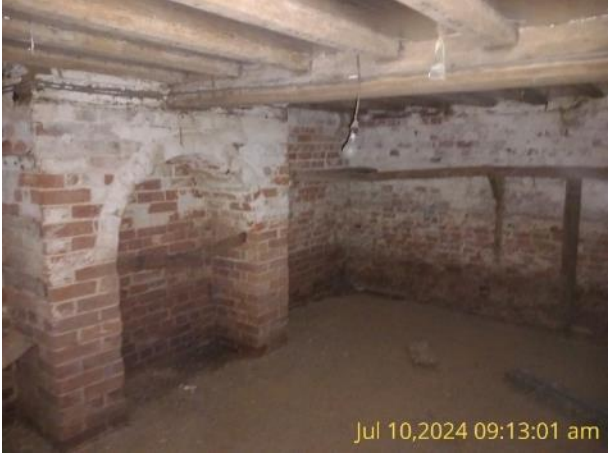
| Photograph | Description |
|---|---|
| | <p style="text-align: center;"><b>Interior of B1</b></p> <p><b>There is a cellar within B1 which was assessed. No evidence of bats was found within the cellar. The abiotic recordings at the time of the survey were 18°C and 86% relative humidity.</b></p> |

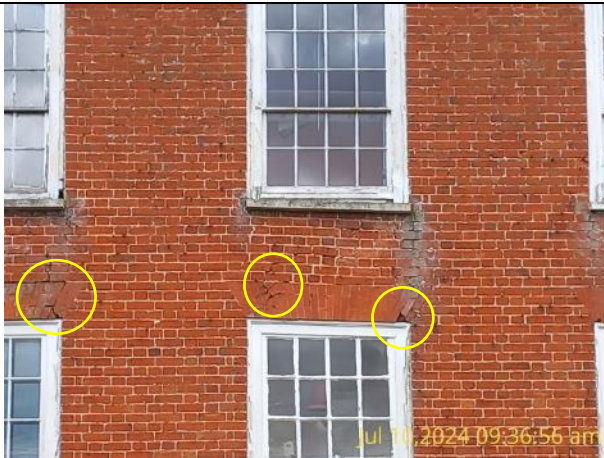
**B1 – Southwest elevation**  
The brickwork is in poor condition and there are gaps and cracks in the mortar which could be used by crevice dwelling bats.

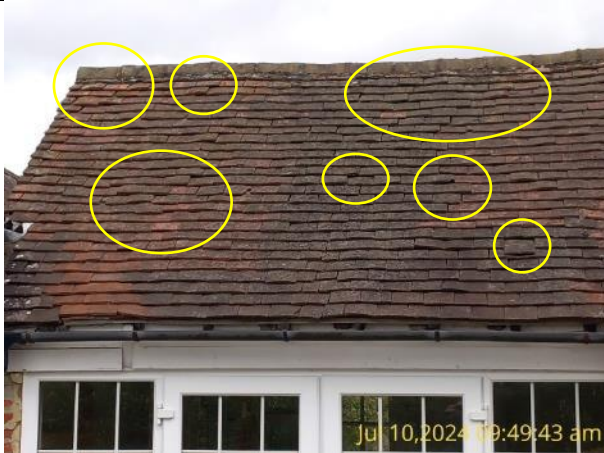
**B1 extension – Southwest elevation**  
There are numerous raised tiles along the entirety of B1, this photo is representative.

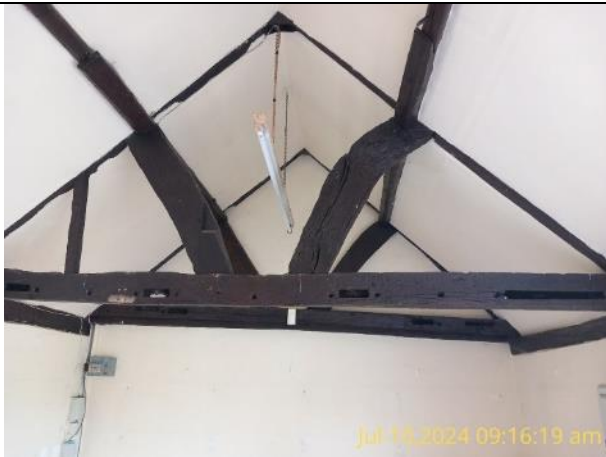
**Interior of the one-storey extension of B1. Ceilings are vaulted and there is no separate loft space.**

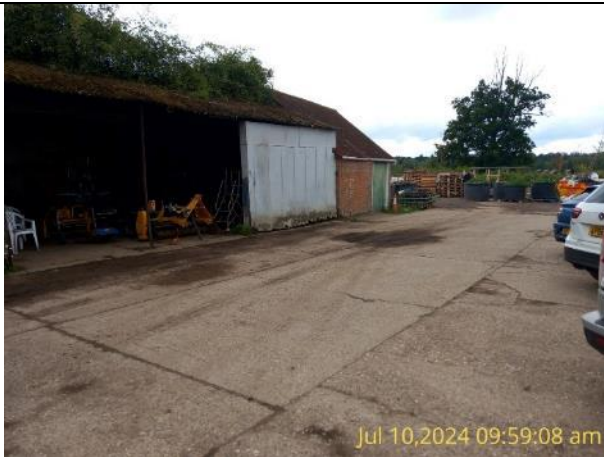
**B3 – East elevation and hardstanding.**

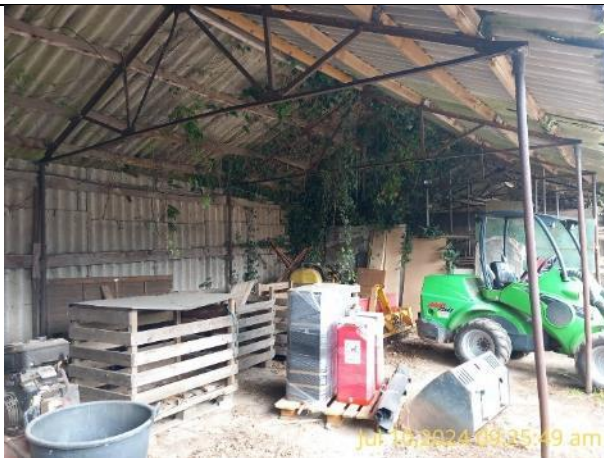
**B3 – Interior.**

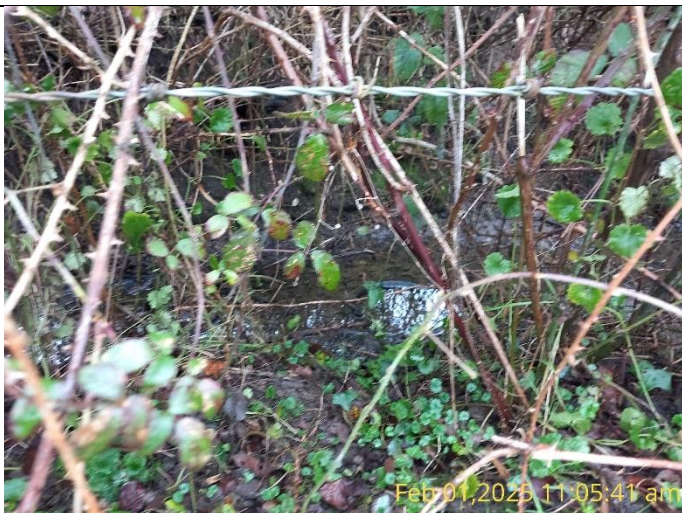
**There was limited visibility of the ditch owing to the presence of dense bramble scrub.**
