**Springholme,  
Basingstoke Road,  
Three Mile Cross,  
Wokingham,  
RG7 1AS**

**PHASE 1 BAT SURVEY  
(Provisional roost assessment)**

**January 2025**

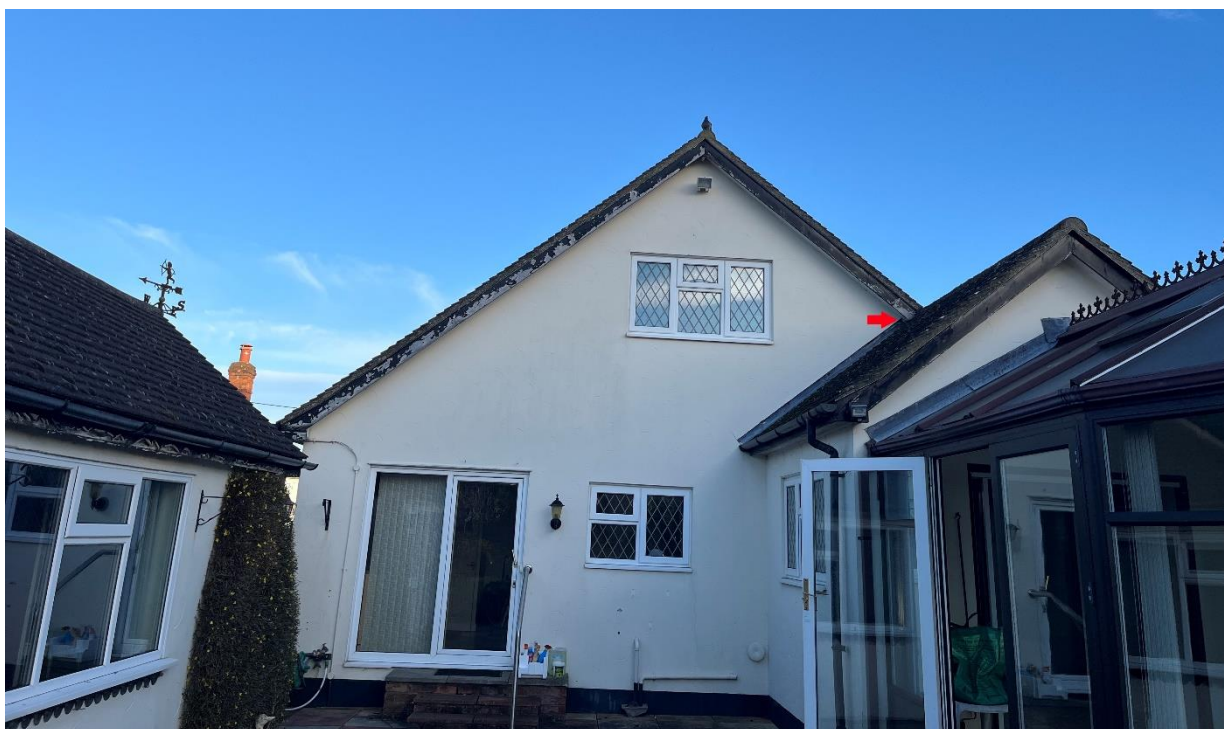
**Figure 3. East elevations of garage looking west: Red arrows indicates potential openings for roosting bats.**

There was no sign of any activity in the loft. However, the clay tiled roof has a few potential openings and there is an opening into the soffit on the rear gable: Therefore, the property has low potential, and a phase 2 emergence survey is recommended.

A dusk emergence survey is recommended to identify whether bats are utilising the property. These can be carried out in suitable weather between May and the end of September.

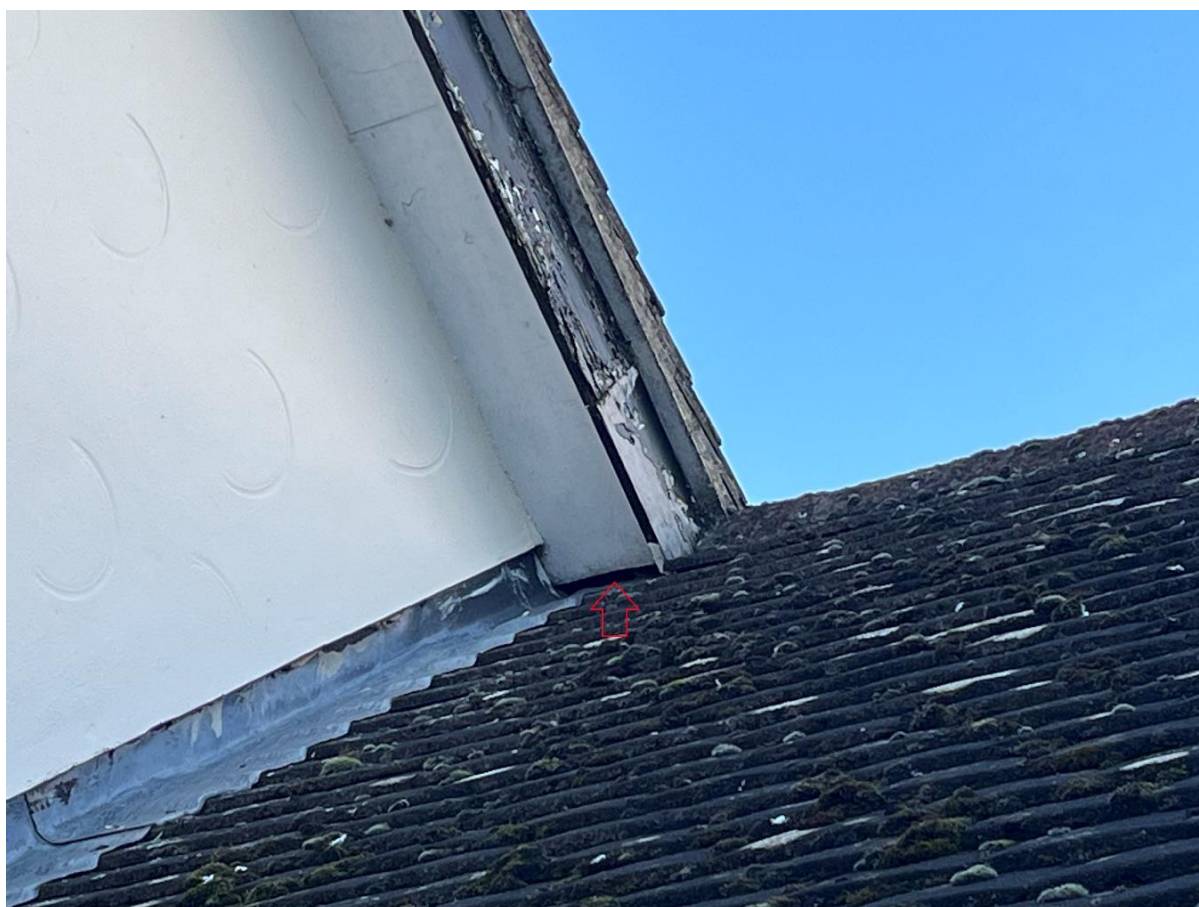
However, there is an opening into the soffit on the rear (see figures 3 & 4). There is an attached single storey extension off the rear with a conservatory off the west end (see figure 8). These have negligible potential for bats.

**Figure 4. Detail of opening into soffit on rear of property: Red arrow indicates potential openings for roosting bats.**

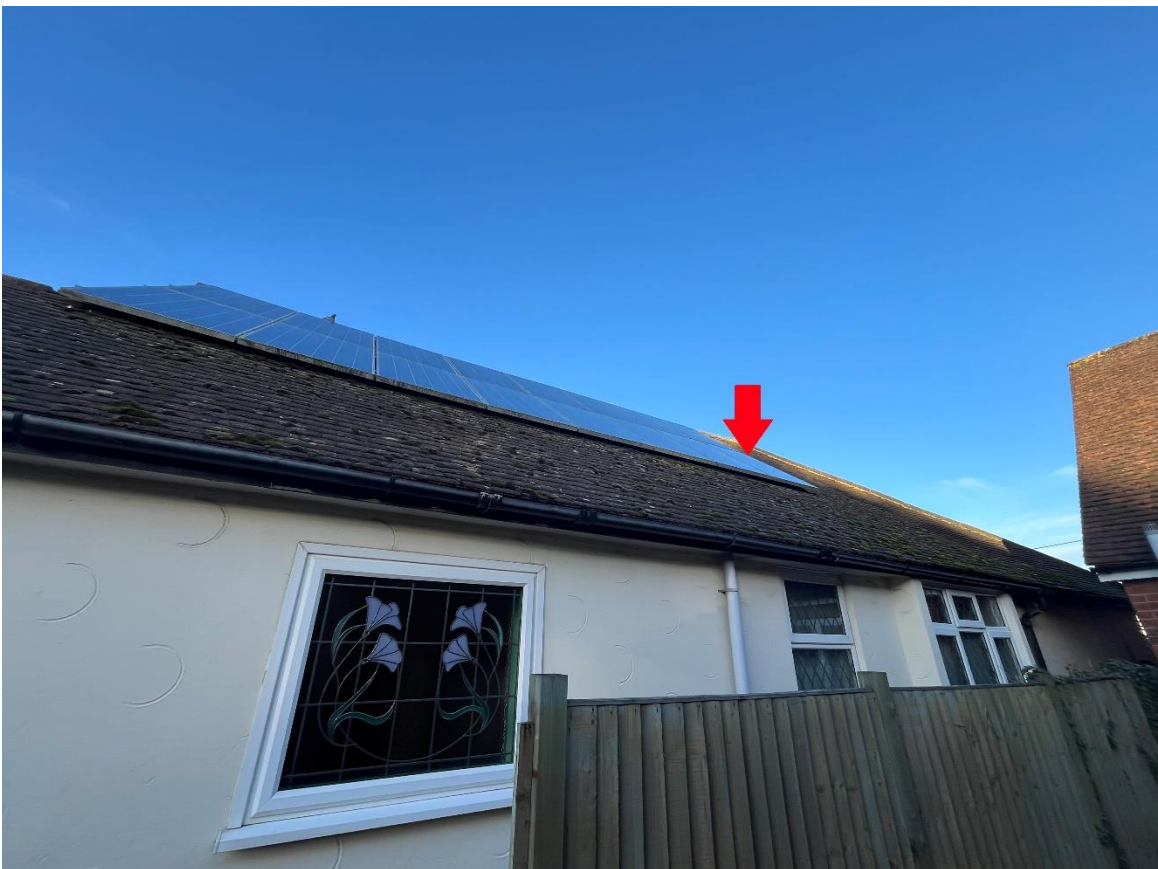
The property has rendered brick walls with a hipped, pitched roof faced with clay tiles. There are a few potential openings around near southeast corner east of solar panels (see figures 6 & 7). The remainder of the roof is in excellent order with no openings.

**Figure 6. South face of roof looking east: red arrow indicates potential openings into undertile spaces (see figure 7)**

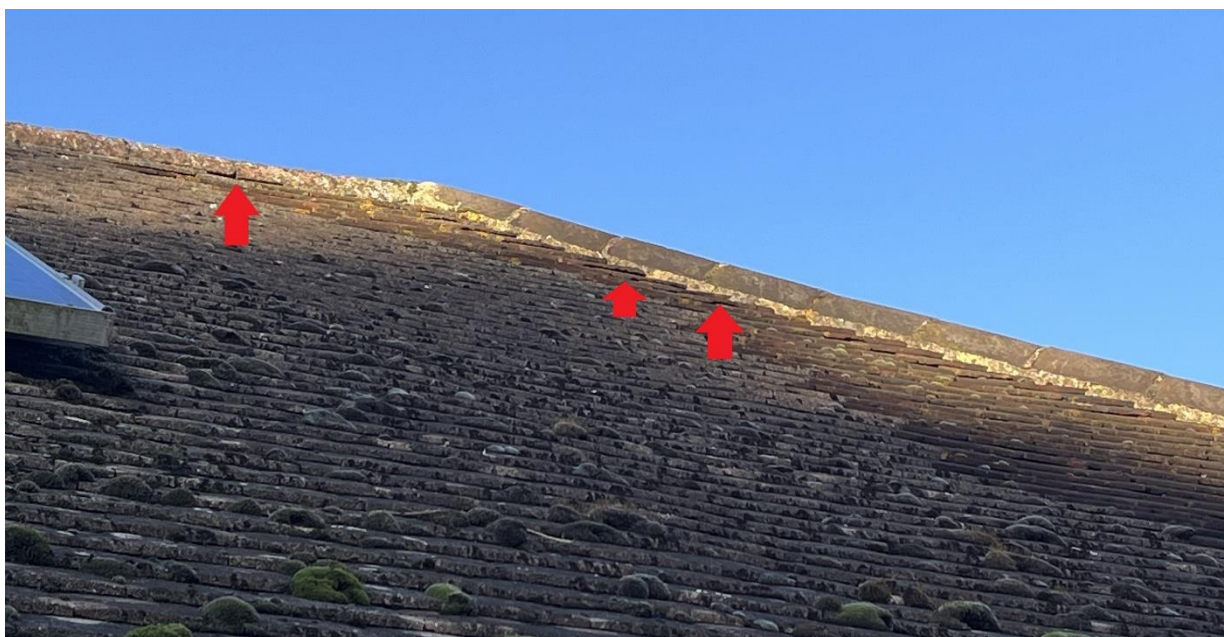
**Figure 7. Detail of south face of roof looking east: red arrows indicate potential openings into undertile spaces**

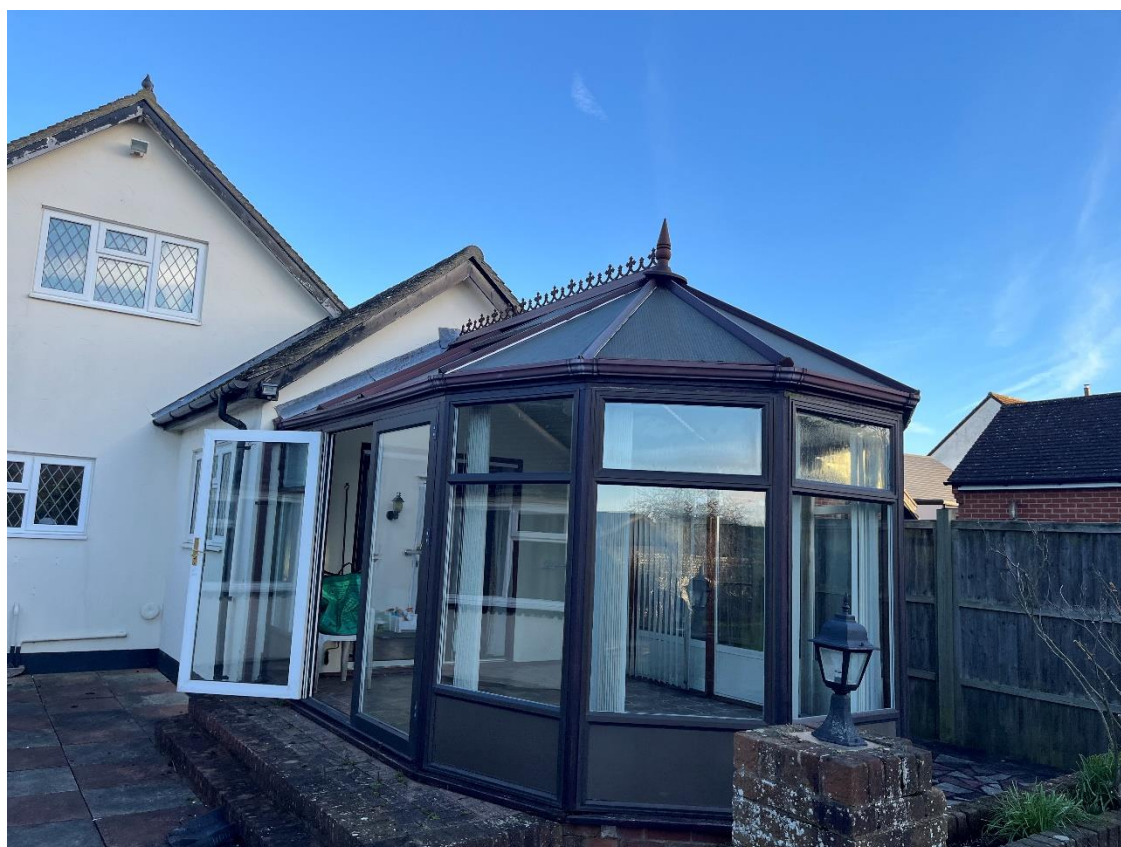
**Figure 8. Conservatory looking east**

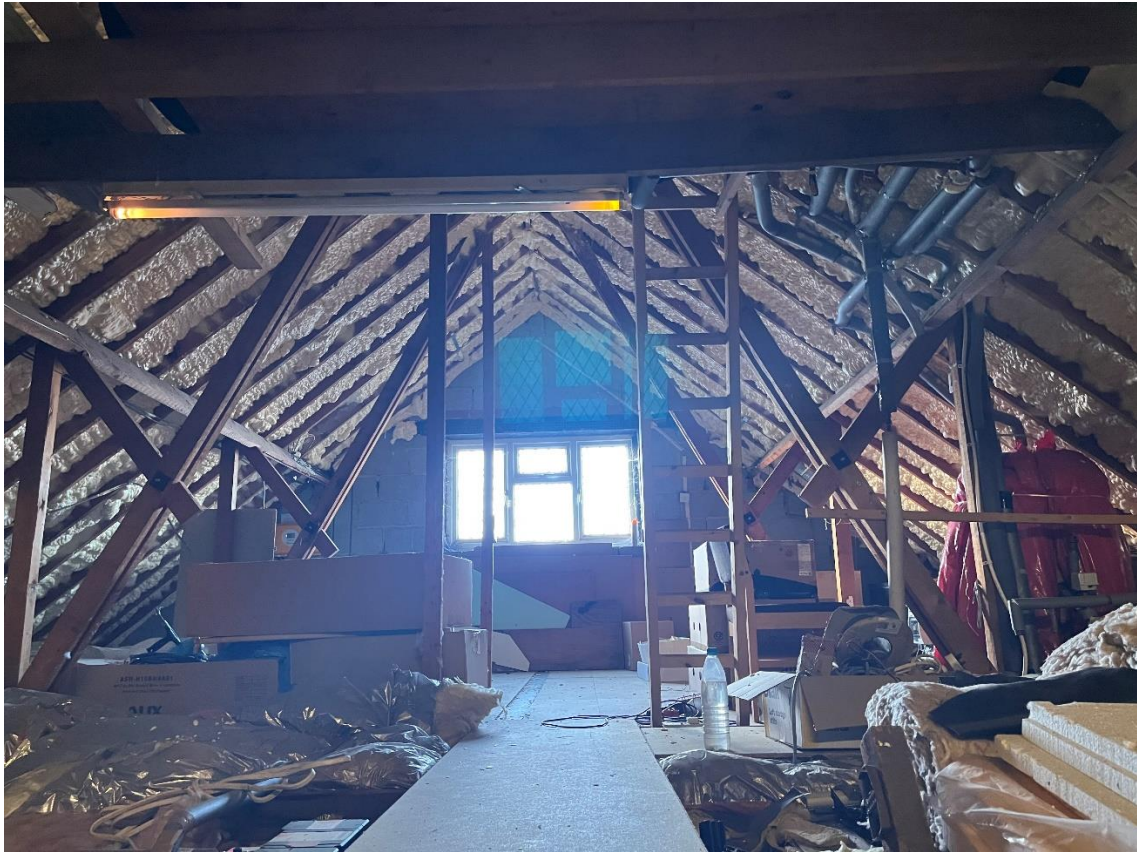
The loft was accessed via a hatch in the hallway, it is permanently illuminated via a window on the rear gable. The roof is sealed with foam insulation and there was no sign of any bat activity within (see figure 9).

**Figure 9. Loft looking west.**

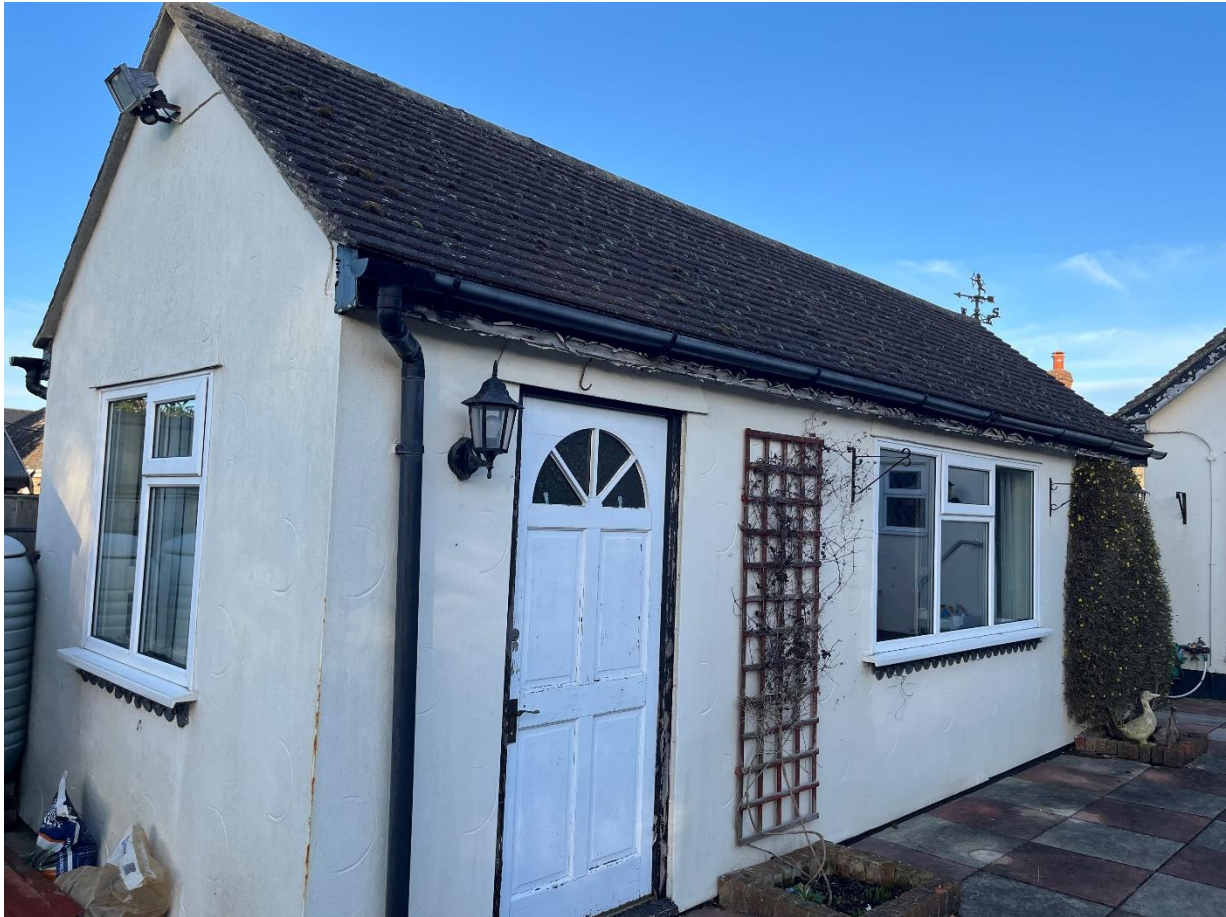
The detached garage has a pitched roof of close-fitting cement tiles which are in excellent order with no openings (see figure 10) and has negligible potential for bats.

**Figure 10. Garage looking north**
