## SHALLOW SOIL INFILTRATION TESTING

| <b>Project Type</b> | Soil Infiltration Testing |
| <b>Site</b> | Ladds Garden Centre, Bath Road, Hare Hatch, RG10 9SB |

| 24-304.03 | 1 | 17 March 2026 |

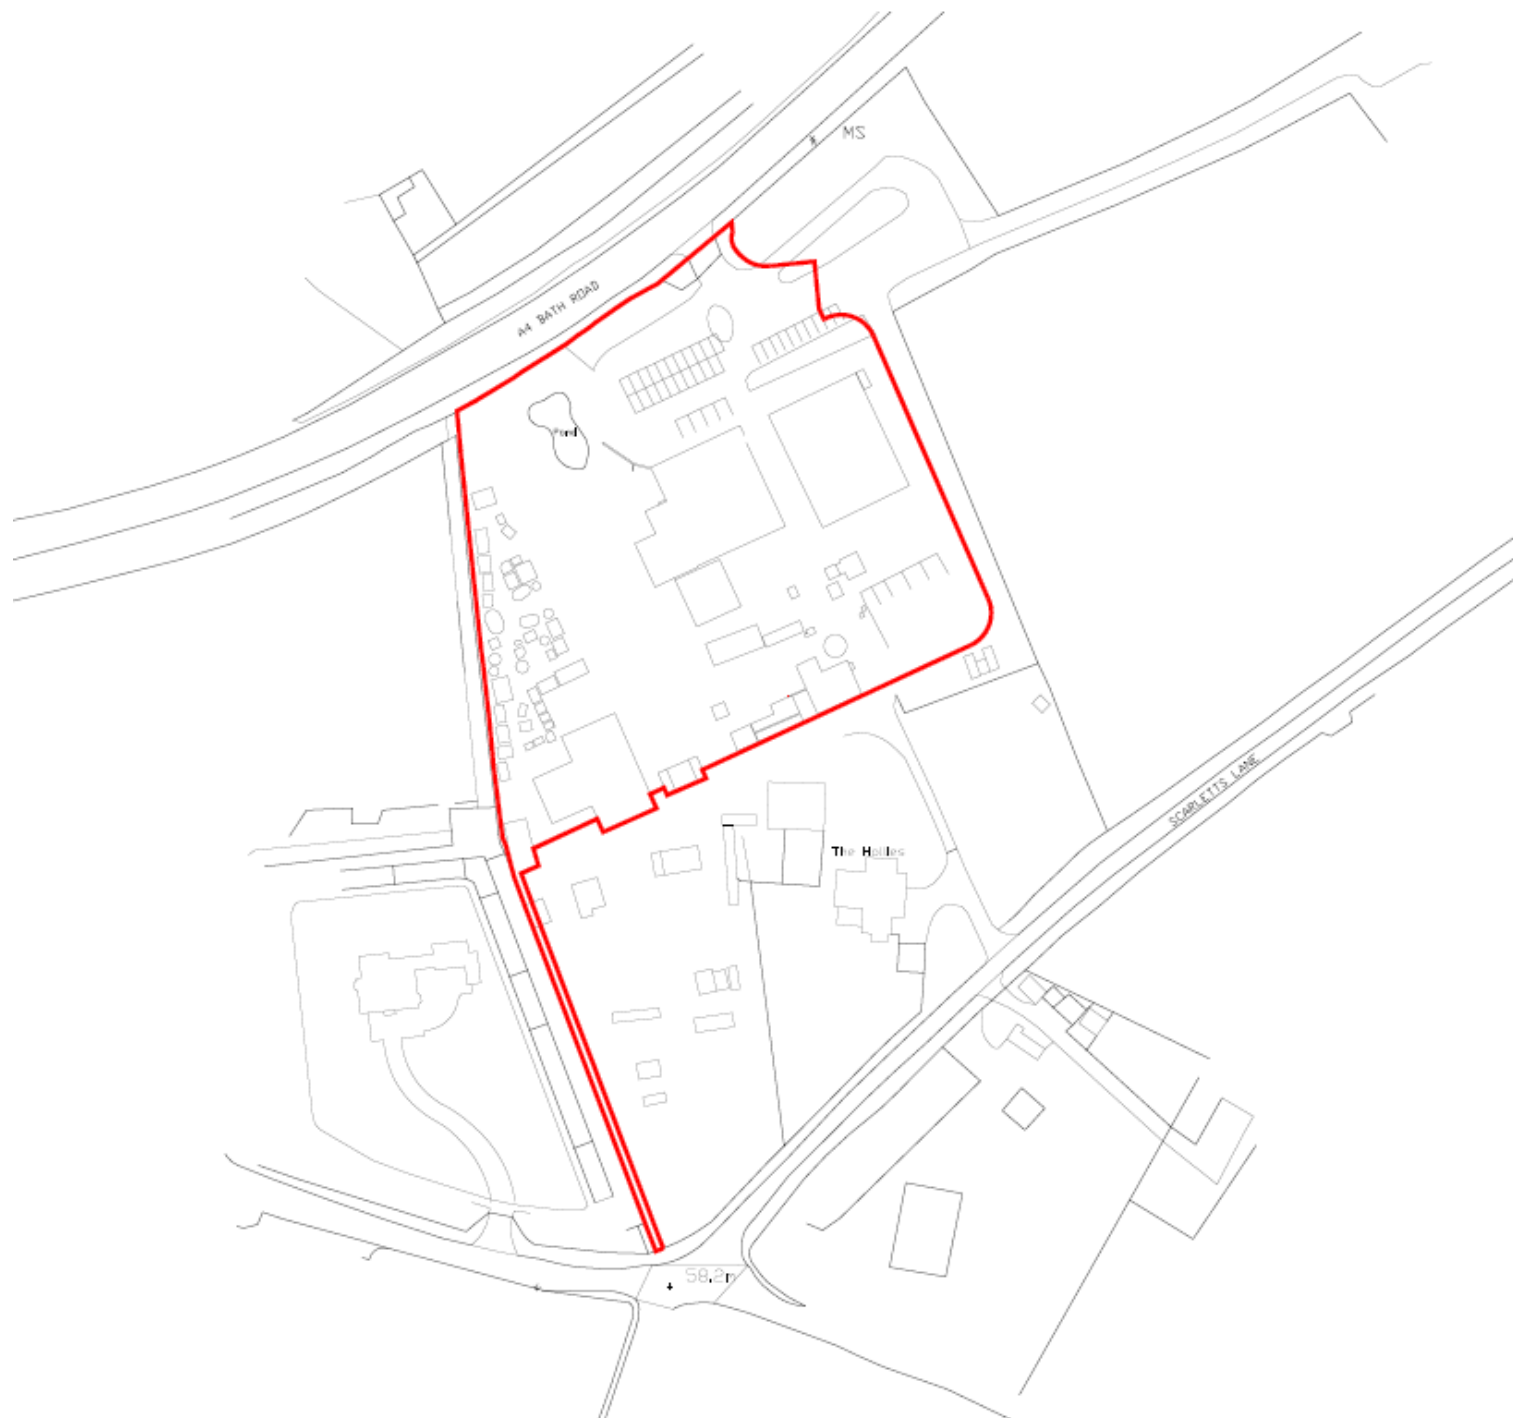
Figure 3 – Proposed Development and Exploratory Hole Location Plan

| Table 1: The Project and Site Environs | |
|---|---|
| <b>Proposed Land Use</b> | <p>The proposed development comprises the demolition of the existing buildings and the construction of nineteen detached and semi-detached dwellings with private gardens, garages and parking as well as associated access drive and communal amenity space.</p> <p><b>Figure 3</b> is enclosed within <b>Appendix I</b> and is presented as the Proposed Development Plan, which also provides locations of exploratory holes..</p> |

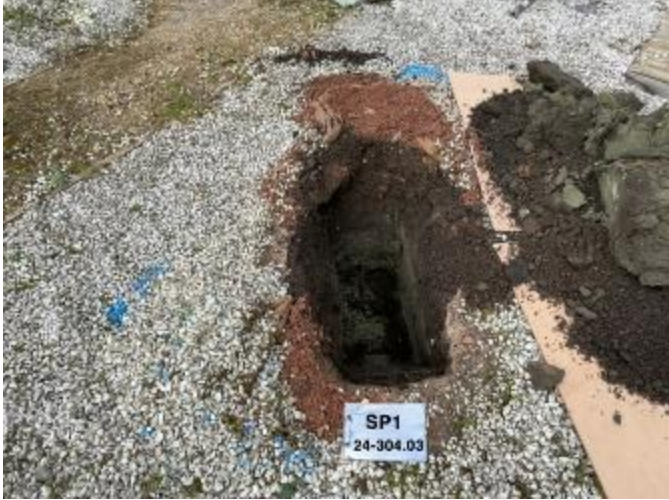
SP1 Hole Photo

| Table 2: Summary of Ground Conditions Encountered | | | |
|---|---|---|---|
| Made Ground | SP1<br>Gravel on top of dark brown silty sandy gravelly CLAY. Gravel is fine rounded of flint. | GL | 0.5m |
| Lambeth Group | SP1, SP2 and SP3<br>Firm, brown, silty, sandy, gravelly CLAY. Gravel is fine to medium, subrounded of flint. | 0.3m/0.5m | 0.6m |

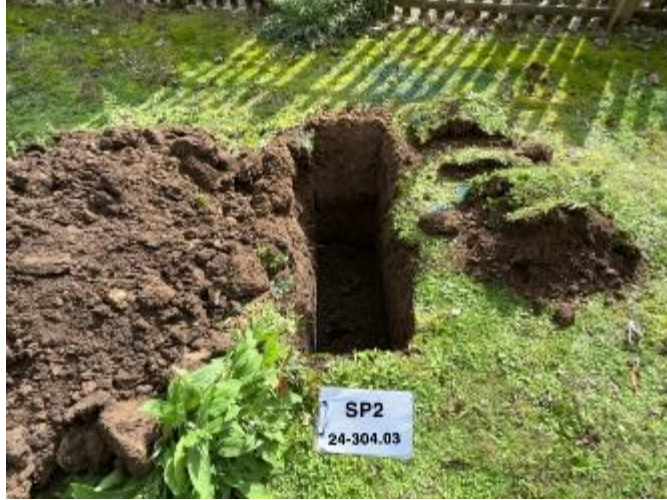
SP2 Hole Photo

| Table 2: Summary of Ground Conditions Encountered | | | |
|---|---|---|---|
| Topsoil | SP2 and SP3<br>Grass covered dark brown sandy clayey reworked TOPSOIL | GL | 0.3m |

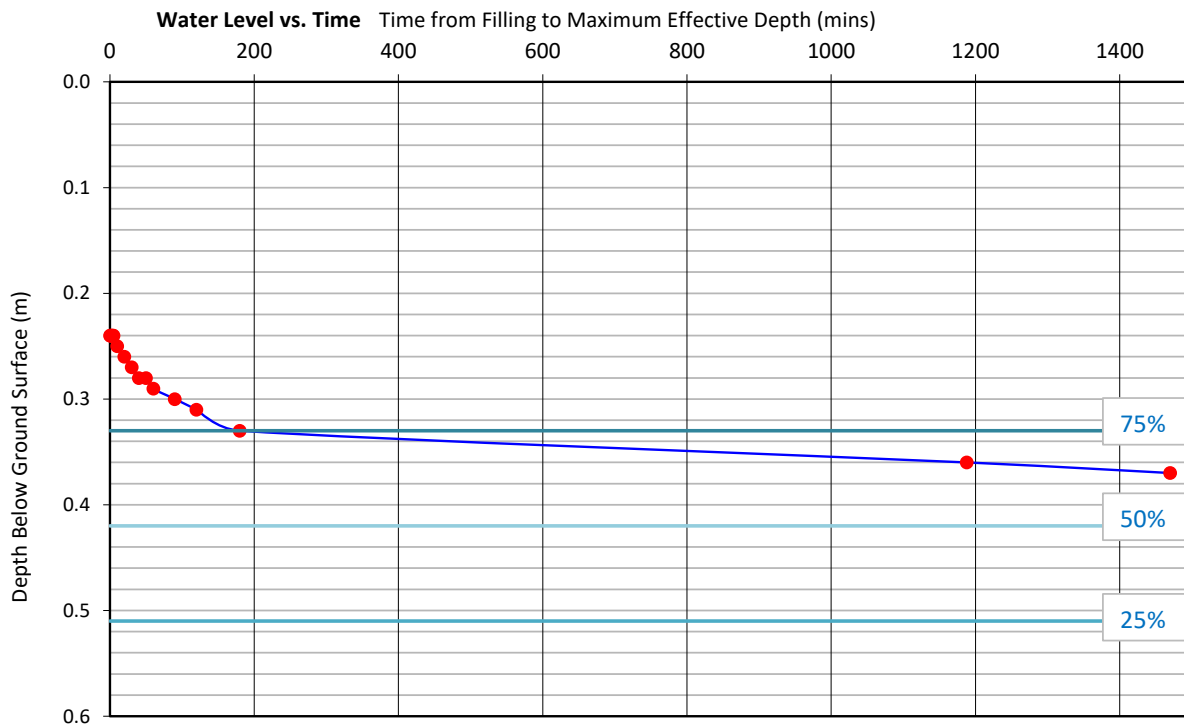
## Test Pit SP1-1

Pit Dimensions: 1m(l) x 0.45m(w) x 0.6m(d)  
Start Water Level: 0.24m

Time of water level fall,  $t_{p75-25}$ : - mins  
 $t_{p75-25}$ : 0 mins  
 $t_{p75-25}$ : 0 secs

Soil infiltration rate,  $f$ : 0.081/(0.972 x 0)  
 $f$ : #DIV/0! ms<sup>-1</sup>

| Table 3: Soil Infiltration Rates | | | | |
|---|---|---|---|---|
| SP1-F1 | 0.24m-0.6m | MADE GROUND-Gravelly CLAY | No rate | Following 24 hours of testing water levels failed to reach 50% or 25% full. It is not possible to determine an infiltration rate. |

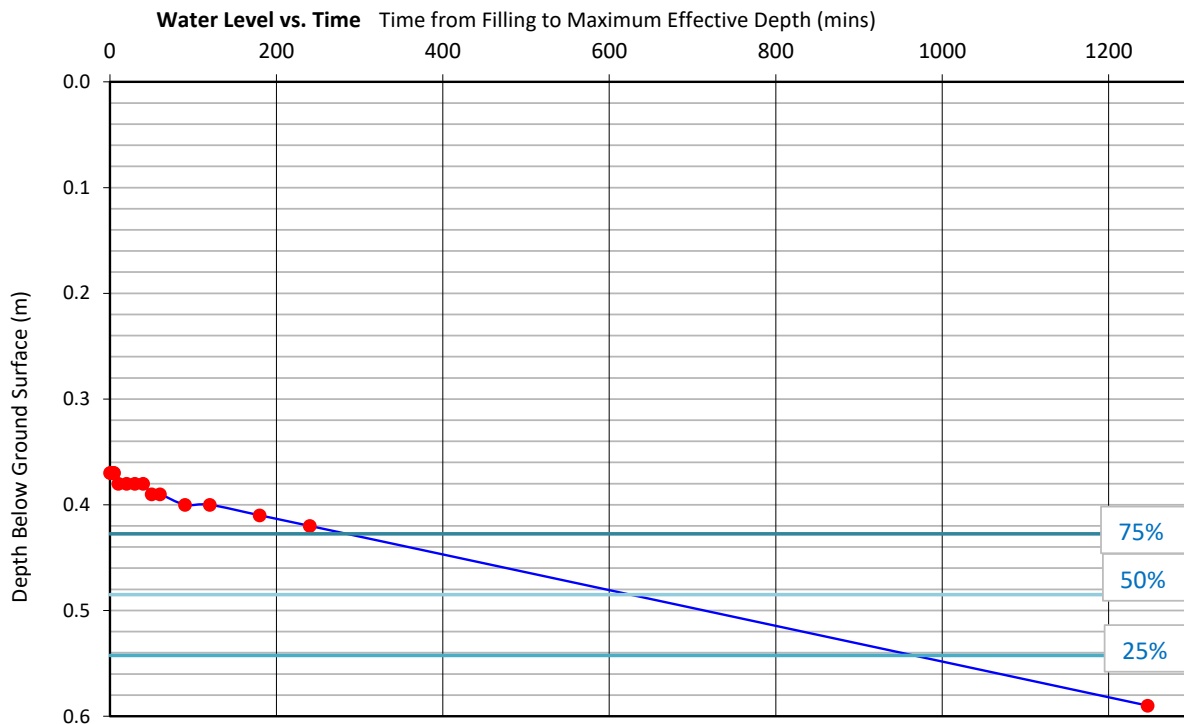
## Test Pit SP3-1

Pit Dimensions: 1m(l) x 0.45m(w) x 0.6m(d)  
Start Water Level: 0.37m

Time of water level fall,  $t_{p75-25}$ : 950 - 260 mins  
 $t_{p75-25}$ : 690 mins  
 $t_{p75-25}$ : 41400 secs

Soil infiltration rate,  $f$ : 0.05175/(0.7835 x 41400)  
 $f$ : 1.60E-06 ms<sup>-1</sup>

| Table 3: Soil Infiltration Rates | | | | |
|---|---|---|---|---|
| SP3-F1 | 0.37m-0.6m | Gravelly CLAY | $1.6 \times 10^{-6}$ | To determine the infiltration rate monitoring was completed over 2 days of testing with the 25% full level determined following a depth measurement taken on the 2 <sup>nd</sup> day. |

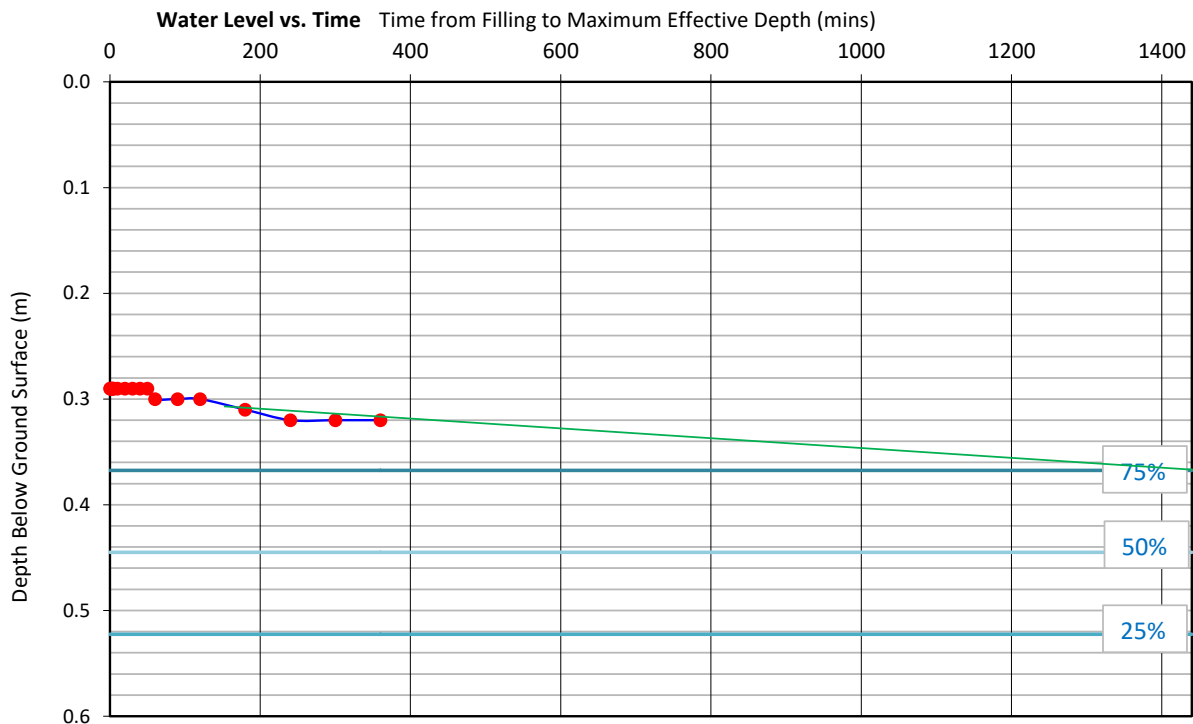
## Test Pit SP3-2

Pit Dimensions: 1m(l) x 0.45m(w) x 0.6m(d)  
Start Water Level: 0.29m

Time of water level fall,  $t_{p75-25}$ : 900 - 260 mins  
 $t_{p75-25}$ : 640 mins  
 $t_{p75-25}$ : 38400 secs

Soil infiltration rate,  $f$ : 0.06975/(0.8995 x 38400)  
 $f$ : 2.02E-06 ms<sup>-1</sup>

| Table 3: Soil Infiltration Rates | | | | |
|---|---|---|---|---|
| SP3-F1 | 0.29m-0.6m | Gravelly CLAY | No rate | Insufficient time remained during the shift on the 2 <sup>nd</sup> day of testing. A line of best fit has been applied to the graphical plot of <b>Appendix III</b> and the x-axis extended to 1,400 minutes (24 hours). From 240 minutes to 360 minutes water levels remained at 0.32m bgl and thus the extrapolated line suggests the water level would fail to reach 50% and 25% full after 24 hours. |
