## DEEP SOIL INFILTRATION TESTING

| <b>Project Type</b> | Deep Soil Infiltration Testing |
| <b>Site</b> | Ladds Garden Centre, Bath Road, Hare Hatch, RG10 9SB |

| 24-304.04 | 1 | 17 March 2026 |

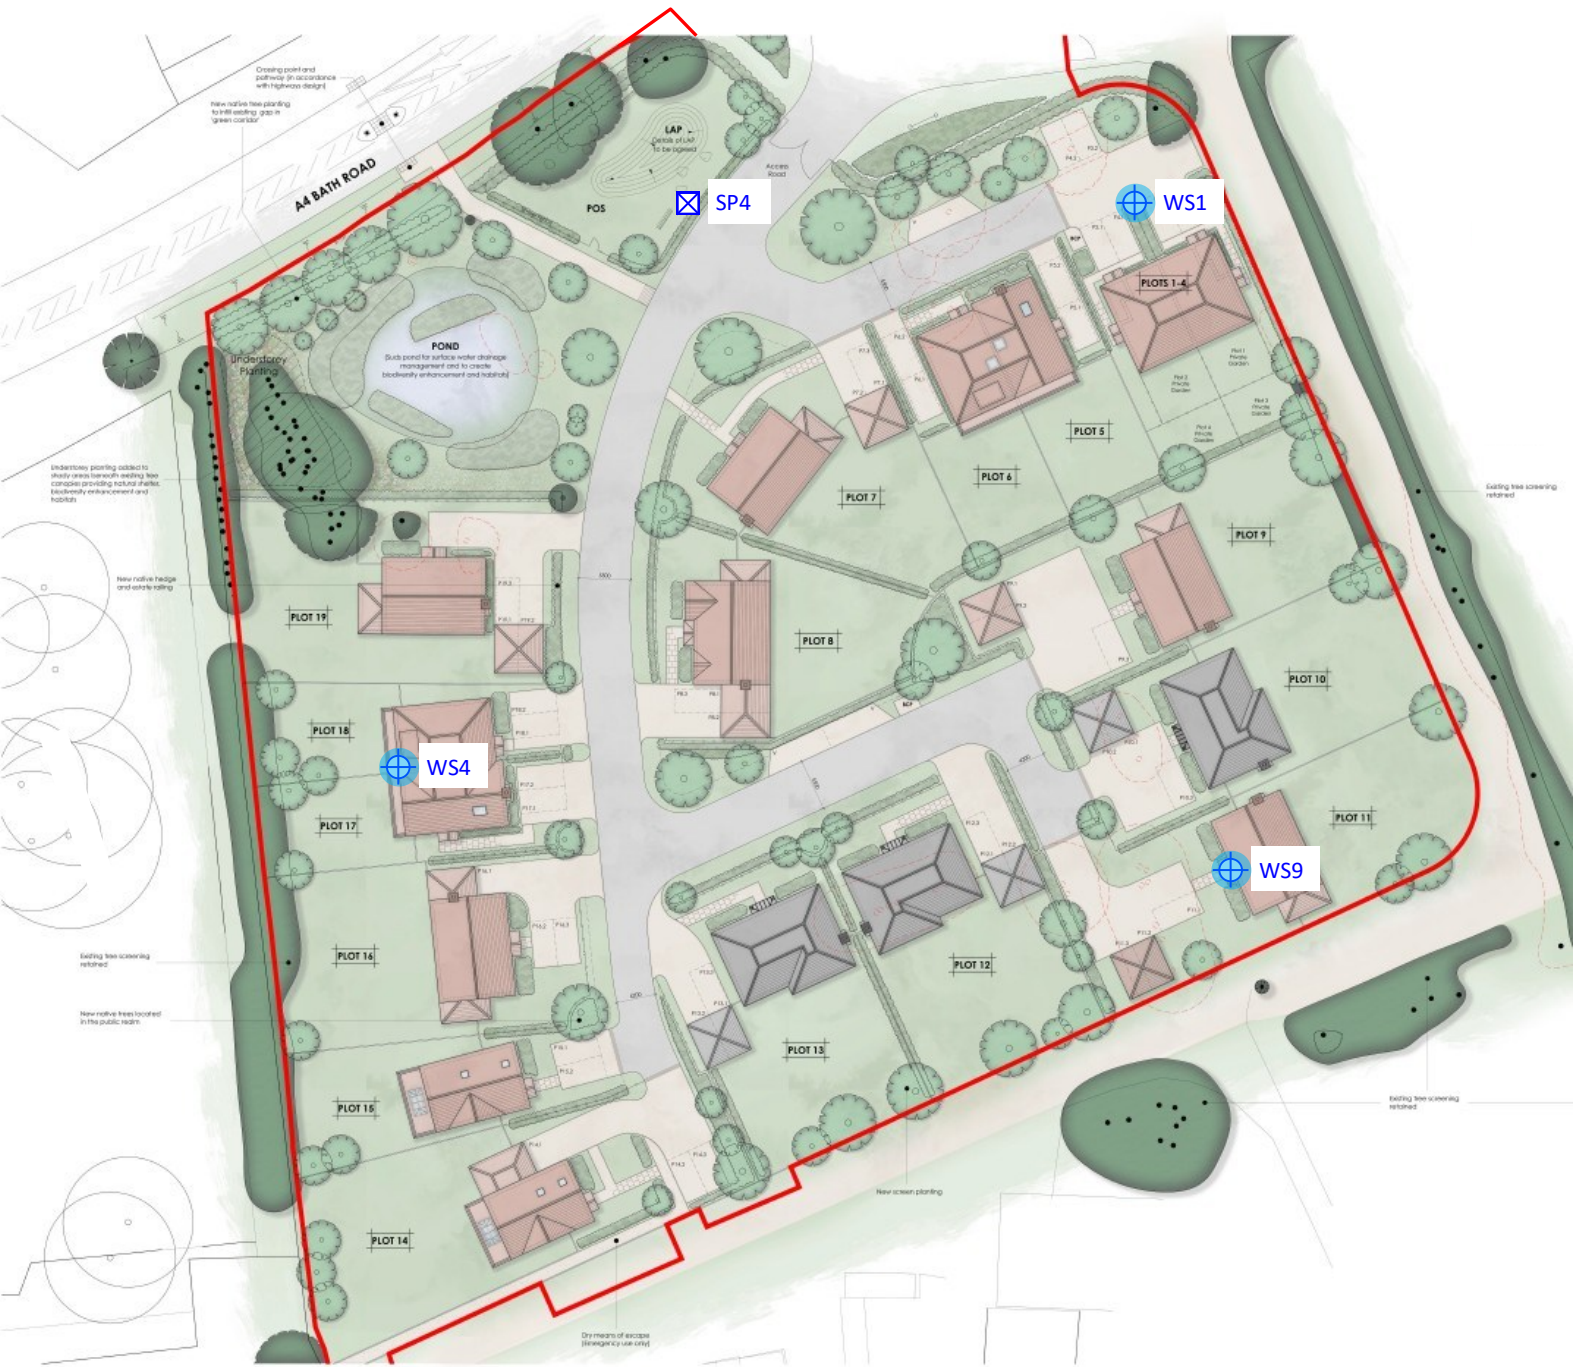
**Figure 3**

| Proposed Development and Exploratory Hole Location Plan | |

Trial pit SP4 was excavated using a JCB 3CX on 11 March 2026 to a depth of 3.3m bgl in order to complete infiltration tests and is shown within **Figures 2** and **3**. The rate of excavation rate was steady and sides of the trial pit were reasonably stable.

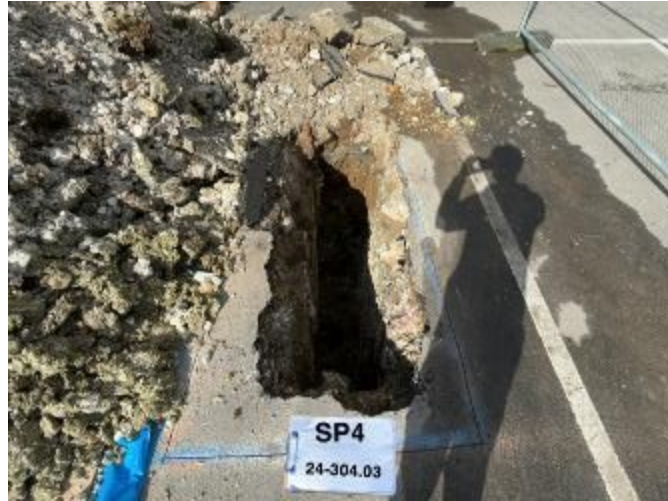
| Project: Ladds Garden Centre, Bath Road, Hare Hatch, RG10 9SB | | | | | | Project No: 24-304.04 | | Trial Pit: SP4 | | | | | |
|---|---|---|---|---|---|---|--|---|--|---|--|--|---|
| Structureless CHALK composed of sandy silty sub-angular to rounded GRAVEL. Clasts are very weak and weak, low density, white, off-white and cream with occasional black specks. Matrix is light brown, brown. Occasional medium and coarse gravel sized flints. Grade Dc. (SEAFORD CHALK FORMATION AND NEWHAVEN CHALK FORMATION) | | (1.2)<br><br>3.3 | | | | | | | | | | | |

SP4 Hole Photo

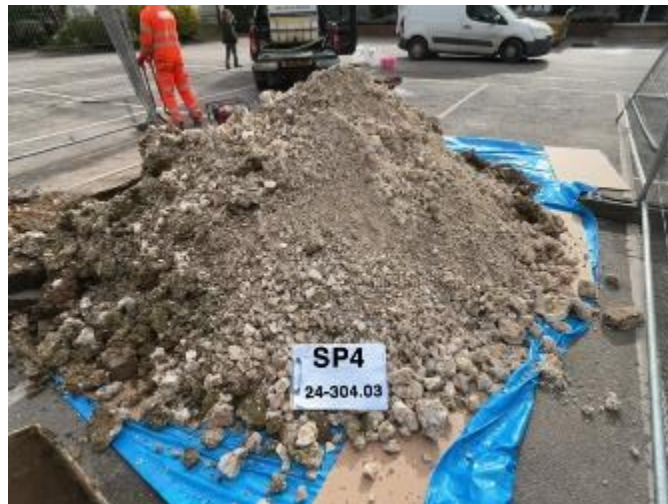
SP4 Arisings

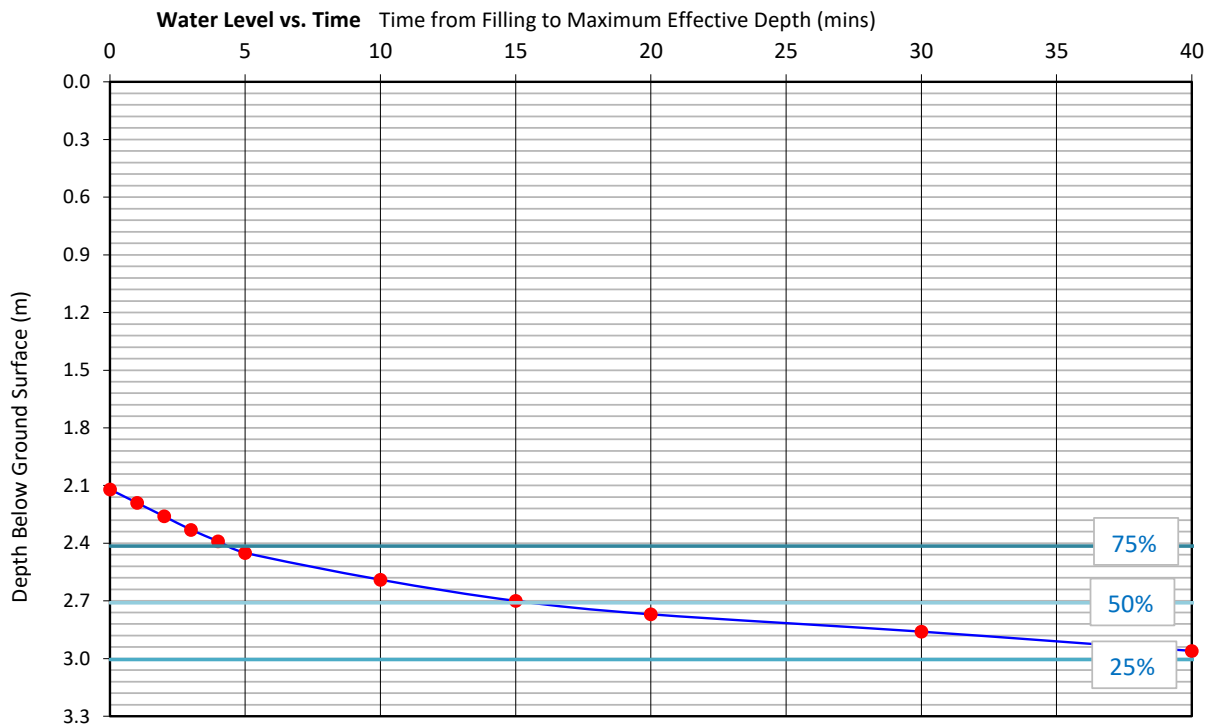
## Test Pit SP4-3

Pit Dimensions: 2.4m(l) x 0.45m(w) x 3.3m(d)  
Start Water Level: 2.12m

Actual Storage Volume: 3.56 m<sup>3</sup>  
Effective Depth: 1.18 m

Time of water level fall,  $t_{p75-25}$ : 49 - 4.5 mins  
 $t_{p75-25}$ : 44.5 mins  
 $t_{p75-25}$ : 2670 secs

Soil infiltration rate,  $f$ : 0.6372/(4.443 x 2670)  
 $f$ : 5.37E-05 ms<sup>-1</sup>

| Table 3: Soil Infiltration Rates | | | | |
|---|---|---|---|---|
| SP4 – F3 | | | 5.37 x10 <sup>-5</sup> | |
