## **BAT ROOST RE-ASSESSMENT REPORT CHICKEN BARN, STOKES FARM, BINFIELD ROAD, WOKINGHAM, RG40 5PR**

We write to confirm the bat roosting potential of a chicken barn within Stokes Farm, off Binfield Road in Wokingham, hereafter referred to as the 'Barn'.

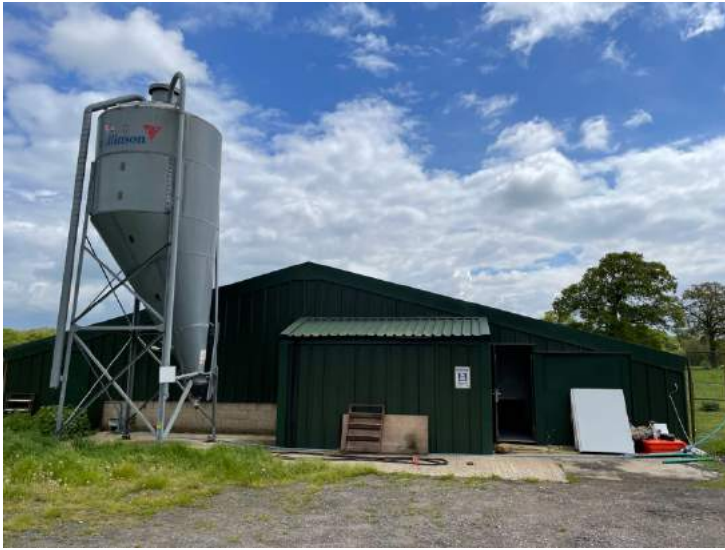
Frontage to Barn

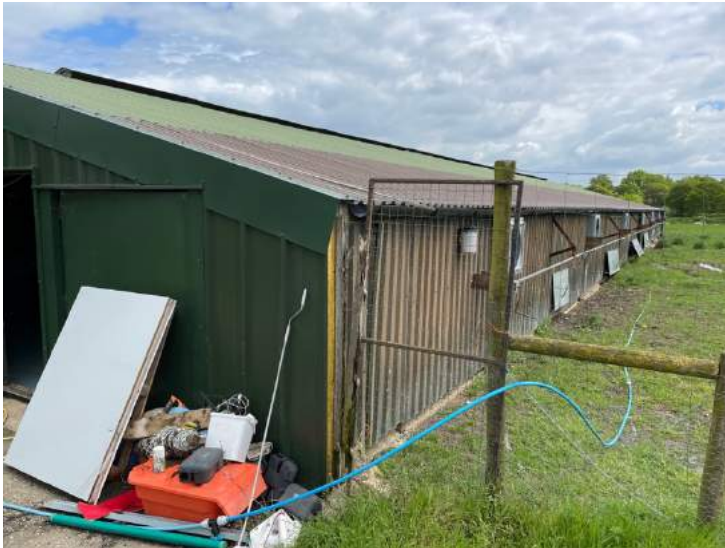
Side of Barn

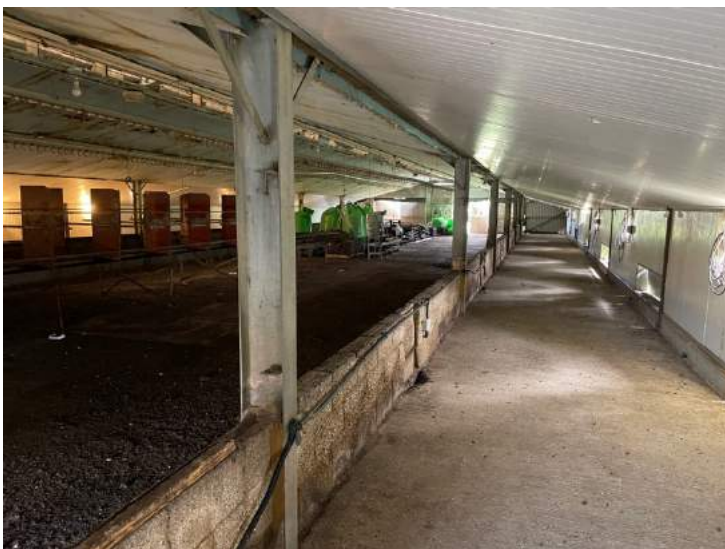
The central bare earth floor area was covered in dry guano, while the sides have a concrete pad that has a lighter covering of guano, along with intermittent clusters of rat droppings and bait traps. There was no obvious signs of bat droppings or insect remains.

Barn interior

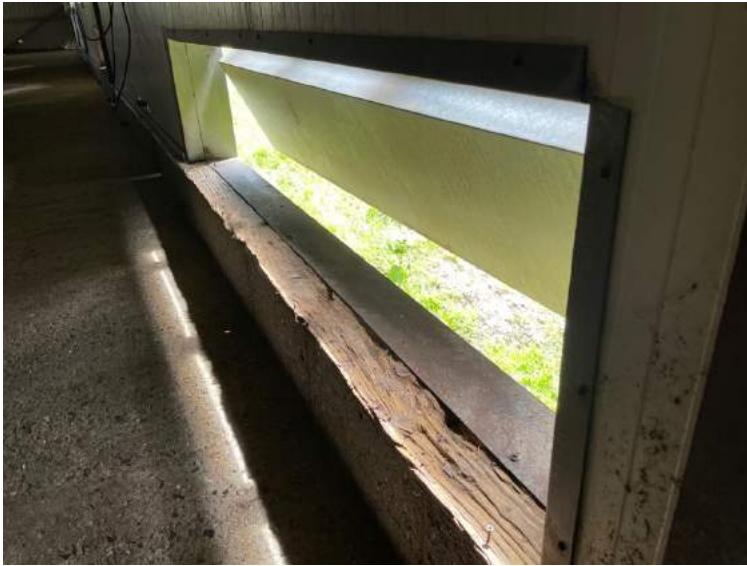
- Approximately 14 extractor fans (now stalled) and six chicken entry/exit flaps on either side of the building; and
- A c.200mm wide gap along the apex of the entire length of the roof.

Chicken access points

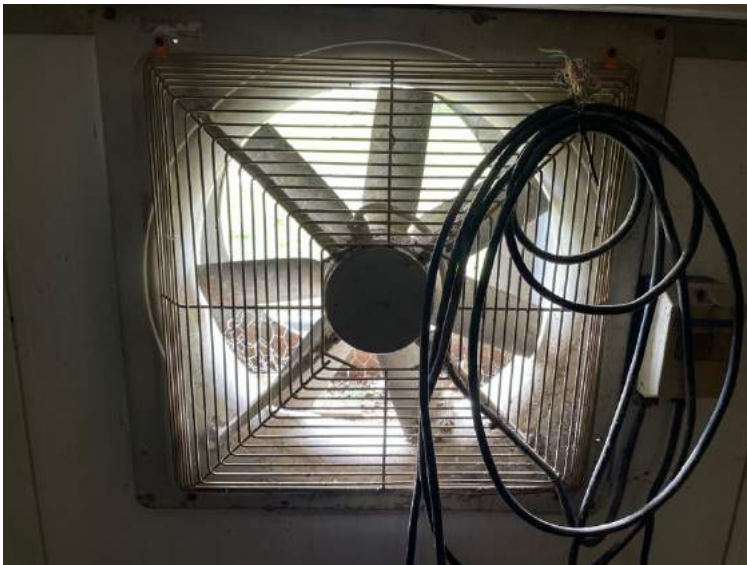
Fans

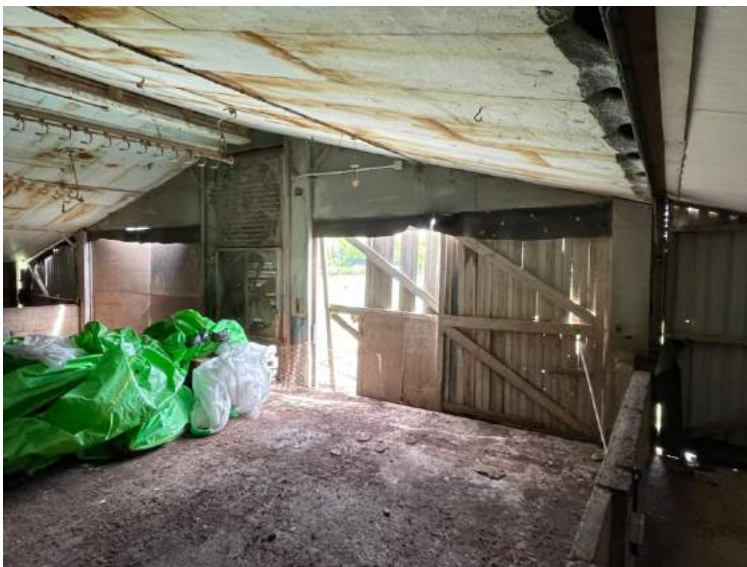
- Well-sealed frontage to the Barn, however, the rear door was damaged and permanently open;
- Tight-fitting steel panelling beneath the roof along the long-sides of the Barn, and polystyrene tiles underlying the roof within the central Barn area. Many of the polystyrene panels had holes and defects, while a few were also missing. There was a gap between the steel panelling and the polystyrene panels along the entire length of the Barn.
- Simple fabricated steel and wooden timber frame that offers no obvious potential roosting features.

Open rear to Barn

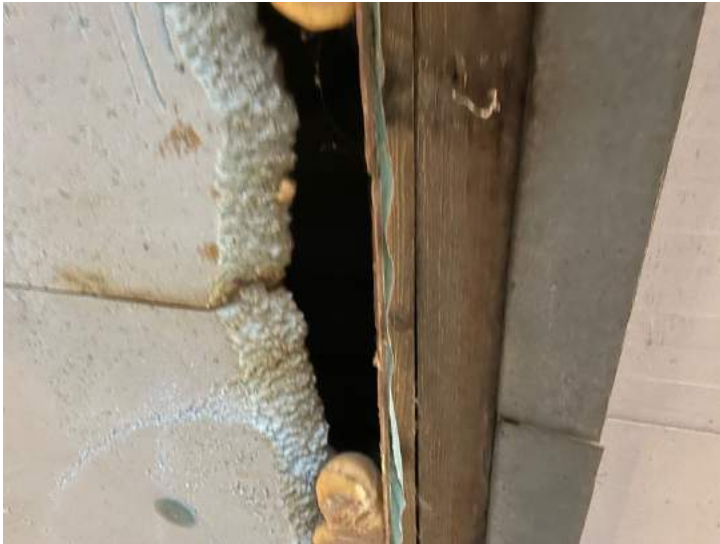
The only significant roost features are the two large voids that run along the length of the Barn, lying between the steel exterior panels and the internal polystyrene insulation panels. There are a number of ready access points into these two voids. However, the nature of the steel exterior is that it provides no thermal insulation from temperature extremes and therefore these expansive voids would be most unsuitable for roosting bats.

Gap between steel & polystyrene  
Panelling

**Recommendations** – For the reasons previously stated, the Barn is considered unsuitable for roosting bats and is it is considered acceptable to demolish or refurbish as required without further consideration of these species.

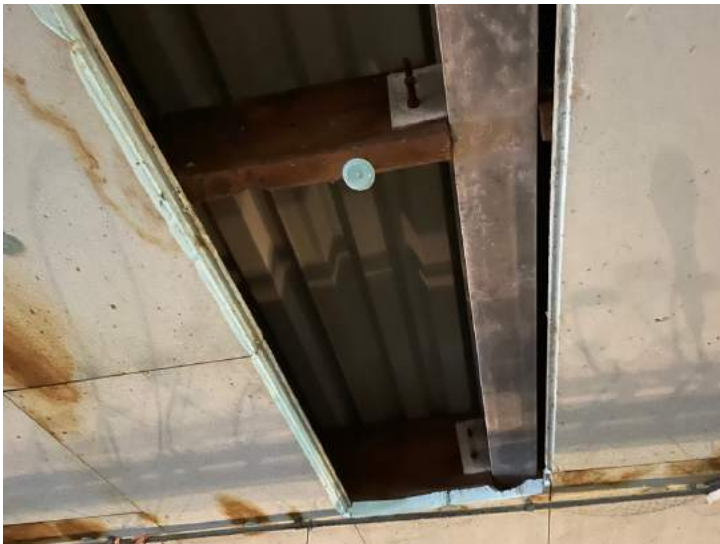
Missing polystyrene panel
