**Heriots,  
Wokingham Road,  
Hurst,  
Wokingham,  
RG10 0RX**

## **Phase 1 Daytime Bat Assessment**

**10<sup>th</sup> September 2024**

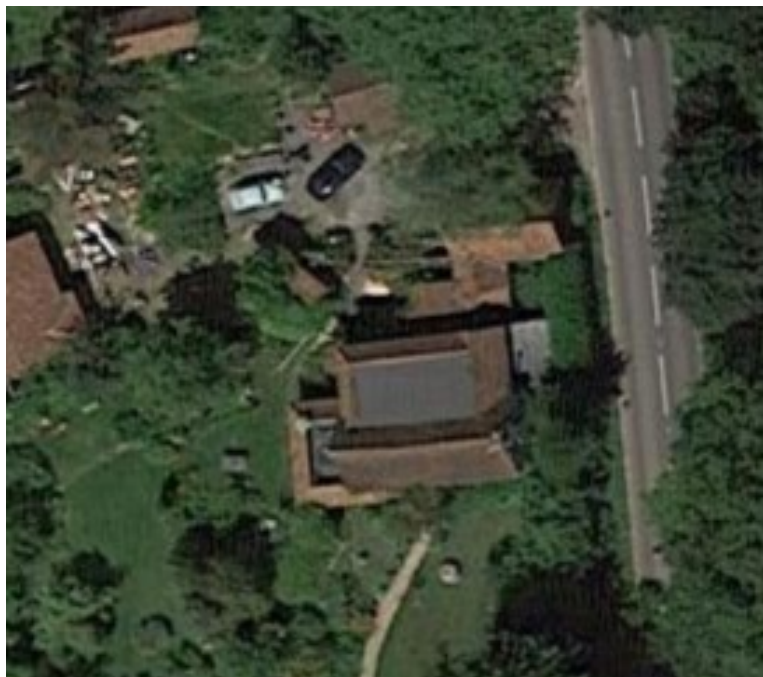
**Figure 2. Roof layout** *Courtesy of Googlemaps*

The house is a grade II listed building dating to the early 17<sup>th</sup> century with a large 20<sup>th</sup> century extension on north. (See figure 2). There are numerous openings into the under-tile spaces on the roof and into the under eaves (see figures 3-7).

There single storey extension off the rear is contiguous with the side garage. These have a felt covered roof and no internal voids and have negligible potential for (See figure 2 and 3).

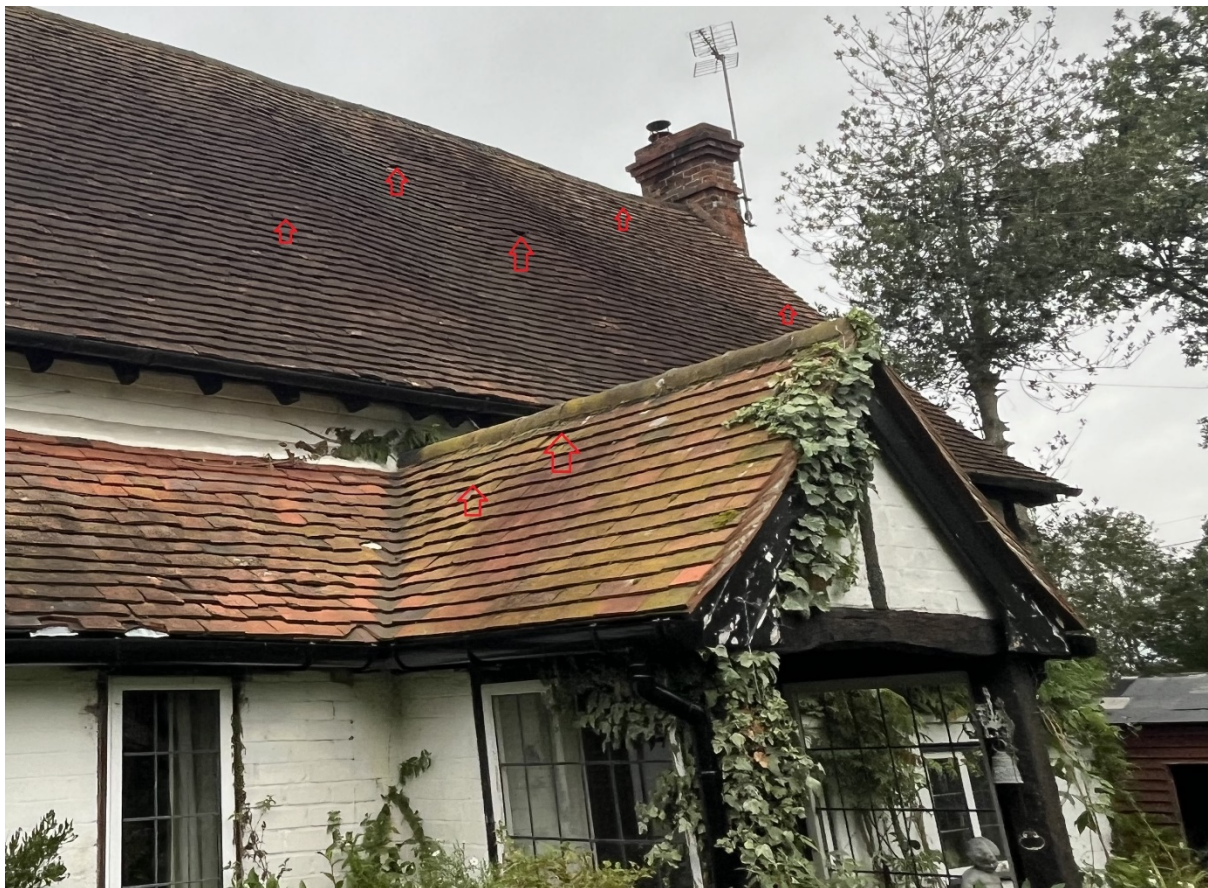
**Figure 3. Southern elevations (eastern half) looking northeast. Red arrows indicate potential openings for crevice roosting bats.**

There is evidence of historic bat activity in the loft of the oldest part of the house in form of droppings. There are inaccessible roof voids in the north wing and above the ground floor extensions. The clay tiled roofs have dozens of potential openings for crevice roosting bats. Therefore, the property has high potential for bats.

Phase 2 emergence surveys would be required to elucidate the current status of bats within the structures.

A dusk emergence survey is recommended to identify whether bats are utilising the property. These can be carried out in suitable weather between May and the end of September.

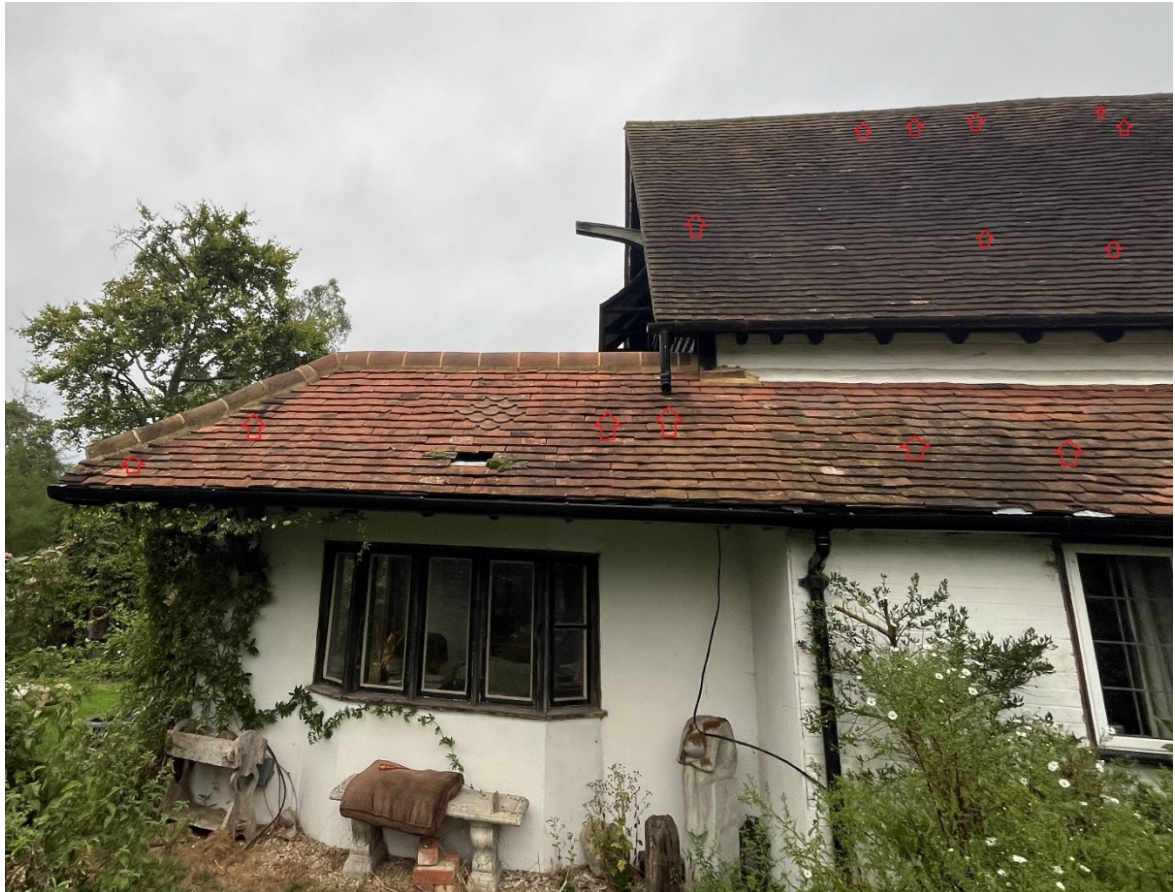
**Figure 4. Southern elevations (western half) looking north. Red arrows indicate potential openings for crevice roosting bats.**

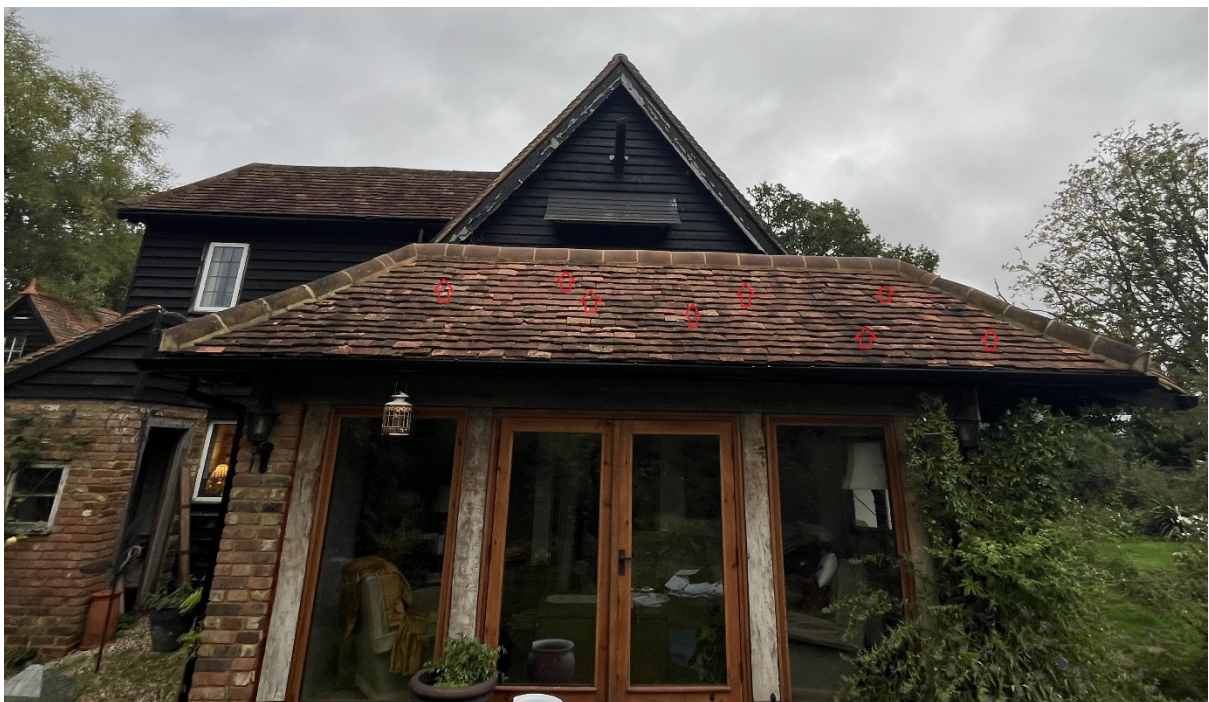
**Figure 5. Western elevations looking east. Red arrows indicate potential openings for crevice roosting bats.**

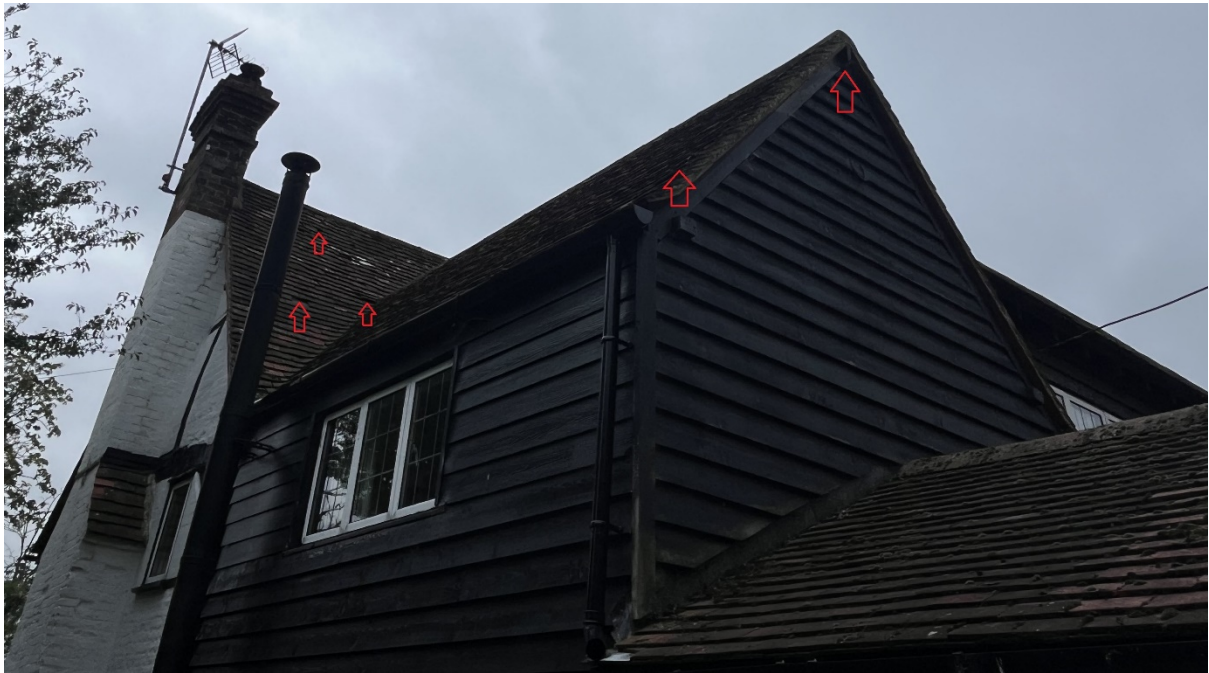
The roof space above the northern extension has a boxed off inaccessible void with a potential opening at the apex of the north gable (see figure 6)

**Figure 6. Northern and eastern elevations looking south. Red arrows indicate potential openings for crevice roosting bats.**

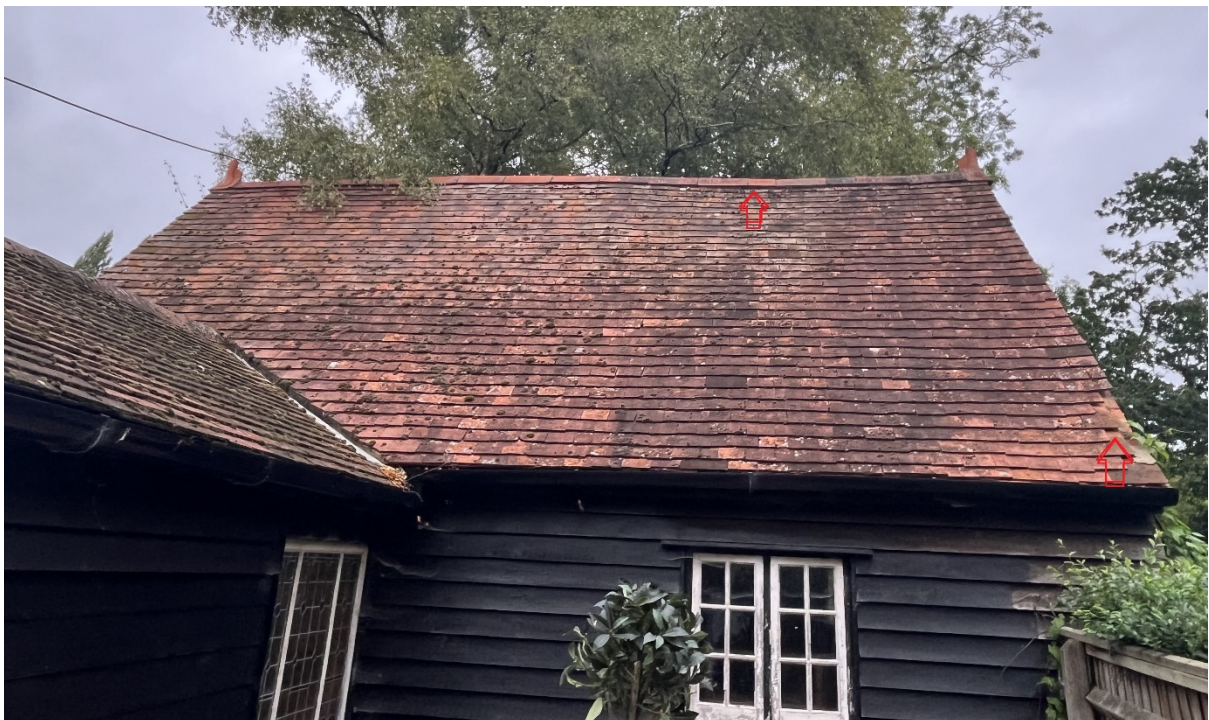
**Figure 7. North outbuilding looking north. Red arrows indicate potential openings for crevice roosting bats.**

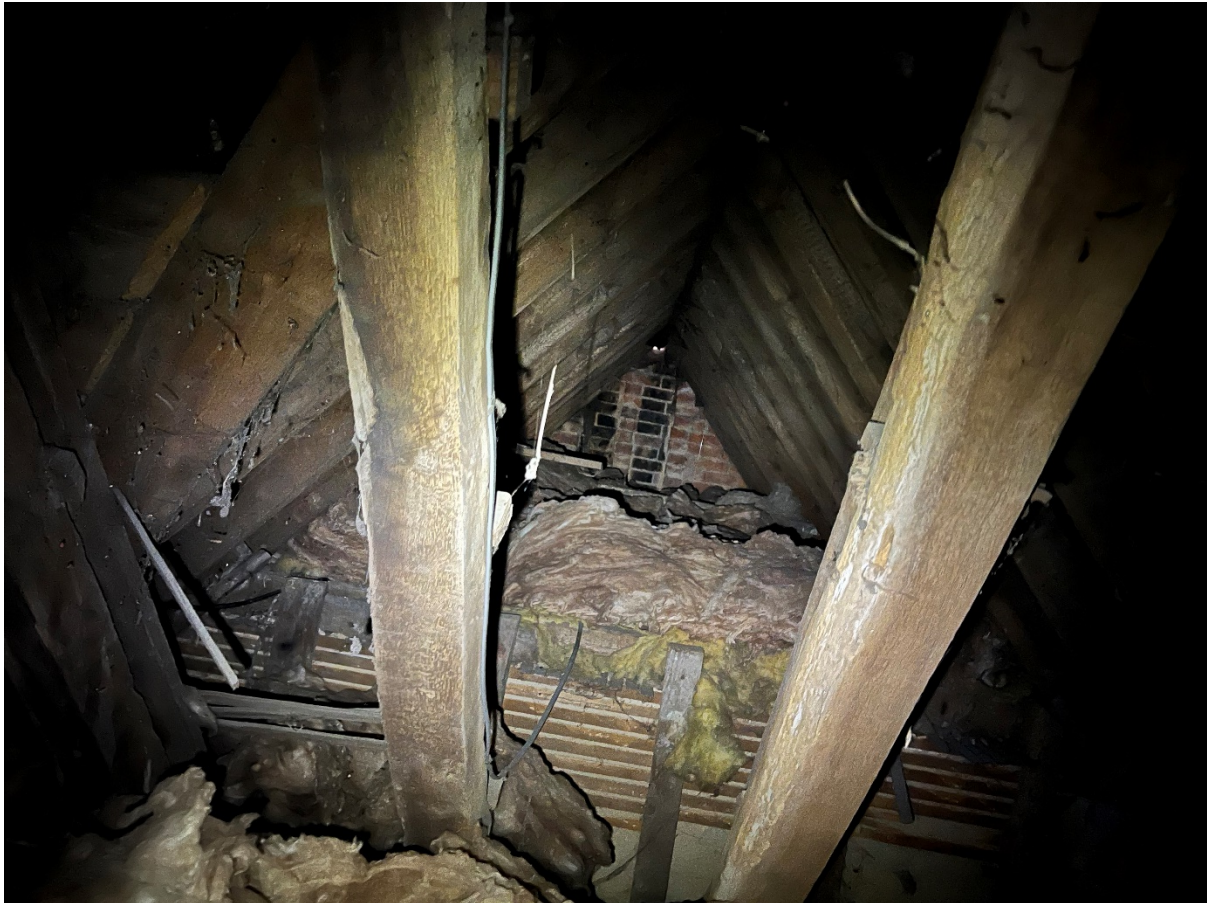
**Figure 8. House Loft**

The main loft is the oldest part of the house is accessed via a doorway up a small flight of stairs. The roof is lined with felting which is in good order (See figure 4). The floor is covered in glass fibre insulation and partly used for storage (see figures 5 and 6). There were a few old bat droppings on the floor of the loft.
