**Billingbear Lodge
Wokingham**

In accordance with your instructions, AA Environmental Limited (AAe) carried out a Preliminary Roost Assessment (PRA) of the above property on Thursday 10 July 2025. The purpose of the survey was to assess the presence or likely absence of bats utilising the buildings and provide appropriate mitigation measures, as necessary. A series of photographs has been attached for reference.

Photograph Record Sheet

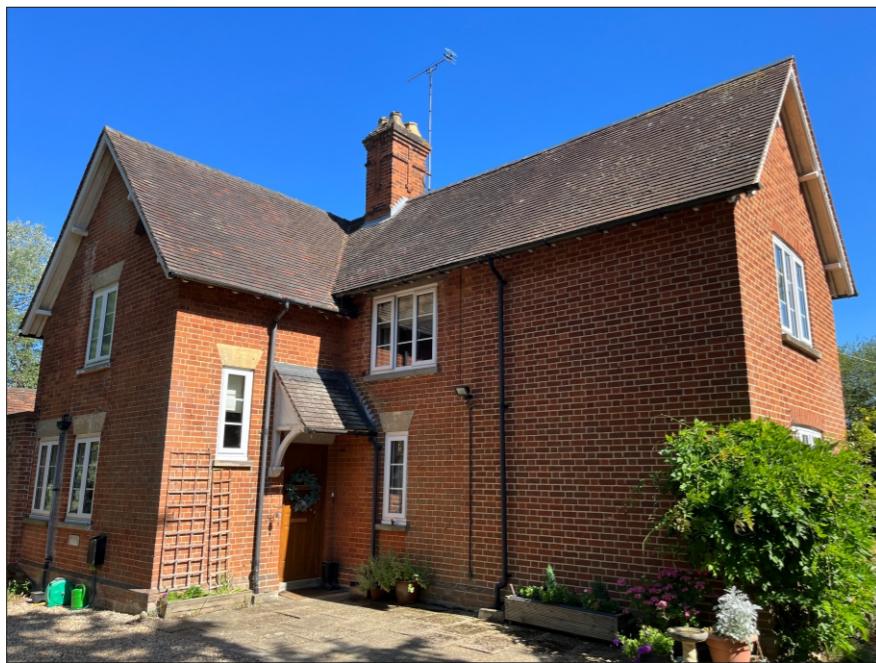
The site comprised the residential property and outbuilding with associated hardstanding and garden areas. The building was a detached two-storey residential dwelling of masonry construction with a pitched tiled roof with two chimneys and timber soffits and fascias. At the rear there was a masonry constructed single-storey extension with a pitched tiled roof with timber soffits and fascias as well as a flat roof section connecting to the main house. The single-storey outbuilding was of masonry construction with a pitched pantiled roof and timber cladding at each gable end. Wooden soffits and fascias were recorded. Internally, there was a single attic space recorded in the main building, which appeared to have been recently relined and insulated with mineral wool. The attic space in the single-storey extension was lined with a bitumen based membrane and insulated. Internal access into the outbuilding was restricted, with the roof void/roof space not fully accessed during the survey.

Photograph 1: Showing the front of the property.

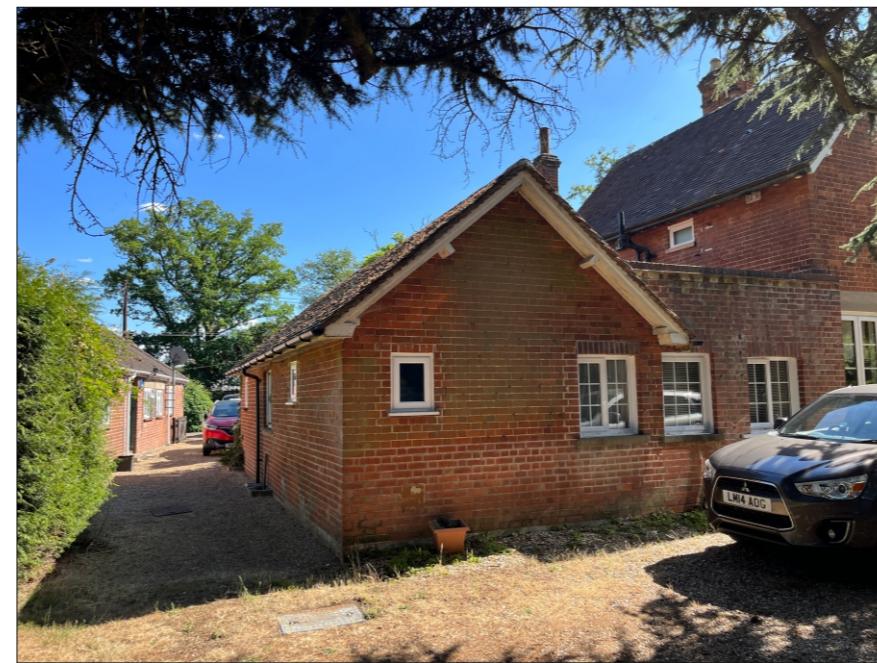
No evidence of bats was recorded during the external inspection of the buildings. The main building and extension lacked any key roosting features, such as areas of tile hanging. The timber cladding on each gable end of the outbuilding was generally tightly sealed with any gaps dusty and cobwebbed with no evidence of bats recorded. The roof tiles on the buildings were generally well-aligned and tightly sealed, with only a few restricted gaps recorded. During the internal inspection of the property, the main attic space was fully accessed and not complex allowing a thorough inspection to be completed, with an accumulation of mixed-age brown long-eared type droppings recorded. During the internal inspection of the single-storey extension, some scattered brown long-eared type droppings were recorded within the roof space. There was an active wasp nest present, which restricted full access.

Photograph 2: Showing the single-storey extension on the main property.

roost) will be carried out carefully and under direct supervision of the licensed ecologist/accredited agent, with the following precautionary measures implemented:

- all site operatives will be given a toolbox talk on the possibility of encountering bats and the legal protection they and their roosts are afforded (copy of a toolbox talk has been attached at Appendix A for reference);
- prior to any works, the buildings (confirmed to support a roost) will be carefully re-checked by a licensed bat worker/accredited agent for any roosting bats;
- initial works will be carried out with great care. All tiles (roof and ridge) will be lifted and removed by hand, lifting them clear with two hands rather than lifting the front and rolling the tile backwards which may crush any bats beneath;
- tiles will also be checked underneath before being stacked or discarded, as bats sometimes cling to the undersides of tiles; and
- a similar soft strip of other features that bats can utilise for roosting (such as timber barge boards/lead flashing) will be completed.

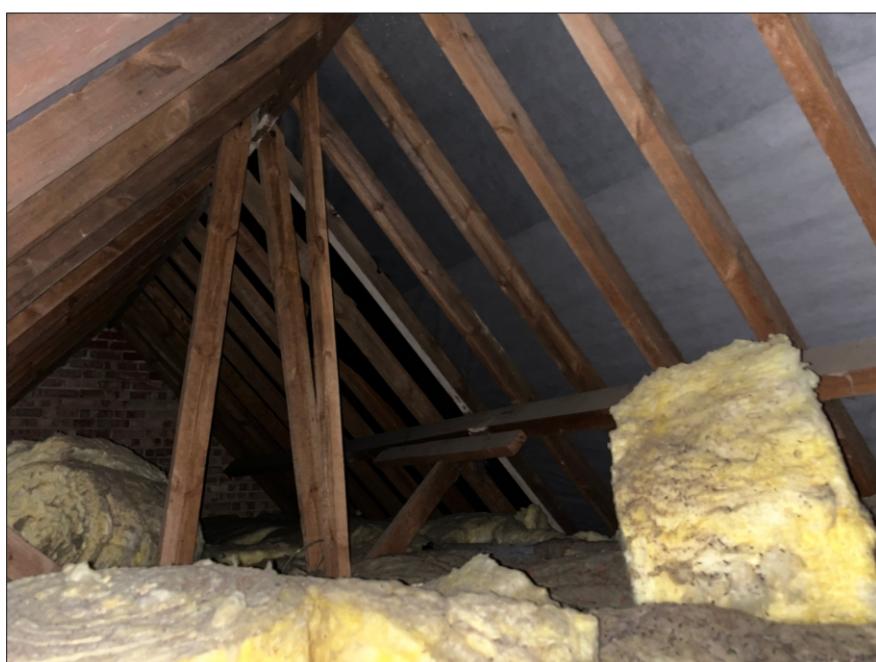
There are no habitats of international, national, county or local importance that would be directly affected by the proposals. The site, comprising a residential plot, is of overall limited ecological value, with the majority of the species recorded described as common or abundant and found in similar places across much of Britain, with the property considered to be a roost used by brown long-eared bats.

Photograph 3: Showing the roof space, with some brown long-eared bat type droppings recorded.

Although it is acknowledged that further surveys are required in order to confirm the status of the roost and provide the further details required to support the appropriate licence application to Natural England, it is important to note that a range of measures can be implemented on the site to minimise disturbance and maintain roosting opportunities for bats in the long-term, as detailed below.

In order to provide alternative/enhanced roosting opportunities for bats, four bat boxes (x4 2FN Schwegler Bat Boxes, or equivalent) will be installed on suitable trees on site. The boxes will be positioned in accordance with best practice and installed as soon as possible and prior to any works. It is important to note that the main roof space will remain largely unaffected, with any works appropriately timed and completed over a relatively short duration, with key works directly supervised by the licenced ecologist/accredited agent. Any new timbers will be treated with 'bat friendly' chemicals and any new roof lining will use a traditional bitumen-based felt (Type 1F) or an approved breathable membrane, which has passed a 'snag test' and has an appropriate certificate. If considered necessary, replacement/new access points will be provided in a similar location as currently being utilised by bats, with a corresponding gap provided within the roof lining (if required), to allow bats back into the attic space. Other works including the removal of the roof of the single-storey extension and demolition of the outbuilding (if confirmed to support a

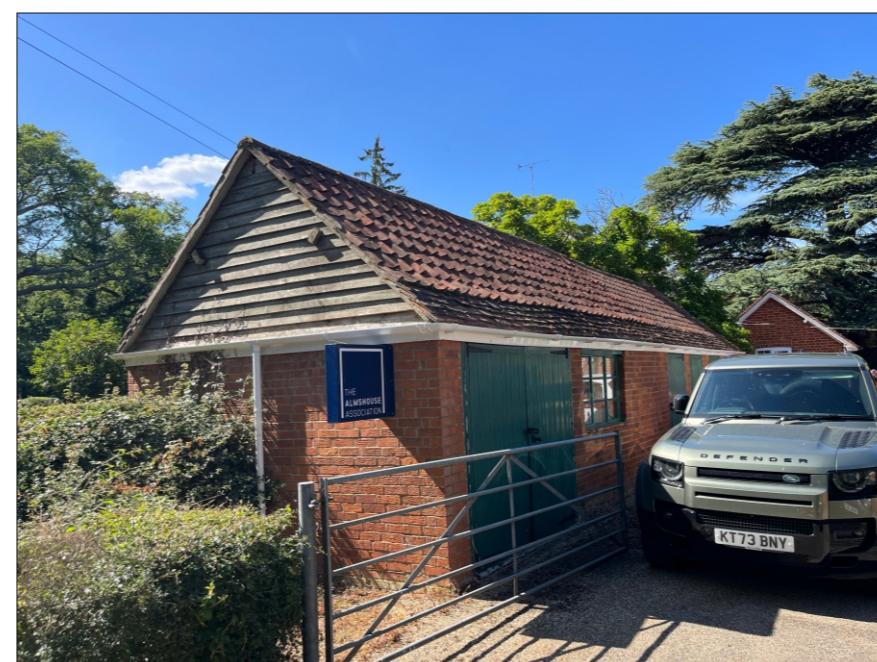
No droppings were recorded within the areas of the outbuilding that were accessible but it is important to note full access was not possible.

Photograph 4: Showing the single-storey outbuilding.
