# MEMORANDUM

| <b>Address:</b> | 19 Woodward Close, Winnersh, Wokingham, RG41 5NW. | | |
| <b>Proposal:</b> | Householder application for a proposed loft conversion including a large rear dormer and a small front dormer to achieve head height over the staircase, alongside installation of solar panels on the roof, with fenestration. | | |

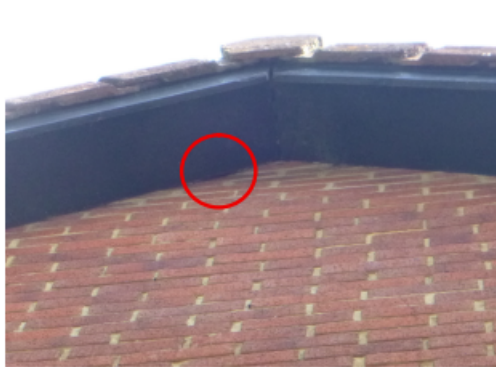
The Preliminary Roost Assessment external inspection identified two areas of potential access for bats. Gaps below the soffit at the apex of the southern gable, and a missing section of plastic ridge guard at the southern end of the ridge. Approximately 350-400 small bat droppings, were observed at the southern gable end inside the roof void is consistent with the house supporting a regularly used summer day roost. The distribution of the bat droppings corresponded with the potential access point in under the soffit, along with the observation of one small bat dropping externally below the soffit gap, and confirms the presence of a roost. The quantity of bat droppings could be indicative of the presence of a small maternity colony but cannot be confirmed by the Ecologist at this stage. The northern gable

Photograph 7. Gap under soffit near apex of the gable (southern elevation).

of roosting bats within the void. In the unlikely event that a bat roost is found during the soft strip, by either uncovering bat droppings or encountering a bat, the work must stop immediately and must not continue until further written advice has been received from the supervising ecologist. A European Protected Species mitigation licence may be required to permit the works to recommence lawfully.

Provided at the Precautionary Method of Working and a closing out report are secured, there are no ecological objections to the proposed development.

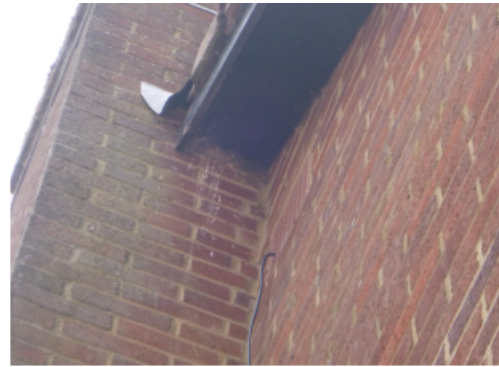
also had gaps over the blockwork along the sides with bird droppings and evidence of nesting material visible on the internal wall. The potential roost features at the southern and northern gable apices are suitable for use by small crevice-dwelling bats, such as the locally recorded Common pipistrelle and Soprano pipistrelle. The Ecologist concludes that the gable end walls have potential to support regular use by individuals or small groups of non-breeding bats. I agree with assigning the house as having moderate potential suitability for roosting bats.

Photograph 8. Lifted lead flashing around chimney and evidence of nesting birds at the soffit (northern elevation).
