**Land at Sonning Golf Club, Duffield Road,  
Sonning-on-Thames, Reading, Berkshire RG4 6GJ**

**Biodiversity Enhancement Strategy**

**August 2026**

***on behalf of Sonning Golf Club Limited***

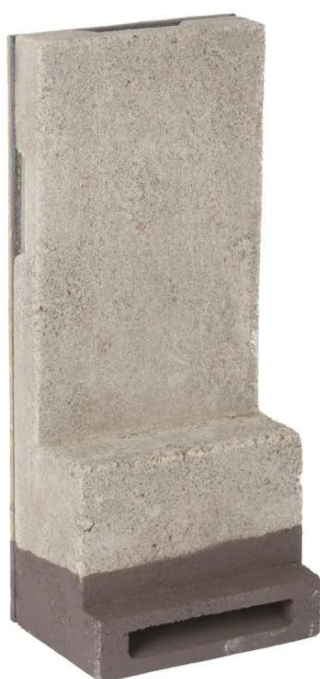
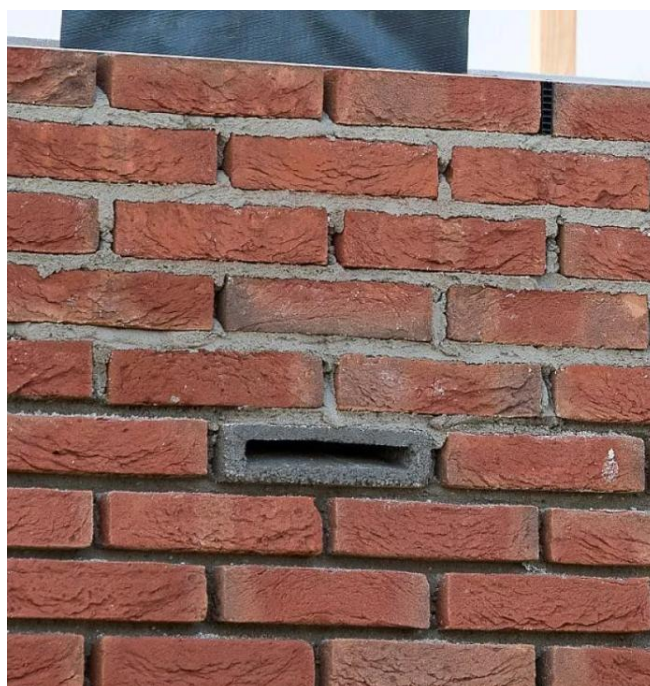
Figure 1. Vivara Pro Build-in Woodstone Bat Box, showing how the box can be integrated into a wall. Source: [www.nhbs.com](http://www.nhbs.com).

One integrated bat tube (Vivara Pro Build-in Woodstone Bat Box, or similar) will be incorporated into the external walls of each of the proposed dwellings, see Figure 1 and Appendix 1 shows the indicative locations of the integrated bat tubes. The tube will be positioned at a minimum height of 3m with a clear flight path to the entrance. The bat tube will be installed on the south or south-western elevation of the proposed elevations and will not be installed above a door or window to avoid accumulation of droppings.

Bat tube features (sometimes also referred to as 'bat bricks') can be obtained prefabricated and integrated directly into the fabric of the exterior walls of a building. The bricks/tubes have an external entrance slot which leads to an internal cavity for roosting.

The brick/tube can be concealed behind external cladding, brickwork, hanging tiles, stonework or render. For example, bat bricks/ bat tubes can easily be installed into traditional or modern buildings with external wooden weatherboarding; the brick/tube being concealed behind the overlapping wooden boards with access via a gap under a lifted board which leads to the entrance slot of the brick/tube. Bats can fit through very small gaps and so a crevice of 2-2.5cm should be sufficient to allow access to the slot of the bat brick/tube.

The Vivara Pro Build-in Woodstone Bat box is of Woodstone® (a mix of concrete and FSC wood fibres) construction. This material is strong and highly insulating, which helps to provide a thermally stable environment within the box. The bat tube will be installed during construction of the dwellings.

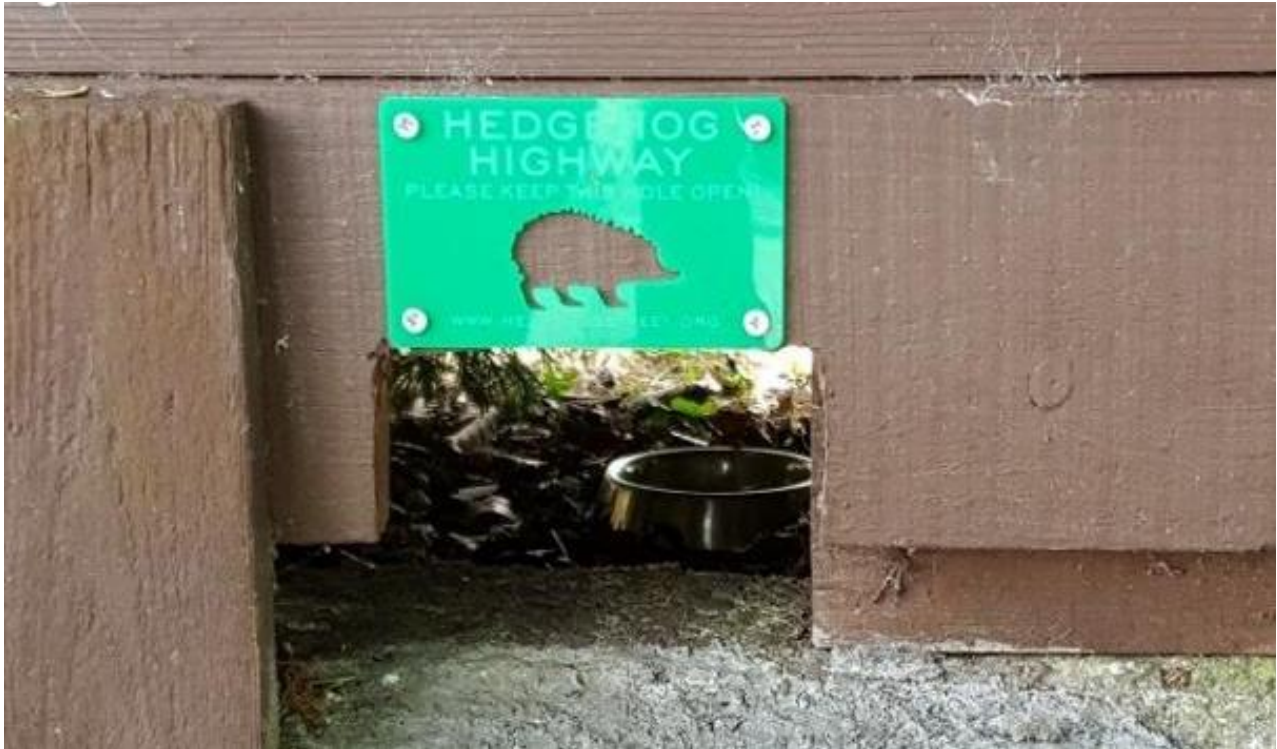
*Figure 4. An example of a hole cut within a fence, creating a 'hedgehog highway'.*

Garden fences or walls erected within the development (that could act as a barrier to hedgehog movement) will be made permeable for hedgehogs. This can be achieved by cutting or leaving a 13cm-by-13cm hole within the fence or wall; this is sufficient for any hedgehog to pass through, and this is too small for nearly all pets (see Figure 4).
