**Report prepared at**  
Land at Johnson Drive  
Finchampstead  
RG40 3NW

**On behalf of**  
Palatine Homes Limited

**Report reference**  
23-176.01

| Report Quality Management | | | |
|---|---|---|---|
| <b>Project Title</b> | Preliminary Risk Assessment and Site Investigation | | |

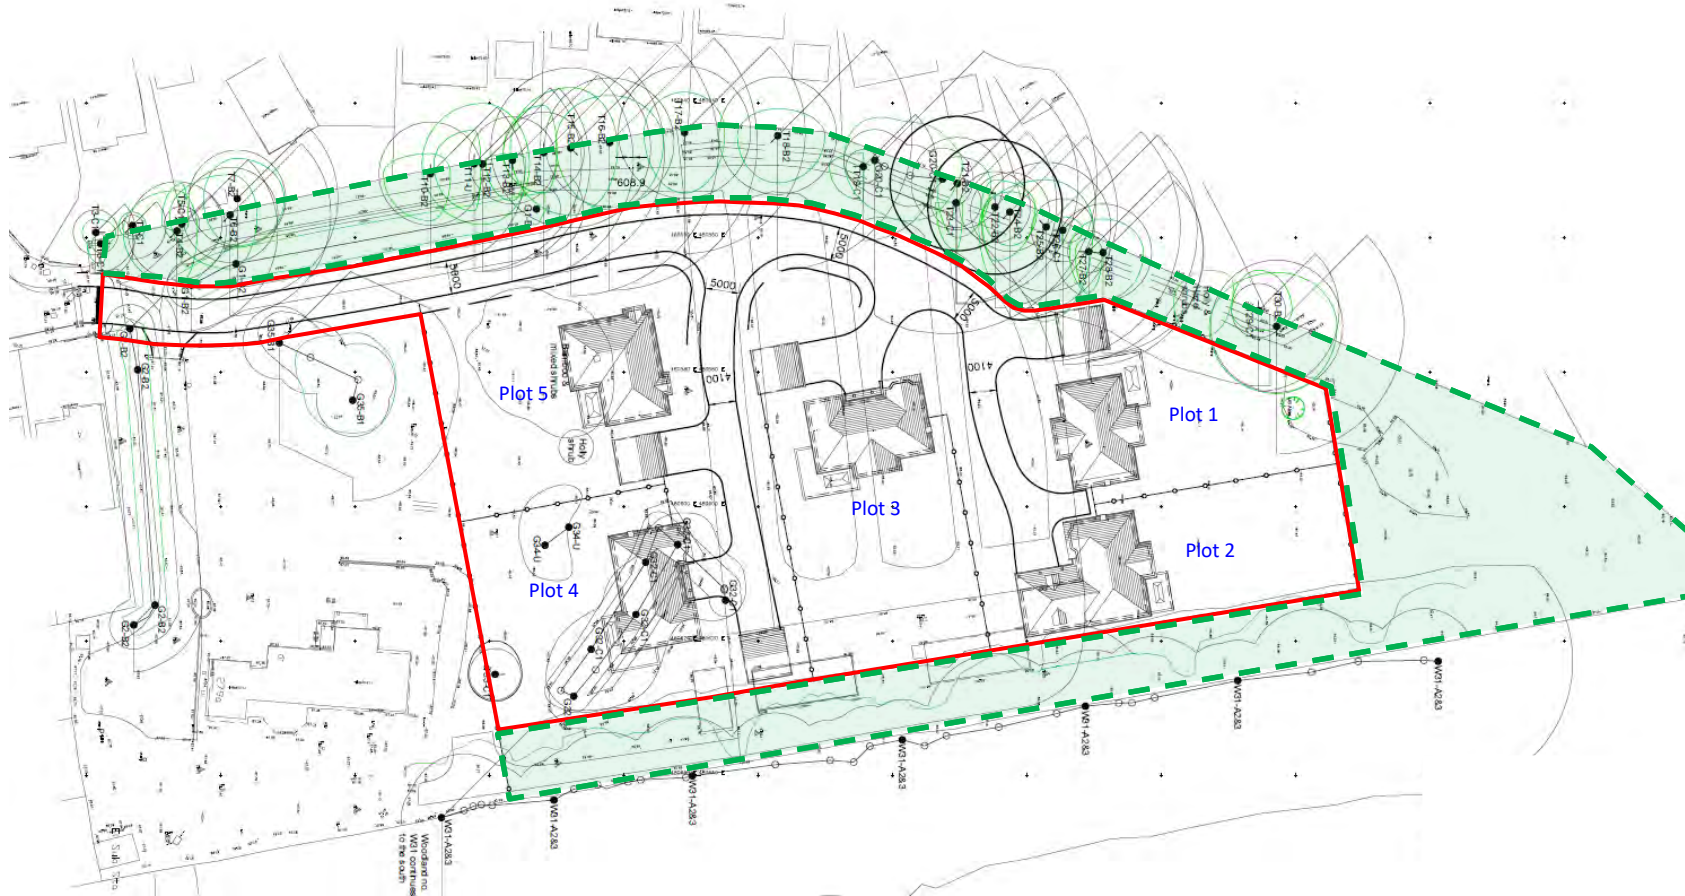
#### Figure 5

| Table 1.2: Site Details | |
|---|---|
| <b>Proposed Land Use</b> | The proposed development comprises the construction of five new detached homes and garages with private gardens, and an access road running along the northern boundary and into the centre of the site at two locations.<br><br><b>Figure 5</b> is presented as the Proposed Development Plan. |

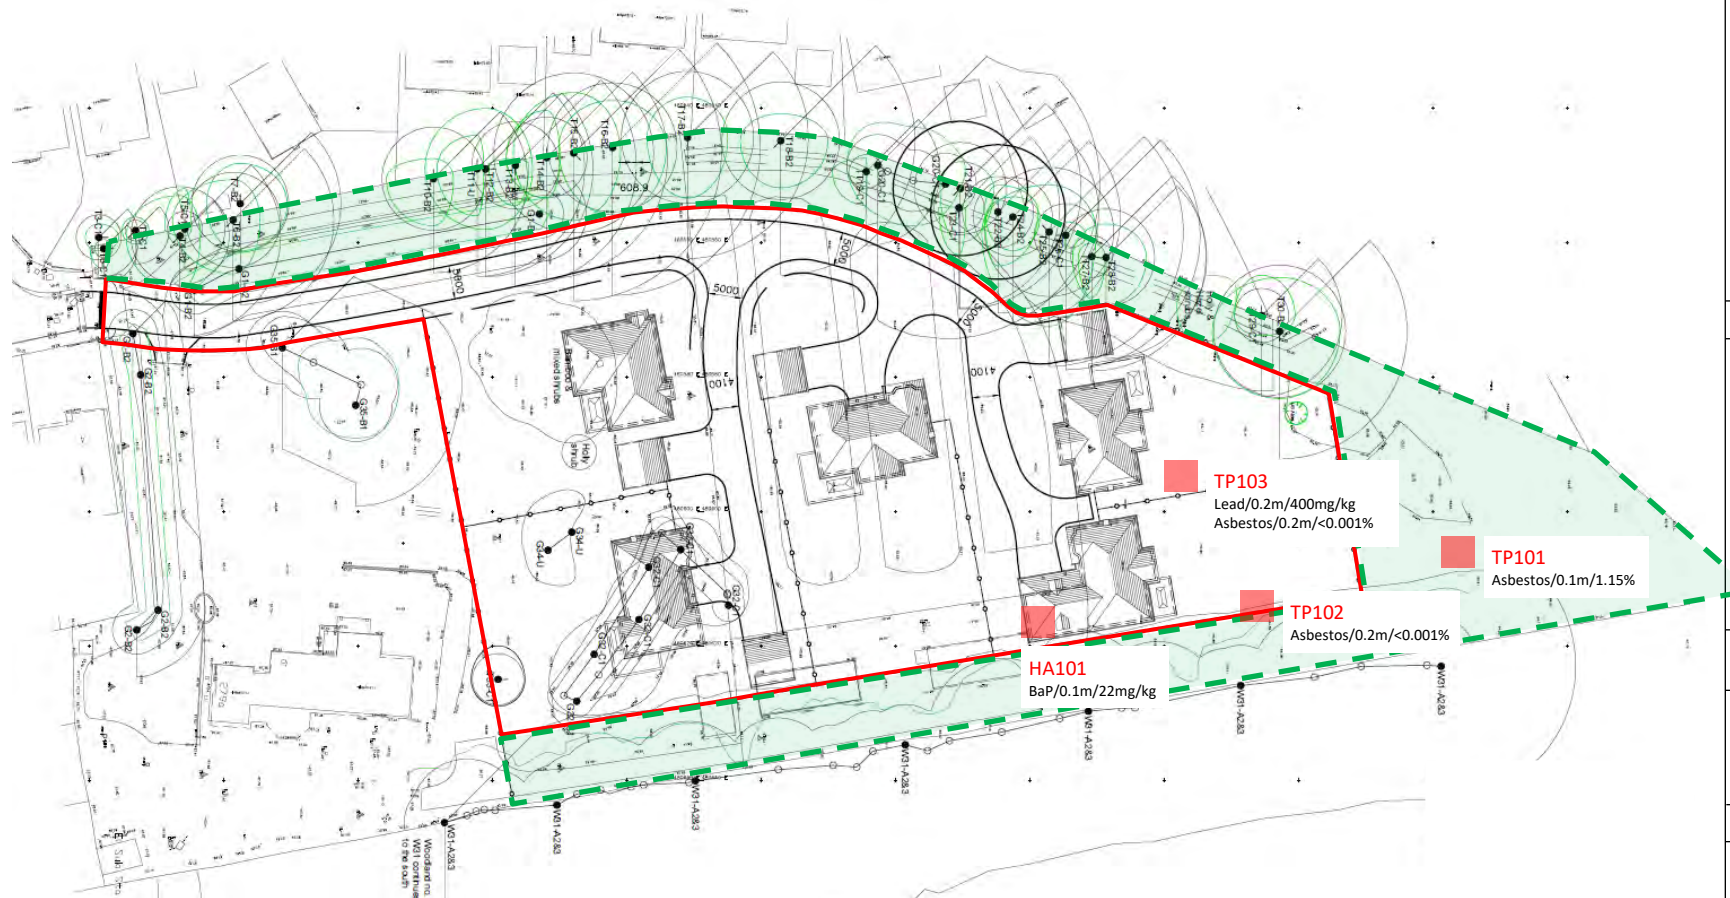
#### Figure 6

Figure 6 is presented as the Southern Testing Soil Contamination Identification Plan

At three positions (TP101, TP102 and TP103) as shown in **Figures 6 and 9** Southern Testing (in 2017) have recorded ACMs and Asbestos Containing Soils (ACS) containing two types of asbestos (chrysotile and amosite). TP101, TP102 and TP103 are located in the north of the site where building materials/rubble (were and) are stored in an area which shall become rear gardens to Plots 1 and 2. Contrary to the results recorded by Southern Testing, Aviron collected three samples of Made Ground in the northern area of the site at triangulated positions WS5, WS6 and TP9; which all recorded the absence of asbestos and acceptable determinant concentrations. It maybe, that following post-2017 earthworks (involving the removal of a bund and stockpile) after Southern Testing completed their investigation the earthworks disturbed and dispersed asbestos fibres from situ.

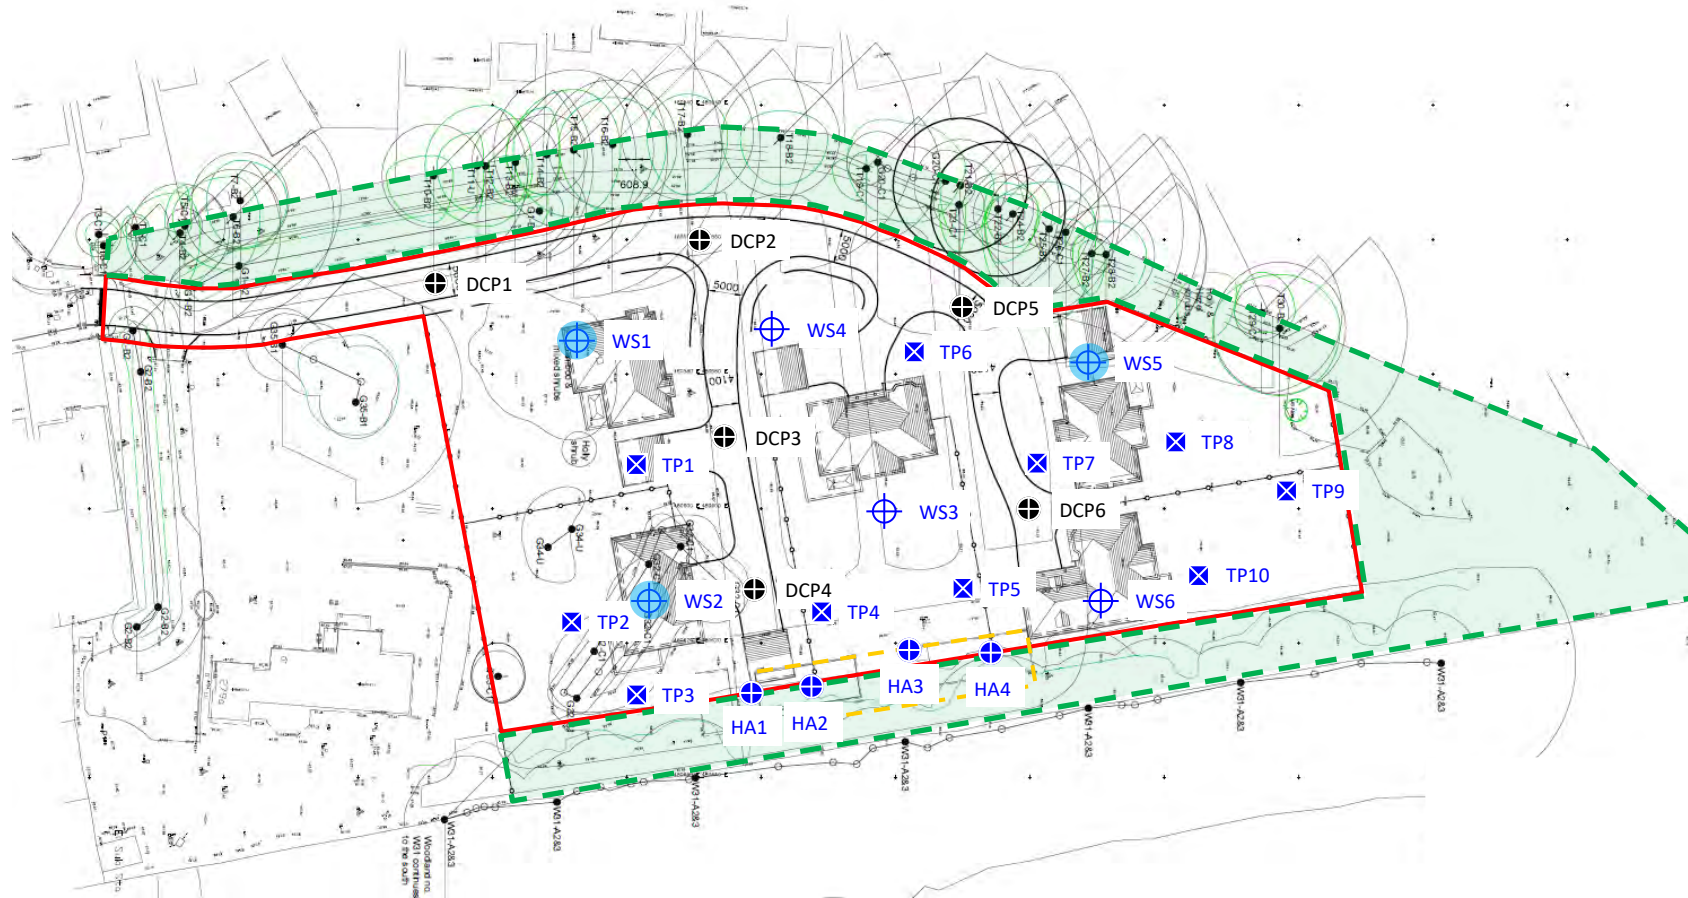
#### Figure 8

Exploratory Hole Location Plans are enclosed as **Figures 7 and 8**.

The tests were undertaken at the locations included in **Figures 7 and 8**.

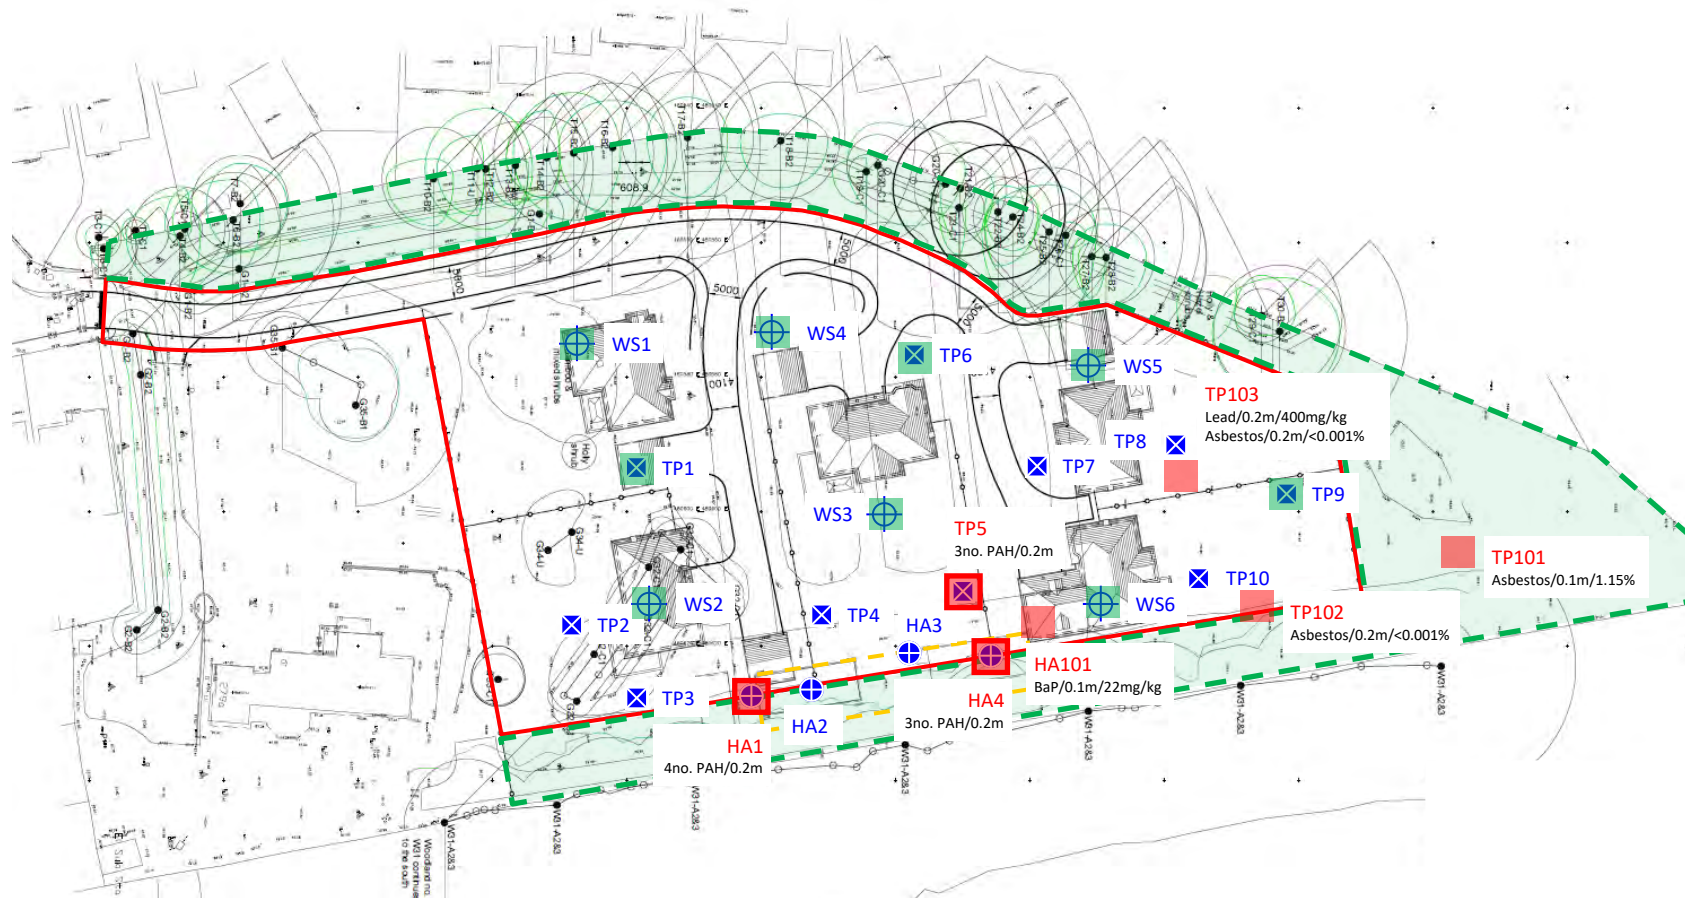
## Figure 9

**Figure 9** is enclosed as enclosed as Combined Soil Contamination Plan which enable the following remedial works to be suggested:

**Figure 9** is enclosed as enclosed as Combined Soil Contamination Plan which indicates potential risks to end users are from:

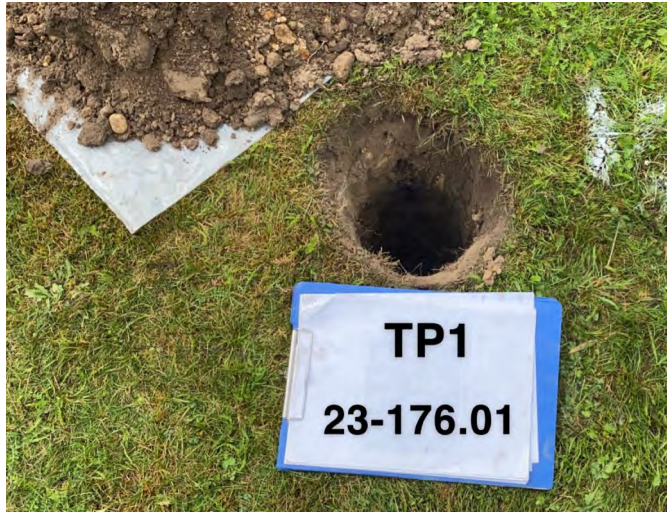
| TP1 | South-west of the site in the soft landscaped area, and rear garden of Plot 5, to determine shallow ground conditions and enable land contamination assessment/testing. | Not installed. |

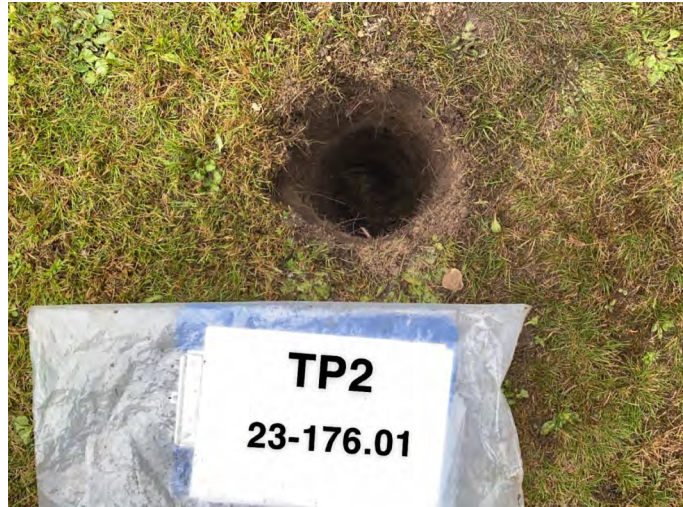
| TP2 | South-east of the site in the soft landscaped area, and rear garden of Plot 4, to determine shallow ground conditions and enable land contamination assessment/testing. | Not installed. |

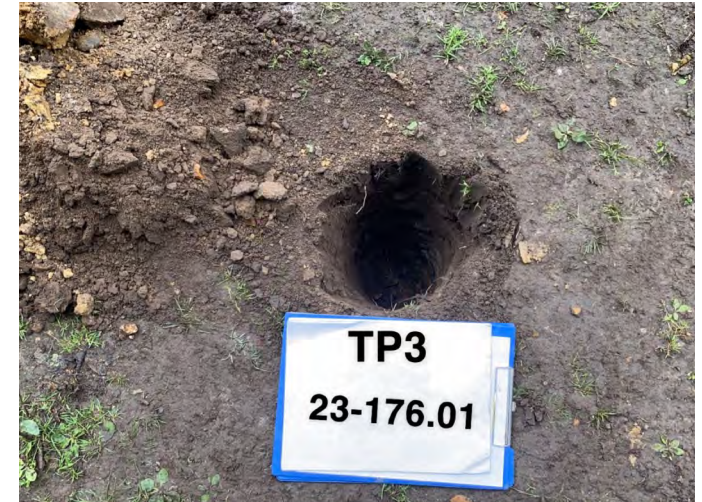
| TP3 | South-east of the site adjacent the wooden equestrian building, and side garden of Plot 4, to determine shallow ground conditions and enable land contamination assessment/testing. | Not installed. |

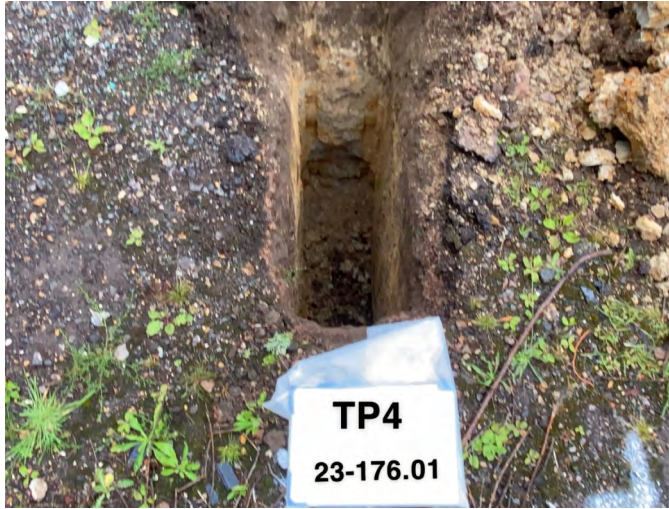
| TP4 | East of the site in the former car storage area, and rear garden of Plot 3, to determine shallow ground conditions and enable land contamination assessment/testing. | Not installed. |

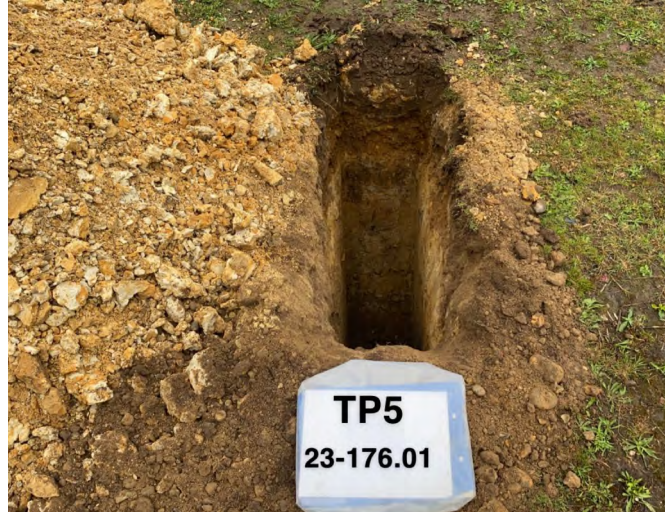
| TP5 | East of the site in the former car storage area, and rear garden of Plot 3, to determine shallow ground conditions and enable land contamination assessment/testing. | Not installed. |

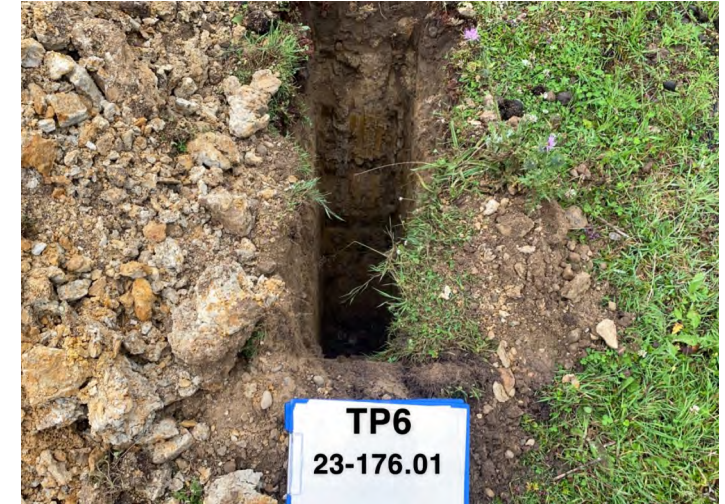
| TP6 | West of the site in the former car storage area, and front garden of Plot 3, to determine shallow ground conditions and enable land contamination assessment/testing. | Not installed. |

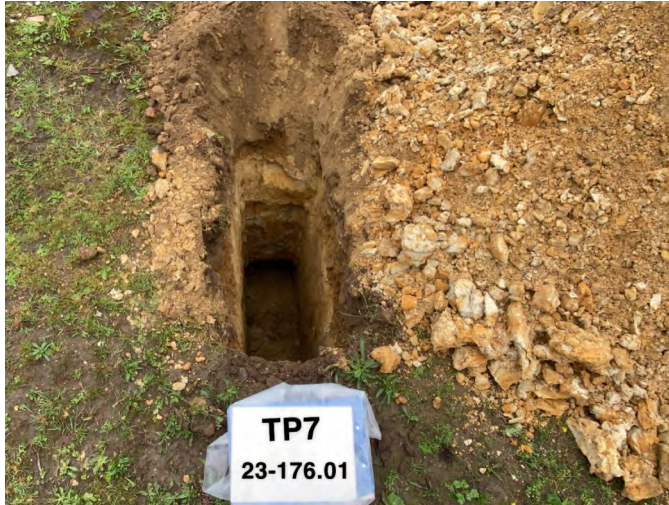
| TP7 | Centre-north of the site in the former car storage area, and front garden of Plot 1, to determine shallow ground conditions and enable land contamination assessment/testing. | Not installed. |

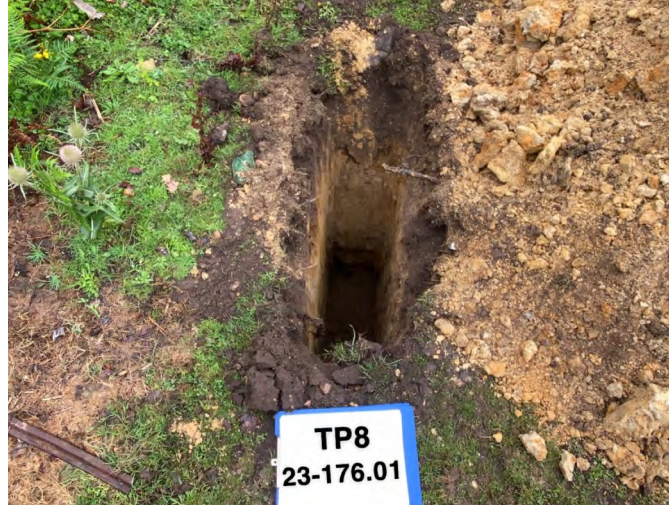
| TP8 | Centre-north of the site in the former builder's yard, and rear garden of Plot 1, to determine shallow ground conditions and enable land contamination assessment/testing. | Not installed. |

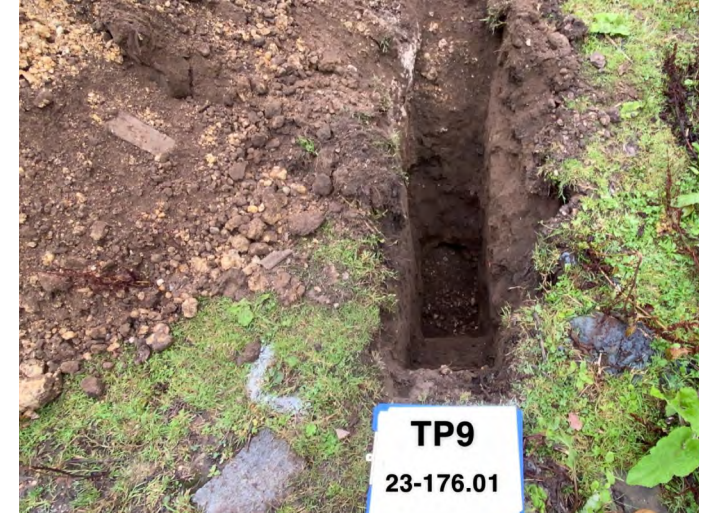
| TP9 | North of the site in the former builder's yard, and rear garden of Plot 2, to determine shallow ground conditions and enable land contamination assessment/testing. | Not installed. |
