**Report prepared at**  
Land at Johnson Drive  
Finchampstead  
RG40 3NW

**On behalf of**  
Palatine Homes Limited

**Report reference**  
23-176.02 : version 3

| Report Quality Management | | | |
|---|---|---|---|
| <b>Project Title</b> | Supplementary Site Investigation and Generic Quantitative Risk Assessment | | |

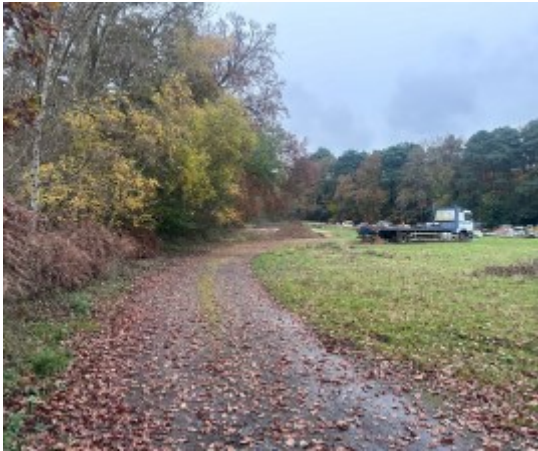
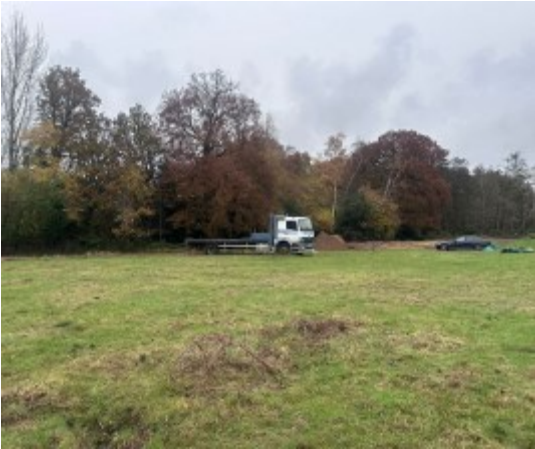
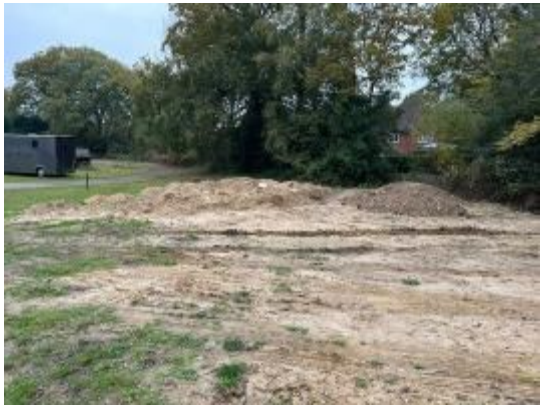
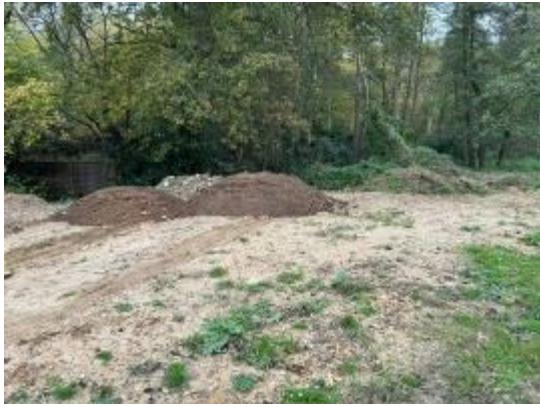
| Table 1.3: Summary of Site Walkover Survey | |
|---|---|
| Waste Storage and Disposal | A small stockpile of clayey, gravelly Sand understood to be from the excavation of a swimming pool to the adjacent home was observed by the north-east boundary (Photos 3 and 4 and 11 and 12) which is defined by the wide area of <b>Figure 6</b> as it is understood similar material has been removed from site. |

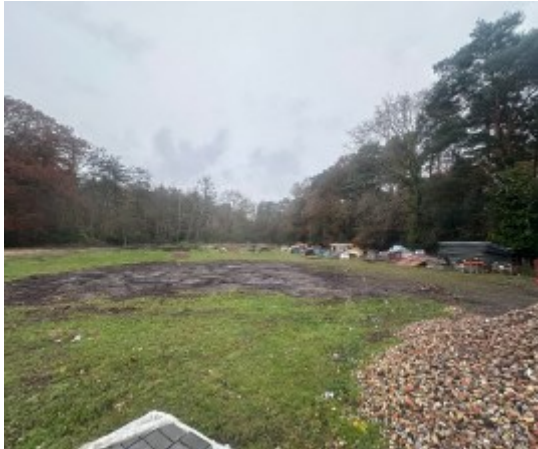
Photo 6

| <b>Potentially Contaminative Activities</b> | Limited contaminative activities associated with the storage of building materials including potential for undiscovered ACMs.<br><br>Burning of materials is understood to have occurred in the north of the site at an area shown in <b>Figure 6</b> , an area illustrated by the Client and generally appears to be the area of exposed earth shown in Photo 6. |

Area of burning (see Photo 6)

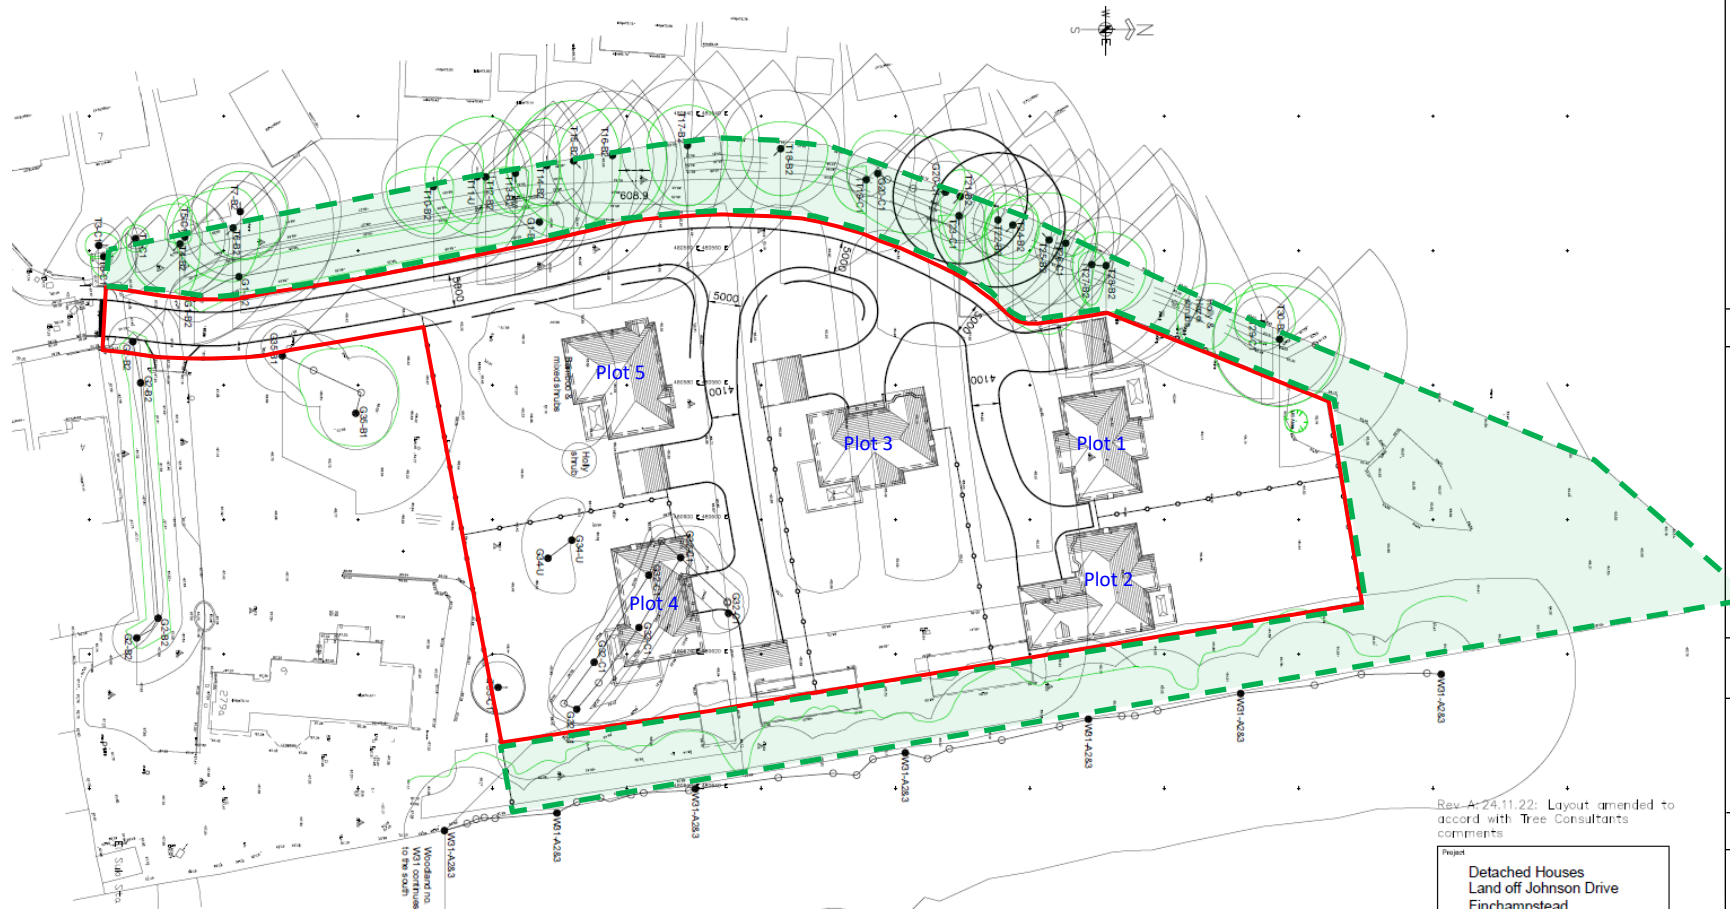
## Figure 5

| Table 1.2: Site Details | |
|---|---|
| <b>Proposed Land Use</b> | The proposed development comprises the construction of eight new detached homes and garages with private gardens, and an access road running along the northern boundary and into the centre of the site at three locations.<br><br><b>Figure 5</b> is presented as the Proposed Development Plan. |

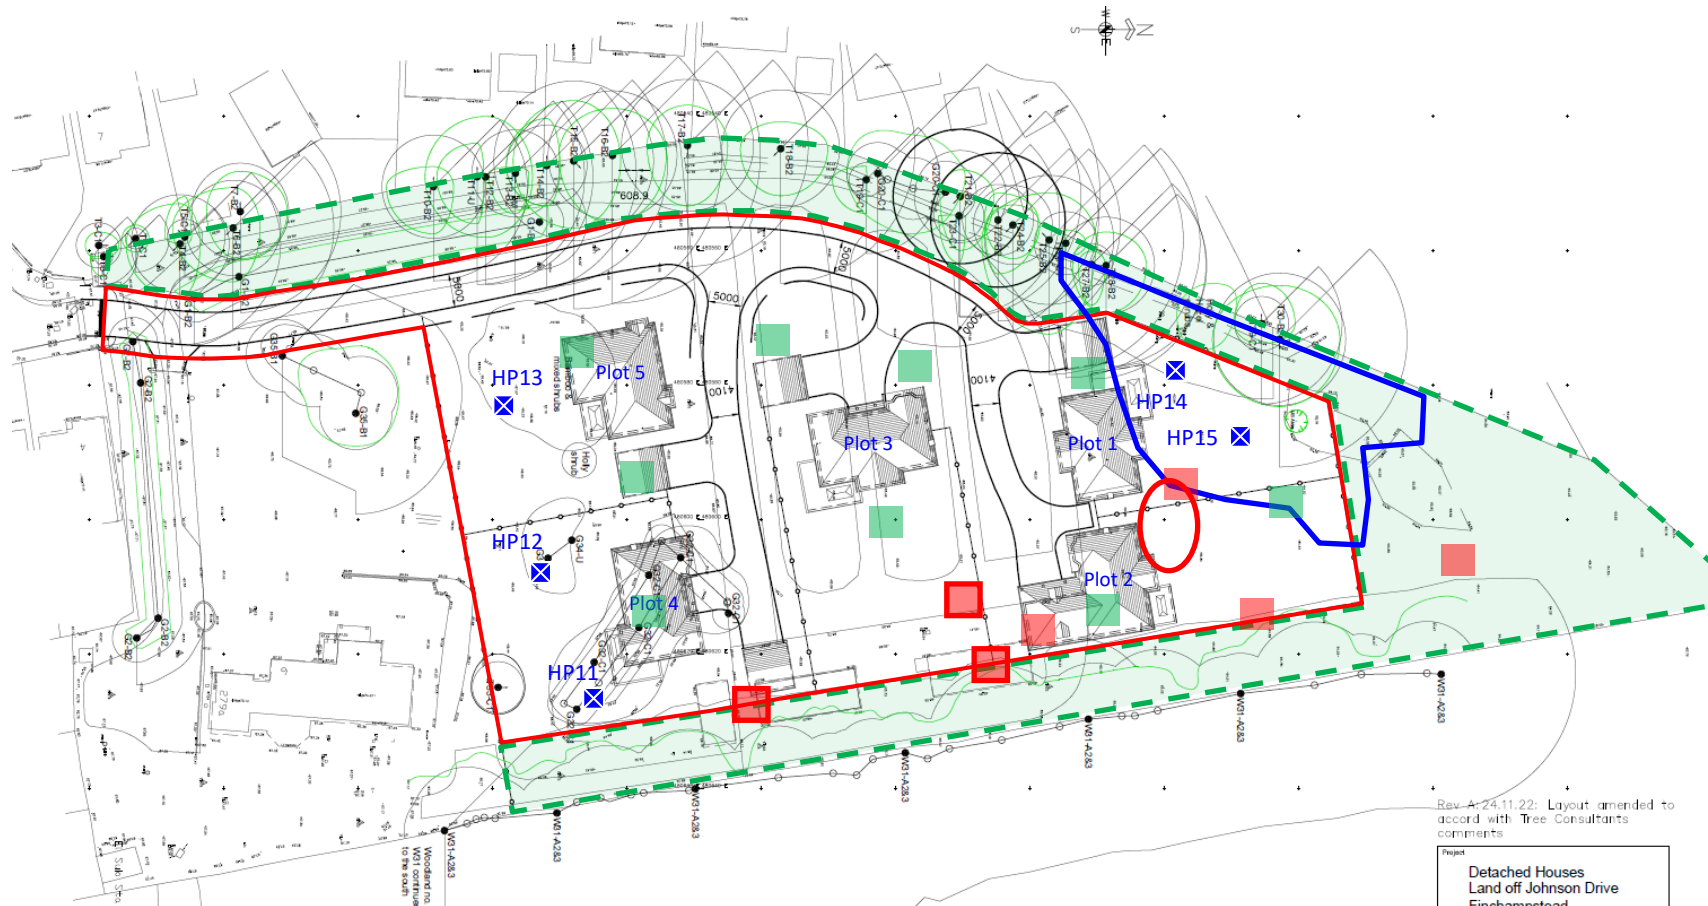
**Figure 7** also presents positions where soil contamination was identified (or not) following the outcome of the previously issued SI and GQRA report. The location of previously encountered soil contamination and the areas of stockpiling and burning were taken into account when designing the investigation. No exploratory holes were targeted towards the area of burning as the locality of this area has been previously investigated and recorded soil contamination, therefore any overlaying proposed garden areas shall be subject to a remedial cover system.

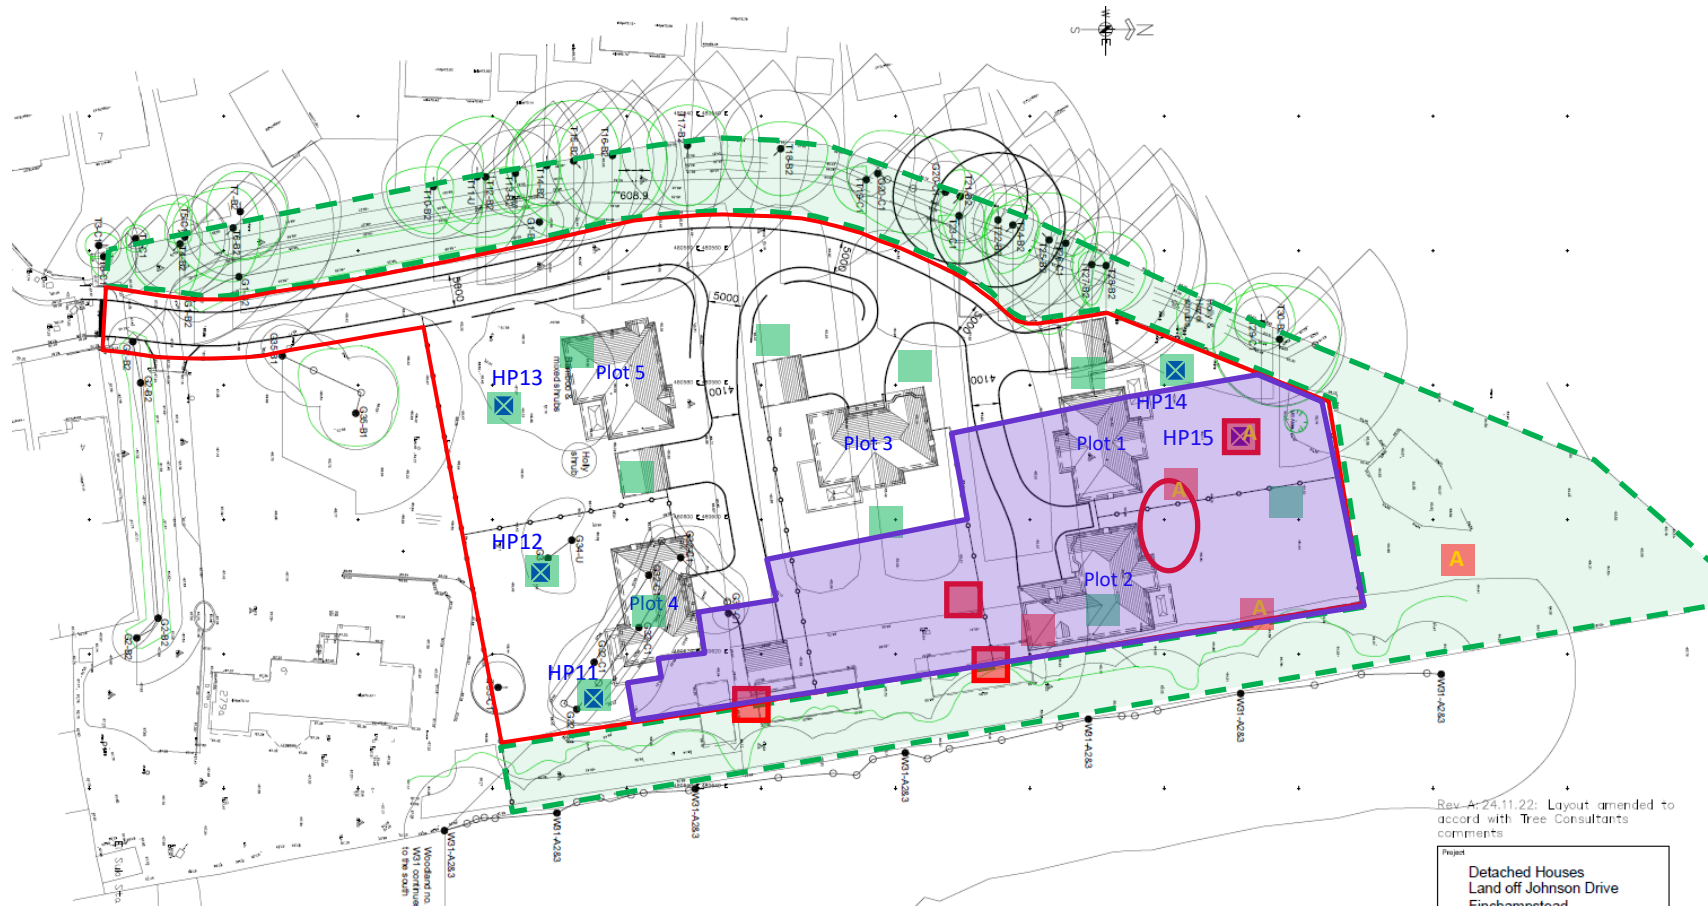
#### Figure 7

An Exploratory Hole Location Plan is enclosed as **Figure 7**.

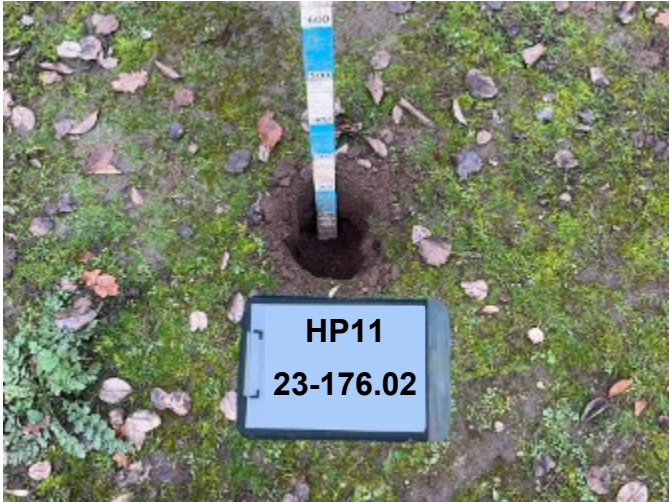
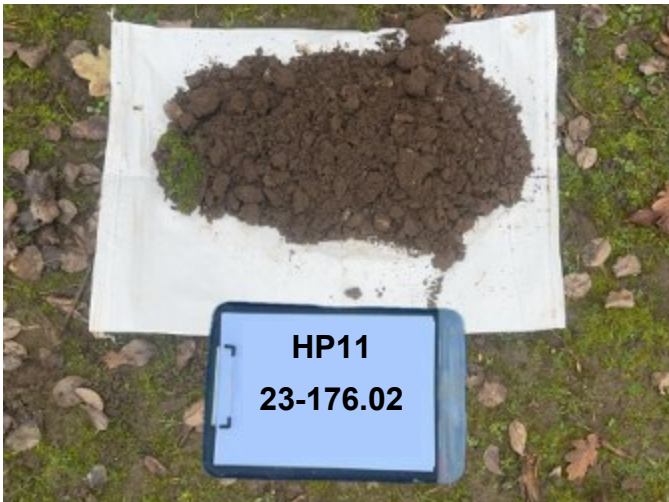
HP11

- Re-worked Topsoil (HP11 to HP13) and re-worked natural strata/Clay (HP14 and HP15) and with inclusions of flint gravel and brick noted to depths up to 0.35m bgl.

No discernible odours or staining were noted during the ground investigation works in the soils encountered across the site.

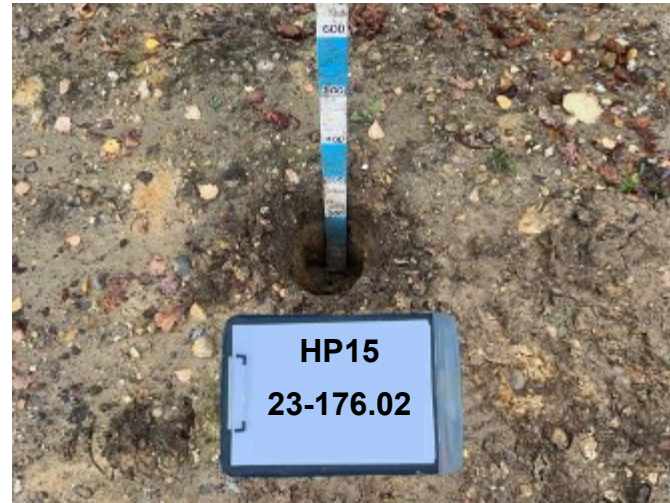
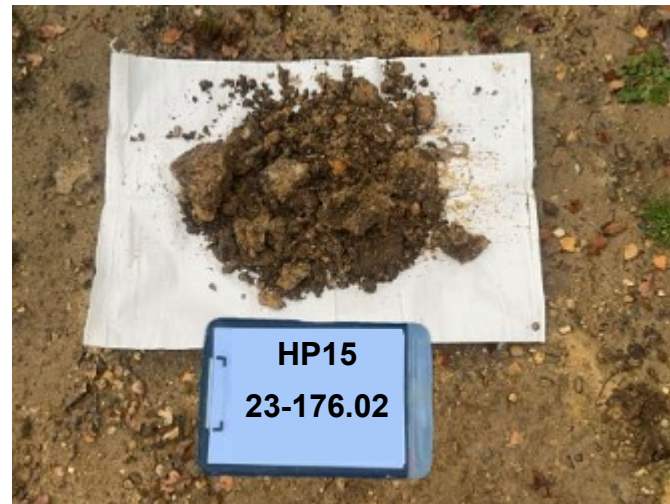
HP15

However, a detection of asbestos has been recorded within HP15, positioned in close proximity to where Southern Testing (2017) previously encountered asbestos contamination within the rear garden of Plot 7 which is close to where material was burned.

**Asbestos Screening and Cover System Construction.** The Made Ground in the north of the site is unlikely to be physically suitable for new planting. It is recommended that prior to forming the gardens of Plots 7 and 8 in the north of the site a watching brief is made to inspection, screen and as necessary sample in-situ soils for asbestos content. A clean cover system should then be constructed to the **frontages and rear gardens of Plots 1 and 2** which should comprise 600mm of clean Topsoil/sub-soil upon a geotextile membrane. A lesser thickness of cover may be suitable should the sub-crop of the 'clean natural strata formation' be verified.
