## **PRELIMINARY ECOLOGICAL APPRAISAL (DBW) AT WEST GRAYLAKE, PART LANE RISELEY**

**Prepared for:  
Mr & Mrs R Ashford  
West Graylake  
Part Lane  
Riseley  
Reading  
RG7 1RU**

**14 June 2024**

**Ref: SPH/PEA-24/06.05**

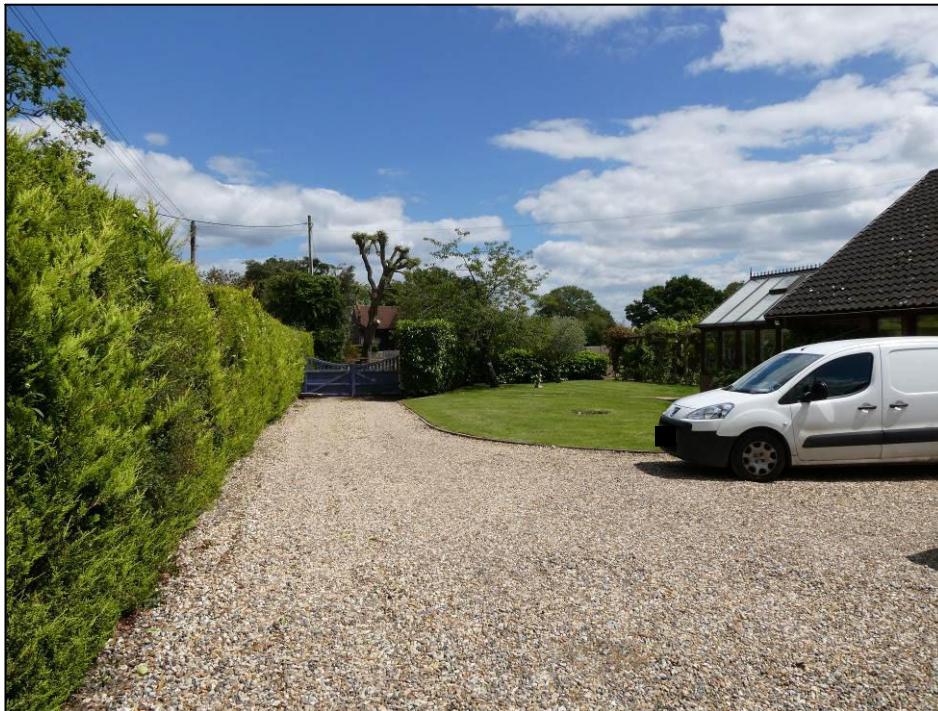
Figure 3. Driveway and front garden. West Greylake, Part Lane, Riseley. 06.05.24

The application site comprises a detached, brick-built property with a two-storey detached garage and wooden shed. The remainder of the site comprises a gravel driveway/parking area, a front garden laid to lawn (see Figure 3 below) and a rear garden, which is mainly laid to lawn with some trees, hedgerows and shrubs throughout, see Figure 4 below. The site itself offers good foraging and commuting habitat for bats and there is direct ecological connectivity to the wider landscape that also provides a diverse habitat for foraging and roosting bats.

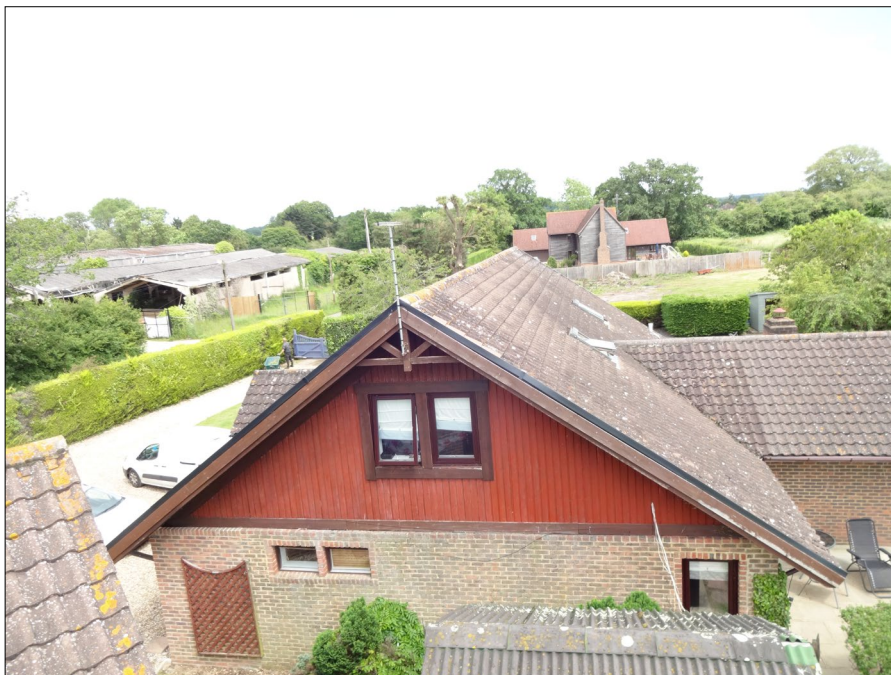
Figure 5. Multi pitched roof. West Greylake, Part Lane, Riseley. 06.05.24

The property is a detached brick-built building which is in a good condition externally. The roof of the property is multi-pitched (see Figure 5 on page 9) and covered in close fitting, composite tiles, none of which are missing or broken, see Figure 6 on page 9. The ridge and hip tiles are all tightly fitted with no gaps in which bats could utilise for roosting and the Velux windows within the roof are tightly fitted to the tiles and had no gaps in which roosting bats could exploit. The house and garage gable ends are timber clad and it was tightly fitted, overlapping and had no obvious gaps in which bats could use to roost, see Figure 7 on page 10. The verge of the house has been finished with metal flashing, which has significant gaps along some sections which could provide potential roosting opportunities for bats, or access to the underside of the tiles, see Figure 8 on page 10. There were a small number of bat droppings on the west facing wall plate below the upper window (see Figure 9 on page 11), which indicates that bats are or could have been using the building to roost. Given the location of the bat droppings, it is likely that they could be related to a roost within the poorly fitted verge.

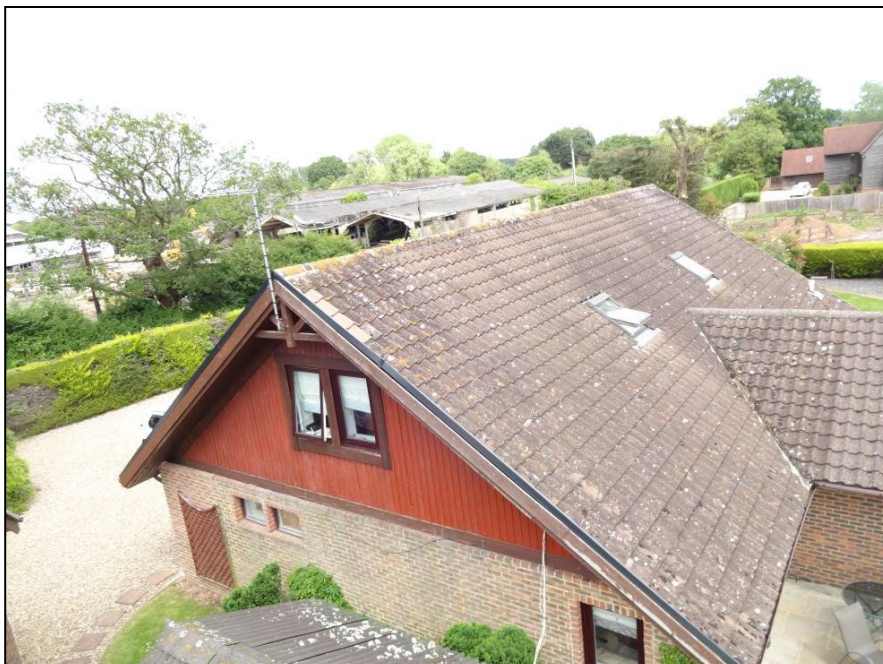
Figure 6. Example of roof tiles. West Greylake, Part Lane, Riseley. 06.05.24

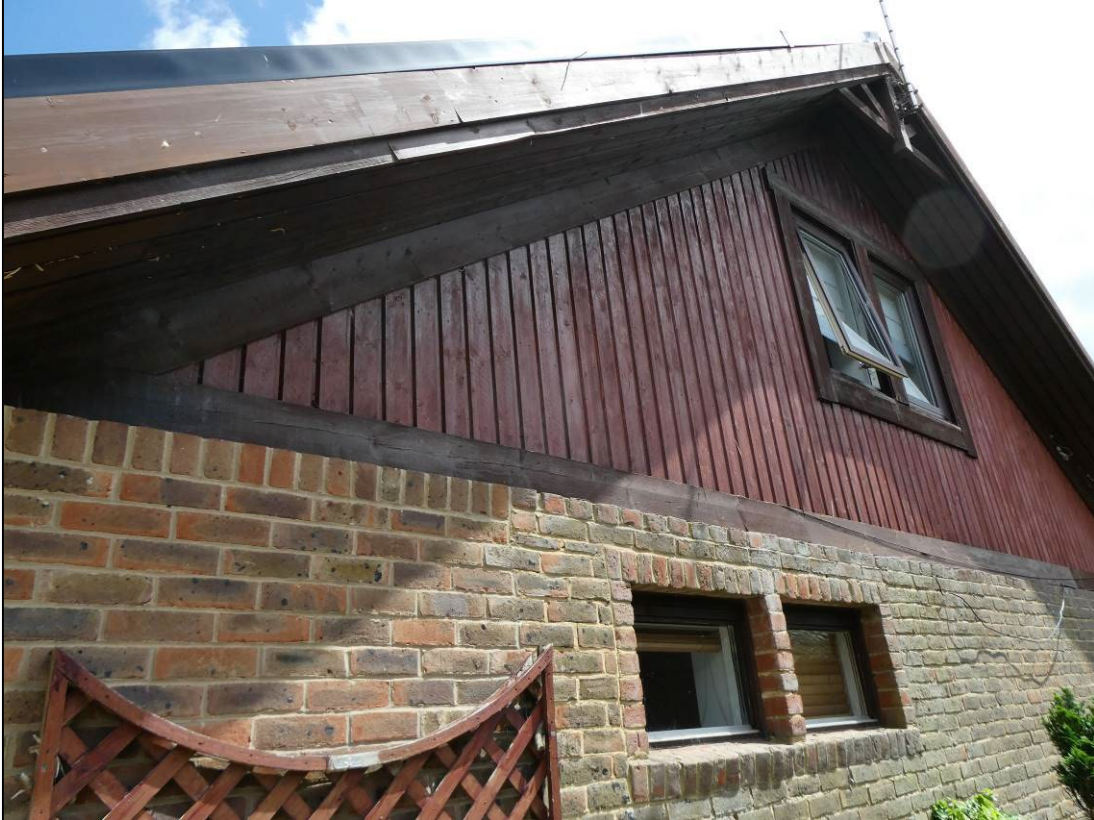
Figure 7. Wooden cladding on property. West Greylake, Part Lane, Riseley. 06.05.24

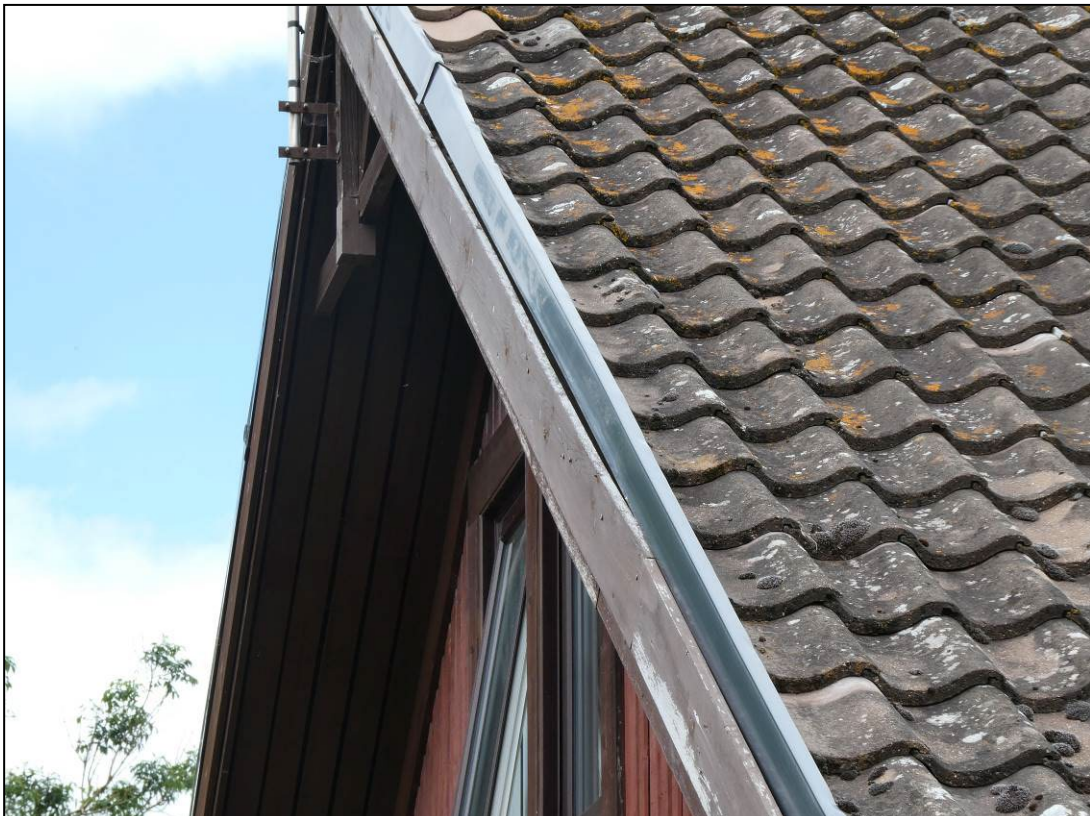
Figure 8. Gaps along the verges. West Greylake, Part Lane, Riseley. 06.05.24

Gaps along the west facing verge (opposite the garage) provide potential access to the underside of the roof tiles and felt that may support roosting bats and the droppings observed along the wall plate were of a similar size to those of the *pipistrelle spp.* (crevice dwelling) bats.

Based on the Bat Workers Manual and the Bat Surveys Good Practice Guidelines, three dusk emergence surveys need to be undertaken on the property and shed, between May and September, to assess the current status of roosting bats, in order to inform appropriate mitigation for the proposed works. The features identified will require three survey positions both equipped with bat detectors and night vision cameras in order to cover the potential bat roosting features. The garage did not provide opportunities for roosting bats and therefore no further survey of the garage is required.

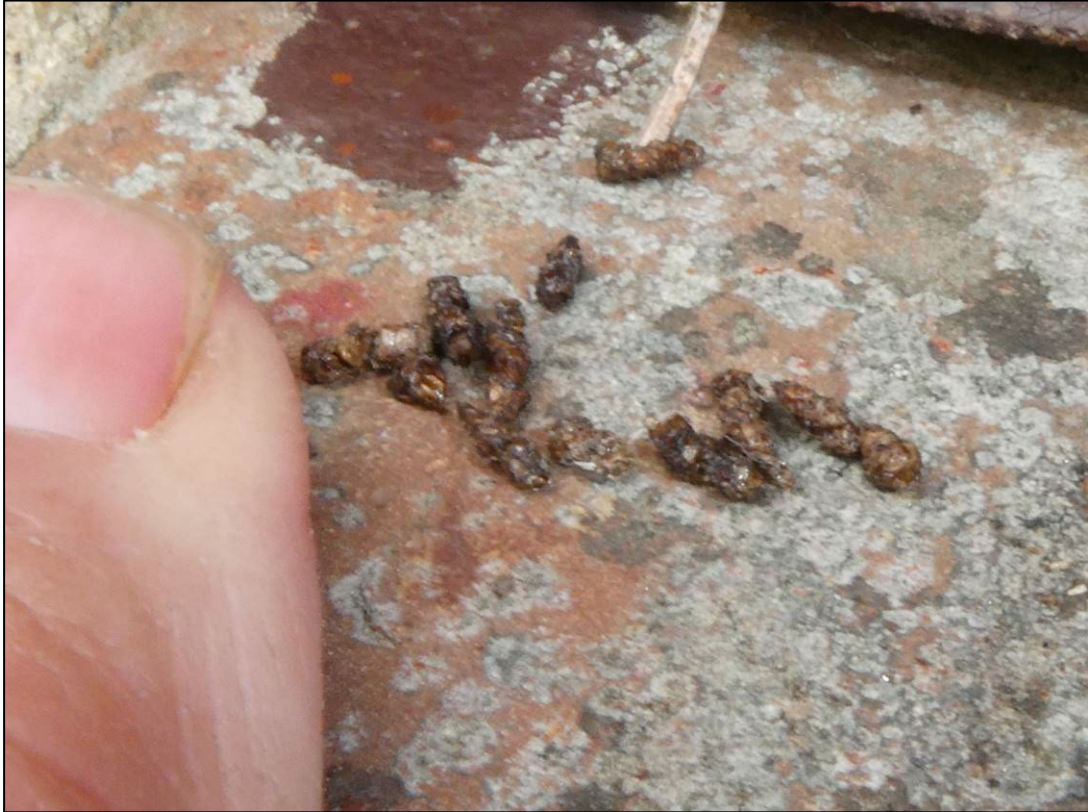
Figure 9. Example of bat droppings externally on wall plate. West Greylake, Part Lane, Riseley. 06.05.24

Low numbers of bat droppings are normally associated with low numbers or individual bats and there is no evidence of maternity roosting or hibernation use at the property or in the shed. The property and shed have, in our opinion, been used opportunistically as a day/summer roost by a low number of *pipistrelle spp.* bats.

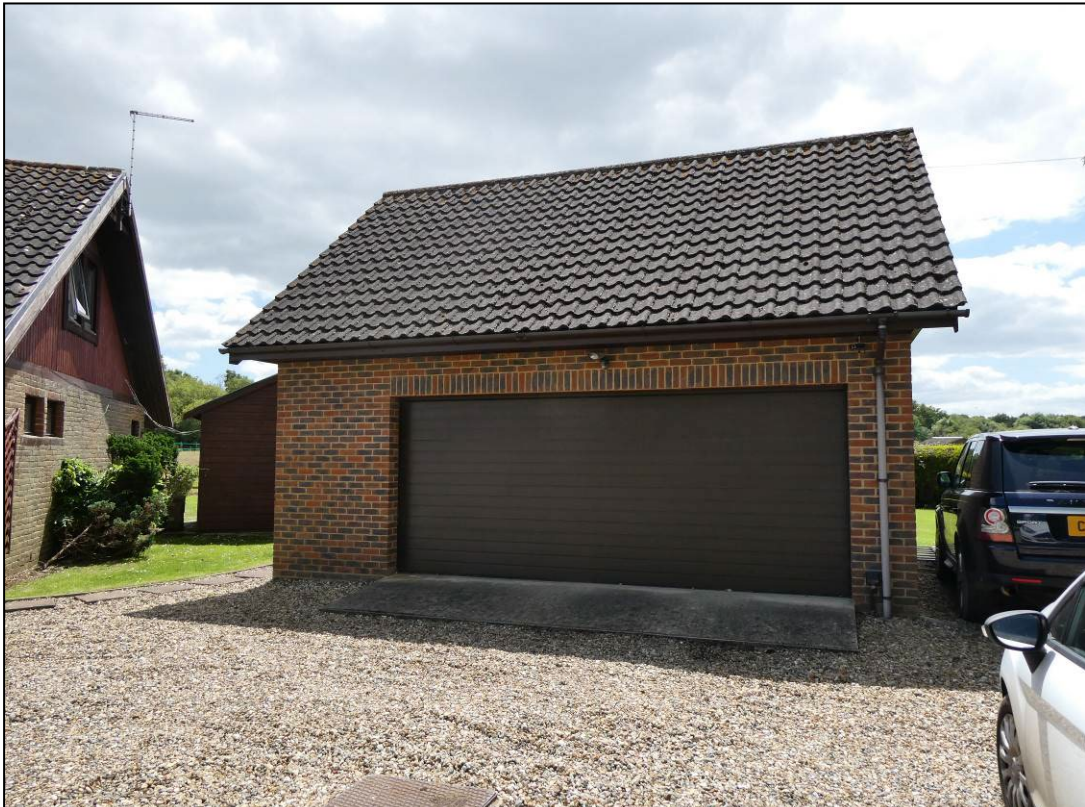
The garage was also inspected externally. The garage is also brick built and in a good condition, see Figure 10 on page 11. The roof and ridge tiles are all tightly fitted with no gaps (see Figure 11 on page 12) and the verges are all well cemented with no gaps in which crevice dwelling bats could use for roosting. There was also a Velux window on the roof of the garage which is tightly fitted to the roof tiles and had no gaps in which roosting bats could exploit, see Figure 12 on page 12. The wooden soffits and fascias are all in a good condition, with no gaps or splits in which crevice dwelling bats could utilise, see Figure 13 on page 13.

Figure 10. The detached garage. West Greylake, Part Lane, Riseley. 06.05.24

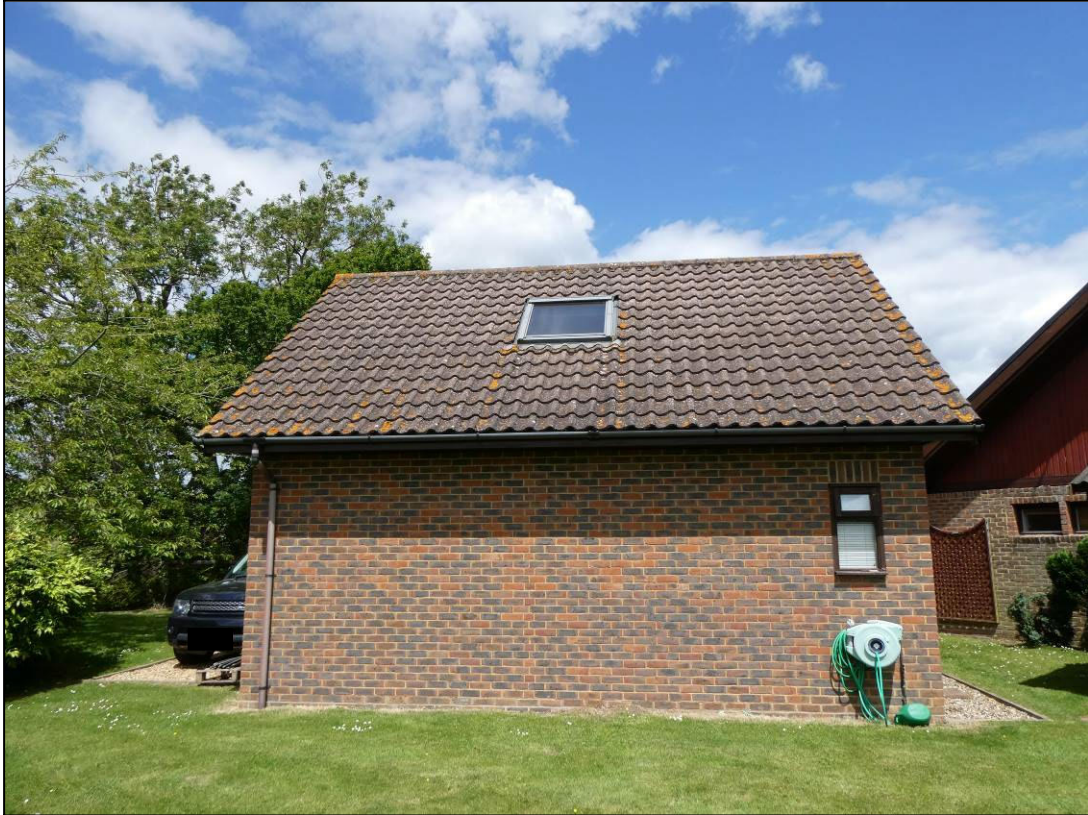
Figure 11. Example of garage roof. West Greylake, Part Lane, Riseley. 06.05.24

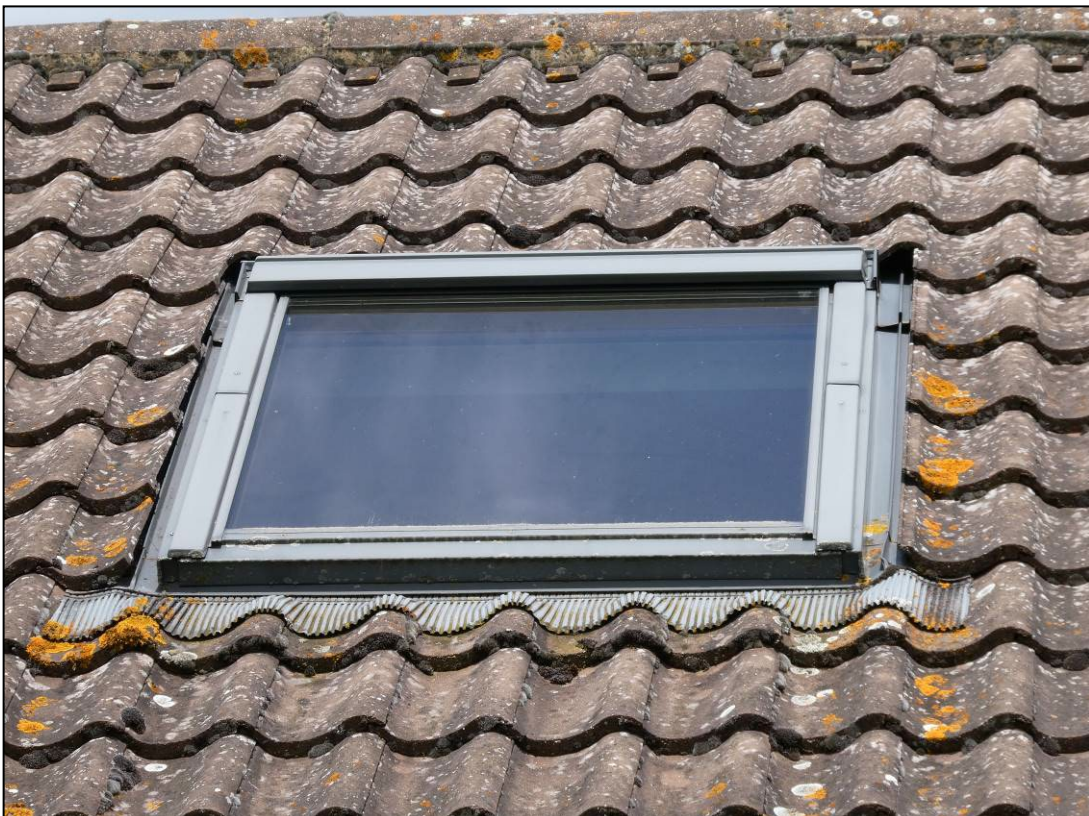
Figure 12. Velux window on garage roof. West Greylake, Part Lane, Riseley. 06.05.24

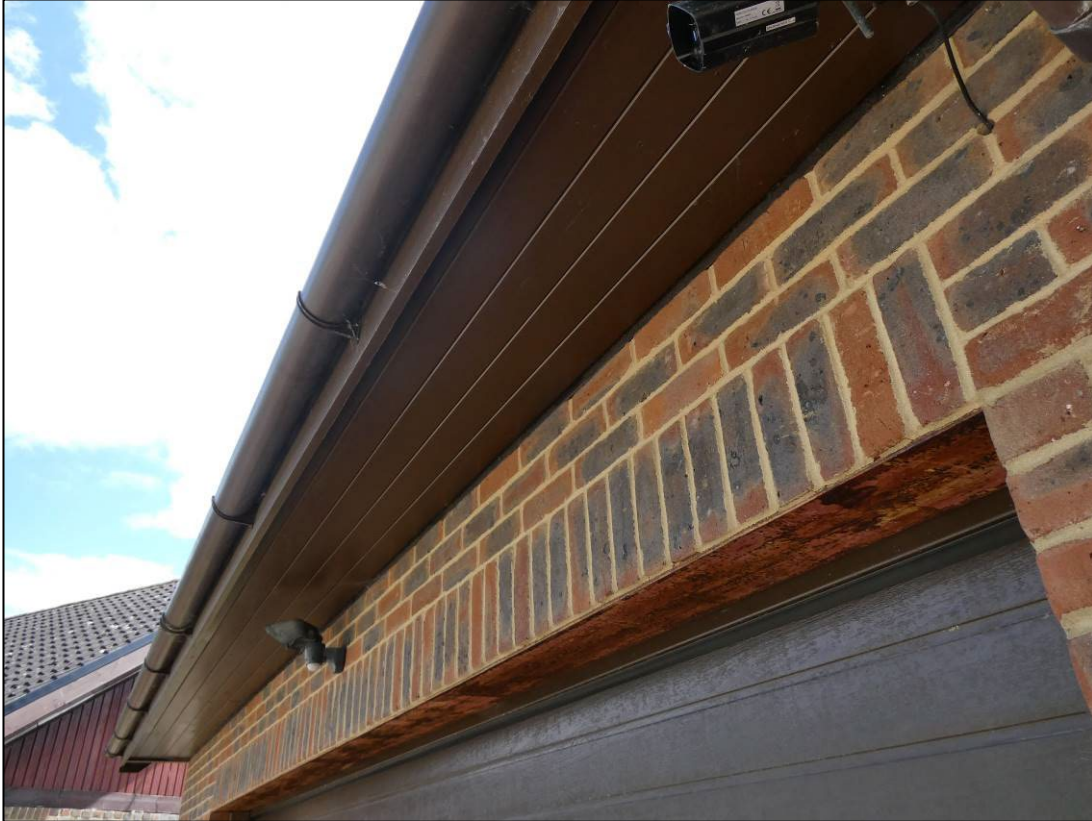
Figure 13. Soffits and fascias on garage. West Greylake, Part Lane, Riseley. 06.05.24

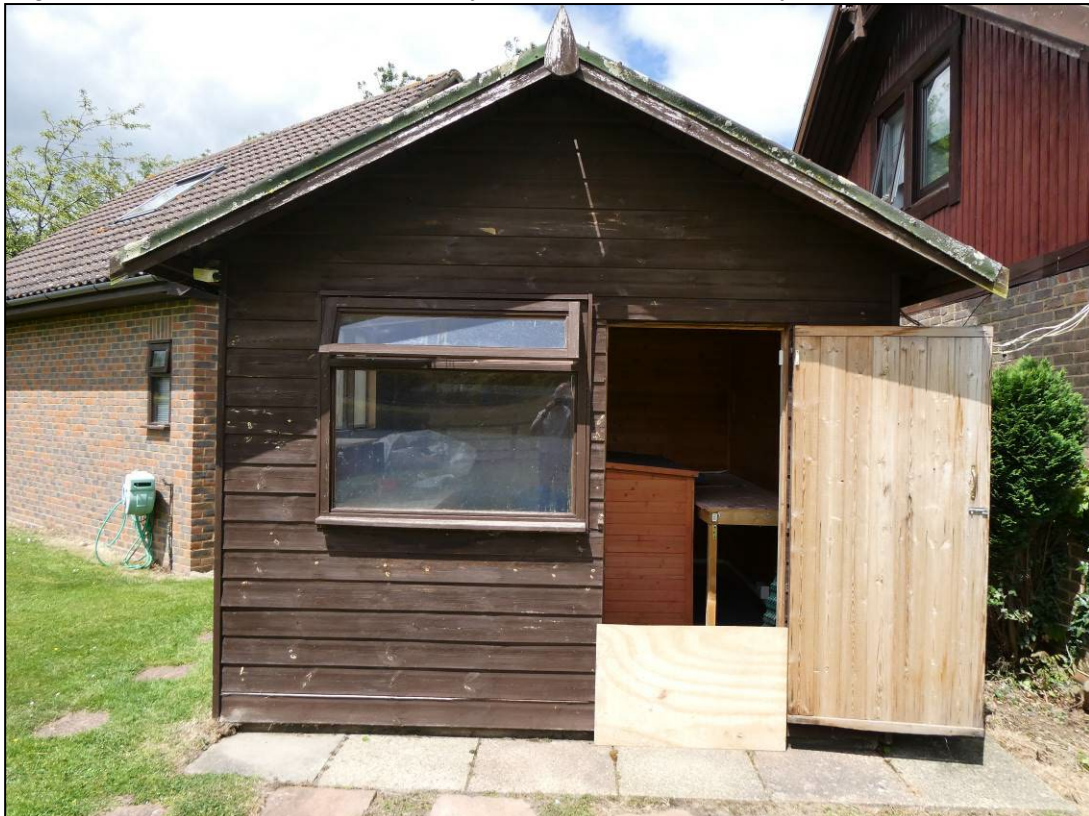
There is a timber shed between the house and garage which was also inspected externally, see Figure 14 on page 13. The shed is of wooden construction, the cladding of which is all tightly fitted and had no obvious gaps in which roosting bats could utilise, see Figure 15 on page 14. The roof of the shed is pitched and covered in corrugated felt, which has some gaps externally in which bats could exploit for roosting or gain access to the shed to roost, see Figure 16 on page 14. There was a single bat dropping stuck to the window of the shed, indicating that bats are either roosting under the felt/roof void or have explored roosting opportunities in the shed, see Figure 17 on page 15.

Figure 14. Wooden shed. West Greylake, Part Lane, Riseley. 06.05.24

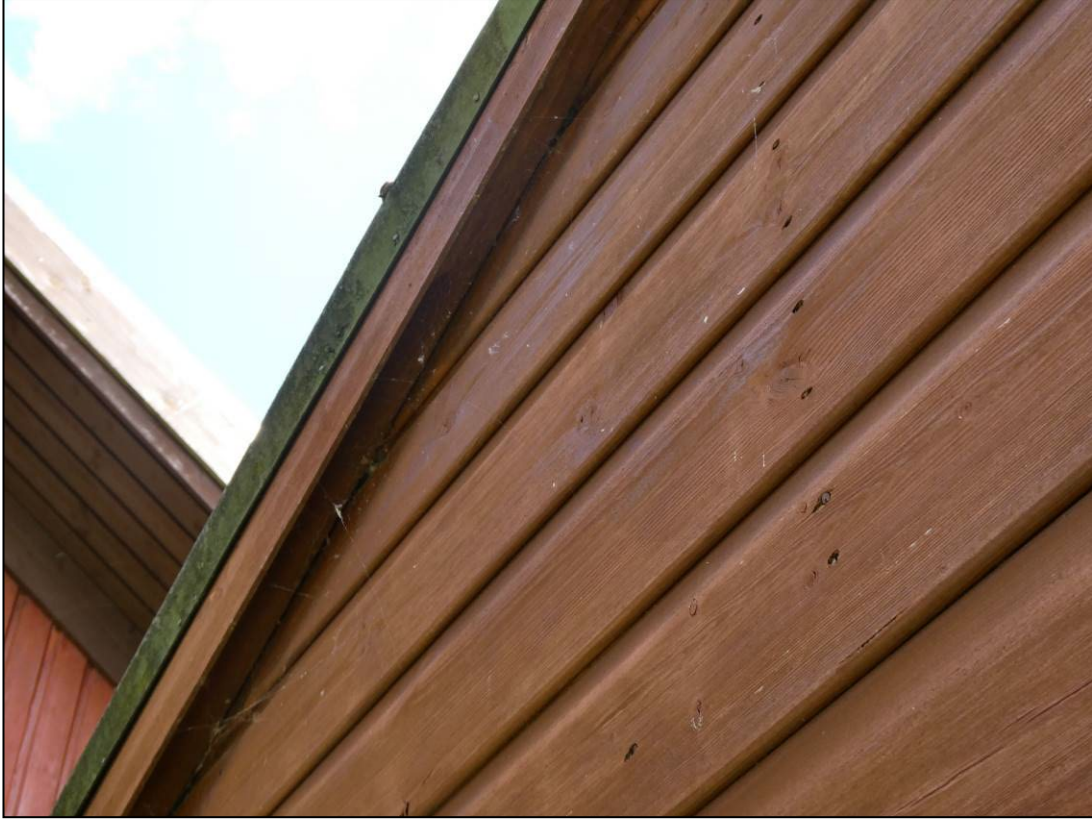
Figure 15. Tightly fitted wooden cladding of shed. West Greylake, Part Lane, Riseley. 06.05.24

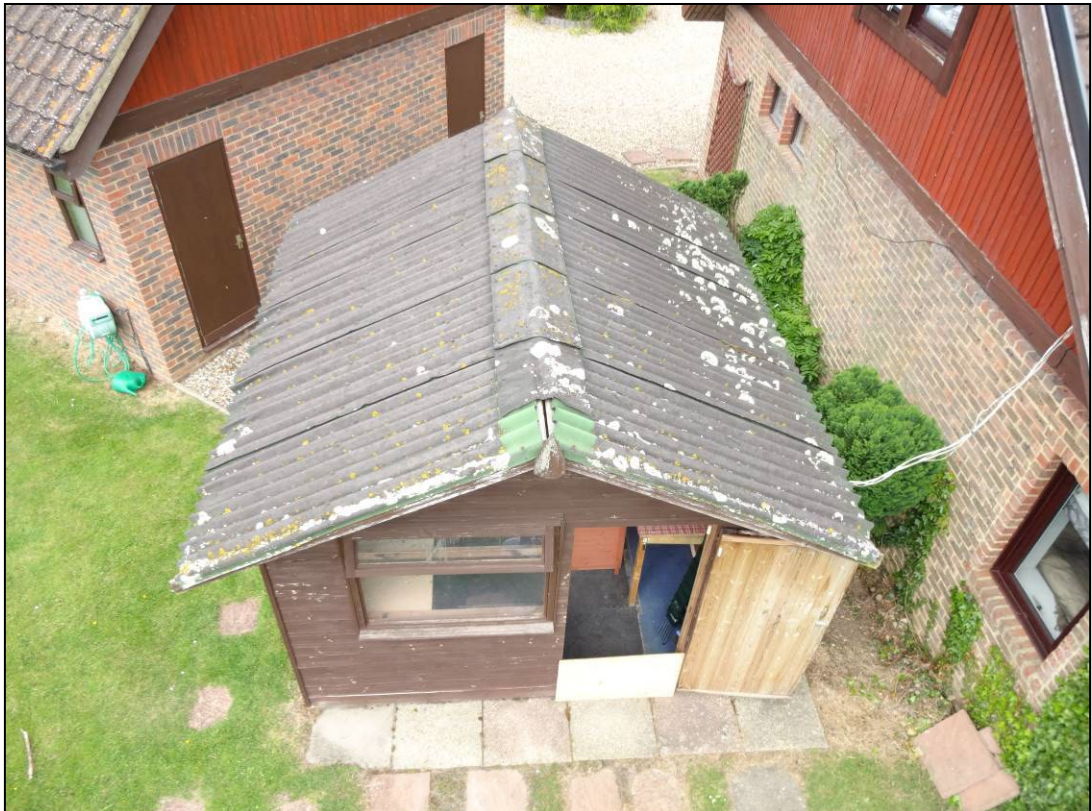
Figure 16. Roof of shed. West Greylake, Part Lane, Riseley. 06.05.24

The dropping observed on the shed window was also a similar size to those of the *pipistrelle spp* bat and the shed roof has crevice like features suitable for bats to roost.

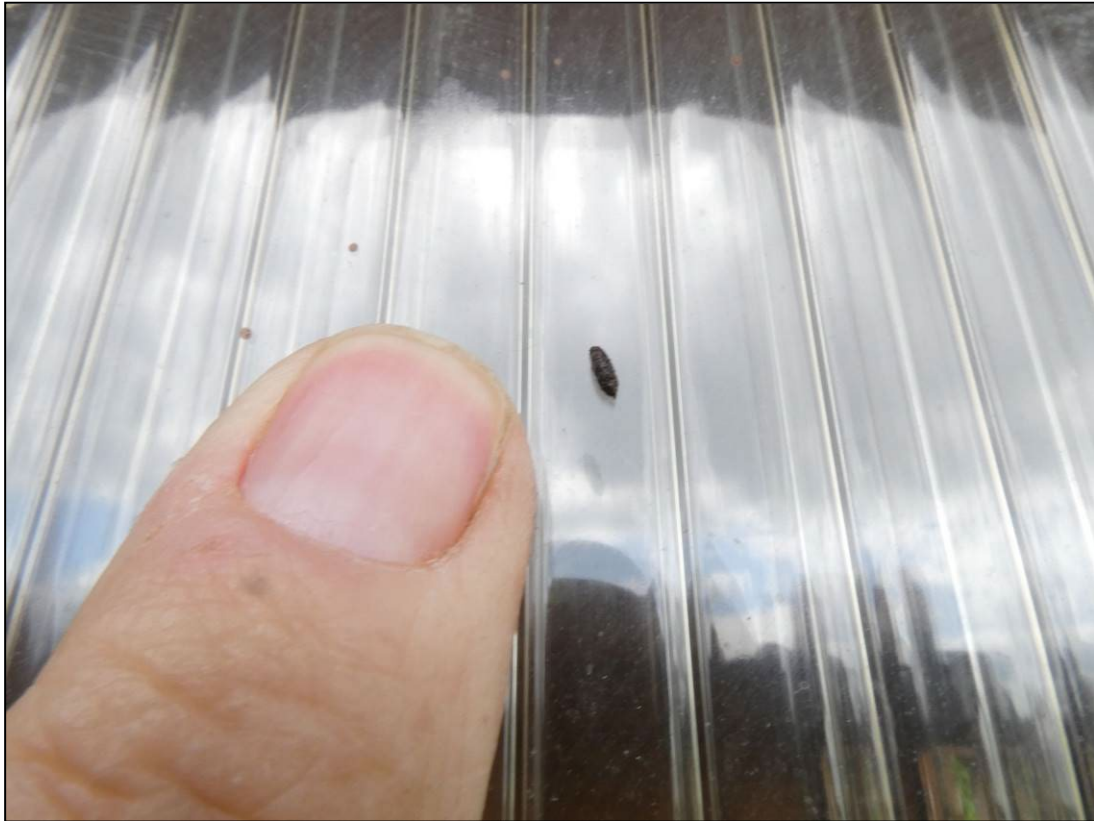
Figure 17. Example of bat dropping on window of shed. West Greylake, Part Lane, Riseley. 06.05.24

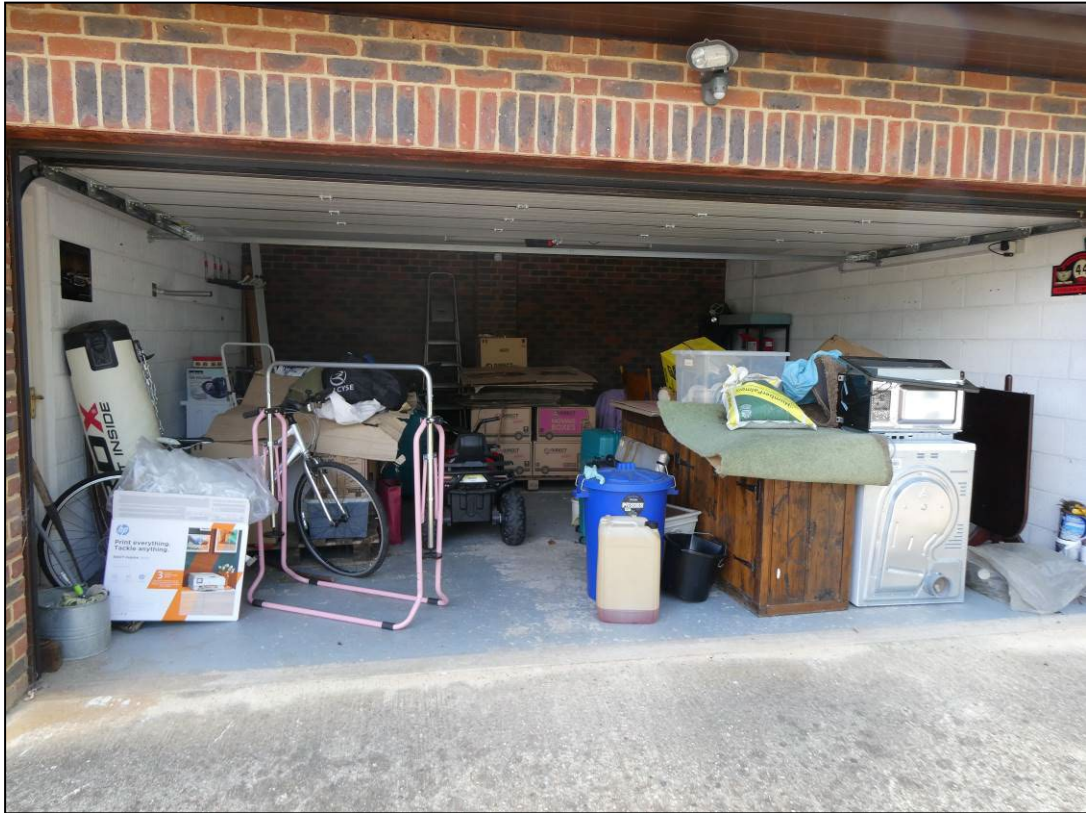
The garage was inspected internally and found to be in a good condition. The garage at ground level is used for storage and is cluttered (see Figure 18 on page 16) but this did not hinder the inspection. The first floor was empty, and has no loft void, it has a plaster board ceiling, wooden floor, with a velux window in the south facing roof and two windows on each gable end.

Figure 18. Internal space of garage. West Greylake, Part Lane, Riseley. 06.05.24
