**3 Woodward Close
Winnersh
Wokingham
Berkshire
RG41 5NW**

Preliminary Roost Assessment

Report ref.: **S3037_PRA_a**

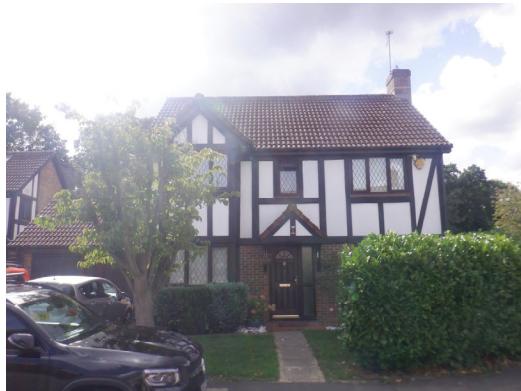
5.2.2 The detached house had a pitched roof with a conservatory at the rear and an attached garage with a pitched roof on the southeast elevation (**Photographs 1 & 2**).

Photograph 1. Front of the property viewed from northeast.

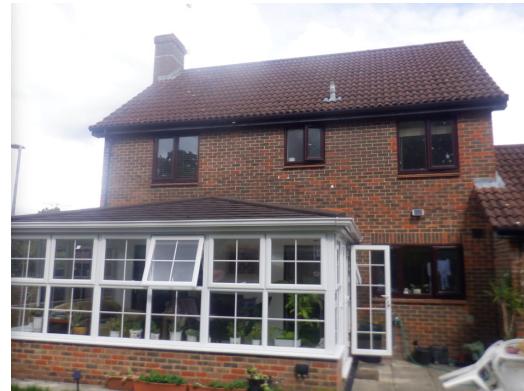
Photograph 2. Rear of the property viewed from southwest.

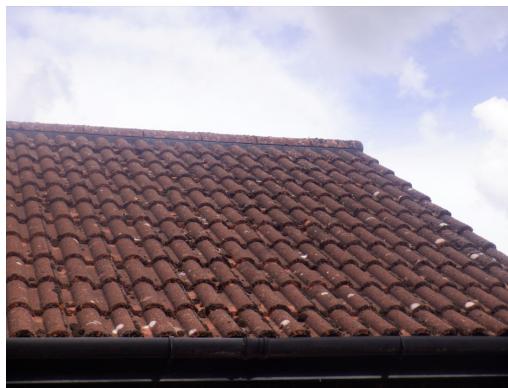
5.2.3 The pitched roof was covered by overlapping roof tiles that were tight across both elevations, and featured a dry-fixed ridge that were mostly intact other than a section of missing plastic on the rear elevation by the chimney at the northern end of the roof (**Photographs 3 & 4; Target note 1**). The verge caps along the southeast, northwest and front gables were tight to the barge boards (**Photograph 5**).

Photograph 3. Roof tiles and dry-ridge tiles flat and sealed (rear elevation).

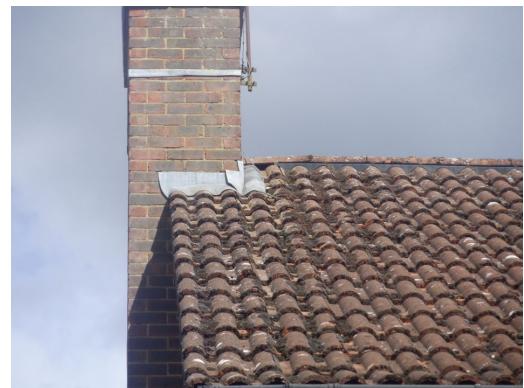
Photograph 4. Missing section of plastic under the ridge (rear elevation).

- A missing section of plastic under the ridge tile adjacent to the chimney (**Photograph 4; Target note 1**);
- Lifted lead flashing at the base of the chimney (**Photograph 7; Target note 2**);
- Gaps under and within the timber soffit (**Photographs 9 & 10; Target notes 3 – 5**);
- Tears within the bitumen & hessian felt roof lining within the main roof (**Photographs 12 & 13; Target note 6**);
- Open gaps along the external gables within the main void and garage (**Photographs 16 & 22; Target notes 7 & 10**); and
- Open eaves within the garage (**Photograph 20; Target note 9**).

6.1.3 The features associated with the ridge, lead flashing and soffit at the northern gable end may directly lead inside the second-storey roof void, which was of a suitable size and condition for void dwelling bats, such as the locally recorded brown long-eared (*Plecotus auritus*). A lack of evidence, i.e. droppings, observed within either of the roof voids indicates void-dwelling species are highly unlikely to be present. There was evidence of nesting birds visible externally and within the roof void, with confirmation from the client that birds had been nesting within the property in previous years.

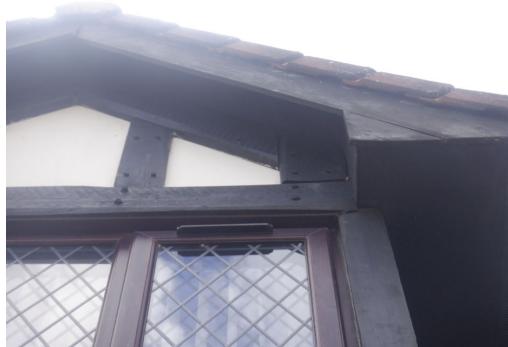
Photograph 5. Verge caps fully sealed (front elevation).

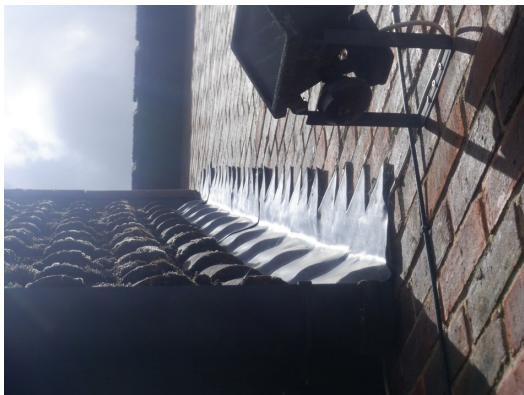
5.2.4 The lead flashing along the garage was sealed to the tiles and brickwork (**Photograph 6**). The lead flashing was slightly lifted beside the brickwork on both sides of the chimney (**Photograph 7; Target note 2**).

Photograph 6. Lead flashing sealed at the base of the chimney (rear elevation).

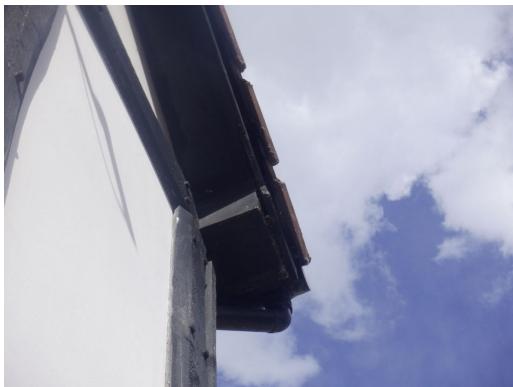
5.2.5 Whilst there was a slight gap within the timber soffit across the front gable, close inspection with a high-powered torch confirmed the feature to be of limited extent with no signs of use by roosting bats (Photograph 8; Target note 3). Slight gaps were situated behind the timber soffit along the northern gable with evidence of bird droppings visible on the brickwork below (Photograph 9; Target note 4). The soffit was damaged at the south-eastern corner of the southern gable with evidence of bird nesting material observed within the soffit (Target note 5). A piece of plastic vent was missing from the soffit on the rear of the garage, which lead into the internal of the void (Photograph 10; Target note 6).

Photograph 8. Gap of limited extent behind soffit along the front gable.

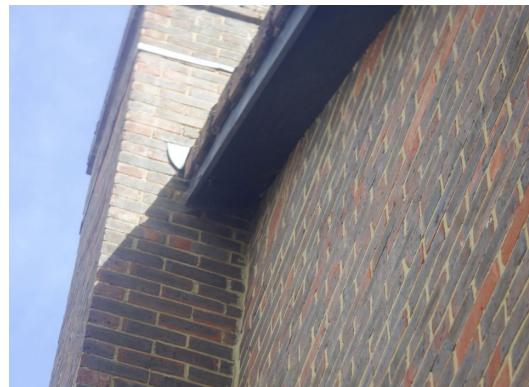
Photograph 9. Gap between timber soffit and brickwork (northwest elevation).

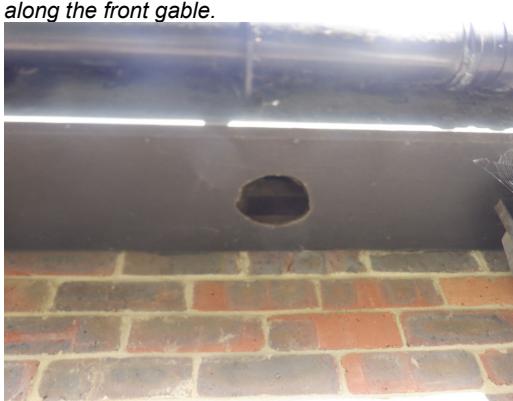
Photograph 10. Missing vent in timber soffit (rear elevation).

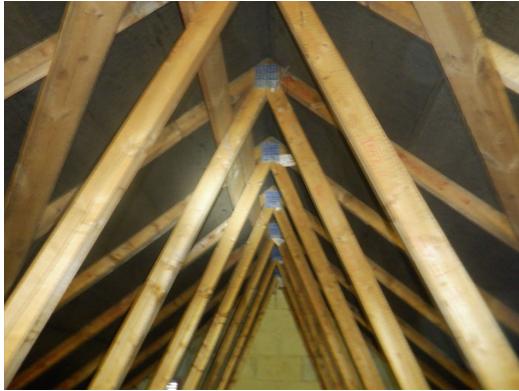
5.2.6 The property had two roof voids. The first roof void covered the second-storey footprint of the house and was accessible via a loft hatch on the first-floor. The void was of trussed construction, lightly cobwebbed throughout and had an approximate floor-to-ridge height of 2.5 metres (**Photograph 11**).

Photograph 11. Void of trussed construction (First roof void).

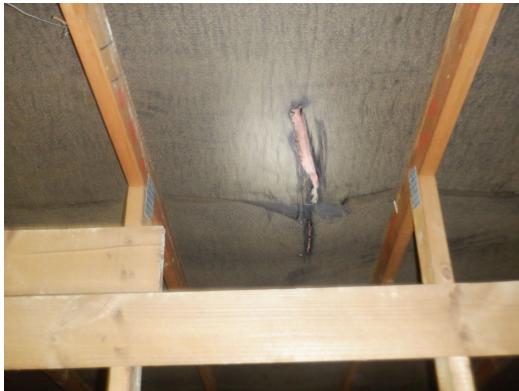
5.2.7 The roof was lined by a hessian and bitumen felt that had occasional tears throughout the void and along the ridge (**Photographs 12 & 13; Target note 7**). The floor was partially boarded over fibreglass insulation which went up to the eaves that were obstructed by plastic vent guards (**Photographs 14**).

Photograph 12. Tear in roof felt (First roof void).

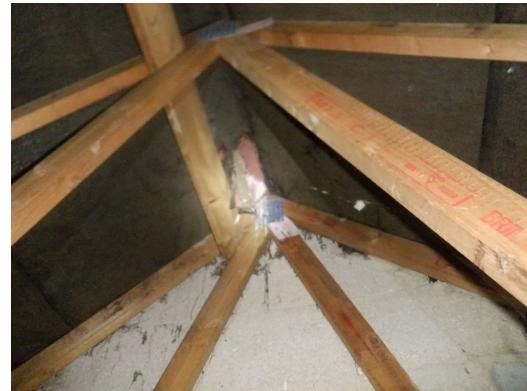
Photograph 13. Tear in roof lining along the ridge (First roof void).

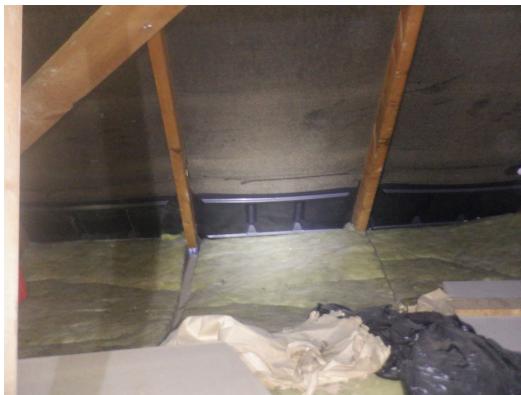
Photograph 14. Eaves blocked by plastic vent guards (First roof void).

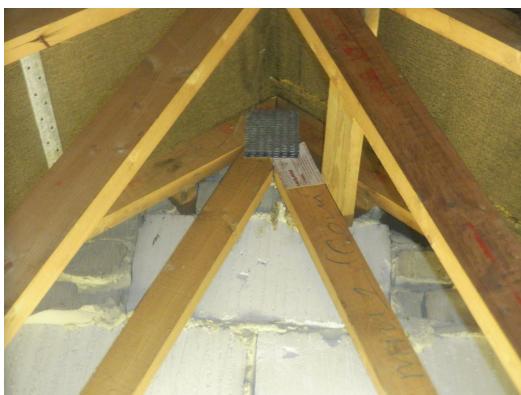
5.2.8 Whilst the southeast blockwork gable was sealed, open gaps were situated along the edges of the northwest blockwork gable with bird nesting material observed at its base (Photographs 15 – 17; Target notes 8 & 9).

Photograph 15. Southeast blockwork gable tight to timbers (First roof void).

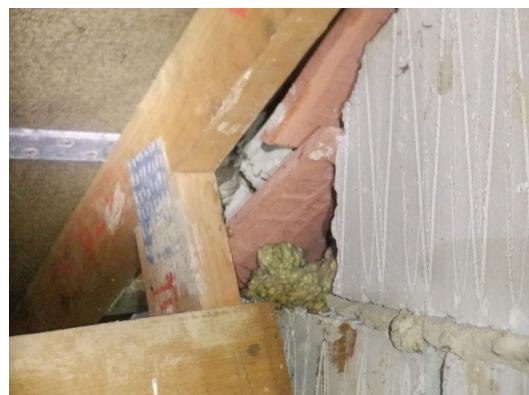
Photograph 16. Gaps along the edges of the northwest blockwork gable (First roof void).

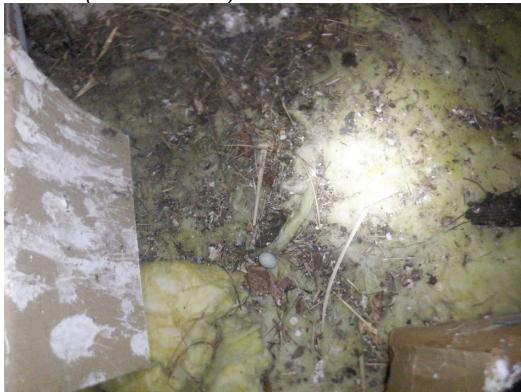
Photograph 17. Bird nesting material at the base of the northwest blockwork gable (First roof void).

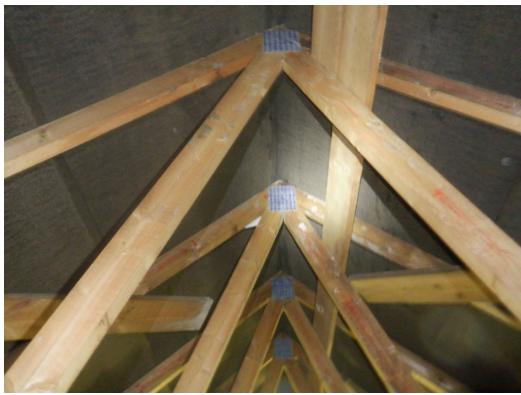
5.2.9 The second roof void covered the footprint of the attached garage and was accessible via a ground-floor hatch. The void was of trussed rafter construction and had an approximate floor-to-ridge height of 1.5 metres, and was lightly cobwebbed throughout (Photograph 18).

Photograph 18. Cobwebbed trussed rafters (Second roof void).

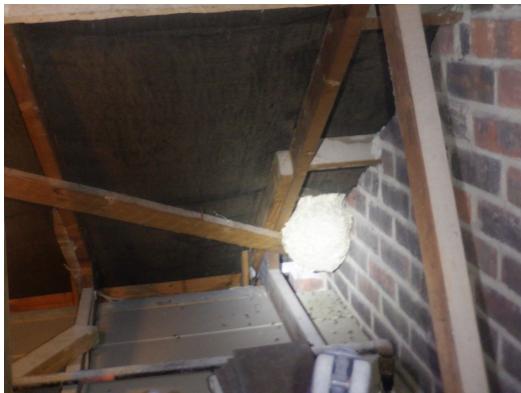
5.2.10 The void was lined by hessian reinforced bitumen felt that was intact throughout (Photograph 19). The floor was partially boarded and uninsulated, with the eaves open to the soffit (Photograph 20; Target note 10).

Photograph 19. Fully intact bitumen & hessian felt (Second roof void).

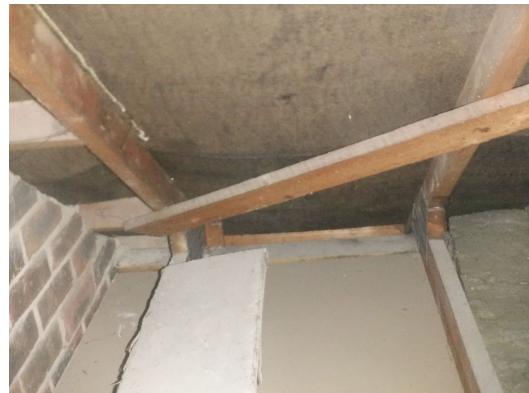
Photograph 20. Open eaves with access to the soffit (Second roof void).

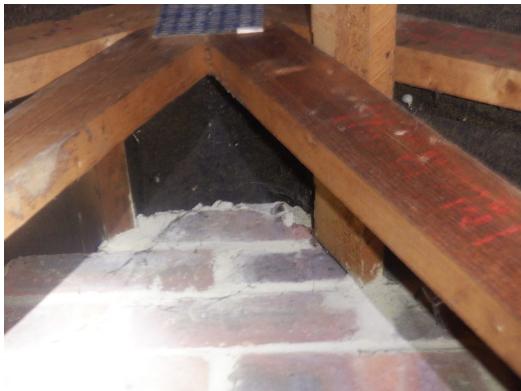
5.2.11 Whilst the southern brickwork gable was fully sealed to the roof felt with intact mortar, daylight visible was visible between the external house wall and roof at the northern gable end, with no signs of use by bats observed (Photographs 21 & 22; Target note 11).

Photograph 21. Southern gable fully sealed (Second roof void).

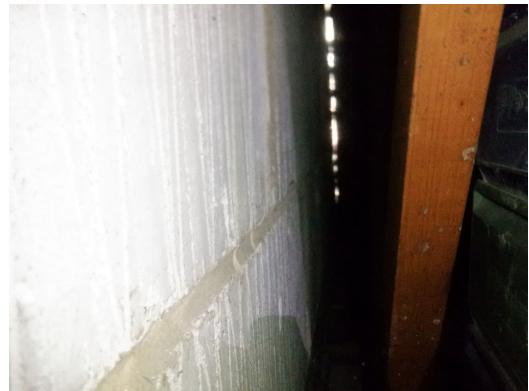
Photograph 22. Daylight visible along the edge of the northern blockwork gable (Second roof void).

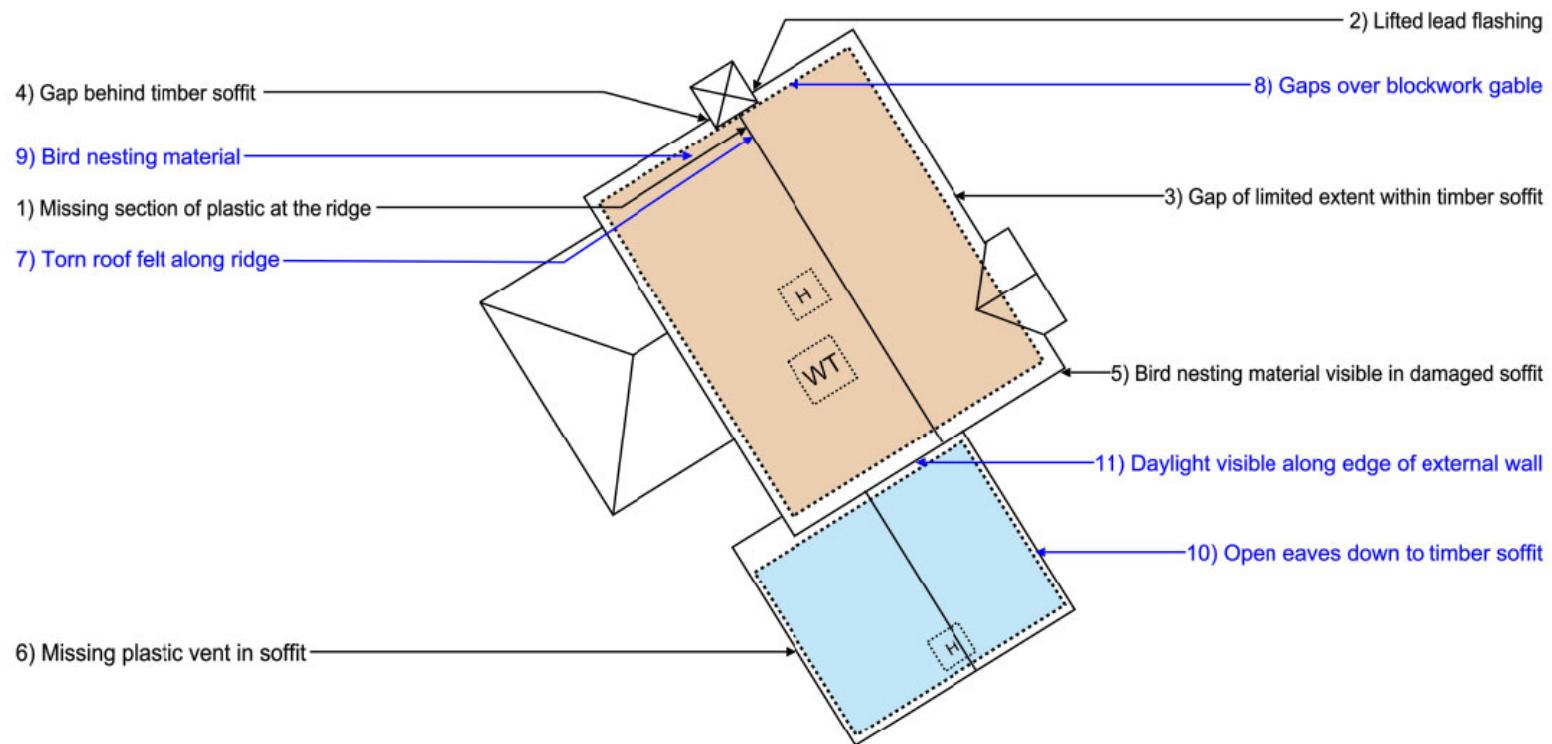
Figure 1. Preliminary Roost Assessment Survey Findings

5.2.1 The findings from the external and internal inspections carried out for the property are described with photographs, and annotated in a plan, as follows:

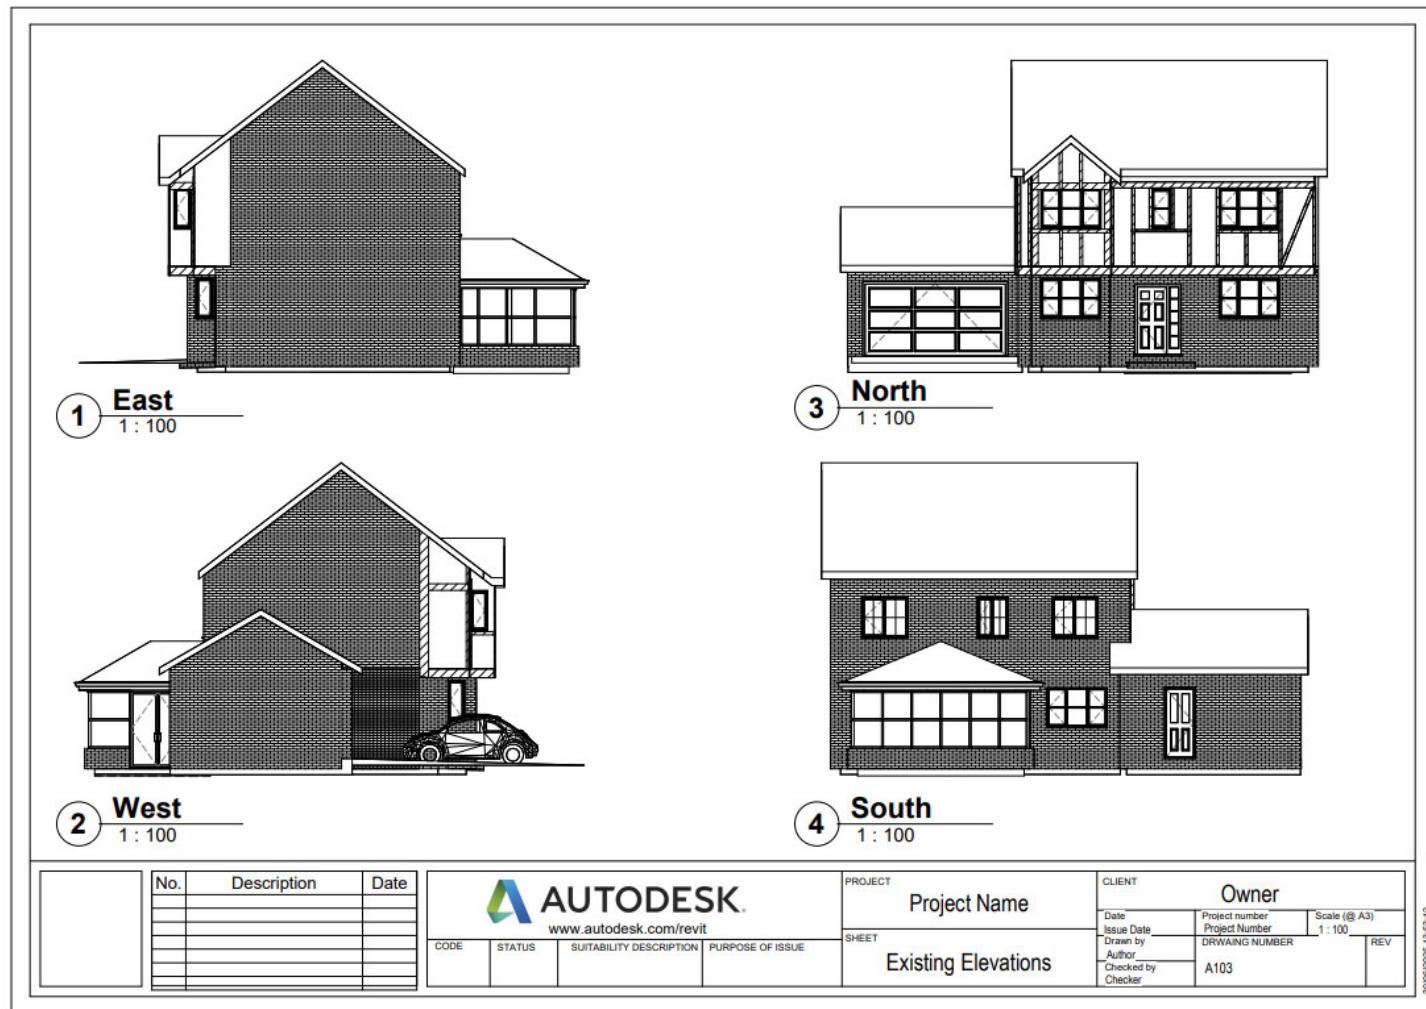
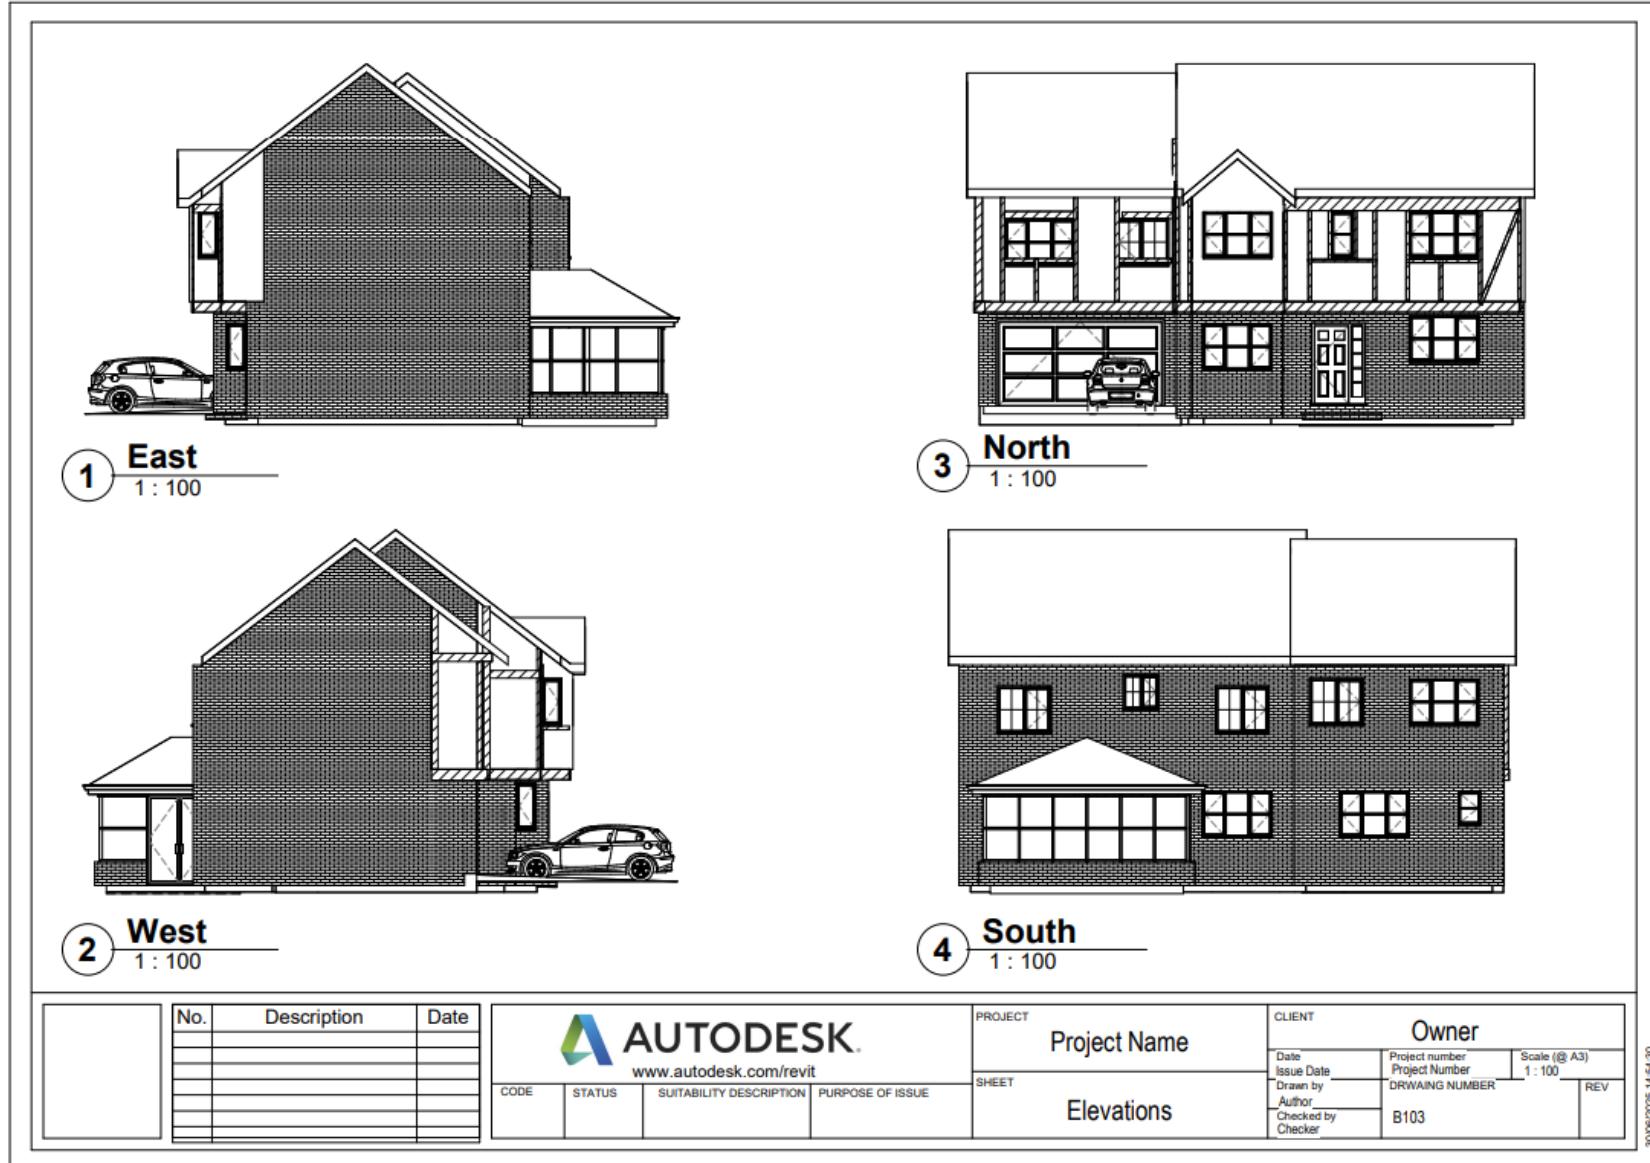
APPENDIX 4 – EXISTING AND PROPOSED DRAWINGS

1.1.1 John Wenman Ecological Consultancy LLP was instructed by Charlie Fu to undertake a Preliminary Roost Assessment (PRA) for bats at 3 Woodward Close in Winnersh Wokingham. The PRA was commissioned to accompany a householder planning application to be submitted to Wokingham Borough Council seeking consent for an extension to the front of the existing garage, with the addition of a second storey above the garage (see proposed drawings in **Appendix 4**).
