Phase 1 & 2 Bat Surveys:

**73 Bearwood Road,**

Survey and report by: Vesper Conservation & Ecology Limited

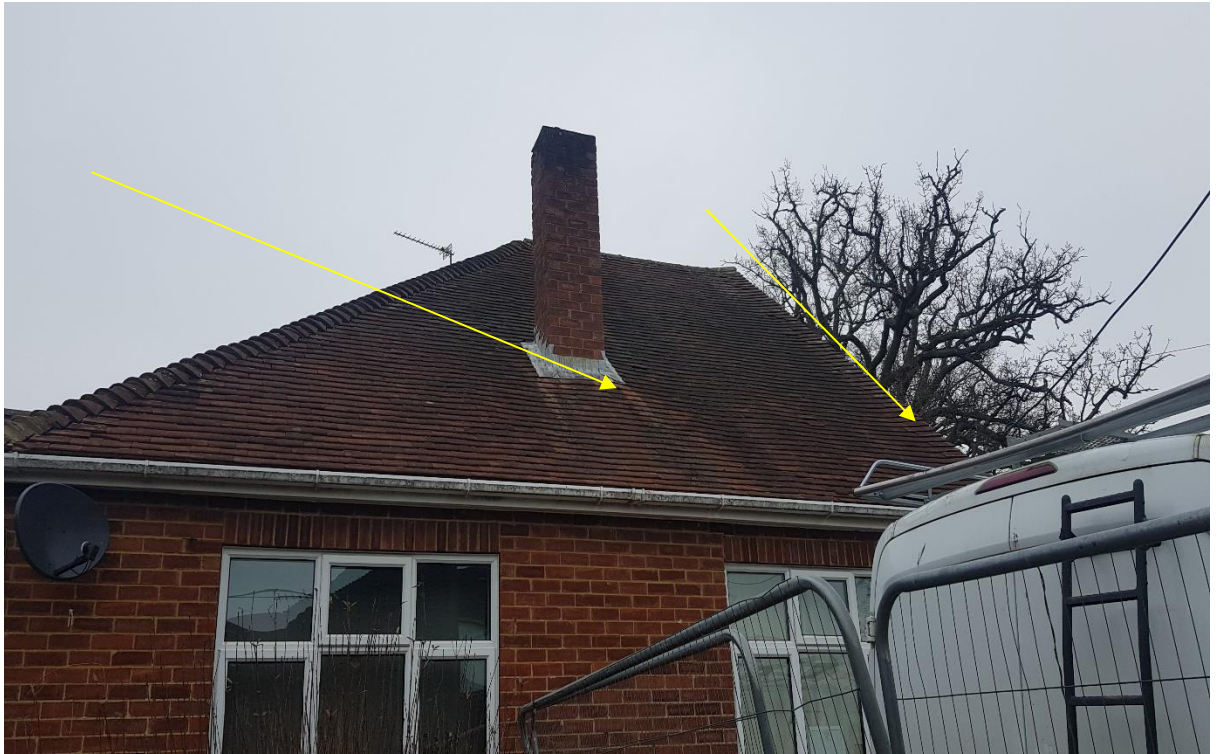
**Figure 3: Showing the area the bat emerged on the southern elevation of the property**

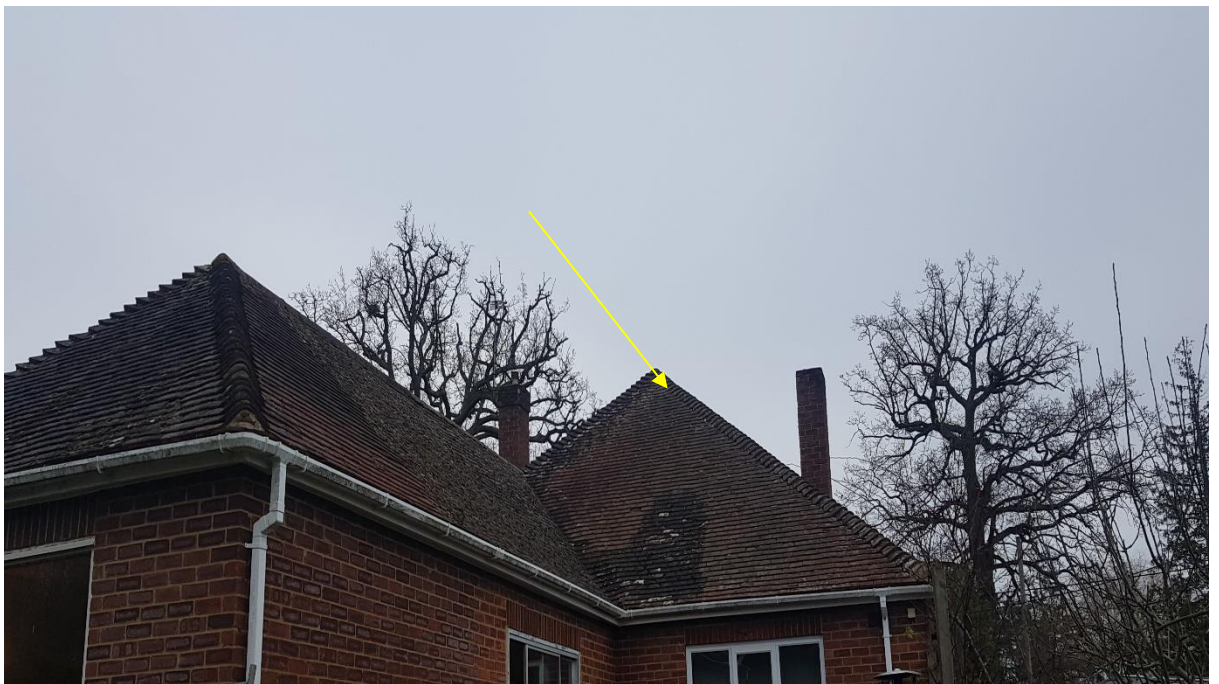
**Figure 4: Showing the area a bat re-entered the building**

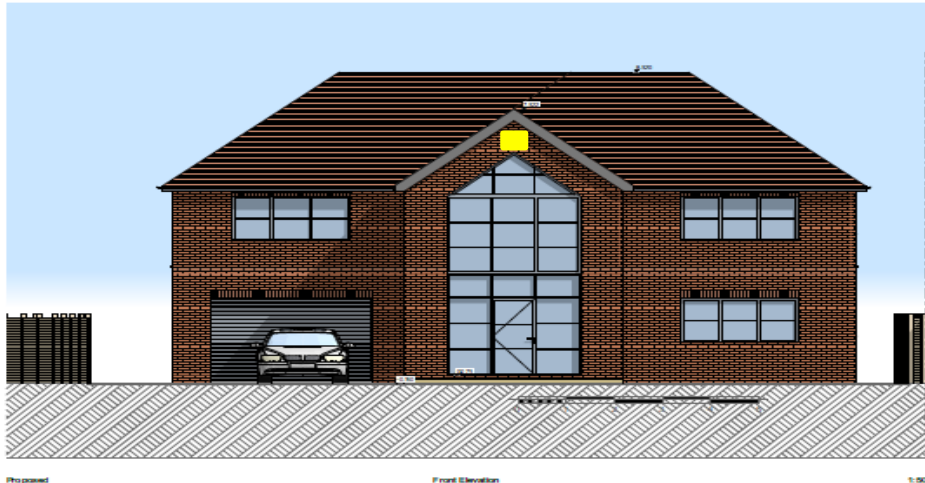
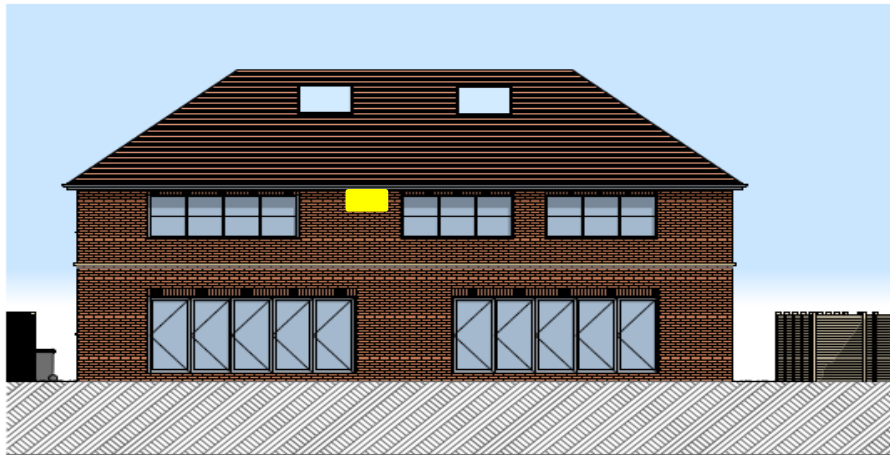
**Figure 4: Showing mitigation (front and rear elevations)**

- 5.7 The following inclusions are therefore recommended for incorporation into the redeveloped building to keep and improve roosting opportunities:
- The addition of 4 inbuilt bat boxes (vivaro Pro built in woodstone bat box or Bird Brick Houses STBAT (brick fronted) into the new elevations as shown in figures 4 & 5 pictures 9 & 10

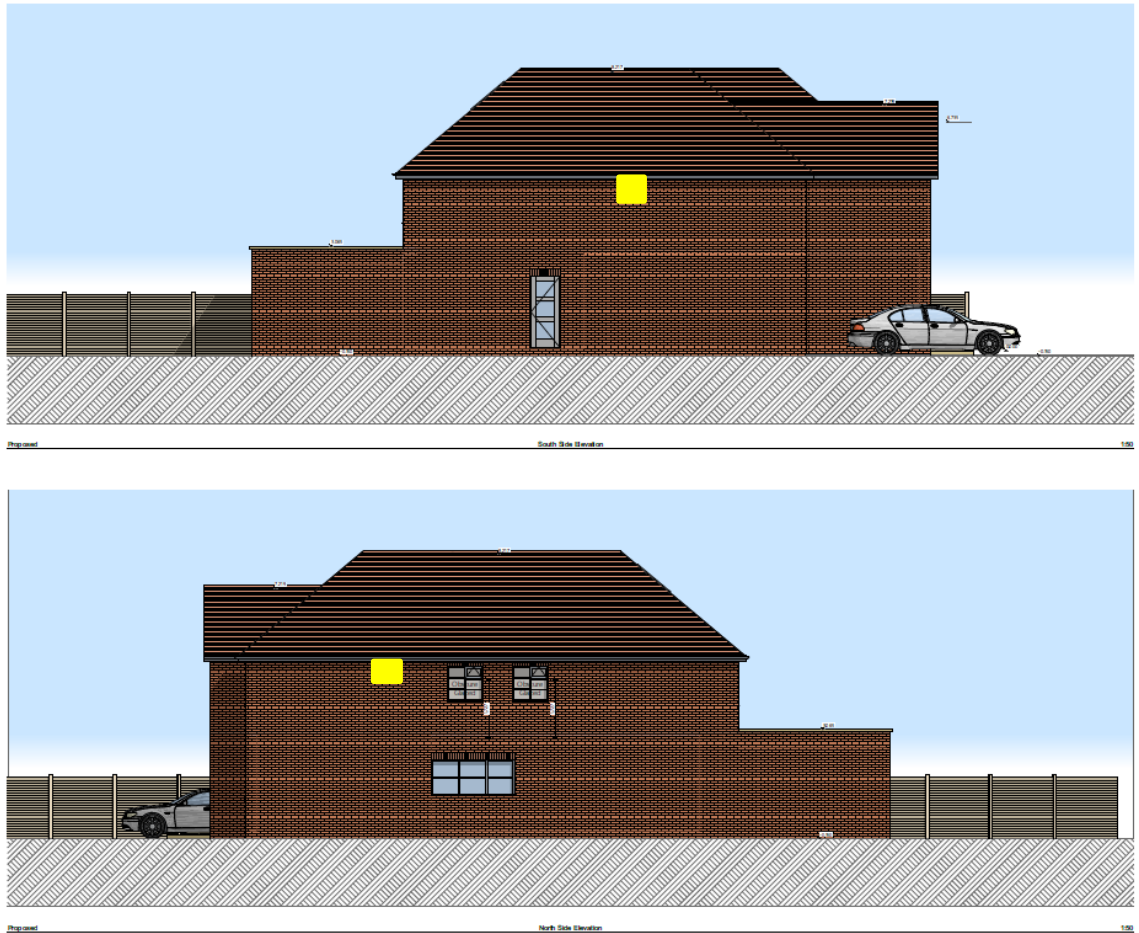
**Figure 5: Showing mitigation (northern and southern elevations)**

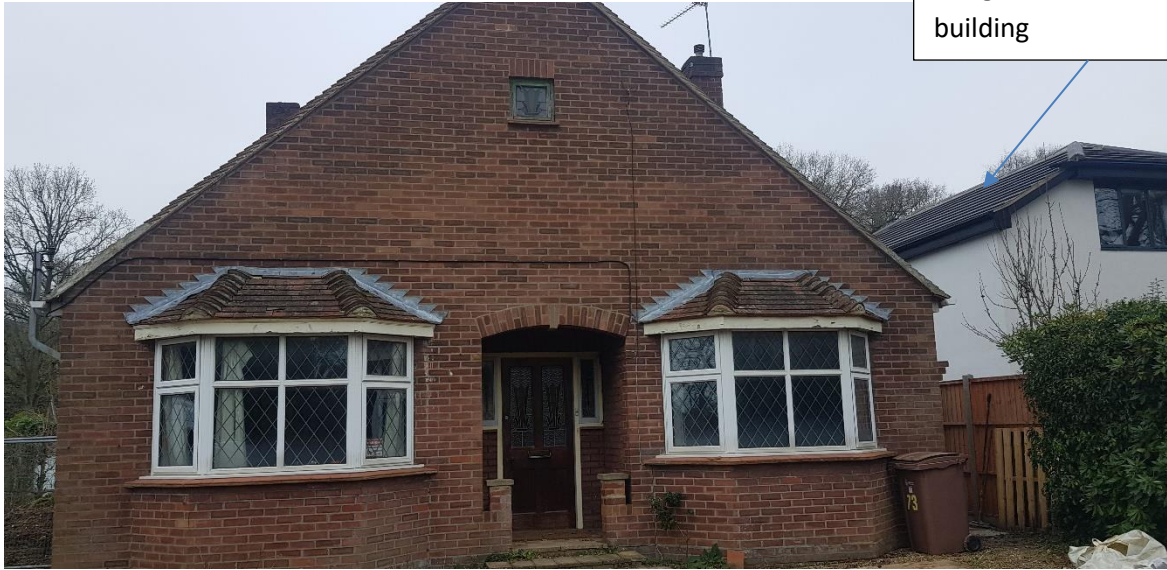
**Picture 1:** Showing the eastern elevation

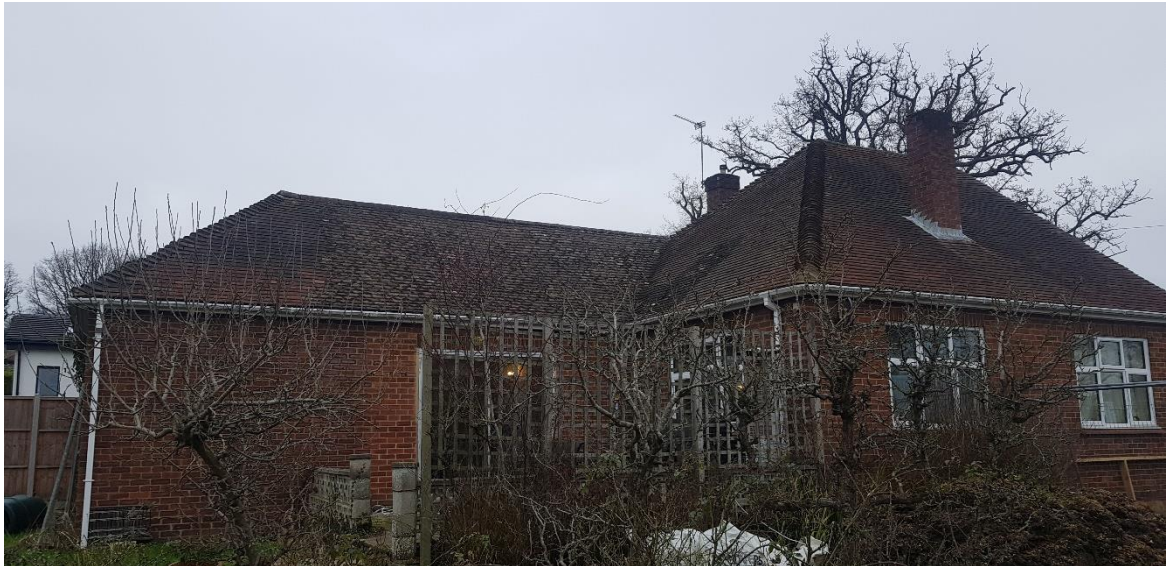
**Picture 2:** Showing the southern elevation.

- 2.6 The ridge is made from the same material as the roof and there are gaps along the ridge on the southern and eastern elevations.
- 2.7 The southern gable wall is covered in hanging tiles, these tiles have numerous gaps and holes that would allow ingress into the fabric of the building.

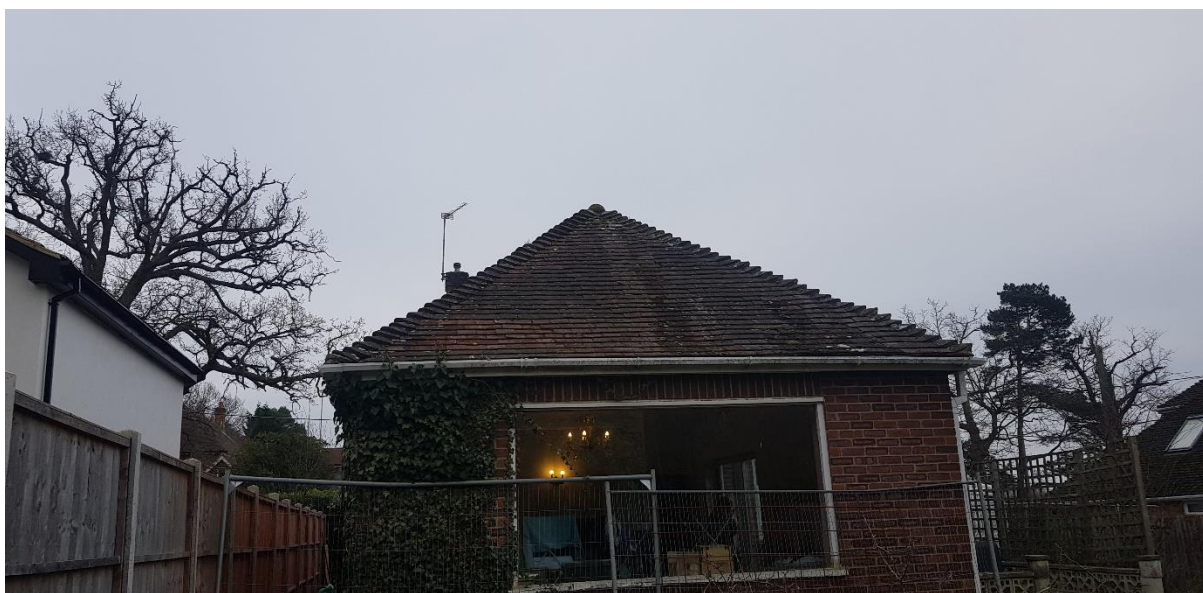
**Picture 3:** Showing the western elevation of the property

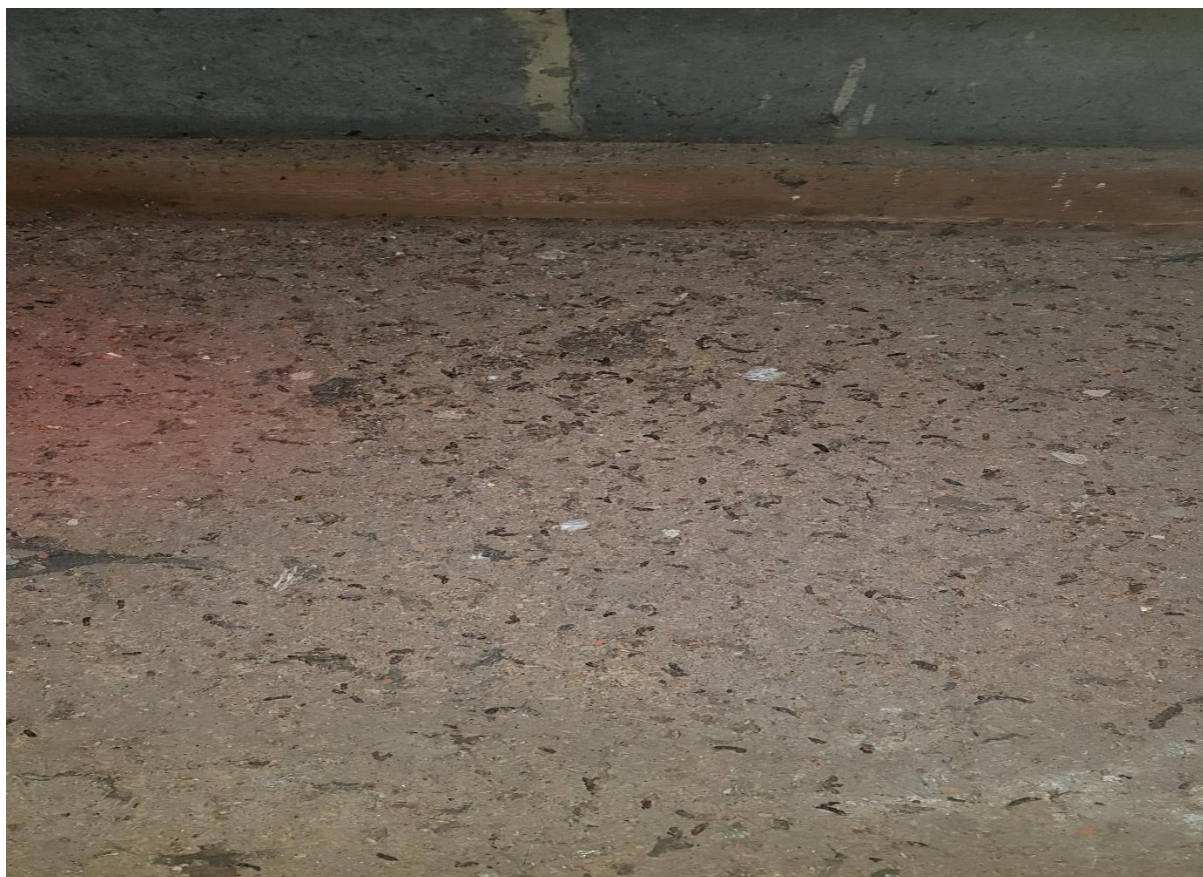
**Picture 4:** Showing bat droppings in the roof near the front gable wall

- 2.15 The floor of the roof was covered with a thick layer of glass fibre insulation throughout. No light was seen coming in through the eaves.
- 2.16 Bat droppings were seen in the larger of the two main roof areas, droppings were seen against the large front facing gable wall they look like from a smaller species of bat such as pipistrelle, a sample was taken for DNA analysis.

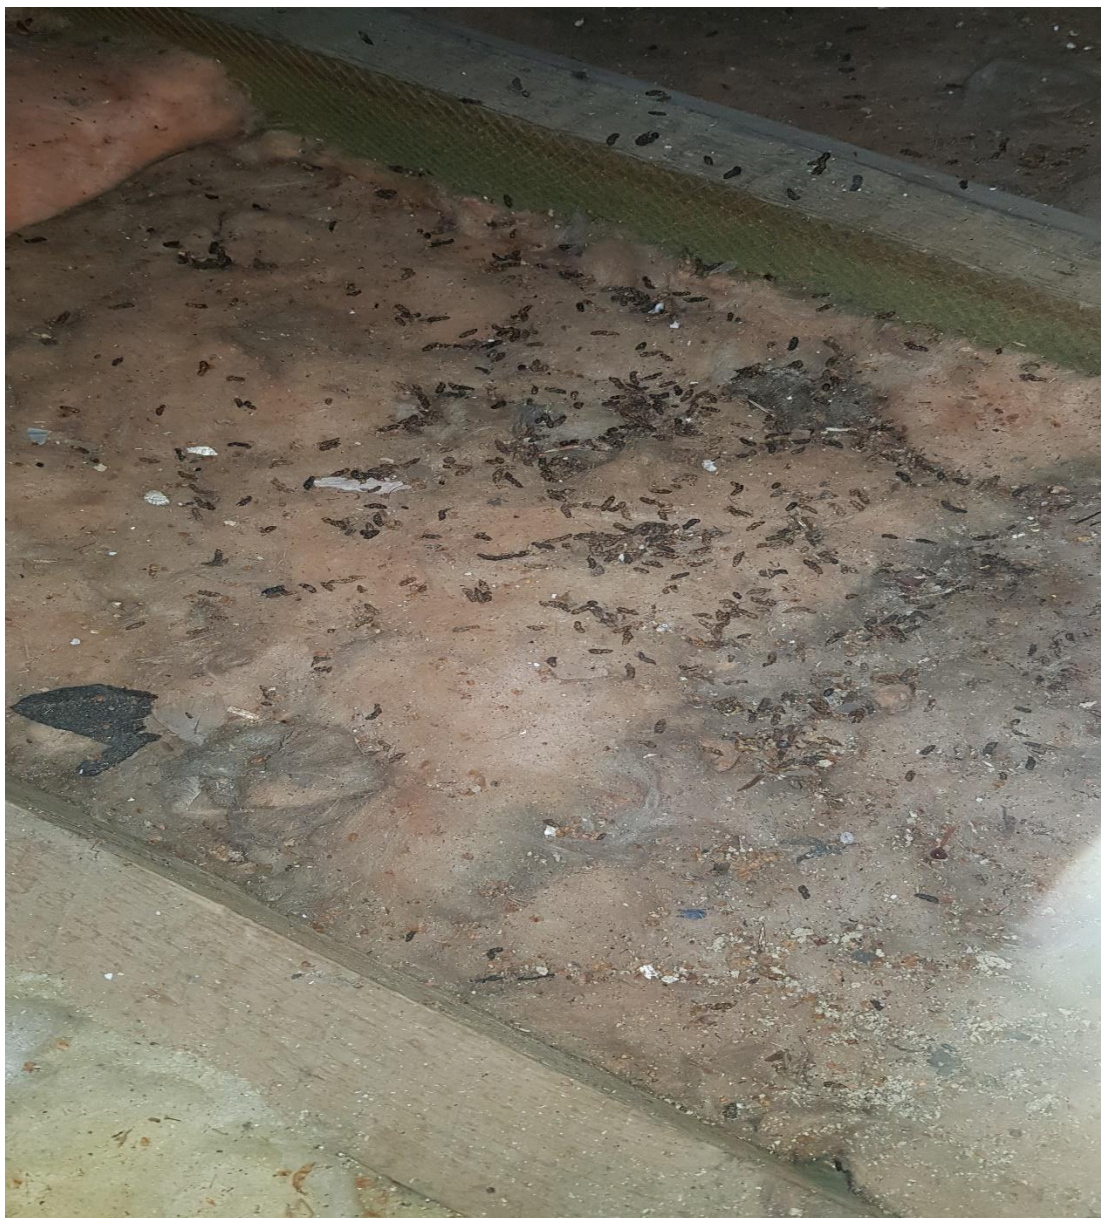
**Picture 6:** Showing the bat dropping on top of the insulation

- 2.17 Bat droppings were also seen in the lower western part of the roof, with droppings seen on the fibre insulation, samples were taken for DNA analysis.

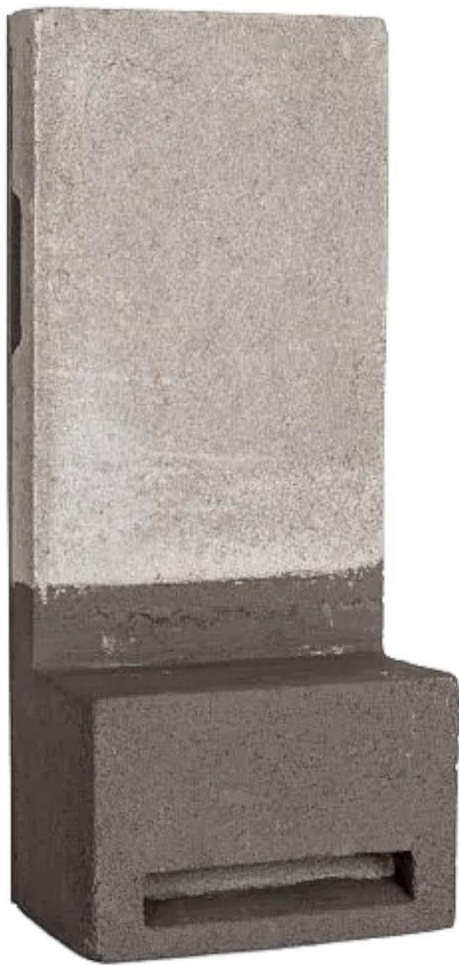
**Picture 9:** Vivaro PRO Build-in WoodStone Bat Box are recommended for this project as they can be built into block work and rendered over
