**SITE INVESTIGATION REPORT**

**ALMA COTTAGE, LODGE ROAD, WHISTLEY GREEN, BERKSHIRE RG10 0EH**

**Report ref:** **10995/CA**

**Date:** **9<sup>th</sup> November 2024**

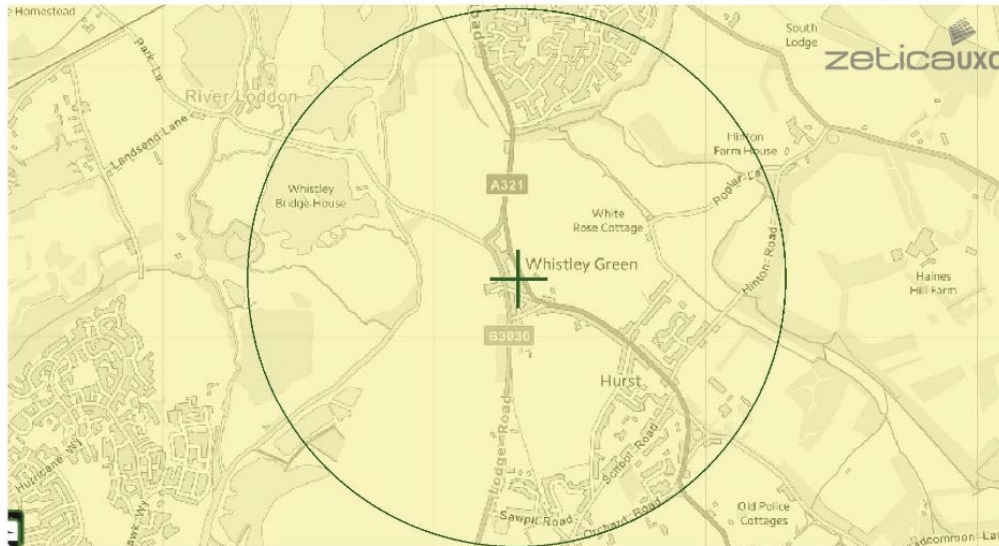
From a preliminary search of UXO risk (shown below), the site is within a low risk UXO area therefore on-site support is not considered to be required for both investigation or development works.

This map principally indicates a hazard from Unexploded Bombs (UXB) due to WWII bombardment. Other sources of Unexploded Ordnance (UXO) may be present. It should be noted that this map does not represent UXO risk and should not be reported as such when reproduced.

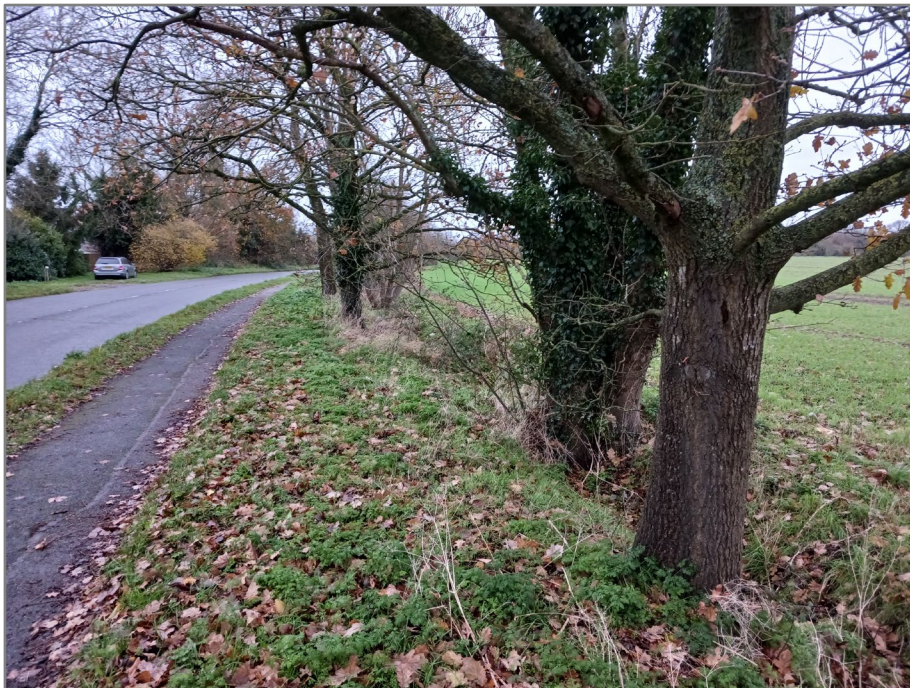
| <b>Photo No 1</b> | |

| <b>Description:</b><br><b>View of fields</b><br><b>to the east of</b><br><b>site from</b><br><b>Broadwater</b><br><b>Lane</b> | |

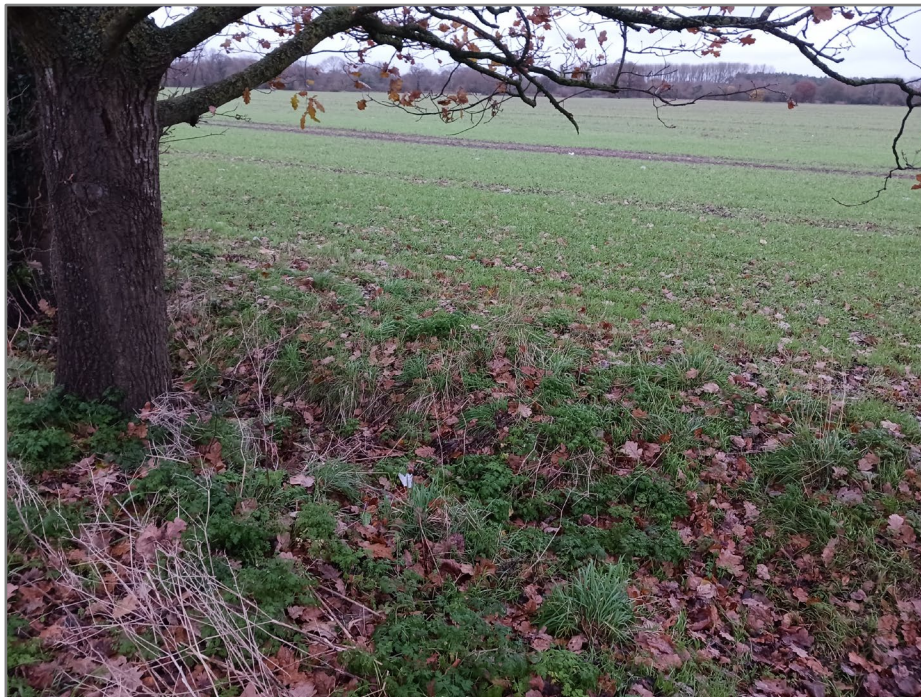
| <b>Photo No 2</b> | |

| <b>Description:</b><br><b>View of fields</b><br><b>to the east of</b><br><b>site from</b><br><b>Broadwater</b><br><b>Lane</b> | |

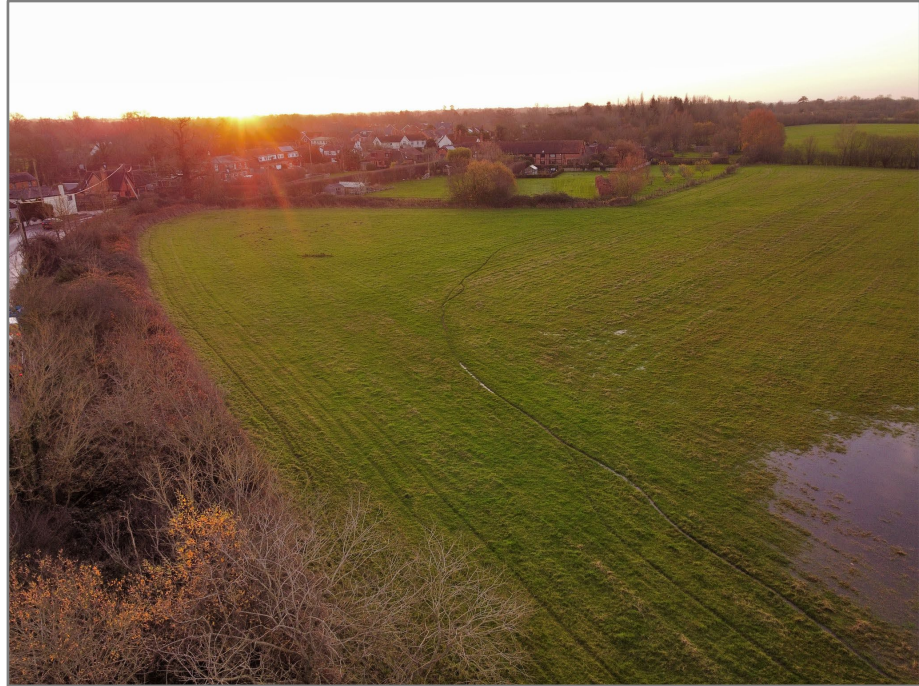
**Photo No 4**

**Description:**  
**View of former**  
**landfill area to**  
**the west of**  
**site**

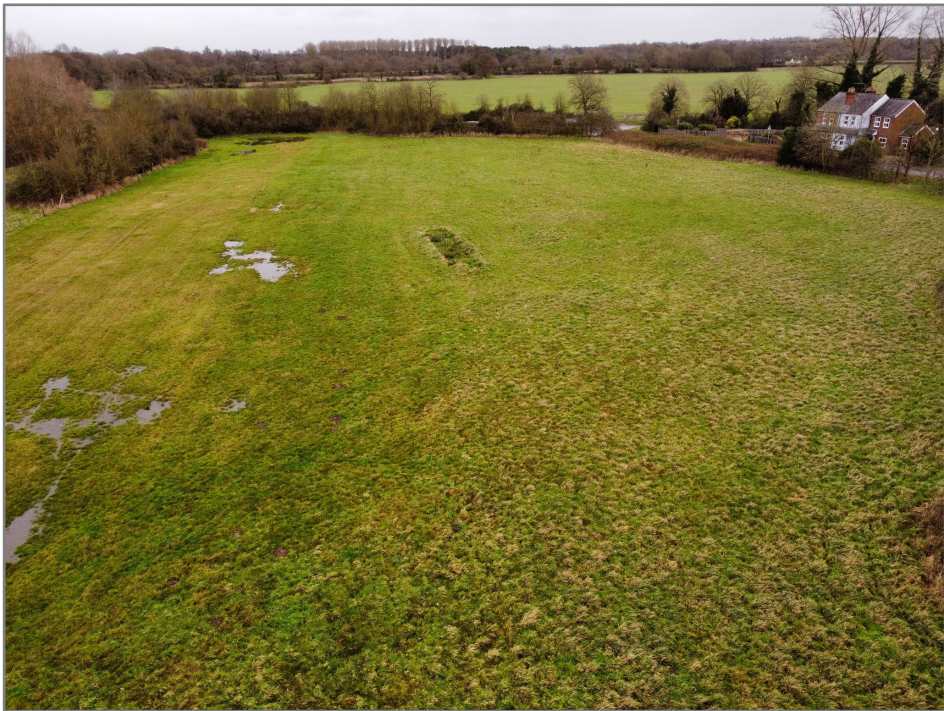
| <b>Photo No 5</b> | |

| Feature | Commentary |
|---|---|
| Evidence of gas protection | ✚ None identified within the site. Gas venting systems were not observed in the surrounding fields to the west and north where former landfill sites are reported. |

| <b>Description:</b><br><b>View of former landfill area to the north of site</b> | |

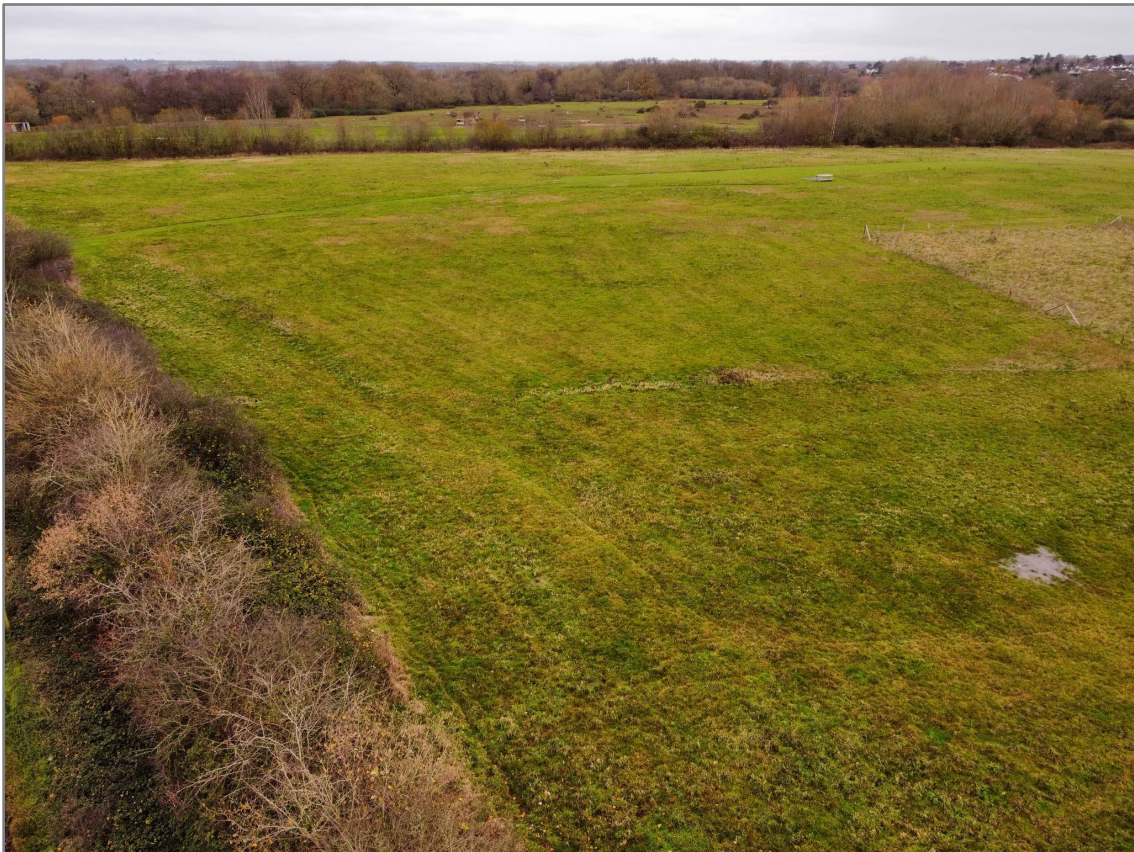
| <b>Photo No 6</b> | |

| <b>Description:</b><br><b>View of former landfill area to the north of site</b> | |

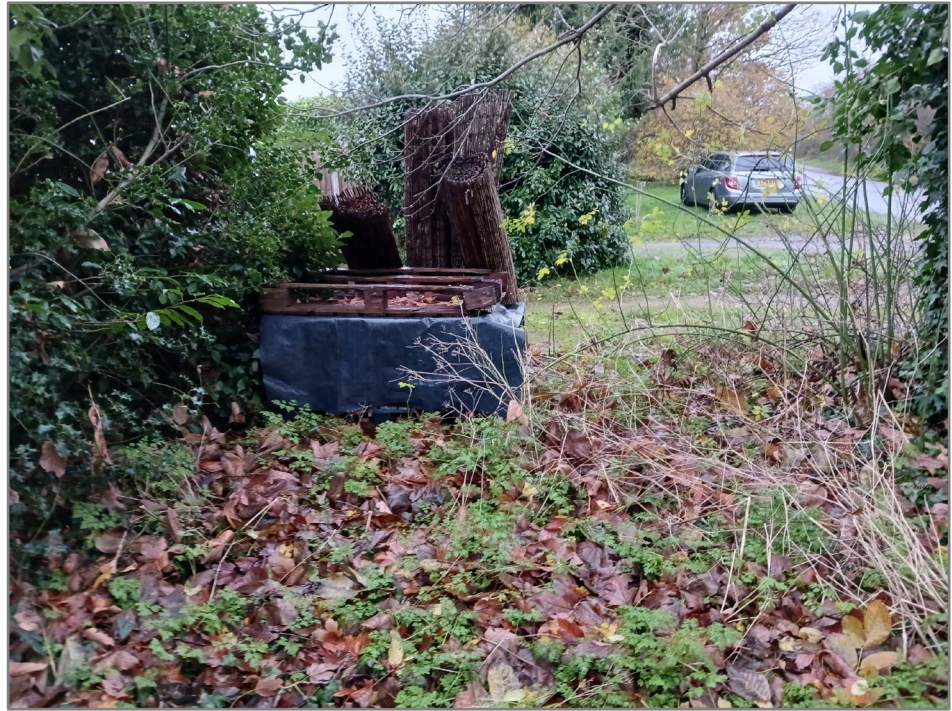
**Photo No 8**

| Element | Description |
|---|---|
| Site description | <ul style="list-style-type: none"> <li>Existing 2-storey house with side and rear garden and brick paving parking area on the southern and western part of the plot (Photo 8)</li> <li>A paved patio area is present to the southern and eastern elevations of the existing house (Photo 8) with a paved path leading to the garden at the rear of the house.</li> <li>At the time of our work, a close boarded fence had been constructed across the garden separating the development plot from the Cottage (Photos 11 and 12).</li> <li>Within the development plot, the area was largely laid to lawn with a small shed and stockpiled building materials located in the south eastern corner (Photos 9 to 12).</li> <li>A sewage/foul drain is known to be present running from the existing Alma Cottage along the northern boundary towards Broadwater Lane to the east of site.</li> </ul> |

**Description:**  
Alma Cottage

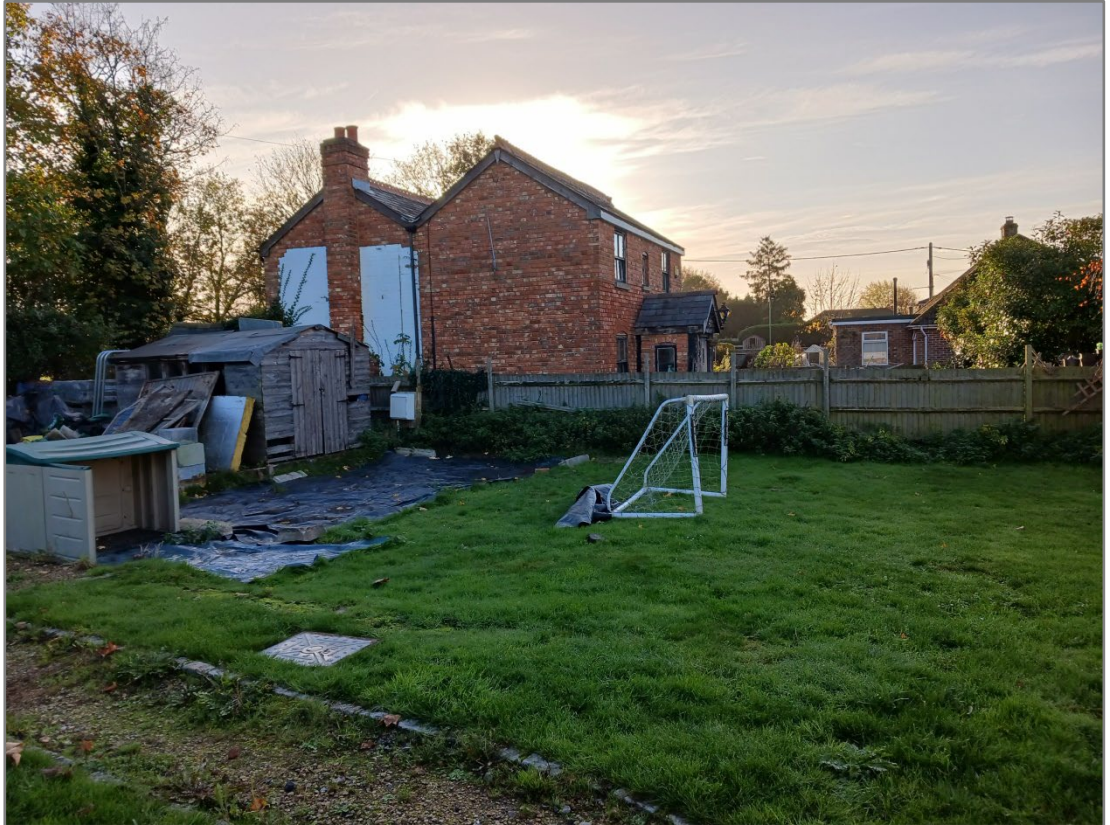
**Photo No 10**

**Description:**  
Garden area  
where new  
house is  
proposed

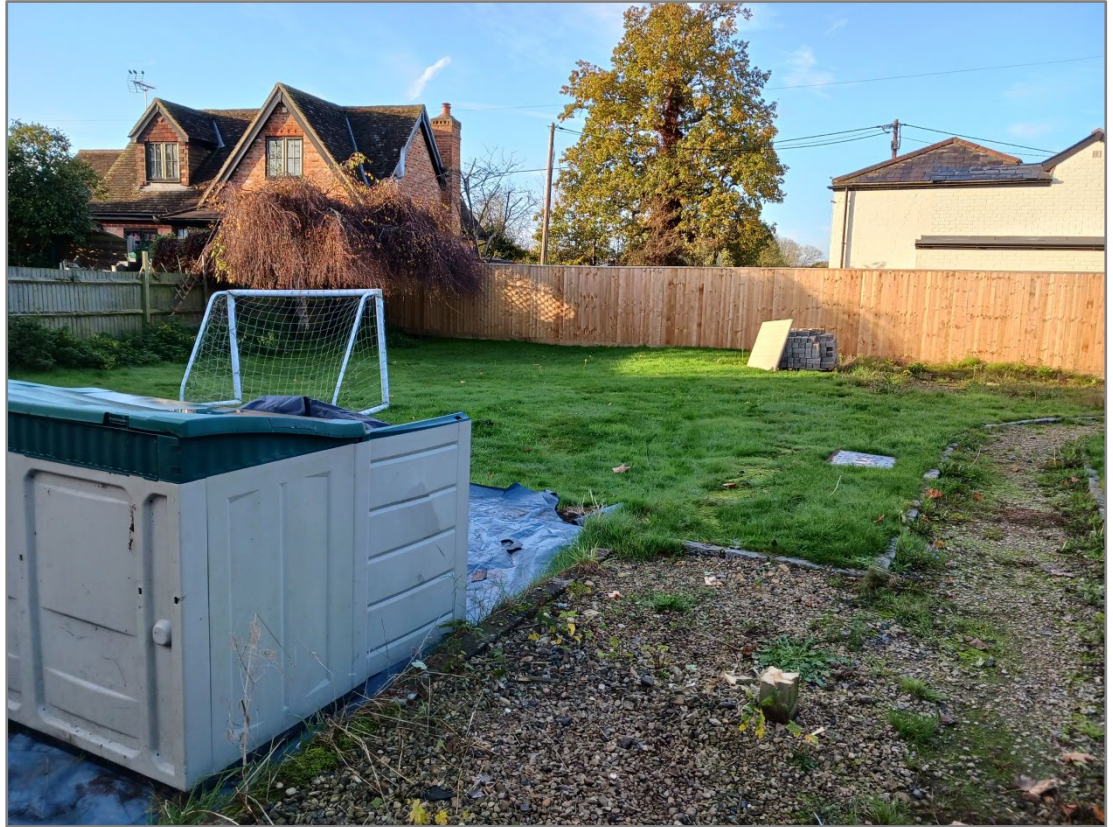
**Photo No 12**

**Description:**  
Garden area  
looking  
towards Alma  
Cottage  
(west) and  
northern  
boundary on  
right. Car  
garage beyond  
fence.

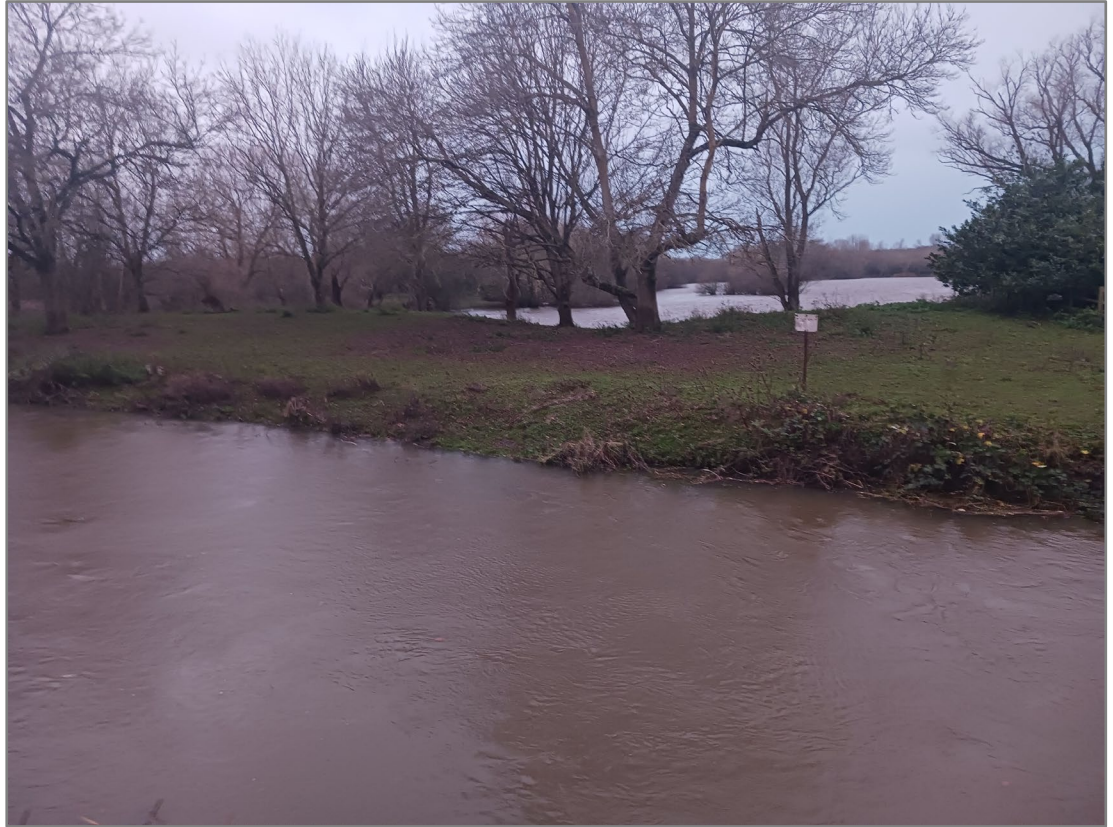
**Photo No 14**

**Description:**  
**View of River**  
**Loddon,**  
**observed from**  
**approx. 360m**  
**northwest of**  
**site**
