**PHASE 2  
GEOTECHNICAL AND GEO-ENVIRONMENTAL  
SITE INVESTIGATION**

**PARCEL 15  
HOGWOOD FARM  
(FINCHWOOD PARK DEVELOPMENT)**

**CALA HOMES THAMES AND  
LEGAL & GENERAL HOMES LIMITED**

**41623-026**

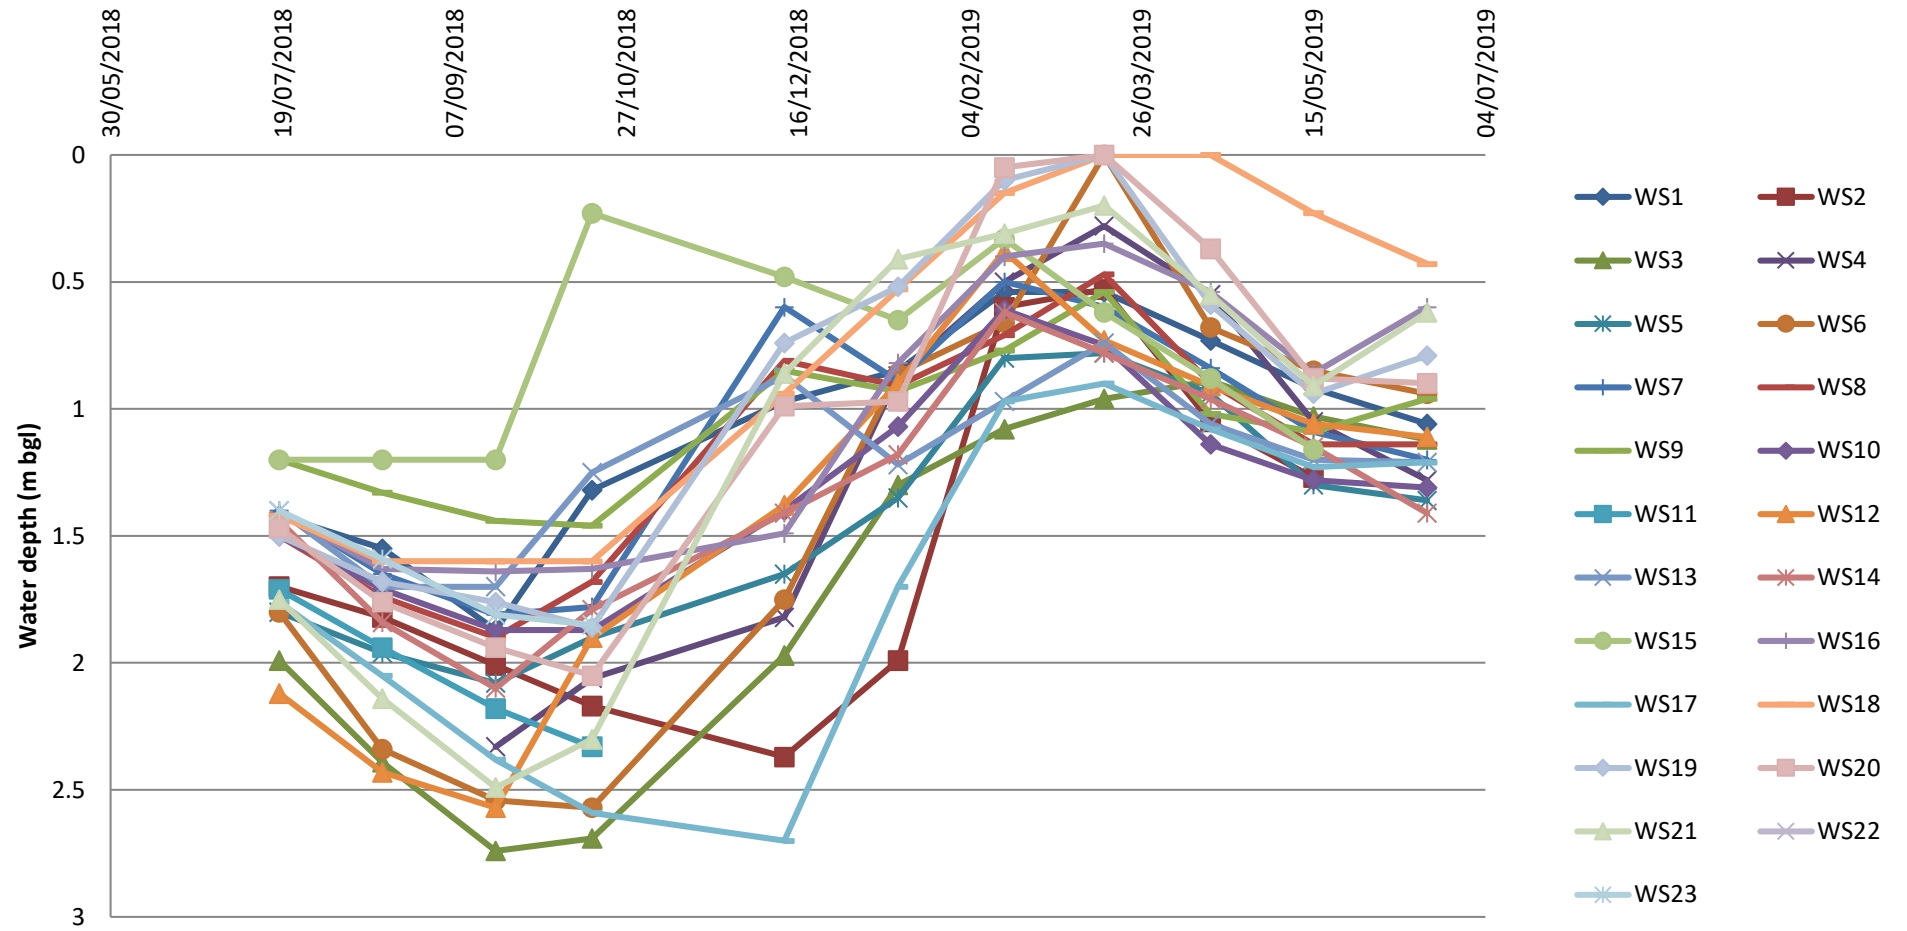
# Water depth over time

their deepest in September 2018 where they were found to be between 1.2 m and 2.7 m bgl. The levels then rose to a peak in March 2019 where the levels were found to be between 0.0 m and 0.96 m bgl. As expected, the levels then fell towards June 2019, although small rises were recorded in a few wells between May and June.

shallowest towards the end of the winter period/beginning of spring and deepest towards the end of the summer period/beginning of autumn. The water levels were observed to be relatively shallow, with water recorded at the surface on a few occasions in a small number of wells. Contour plans have been produced which indicate the groundwater is flowing towards a surface water drain/stream which exits the centre of the southern boundary of the site and flows towards the Blackwater River. The values recorded are considered to be representative of the true groundwater, and not a perched water table.
