RAN/AML/41623-060

8 May 2025

## Parcel 15, Hogwood Farm, Finchampstead Capping Verification – Plot 504, 505 and 506

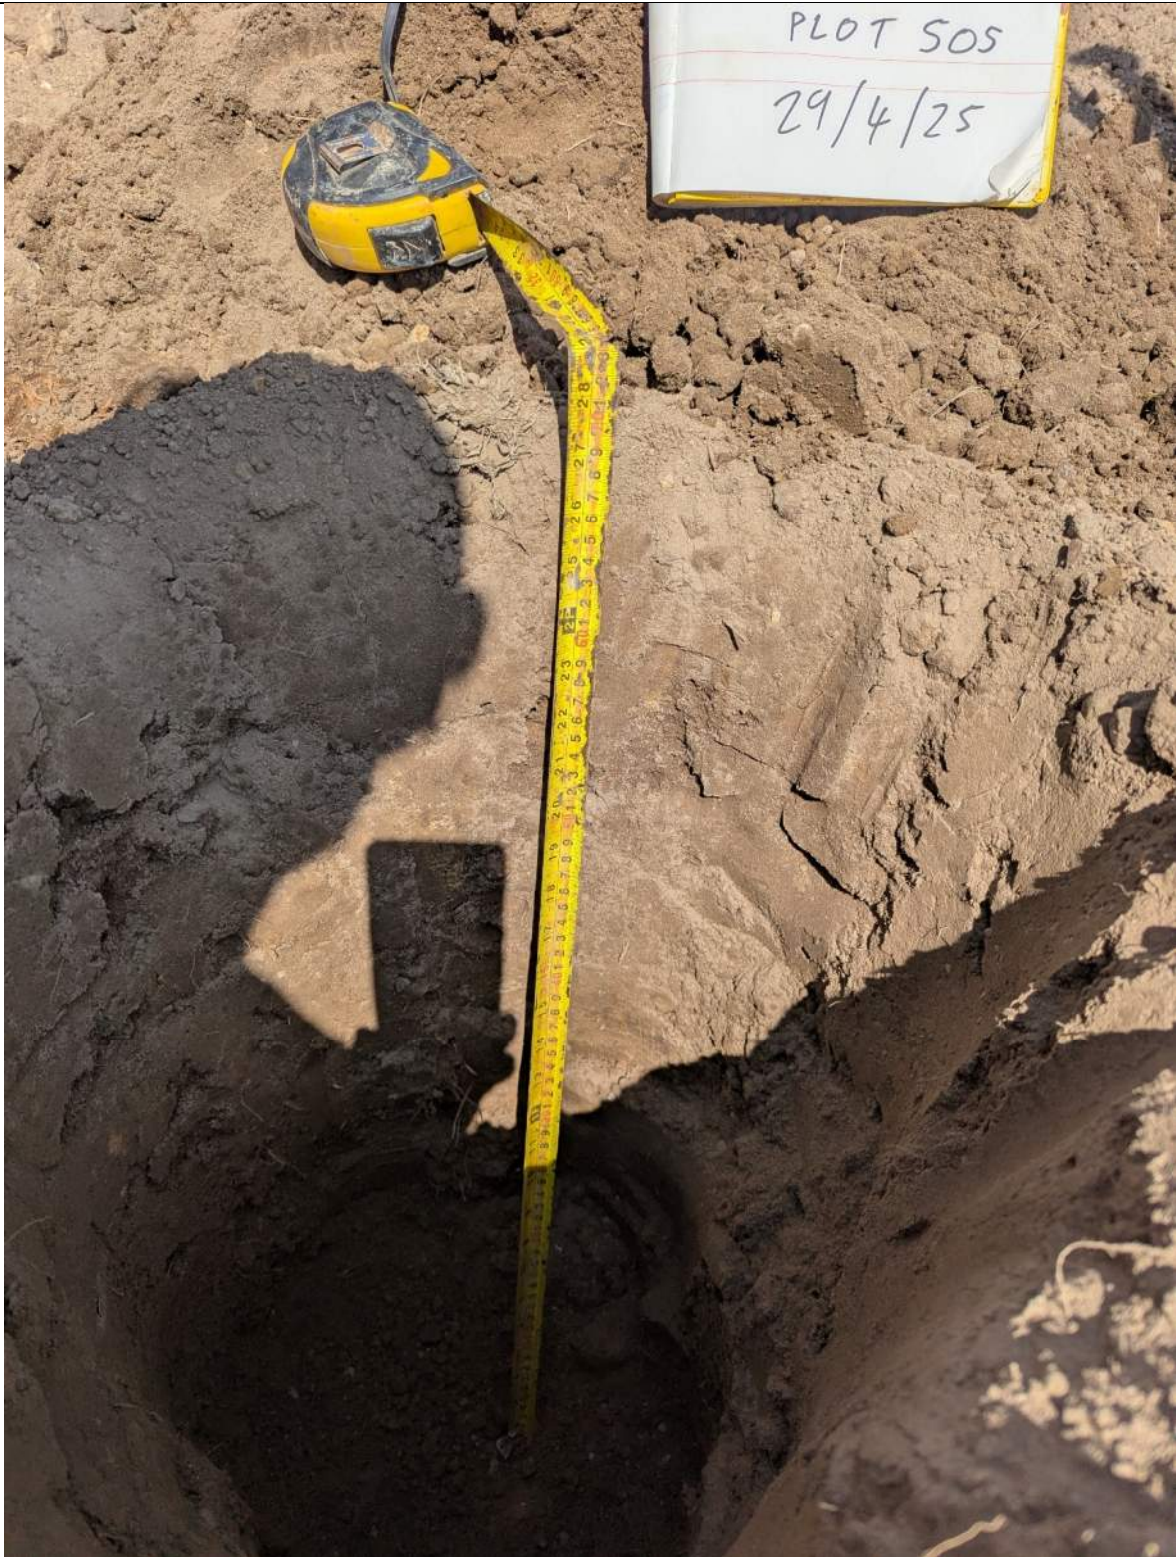
| Plot | Description | Thickness (mm) | Total Thickness (mm) |
|---|---|---|---|
| 505 | TOPSOIL: Dark brown slightly silty fine to medium sand with occasional to frequent rootlets. | 350 | 700 |
| | SUBSOIL: Firm orangish brown and grey mottled slightly gravelly micaceous silty CLAY with rare rootlets. Gravel is fine to medium of chert and mudstone. | 350 | |

The above table demonstrates that the capping layer in plot 505 was found meet the remedial requirements.

Plot 505 – Capping depth

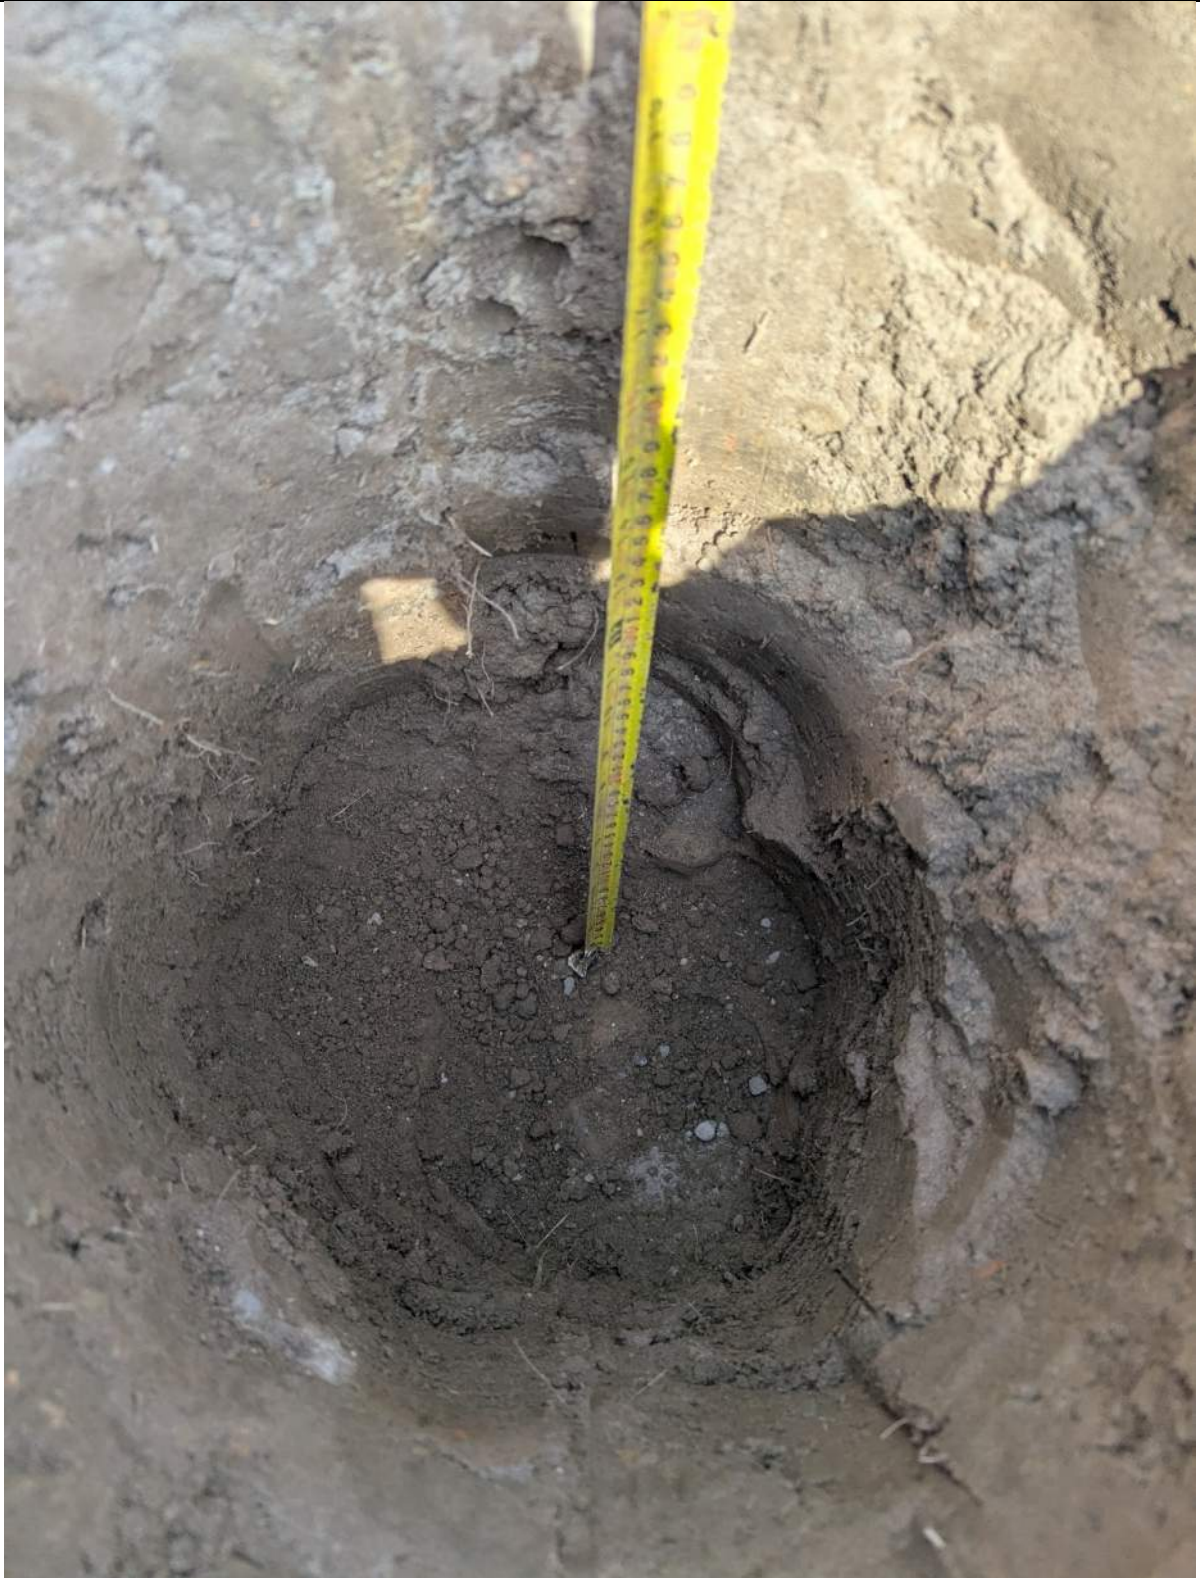
The presence of natural ground was confirmed in the base of the verification pit.

**Plot 505 – Base of verification pit**

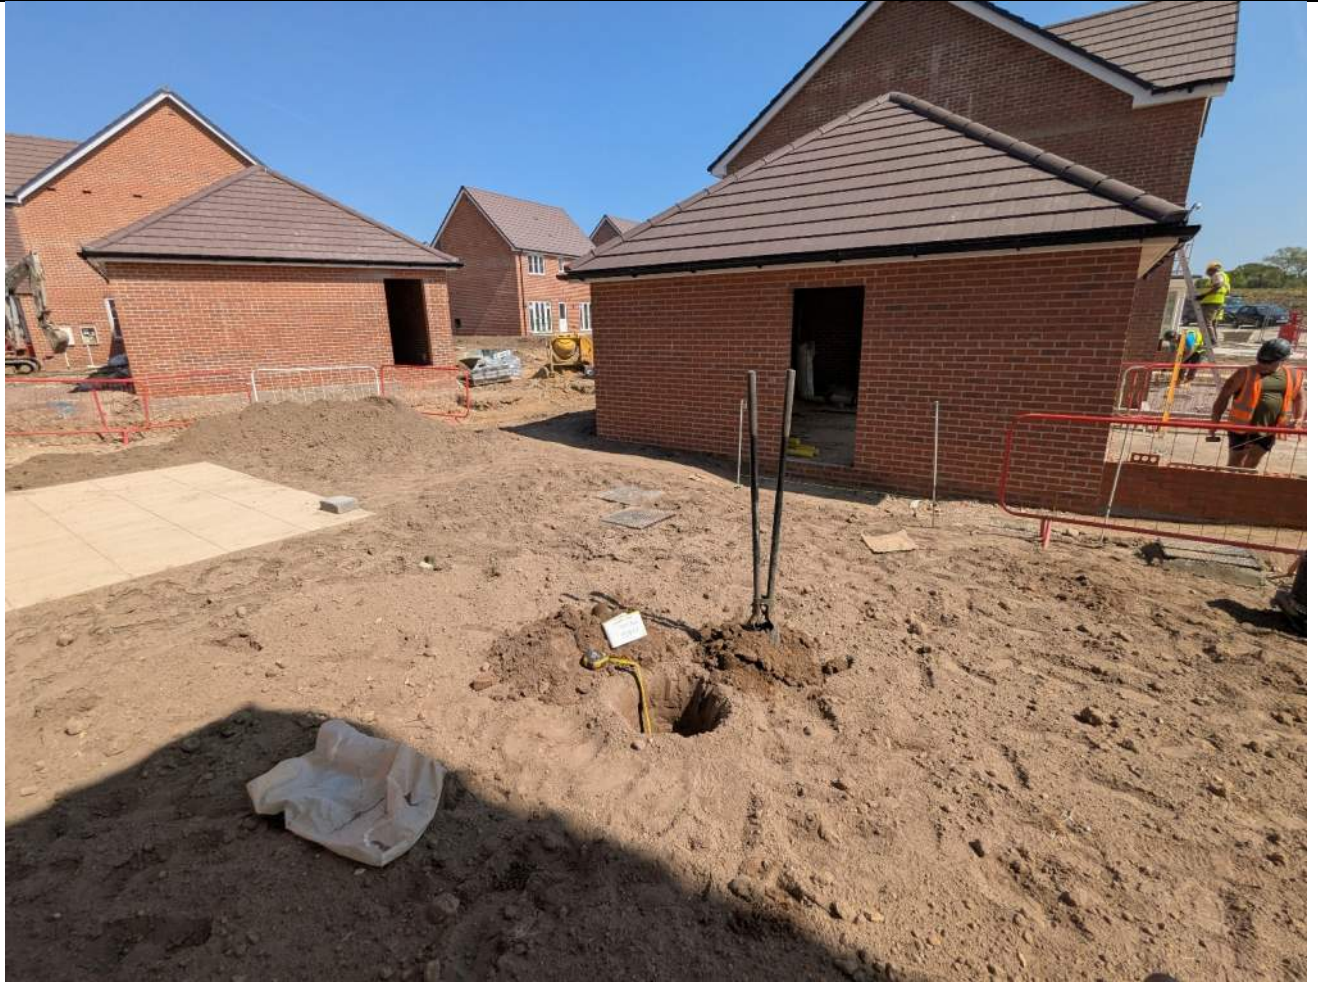
**Plot 505 – Rear garden and spoil**

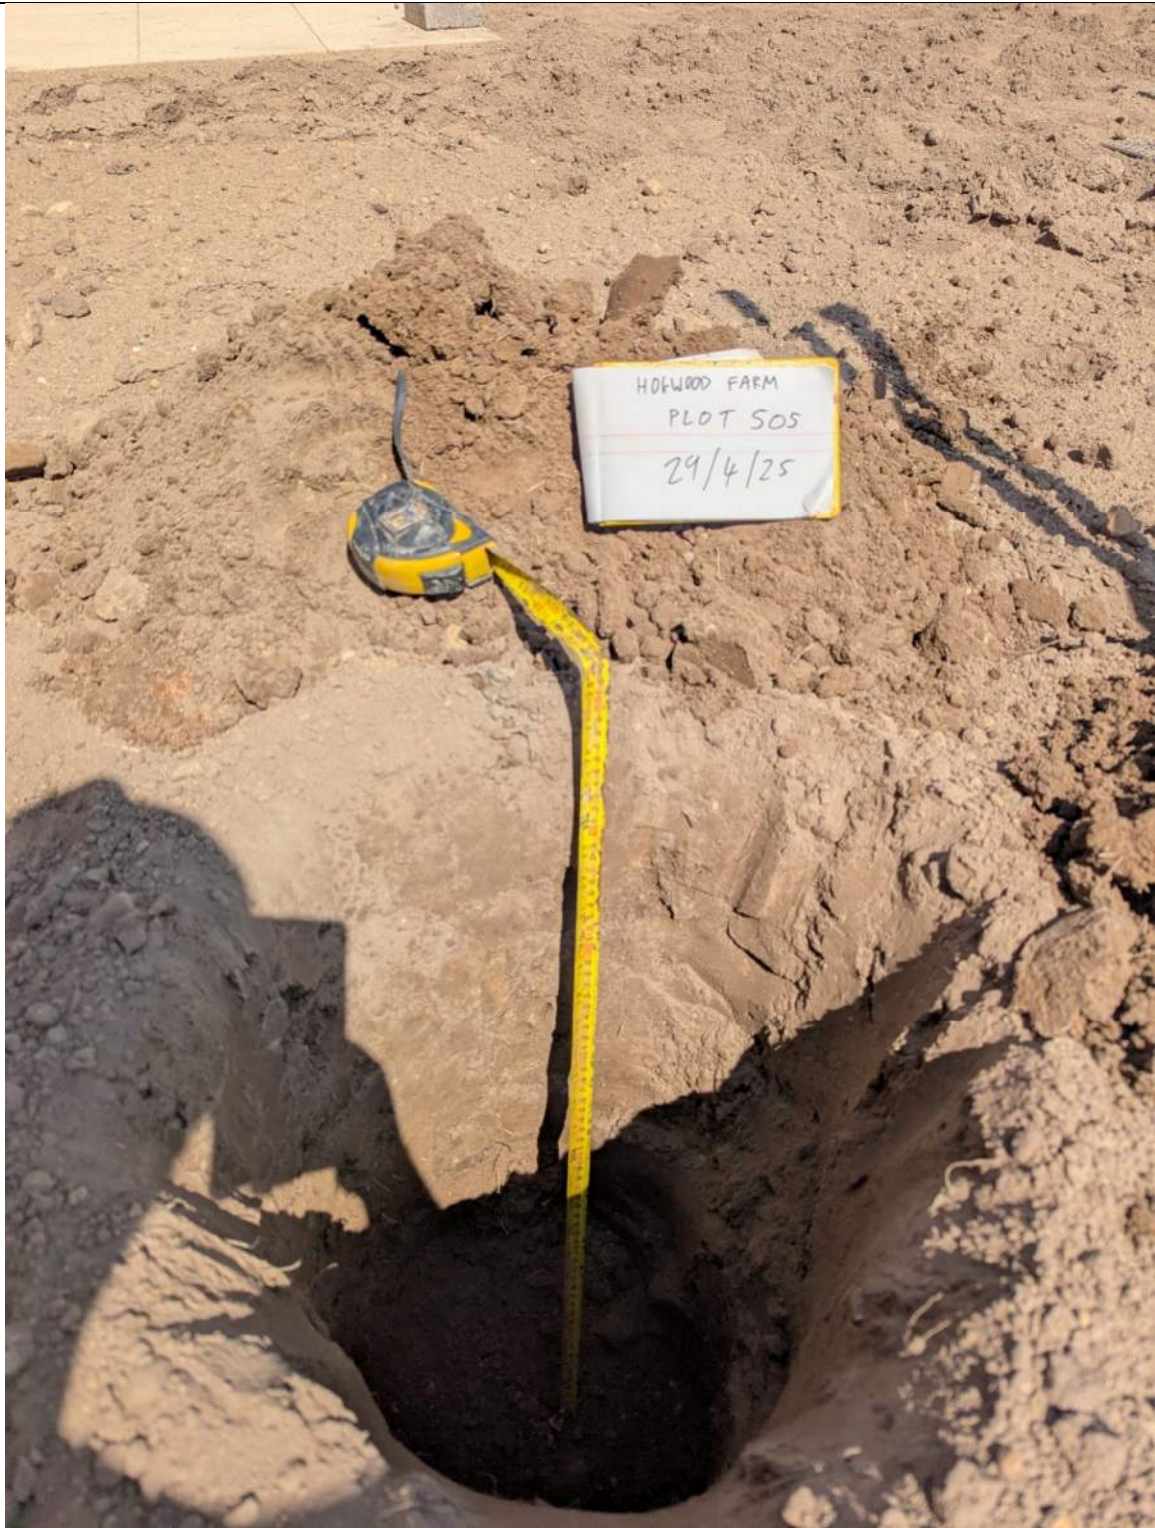
We visited site on 29 April 2025 and excavated a verification pit within the rear garden of plot 505 to verify the depth of the capping layer.

**Plot 505 – Verification pit**
