# **BS5837 – Arboricultural Report**

## **Hennerton House**

March 2026

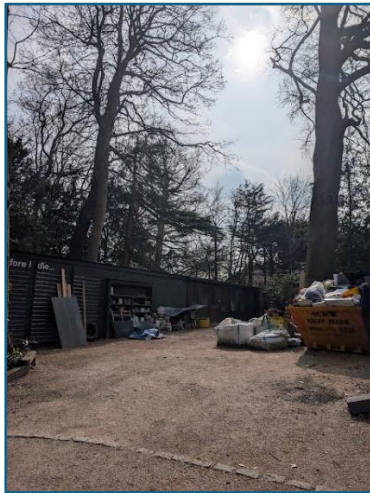
Plate 1

**Plate 1** – Location of the existing timber structure, with third-party woodland visible to the south-east beyond. T011 behind structure, T002 to right of picture.

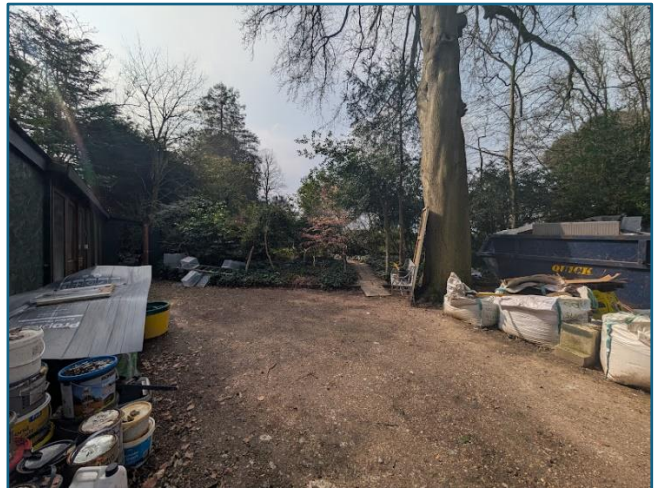
Plate 2

**Plate 2** – Existing timber structure shown to the left of the photograph, viewed in a south-westerly direction. Compacted gravel and aggregate hardstanding is visible in the foreground. T002 to right of picture.

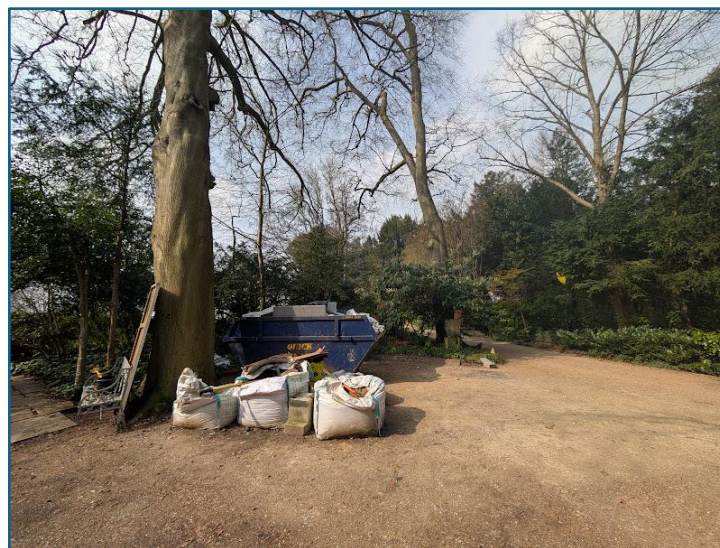
Plate 3

**Plate 3** – View looking in a north-westerly direction from the location of the existing structure. T002 on left of picture. T003 to the right.
