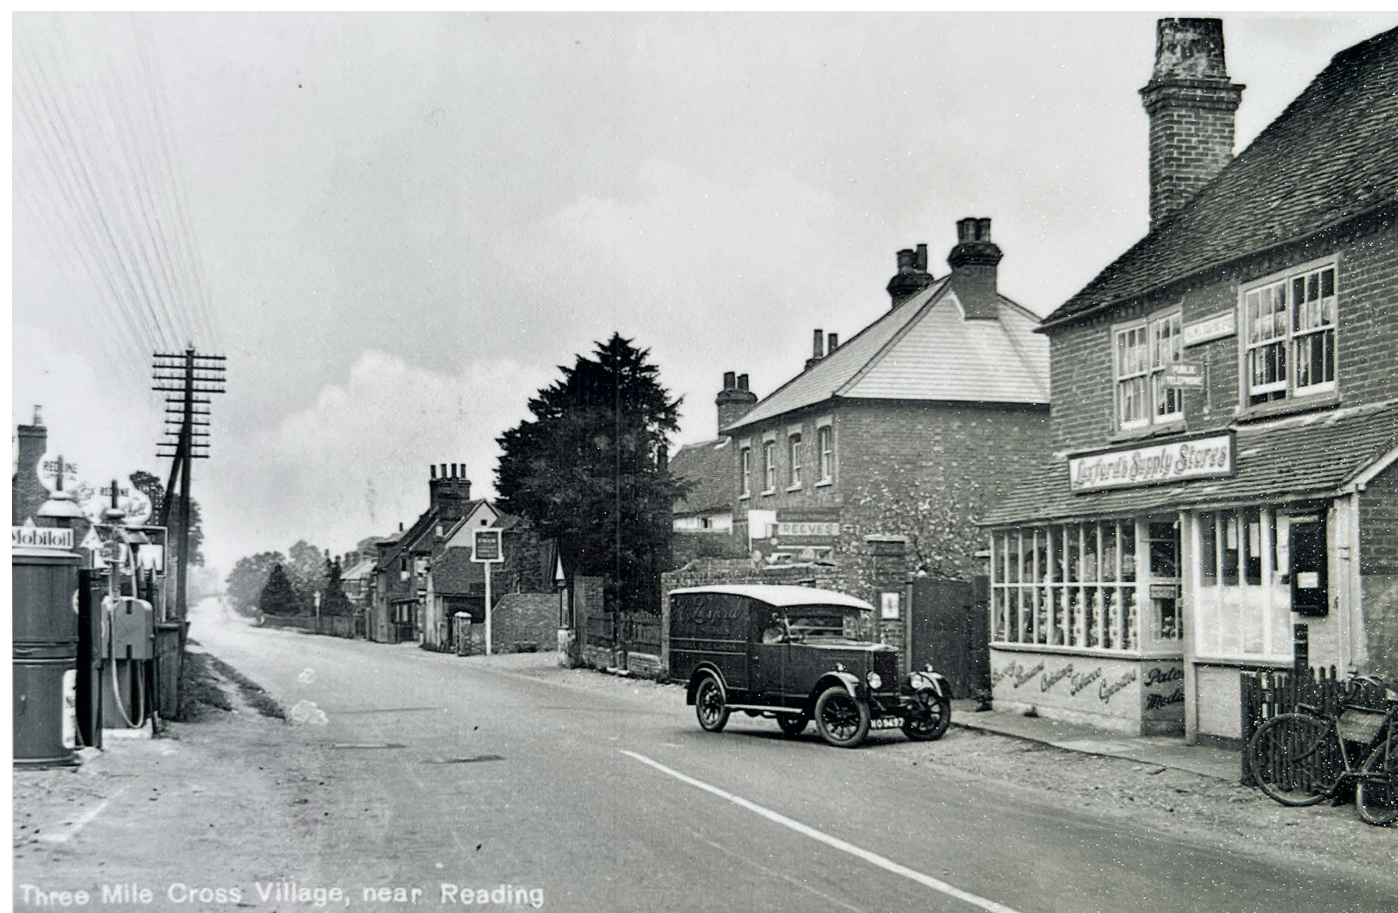
Fig. 19, Early 20th century photograph.

Below, the photographs present the view from the south.  
The Swan Inn is partially obscured by a tree, but the roof outline and the front extension are visible. To the right-hand side, in the foreground, is the Grade II listed Post Office and Newsagent.

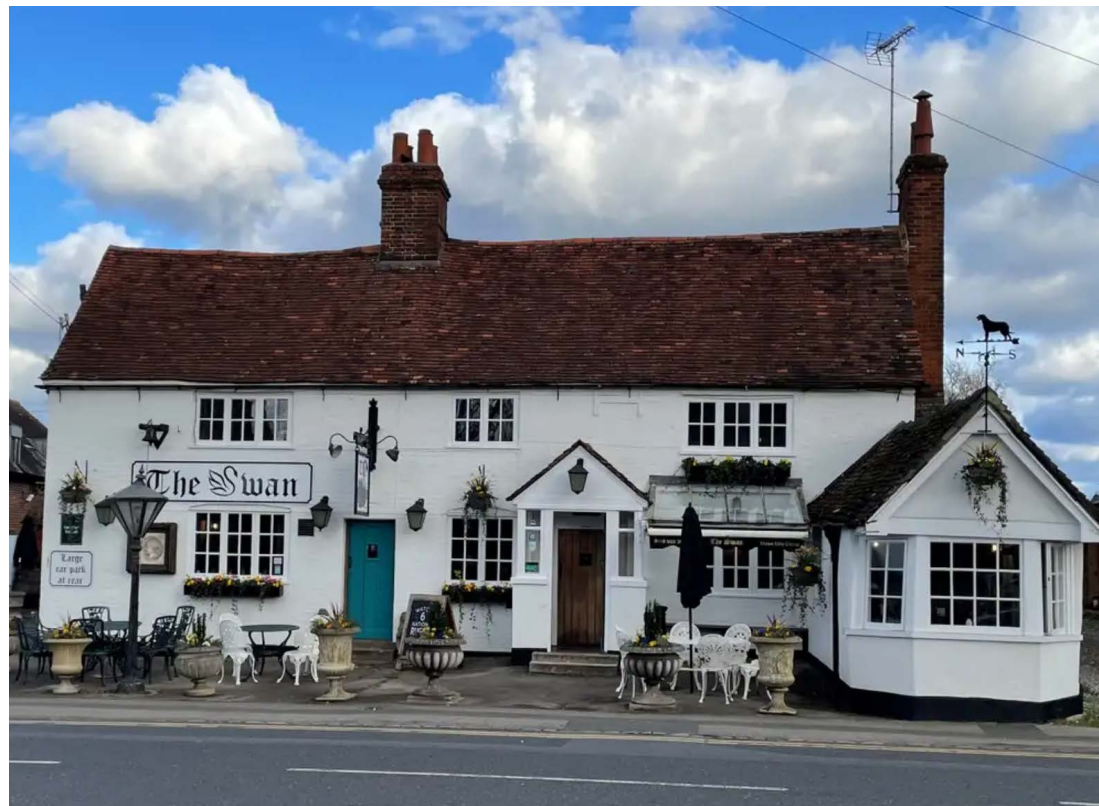
The west elevation is the principal facade of the building, set back from Basingstoke Road. The ground floor windows feature casements with segmental heads. Around 1800, a single-storey extension was added to the southwest corner of the building. An additional door opening was created on the left-hand side of the building, providing direct access to the bar area.

Fig. 21, West elevation, as existing.

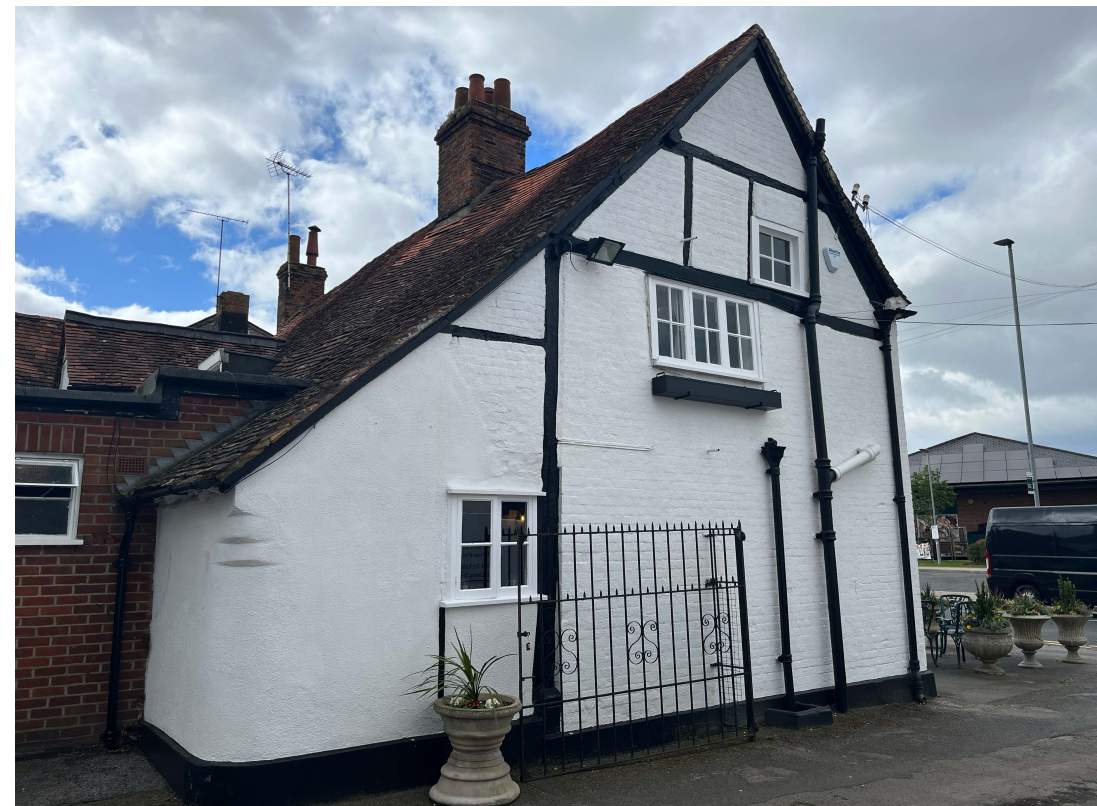
The north elevation is characterized by an extended low-sloping gable and irregular fenestration. The top window opening is modern. The main box frame of the building is constructed with a timber frame featuring a queen strut. The frame has been in-filled with white-painted brickwork, while the timber frame itself was originally painted black in Victorian fashion, later repainted white, and again black in the mid-20th century. There is a catslide roofed extension. The northeast low-level corner is curved and rendered with corbelled eaves detail.

Fig. 22, North elevation, as existing.

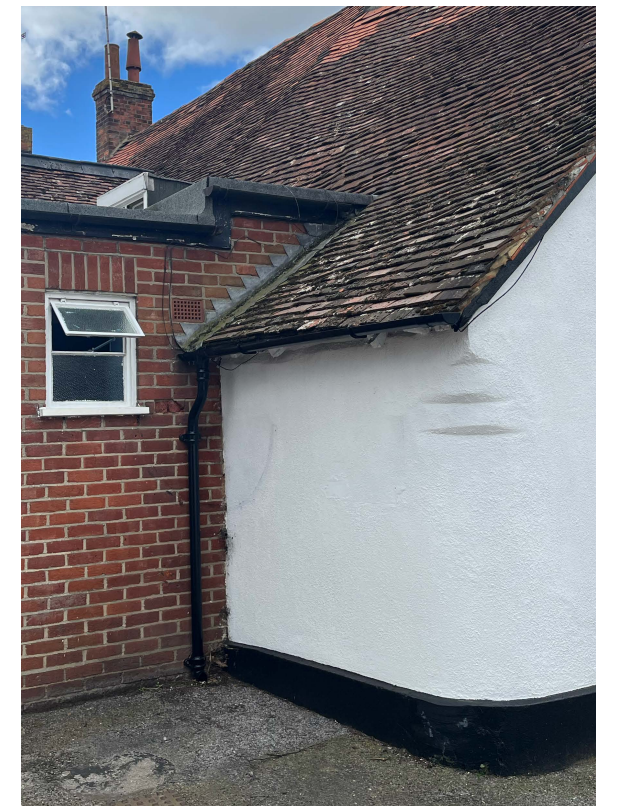
Fig. 23, Rounded stepped corner.

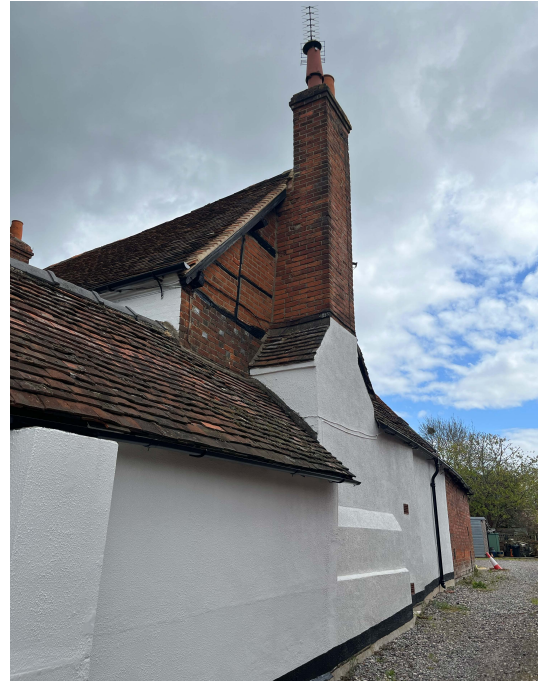
The lower portion of the south elevation is rendered, with upper gable formed of exposed brick and timber wall studs. It features a chimney brick stack and a rendered breast.

Fig. 24, South elevation, as existing.

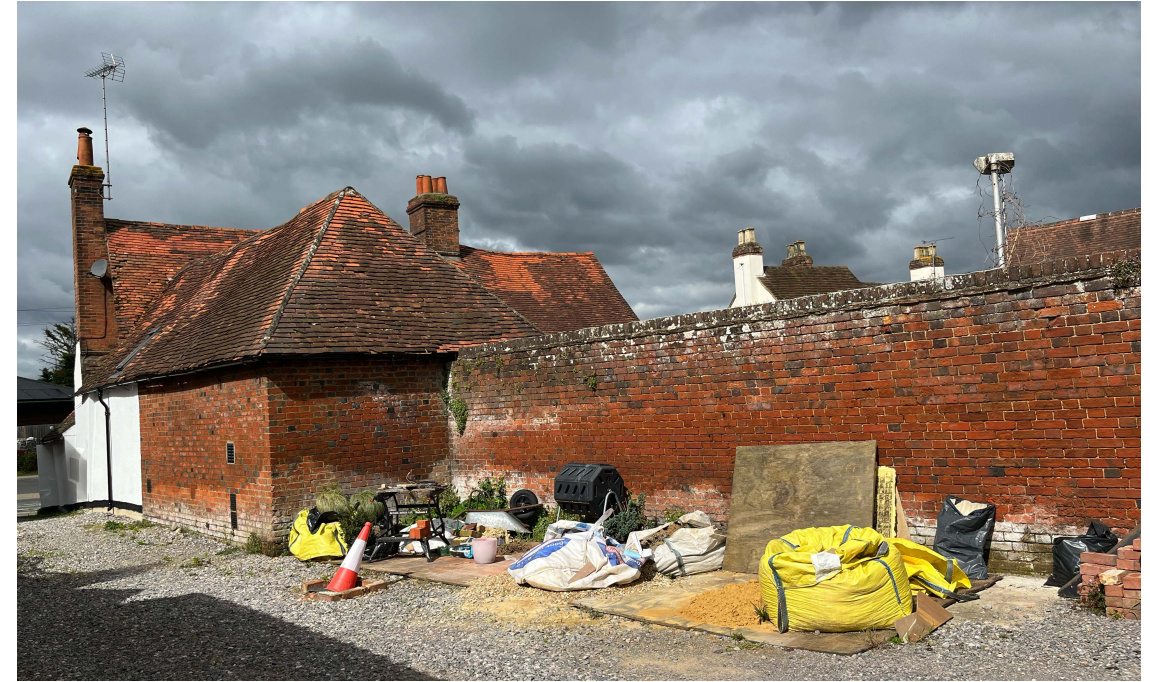
The early 19th-century extension is constructed of red brick in Flemish bond. The Garden Wall, contemporary to the extension, also continues in Flemish bond. A modern skylight is situated on the south slope of the hipped roof.

Fig. 25, Extension at the rear, as seen from south. Garden wall adjoining the early 19th century extension.

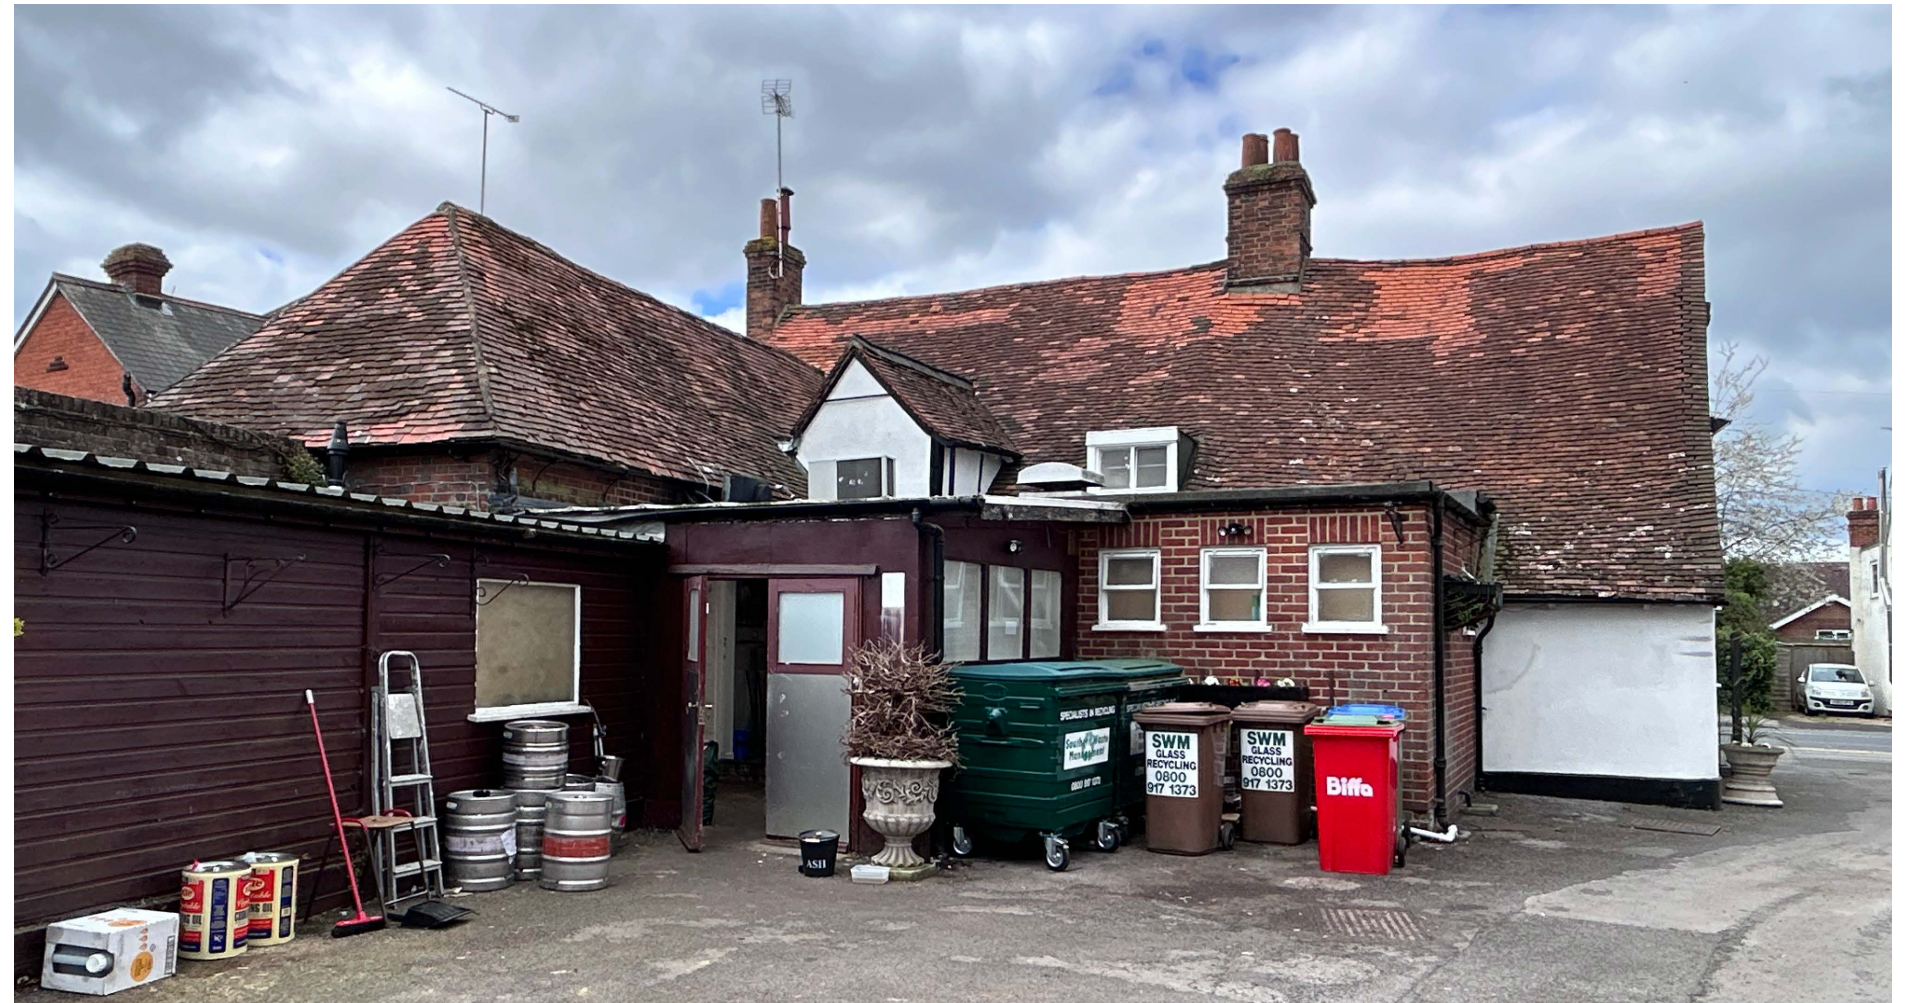
The east elevation (rear) is largely concealed by modern one-story extensions, though some historical character of this elevation remain visible. A dormer, dating back to the early phases of the building's development, provides access to the staircase leading to the first floor. It is pitched, tiled, and hipped into the existing roof, with valley gutters that are not lead flashed. The ridge tiles do not match those of the main roof or the southerly extension. Another dormer, with a flat roof, belongs to the modern redevelopment phase. An air conditioning unit is mounted on the roof above the modern kitchen extension.

The kitchen and WCs have been inserted into the hipped roof to accommodate a one-story extension. These, along with the storage room at the rear of the kitchen and the office extending from it, create a very irregular and chaotic arrangement characterized by poor-quality construction and materials. Part of the early 19th-century extension to the southeast is visible above the modern office, with its height matching that of the Garden Wall.

Fig. 26, East elevation and outbuildings, as existing.

Based on the previous analysis in this report, the removal of the existing extensions to the rear of the building is expected to have a positive impact on the building's significance values. This action presents an opportunity to reinterpret the east elevation and introduce a new design language that effectively communicates the historical narrative in a clear and authentic manner.

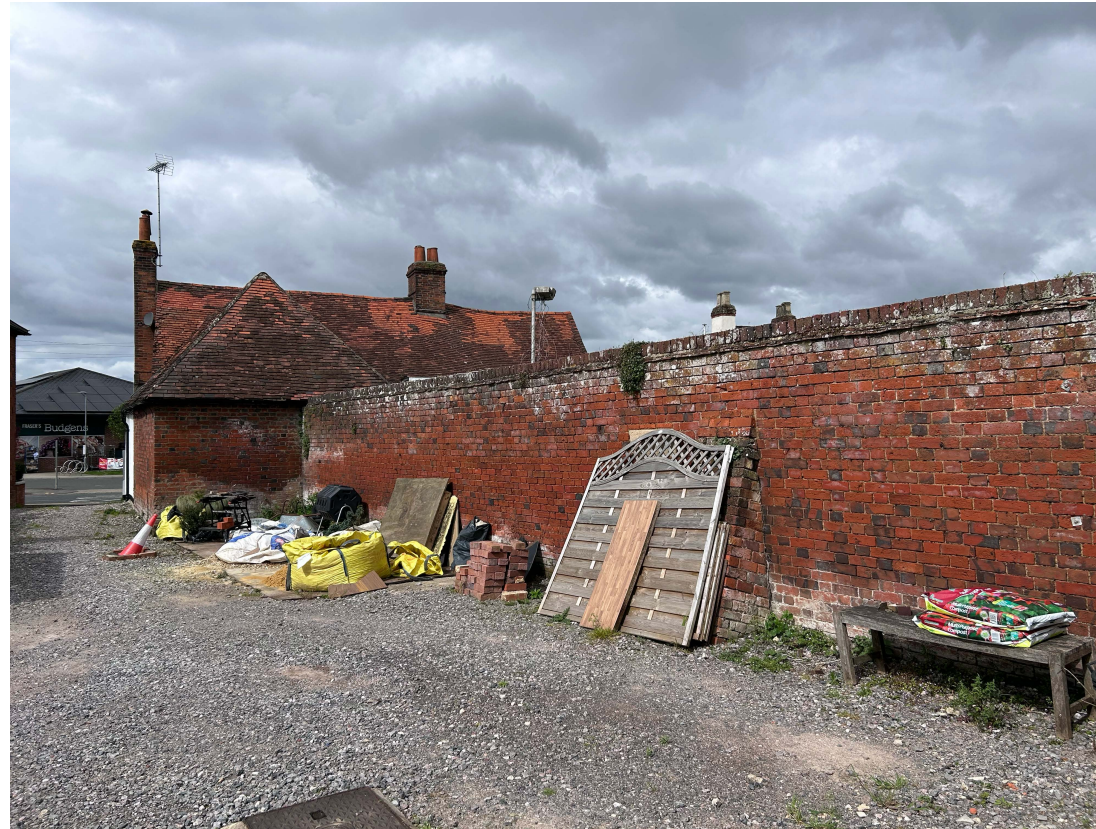
The inscription on the stone set on the southern side of the garden wall dates back to 1823, likely indicating the original construction date of the wall. The wall maintains its height along the south-east extension but gradually reduces in height along the beer garden. The supporting buttresses also decrease in height accordingly. The wall is finished with the brick coping throughout. Wooden fencing has been installed to maintain a uniform height, ensuring adequate separation and privacy for the adjacent property.

The Condition Report, conducted by Hockley & Dawson Consulting Engineers in July 2024 notes that the boundary wall “has a significant lean towards the neighbouring property; the lean is outside the middle third of the wall line and is therefore unstable.” It also states that “the wall is past the stage of being able to be supported with additional; buttressing and will continue to lean until it eventually collapses”.

Fig. 27, Garden Wall as seen from the adjacent property from the south.

The Condition Report by Hockley & Dawson Consulting Engineers recommends rebuilding of the wall due to its poor structural condition beyond repair. Therefore, the recommendation is to reclaim the existing brick and ensure the lime based pointing throughout. As such, this would allow to retain the evidential and historical character of the wall. The design consideration acknowledges that a portion of the Garden Wall remains visible from the outdoor pergola area, while another segment is concealed behind the enclosed dining space. This approach ensures that there is adequate context to recognize the presence and function of the Garden Wall, thereby retaining its evidential and historical illustrative value.

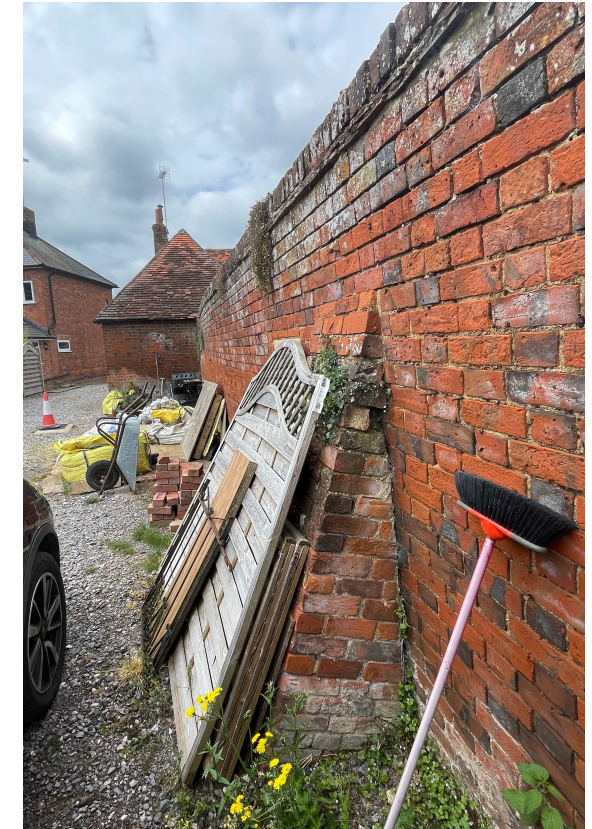
Fig. 28, Buttress.

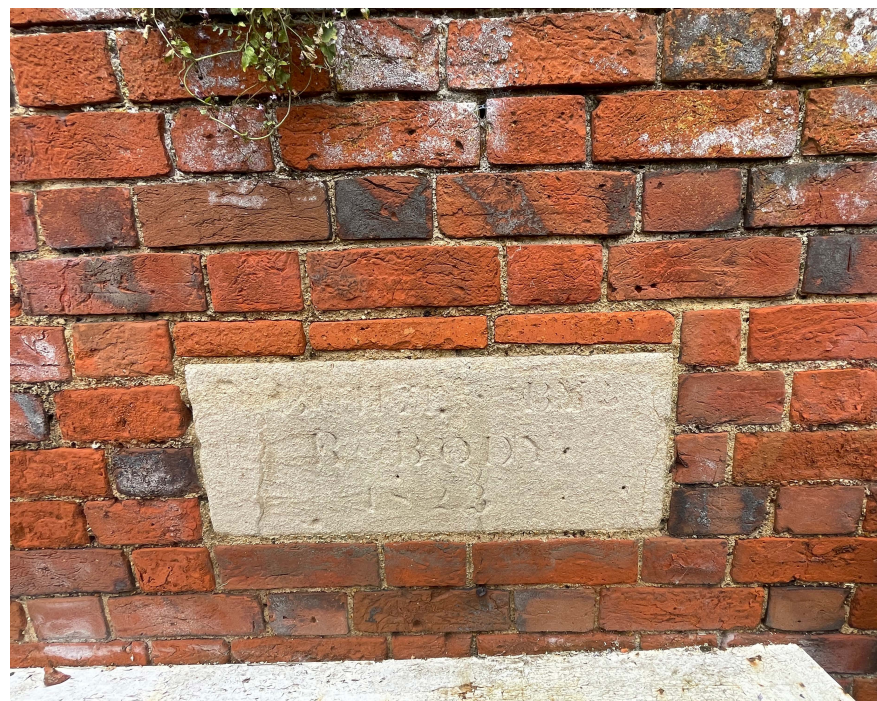
Fig. 29, 1823 stone inscription.

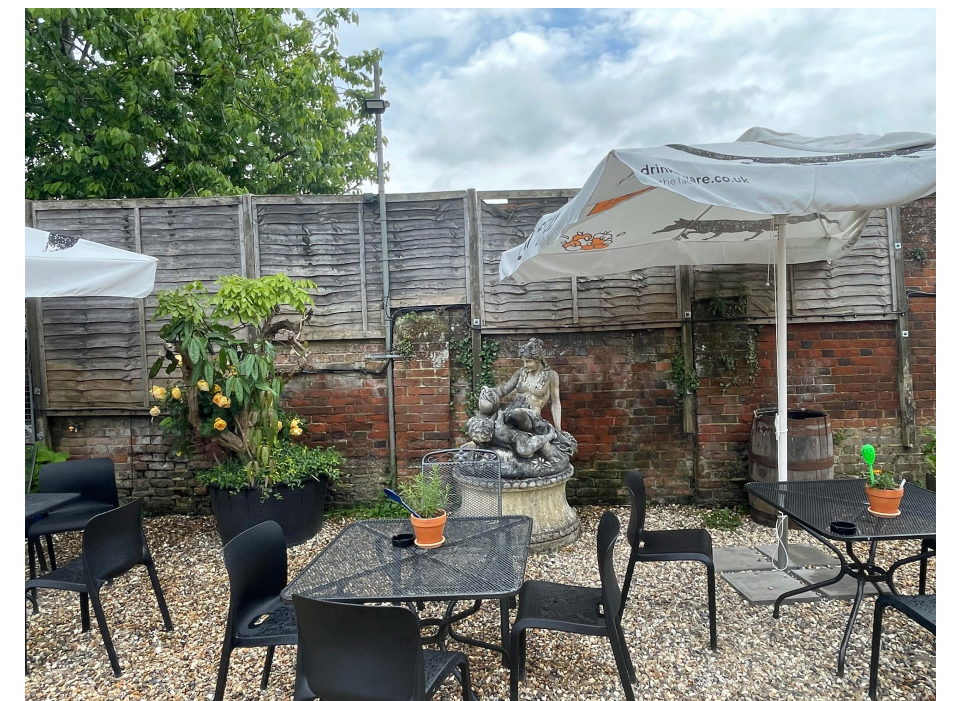
Fig. 30, Garden Wall as seen from the pubs' beer garden and the car park.

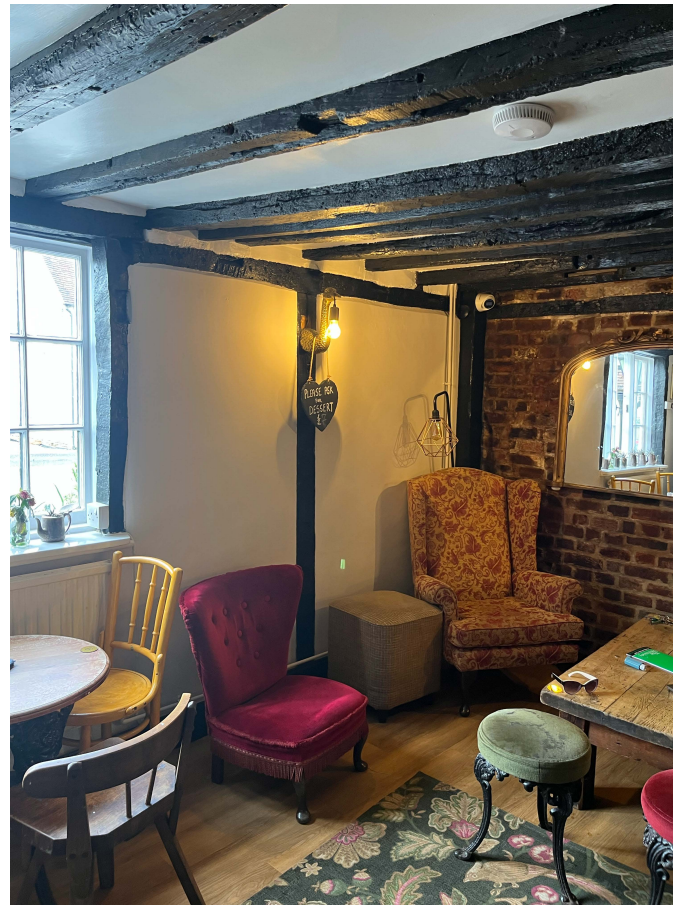
The Bar Room spans the entire width of the building and can be accessed externally through a 19th-century porch or an additional post-war door opening. A modern bar occupies a central position. The axial beam extends from a lateral beam, supported by a centrally positioned post with a brick plinth. Floor joists are visible in the northern part of the bar room. Both gable walls are left unfinished with exposed brick, while the east and west internal elevations reveal posts and plastered infill. A brick chimney breast with a timber lintel is located on the southern side of the room, appearing recently refurbished.

Fig. 31, North-west portion of the bar area.

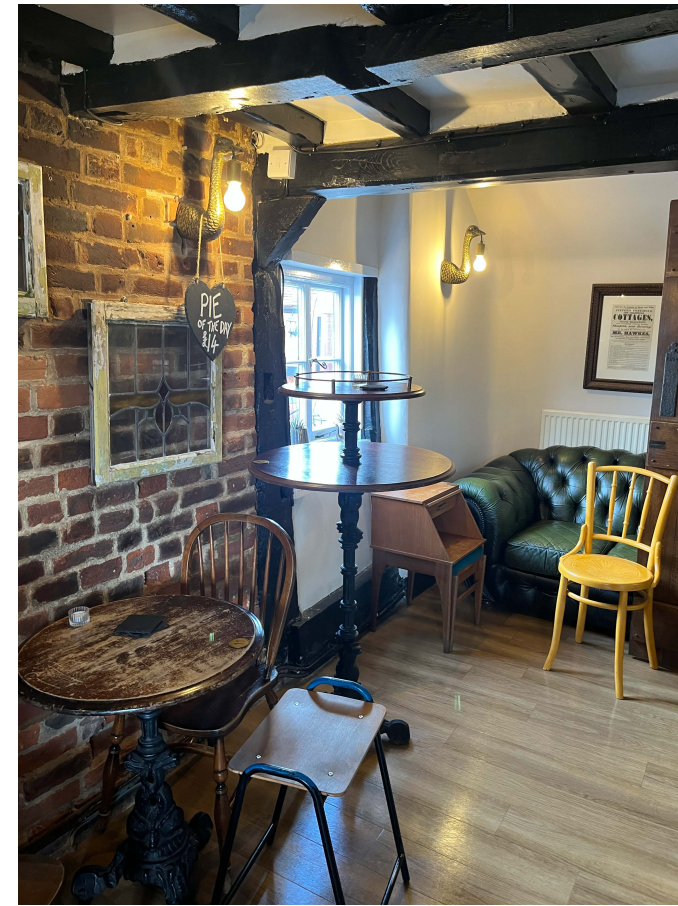
The northeast portion of the bar area is finished with plain render, except for two timber posts at the gable wall. Along the east elevation of the room, a timber frame is exposed, suggesting that this could have been the original size of the room, with the northeast corner being an extension.

Fig. 32, North-east portion of the bar area.

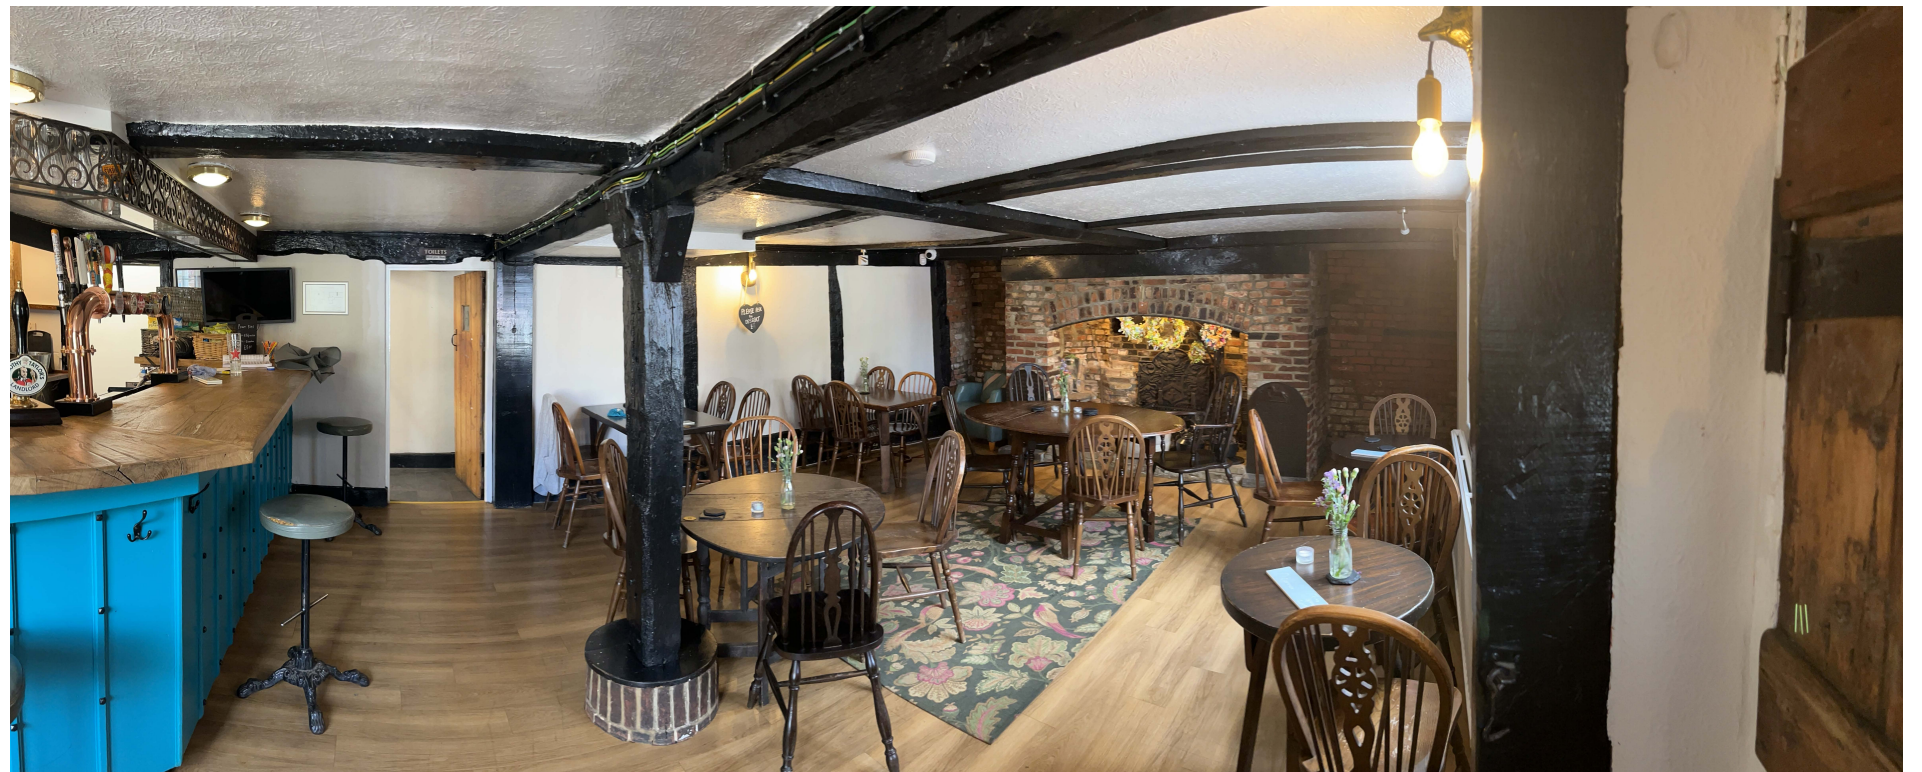
Fig. 33, Bar room.

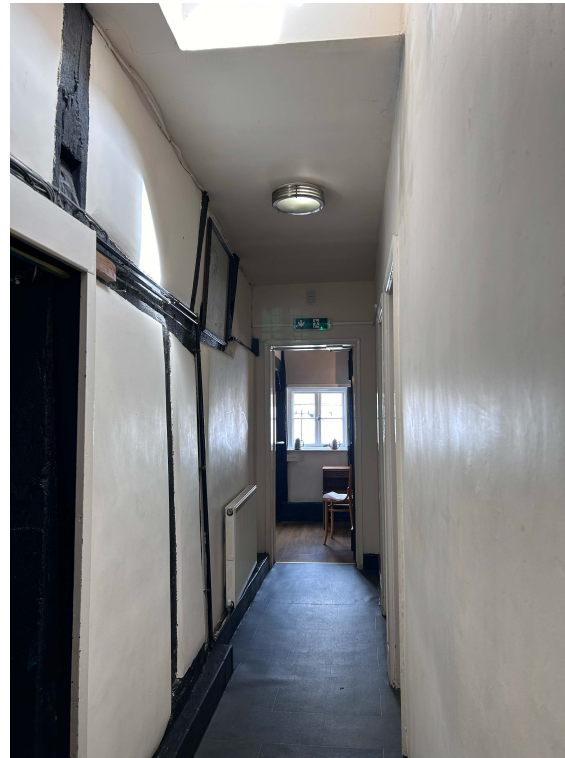
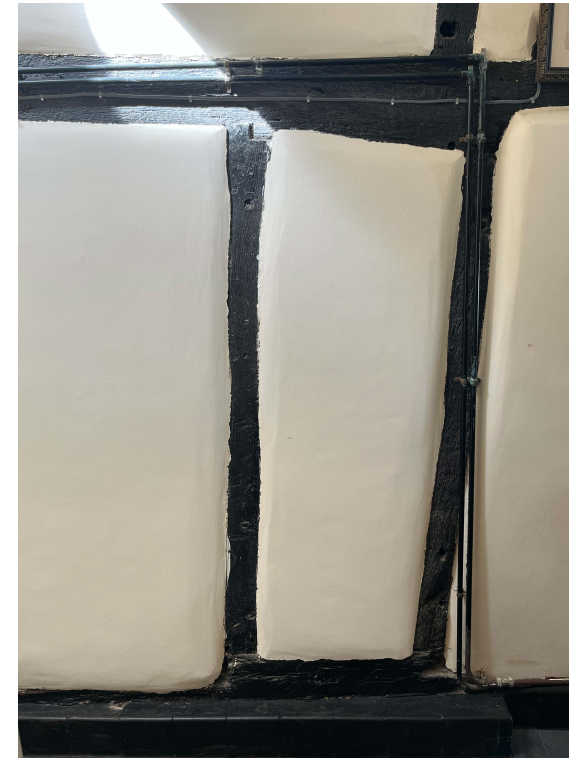
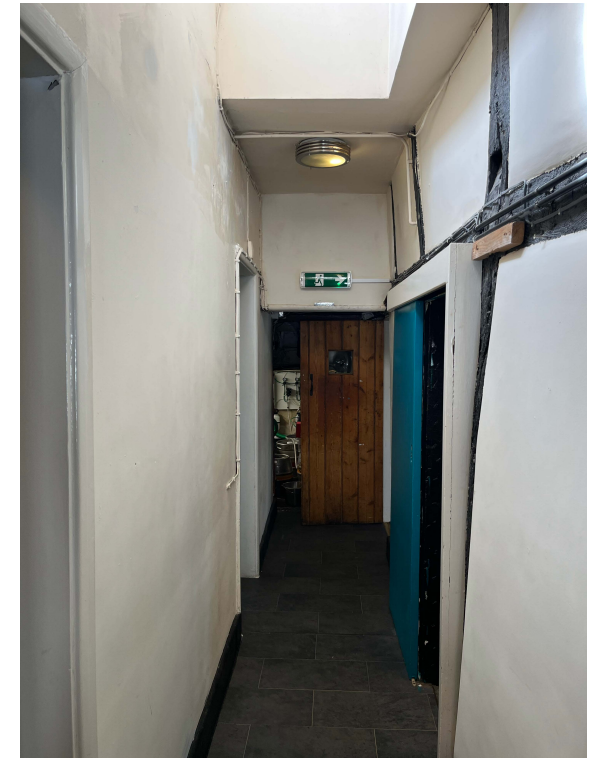
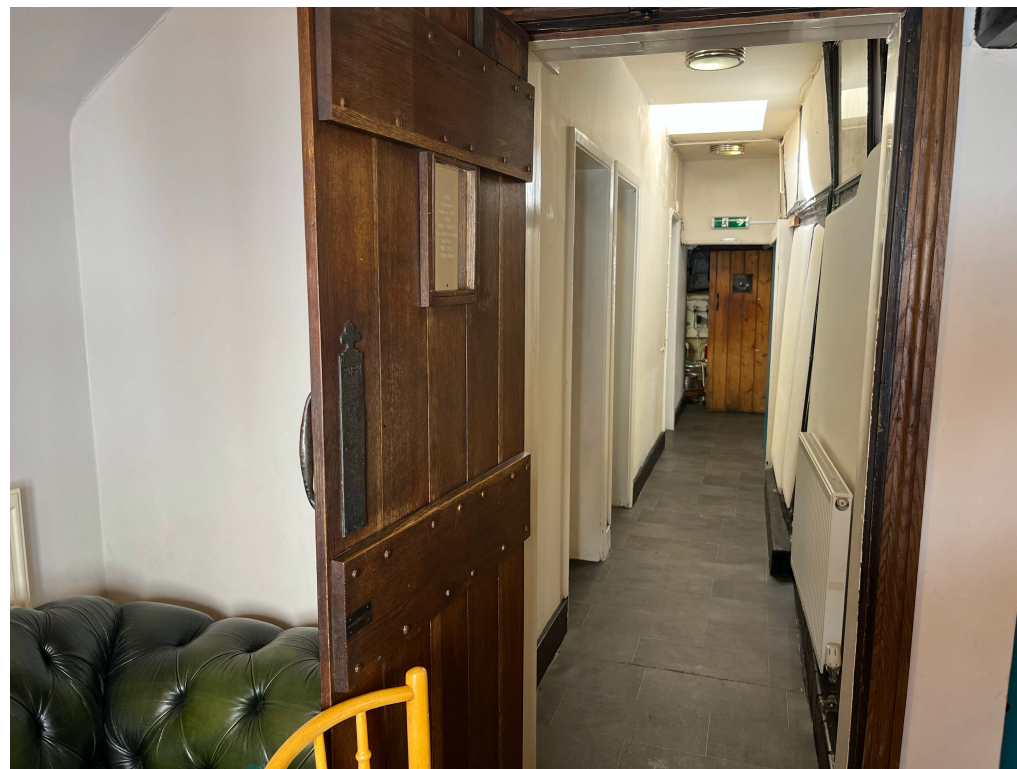
The original east elevation is enclosed by modern extensions, creating a corridor along the elevation. The timber frame remains exposed, reinforced with a timber plinth along the posts. The entrance to the bar area, constrained by the existing timber structure, appears to have been enlarged and additionally framed to accommodate a sliding door. Opposite the historic internal elevation, there is a modern plastered wall with three doorways leading to modern WCs and kitchen facilities. The door leaves at each end of the hallway have been replaced with modern ones. A modern skylight is positioned near the entrance to the bar area.

Fig. 34, Corridor, original east elevation seen to right.

Fig. 35, Details of the east elevation.

Fig. 36, Corridor, east elevation seen to the left.

Fig. 37, Doorway into the corridor, internal east elevation seen to the right.

In terms of mitigation, internally, there is a need to ensure that the interventions are done with care of the existing buildings fabric. Particularly, the internal east elevation of the hallway would be exposed to the re-development and adjoining the perpendicular wall and the door frame. It is recommended that there would be no structural changes to the existing wall in the process of attaching the new partition wall as it is very likely that the wattle and daub infill panels, contemporary to the timber frame, survive and they should not be disturbed. Rather, the structural “burden” should be put on the newly introduced partition wall and its eastern side. The profile of the historic wall is irregular due to the buildings setting over time of the box frame timber construction. It is advised that the profile of the partition should not cut through plaster but be shaped around it to allow for the possibility of reinstatement at a later date. The adjoining of the new wall should be done with the traditional materials compatible with the existing to maintain the traditional breathing performance. This approach is recommended with any jointing to the existing structure would take place.

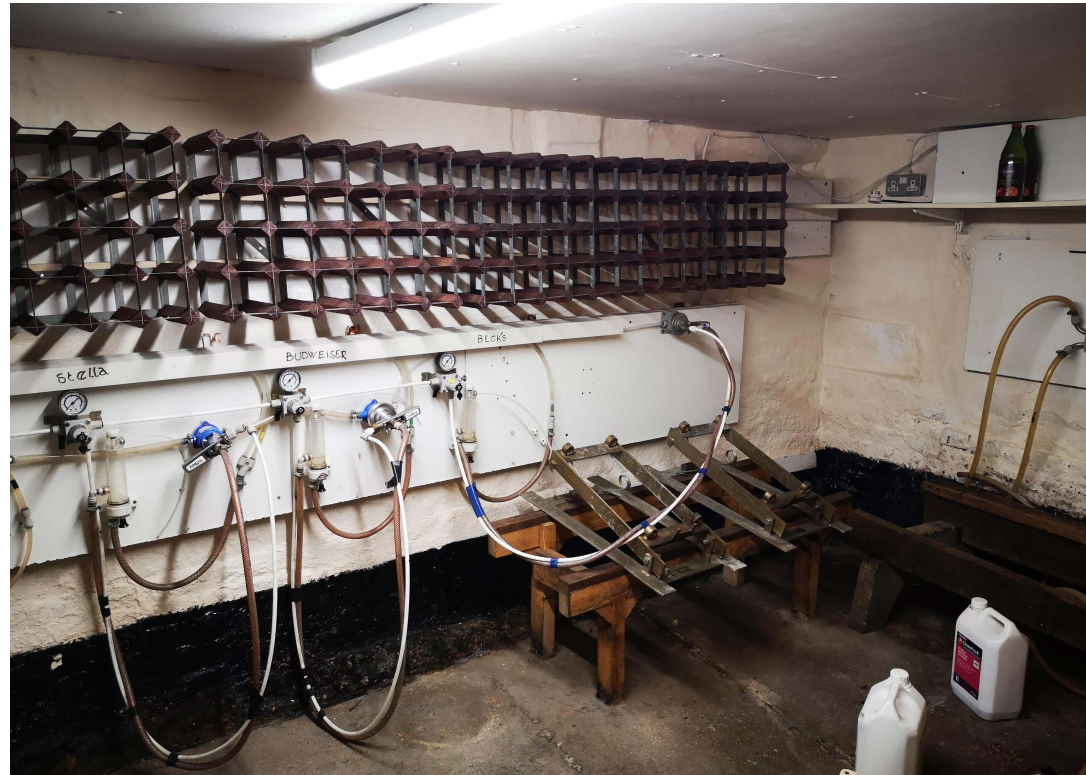
The interior of the Barrel Store which belongs to the early 19th century extension has been fully concealed with modern wall cladding. The height of the room increases when accessed from the adjacent Barrel Room. There is a modern steel column supporting the floor joist.

Fig. 38, Store Room.

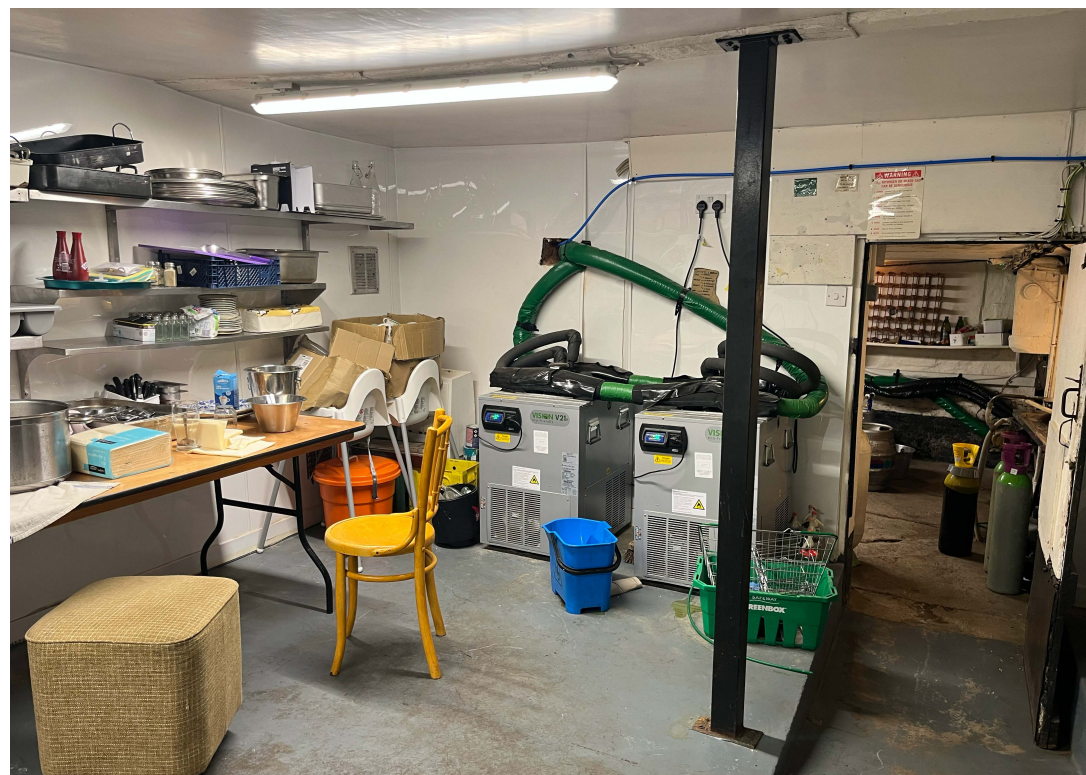
The height of the Barrel Store is significantly lower than the rest of the store rooms. Brick wall finish present but the floor and the ceiling both have a modern finish.

Fig. 39, Barrel Store.

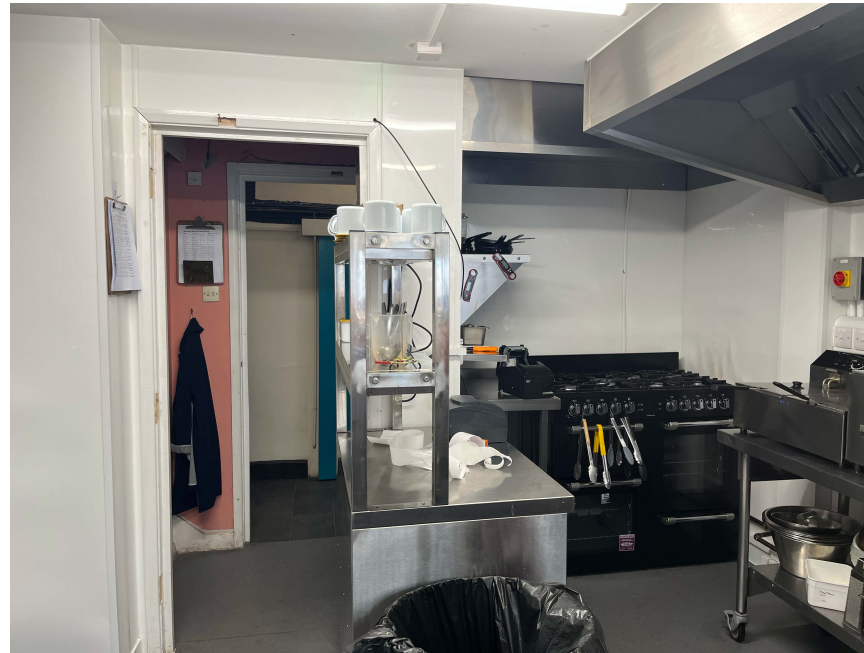
The kitchen extension has been fully concealed by modern wall, floor and ceiling finishes. Commercial kitchen appliances are present, with large vents fixed on the ceiling. Notably, this room adjoins the staircase and a doorway provides an access to staircases hallway. It is possible that some of the original fabric and features of the staircase survive under the wall cladding.

Fig. 40, Commercial Kitchen, as existing.

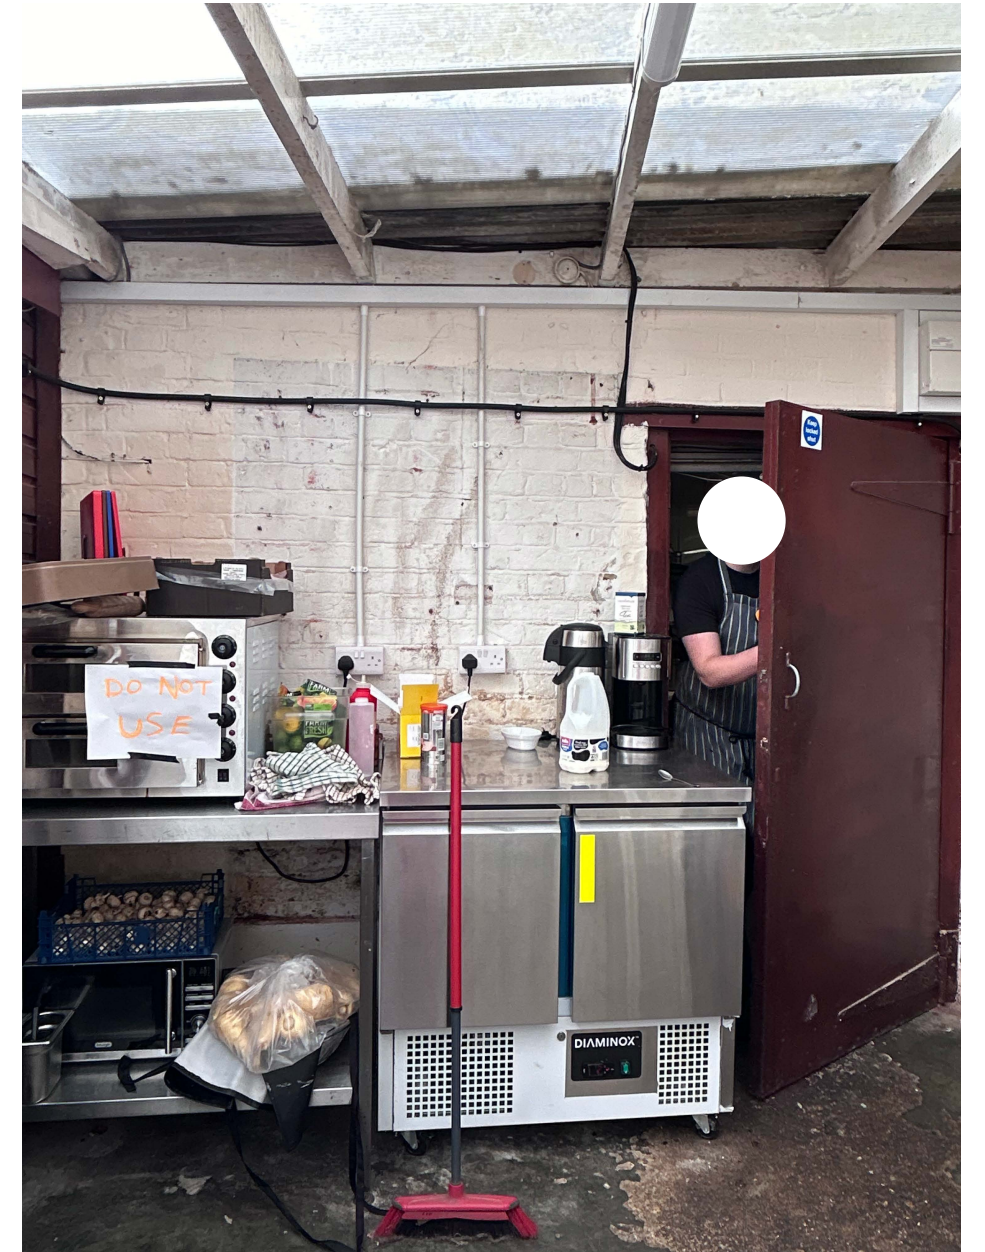
The kitchen store is a lean-to structure adjacent the kitchen extension. The ceiling is construction of simple timber trusses and polycarbonate sheets.

Fig. 41, Kitchen Store, as existing.

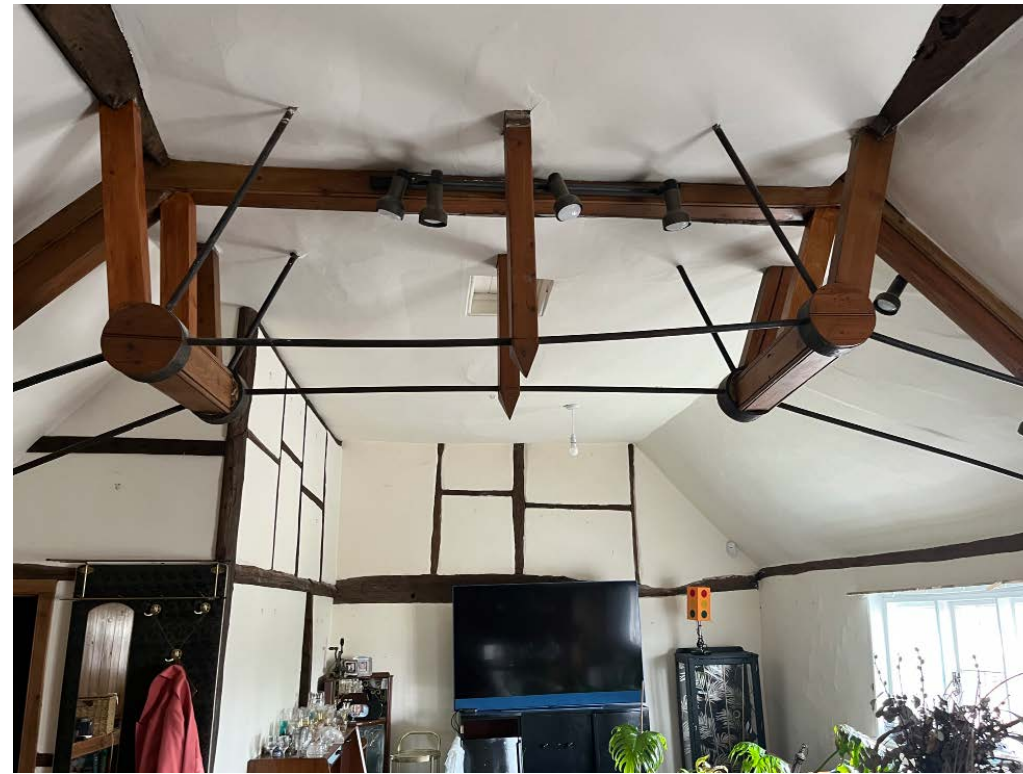
There is a frame with queen post and queen strut trusses and straight wind braces. The studs partitions, likely 19th century, are visible throughout, including in the walk-in closet, see Fig. 42.

Fig. 42, Bedroom.

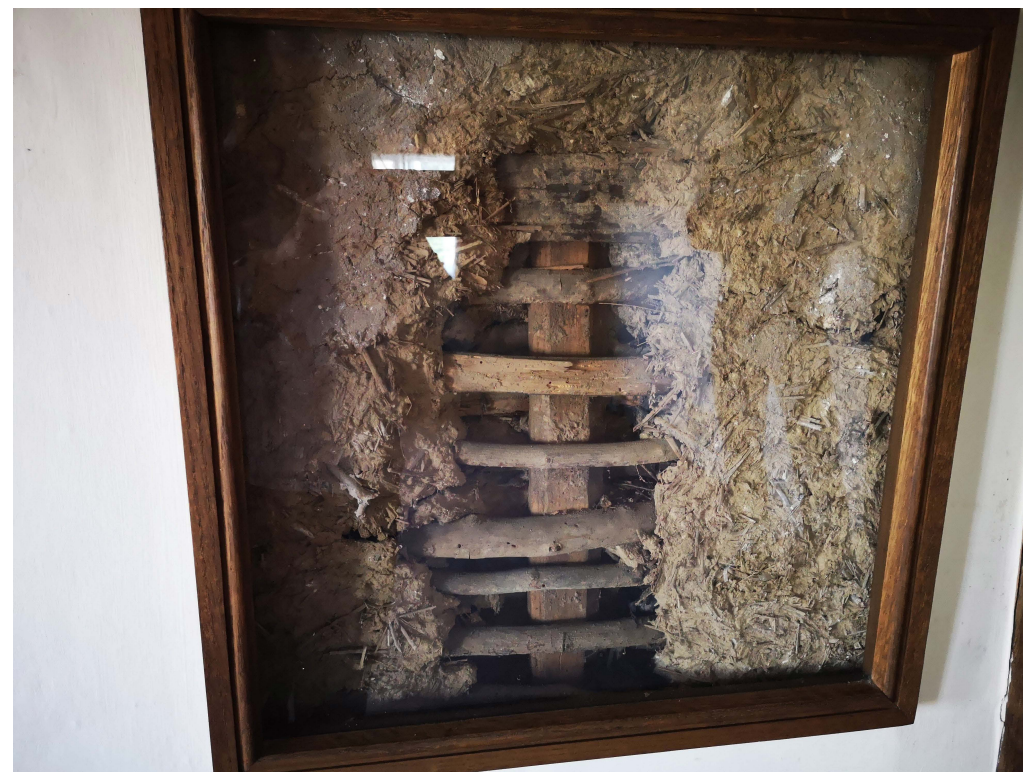
A portion of the original wattle and daub has been left exposed on the internal east elevation on the bedroom. This represents the earliest phase of buildings' construction and hence is a feature of high significance.

Fig. 43, Wattle and daub framed feature.

The evidential value of the Swan Inn is also particularly demonstrated by a portion of the wall in the first floor, exposed and framed, to show the construction of the building. The staves and withies are visible, as well the daub mixture. As such, this “feature” yields the understanding of the traditional construction methods, typical to the period and the area.
