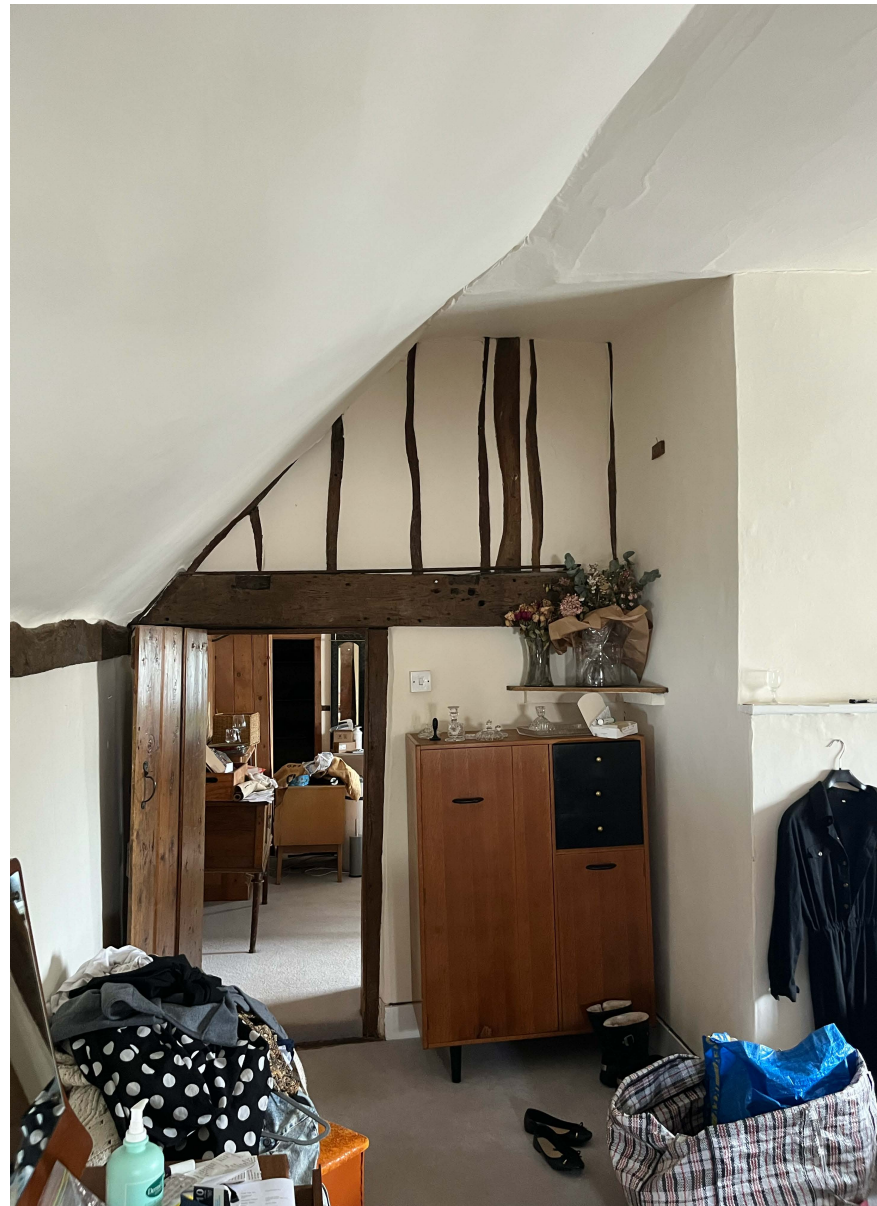
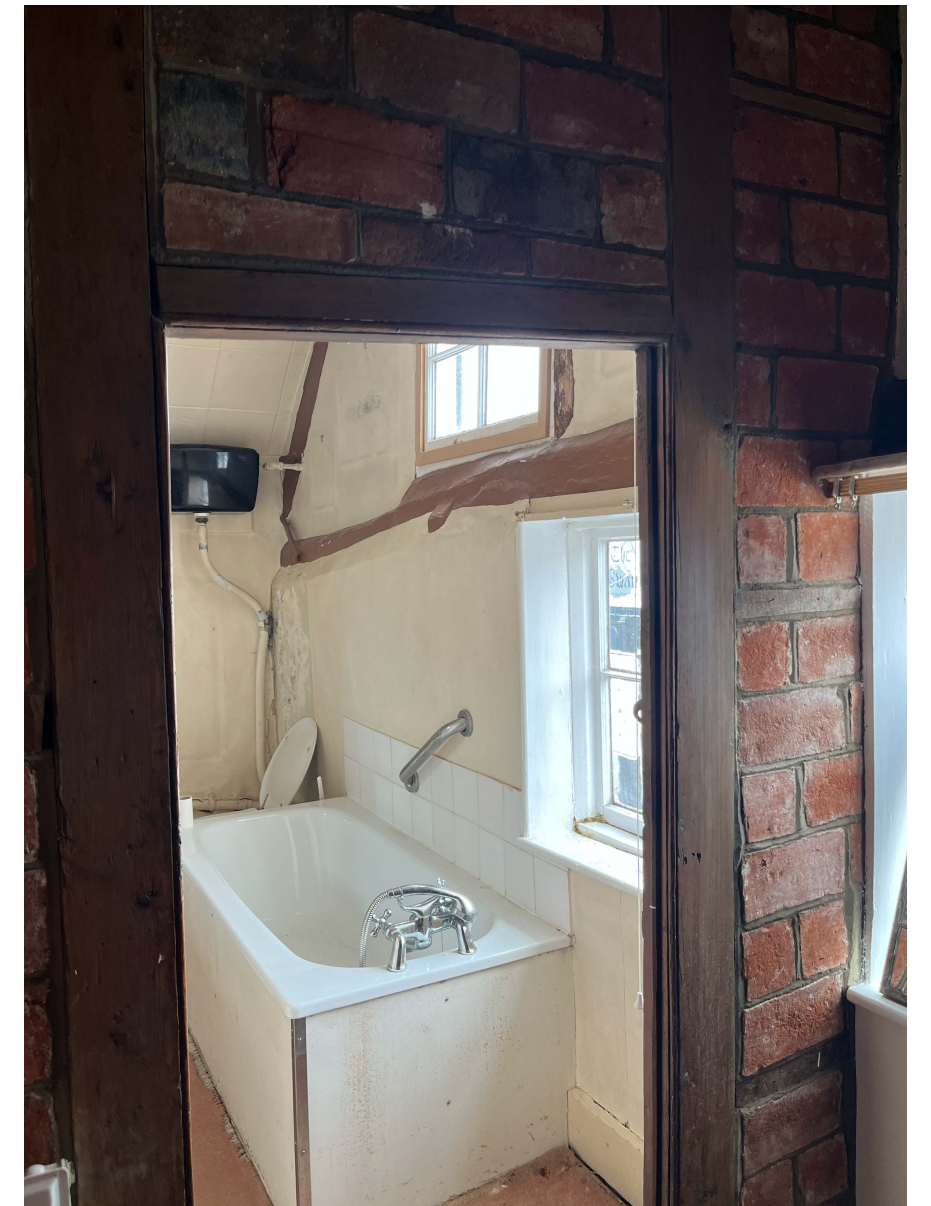
Located in the northern part of the building, this bedroom has a modern built en-suite with a “rusticated” look. The partition is made of single brick layer and timber posts. The wall studs are visible but the slopping ceiling is plastered over.

Fig. 44, Bedroom.

Fig. 45, Modern en-suite in the main bedroom.
