95 Hyde End Lane  
Ryeish Green  
Reading  
Berkshire  
RG7 1ES

# Preliminary Roost Assessment

Report ref.: R2640\_PRA\_a

**February 2024**

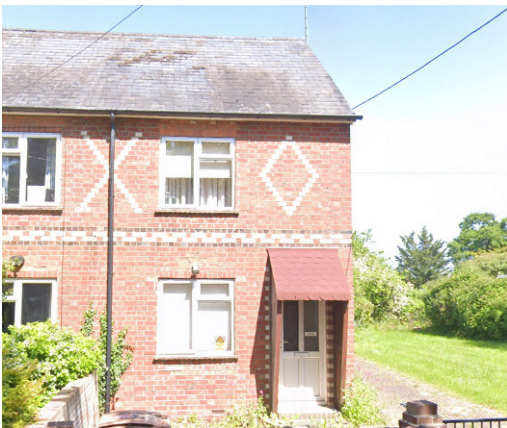
- 5.2.2** The house is a semi-detached brick building with a pitched roof, two flat roofed sections at the rear, a single-storey pitched roofed section on the southeastern elevation and a front porch (**Photographs 1 & 2**).

*Photograph 1. Front of property viewed from west.*

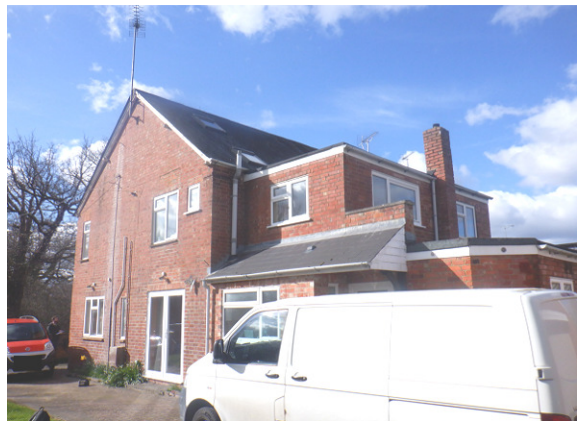
*Photograph 2. Rear and southeastern side of property viewed from southeast.*

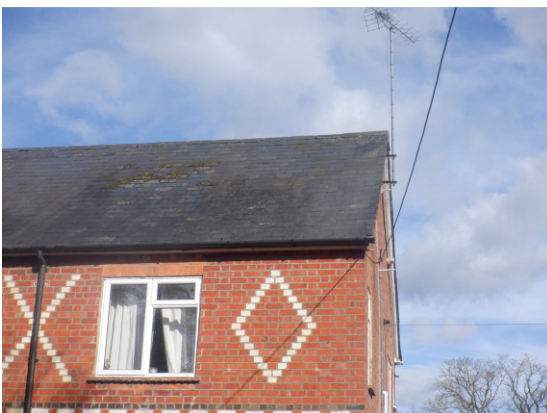
- 5.2.3** The pitched roof, ridge and pitched roofed single-storey section were covered by flat slate tiles that were intact and sealed (**Photograph 3**). The flat roofed sections at the rear of the property were covered by bitumen felt that was occasionally lifted against the uPVC fascia, however, close inspection with a high-powered torch showed the resulting gaps to be superficial (**Photograph 4**). The front porch was covered by a flat felt (**Photograph 5**).

*Photograph 3. Slate tiles sealed on roof and ridge (front elevation).*

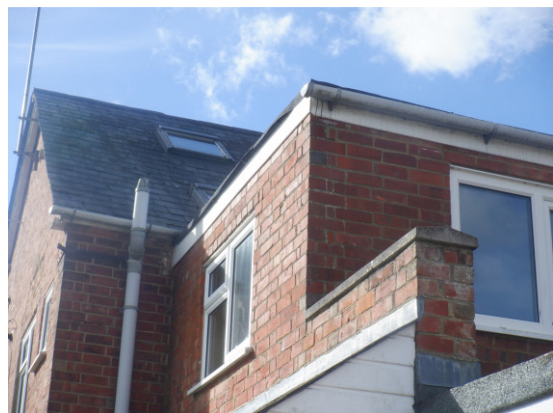
*Photograph 4. Hessian-reinforced bitumen felt slightly lifted (southeast elevation).*

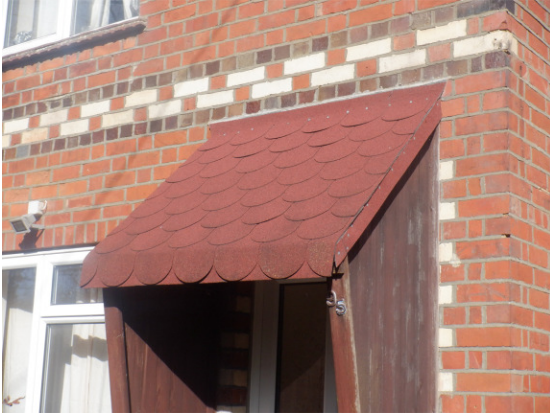
*Photograph 5. Porch covered by a flat felt (front elevation).*

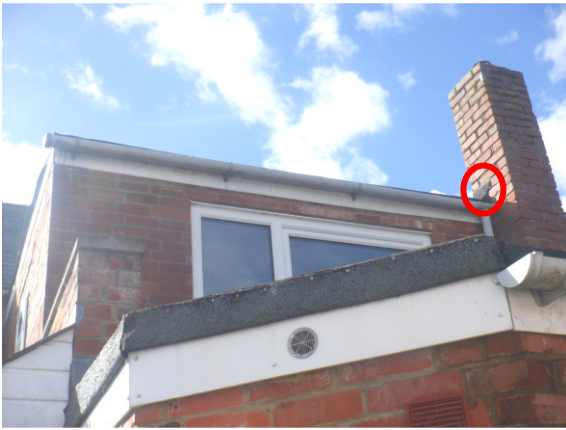
- 5.2.4** Whilst the lead flashing was flat along the pitched single-storey section, a slight gap was situated behind the bitumen felt at the base of the rear chimney (**Photograph 6; Target note 1**).

*Photograph 6. Lifted bitumen felt at the base of the chimney (rear elevation).*

- A gap under lifted bitumen felt at the base of the rear chimney (**Photograph 6; Target note 1**);
- Gaps behind the timber fascia along the southeastern brickwork gable (**Photograph 7; Target note 2**);
- A gap within a damaged section of the timber soffit at the southwestern corner of the property (**Photograph 8; Target note 3**);
- Gaps under lifted slate verge tiles along the southeastern brickwork gable (**Photograph 9; Target note 4**); and
- Gaps behind the uPVC fascia along both flat roofed sections at the rear (**Photograph 10; Target note 5**).

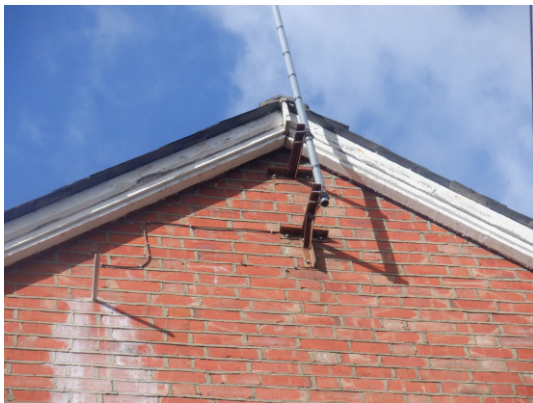
- 5.2.5** The brickwork gable had an open gap situated behind the timber fascia and within the timber soffit on the southwest corner of the property where a section of the soffit was damaged with direct internal access (**Photographs 7 & 8; Target notes 2 & 3**). Furthermore, a slight gap was situated between the timber fascia and the slate verge tiles along the gable (**Photograph 9; Target note 4**).

*Photograph 7. Gaps between timber fascia and brickwork gable (southeastern elevation).*

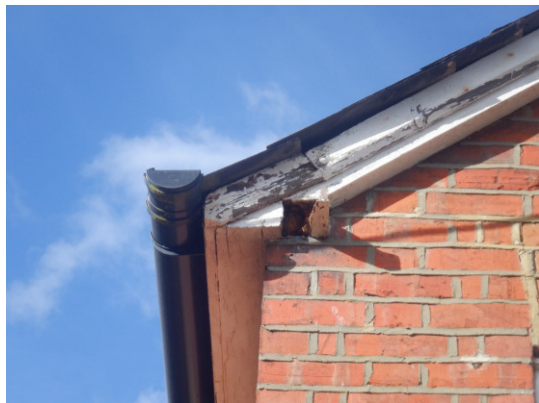
*Photograph 8. Damaged section of the timber soffit with direct internal access (southeastern elevation).*

**6.1.2** With the roof void largely comprising boarded out living space, the gaps behind the timber fascia and under the slate verge tiles along the southeastern brickwork gable were inaccessible inside the void. The damaged soffit at the southwestern corner of the roof likely leads inside the southwestern eaves space where daylight and bird droppings were observed. The eaves spaces both lacked sufficient space for internal flight and suitable conditions for supporting large numbers of void-dwelling bats, such as the locally recorded brown long-eared bat (*Plecotus auritus*).

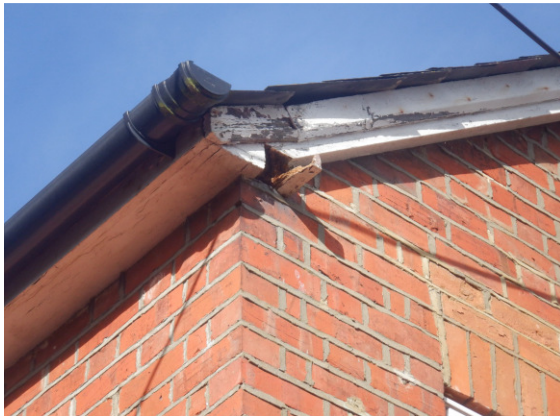
*Photograph 9. Gap between timber fascia and verge tiles (southeastern elevation).*

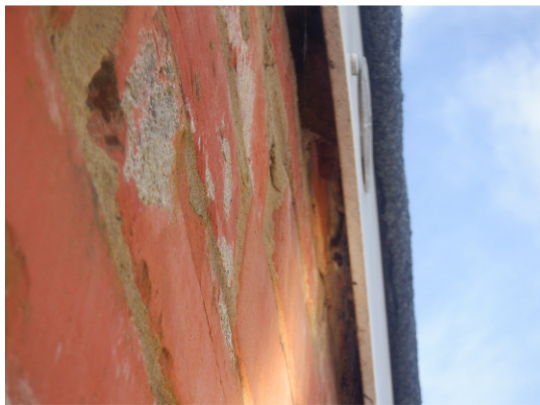
- 5.2.6** Whilst the timber soffit was sealed to the brickwork on the front elevation, gaps were situated behind the uPVC fascia of both flat roofed sections at the rear (**Photograph 10; Target note 5**)

*Photograph 10. Gap behind uPVC fascia (rear elevation).*

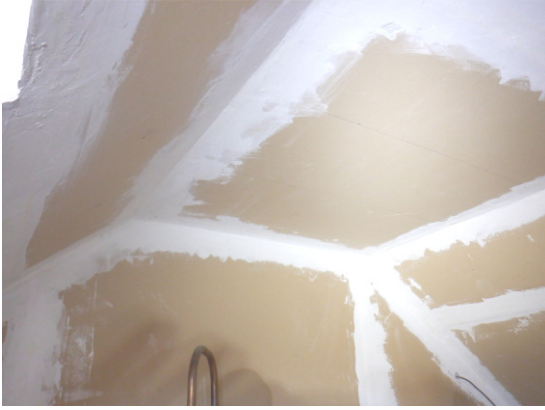
- 5.2.7** The roof void was accessible from the first floor via a ladder and was partly lined with plasterboard to form a currently undecorated living space, with an approximate floor-to-ridge height of 2.5 metres (**Photograph 11**). Two enclosed eaves spaces covering the southwestern and northeastern elevations of the pitched roof were accessible via doors with both spaces unlined (**Photograph 12**).

*Photograph 11. Central roof void with plasterboard lining.*

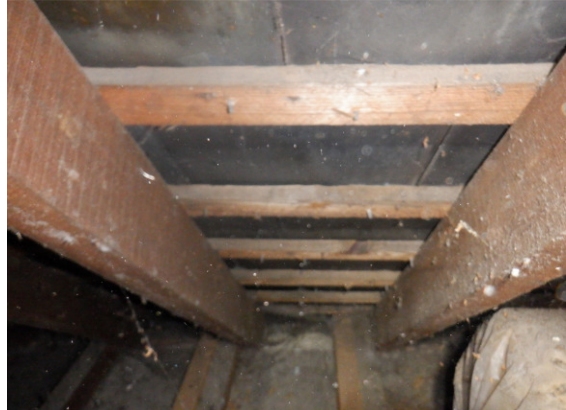
*Photograph 12. Unlined roof (Southwest eaves space).*

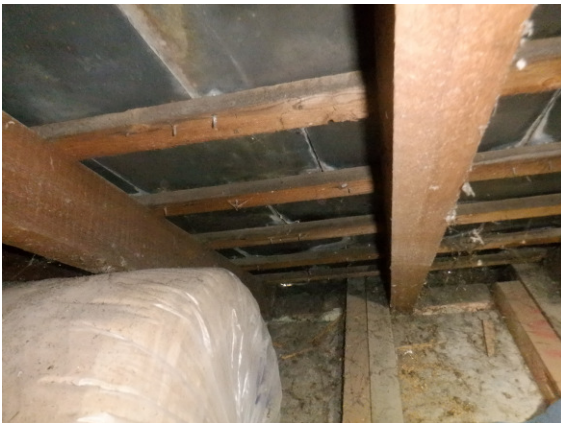
- 5.2.8** Whilst some eaves were filled by fibreglass insulation, others were open with daylight visible (**Photograph 13**).

*Photograph 13. Daylight within the eaves (southwest eaves space).*

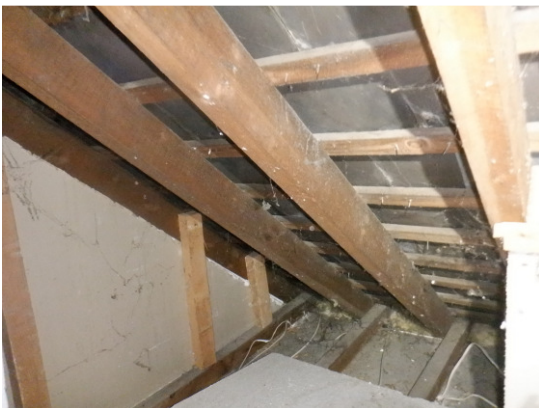
- 5.2.9** The northeastern and northwestern gables of the eaves spaces were covered by insulation boards with gaps situated between the slate roof tiles and boarding (**Photograph 14**). In addition, the southwestern and southeastern brickwork gables were heavily cobwebbed with mortar sealing the edges of both (**Photograph 15**).

*Photograph 14. Gaps situated between insulation boarding and slate roof tiles (northeast eave space).*

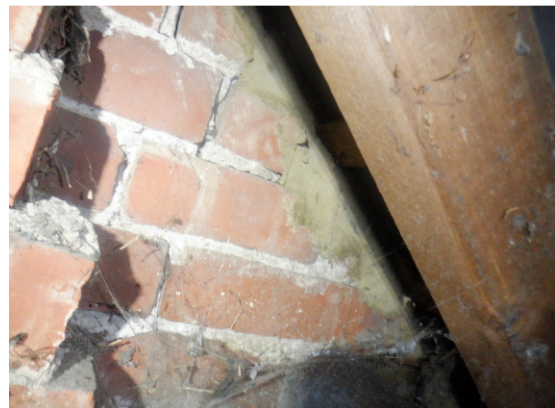
*Photograph 15. Edges of the brickwork gables sealed by mortar (northeast eave space).*

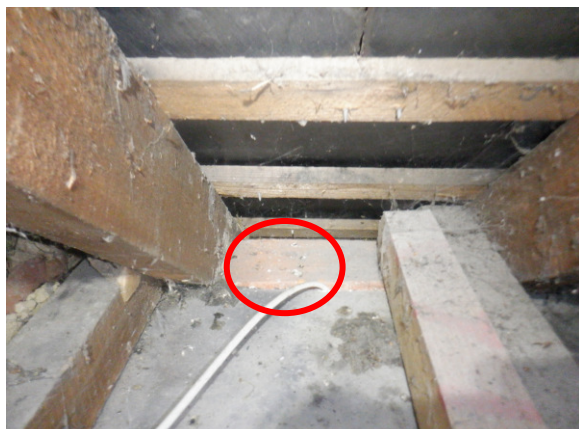
**5.2.10** Bird droppings were observed within both eaves spaces (**Photograph 16**).

*Photograph 16. Bird droppings (southwest eave space).*
