## **PRELIMINARY ECOLOGICAL APPRAISAL (DBW) AT 26 PRIEST AVENUE WOKINGHAM**

**Prepared for:  
Mr A Middlecote  
26 Priest Avenue  
Wokingham  
RG40 2LX**

**19 May 2025**

**Ref: SPH/NP/PEA-25/13.05**

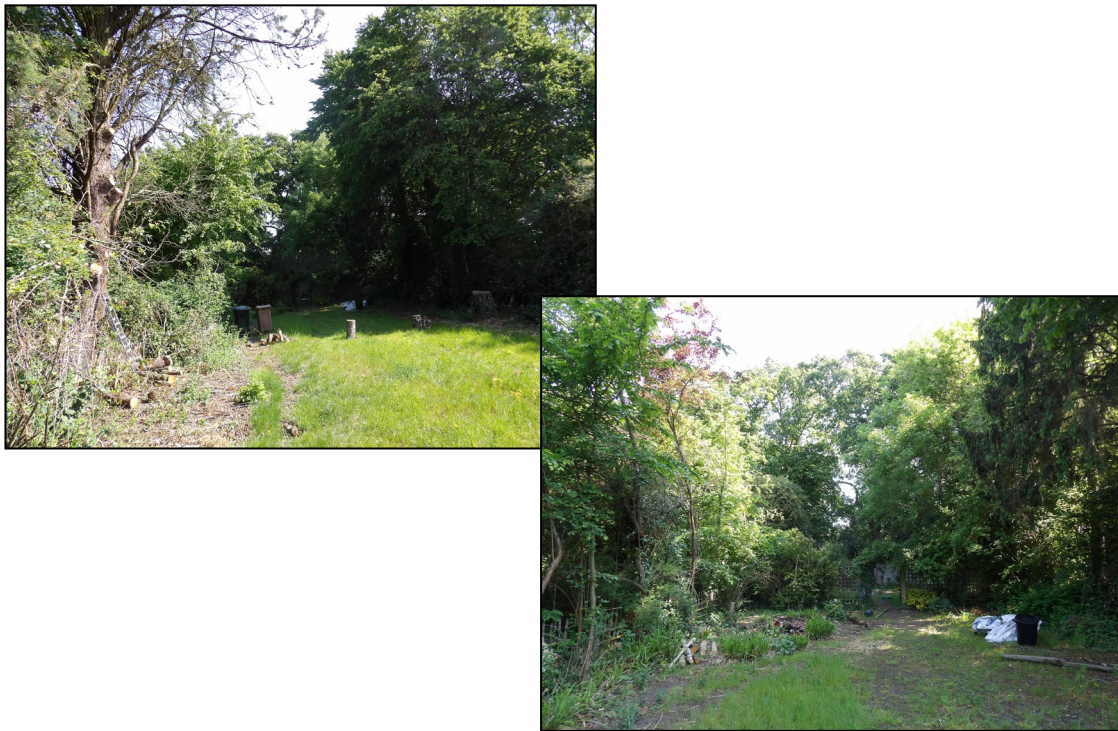
The application site comprises a detached two-storey, brick-built property with integral garage and rear, single story extension. The remainder of the site comprises, to the front, a driveway/parking area and lawn surrounded by hedgerows and a long rear garden that is mainly laid to lawn, with mature trees and shrubs on the boundaries, see Figure 3 below. The site itself offers foraging and commuting habitat for bats and there is direct ecological connectivity to the wider landscape that provides good habitat for foraging and roosting bats.

Figure 3. Rear garden. 26 Priest Avenue, Wokingham. 13.05.25

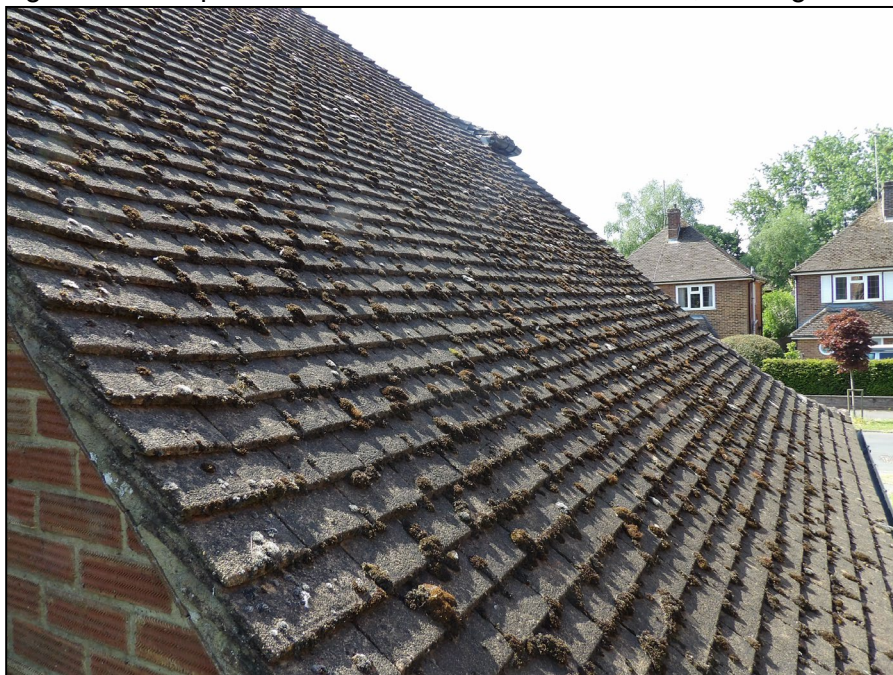
The property is a detached, brick-built building with integral garage under a catslide roof and rear single storey extension, all of which is in a good condition. The multi pitched roof is covered in tightly fitted tiles (see Figure 4 on page 8) however, on the front southeastern corner the tiles have moved and there is missing mortar from a bonnet tile, see Figure 5 on page 8. The rest of the bonnet tiles, valleys and ridge tiles are sealed and offer no roosting opportunities, see Figure 6 on page 9. The verges are sealed as is the lead flashing around the chimney stack, see Figure 7 on page 9. The eaves are covered in bitumen felt that has rotted leaving gaps that could be exploited by roosting bats or afford access into the loft, see Figure 8 on page 9.

Figure 4. Example sealed roof tiles. 26 Priest Avenue, Wokingham. 13.05.25

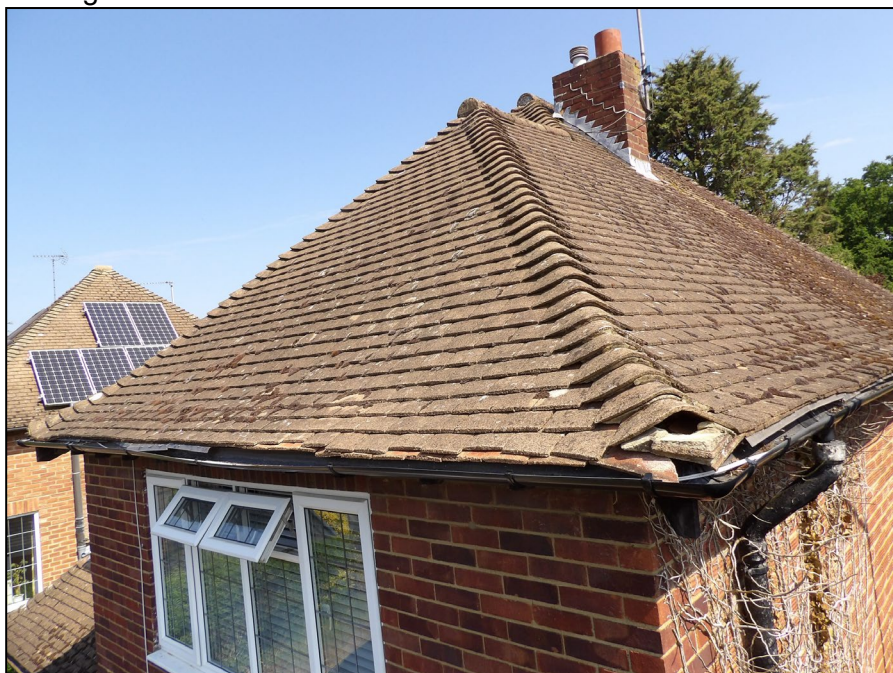
Figure 5. Moved tiles and missing mortar at southeaster roof corner. 26 Priest Avenue, Wokingham. 13.05.25

The property is in a good condition internally and externally. There is missing mortar/moved tiles on the front (southern) corner roof and gaps in the eaves which provide crevice-like features suitable for bats to roost and may provide access into the building for bats and we are unable to determine the presence or absence of bats in the property without further survey effort. When the findings are combined with the desk top study the property was assessed as having a low potential to support roosting bats.

Based on the Bat Workers Manual and the Bat Surveys Good Practice Guidelines, one dusk emergence survey needs to be undertaken on the property, between May and August, to establish the presence or absence of roosting bats and in order to inform appropriate mitigation for the proposed works if necessary.

The features identified will require three survey positions equipped with bat detectors and night vision cameras in order to cover the potential bat roosting features. If bats are recorded emerging from the building during the survey, two further activity surveys and an EPSL will be required in order for the development to proceed legally.

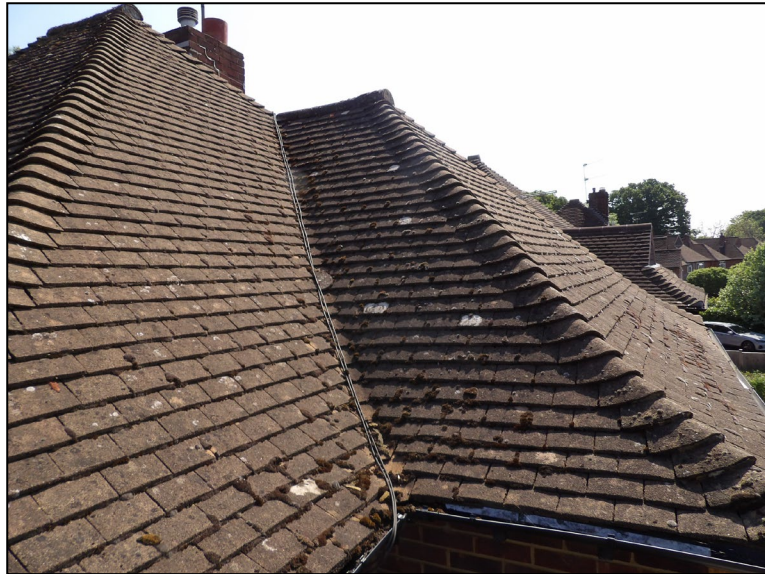
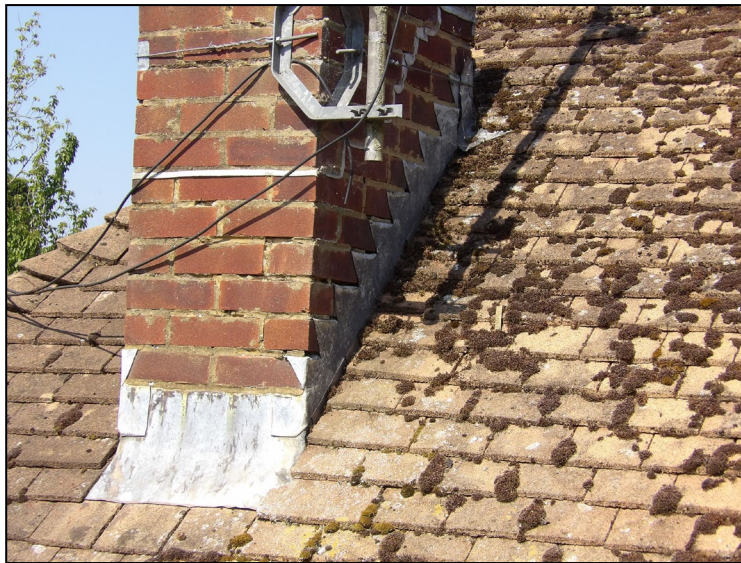
Figure 6. Example sealed ridge/bonnet tiles and valleys. 26 Priest Avenue, Wokingham. 13.05.25

Figure 7. Example sealed lead flashing around chimney stack. 26 Priest Avenue, Wokingham. 13.05.25

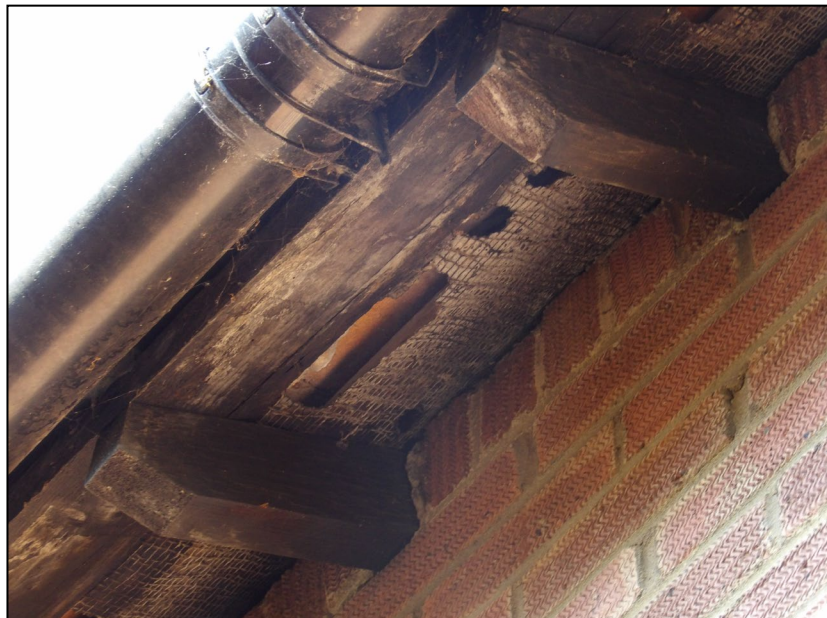
Figure 8. Example rotten bitumen covering eaves. 26 Priest Avenue, Wokingham. 13.05.25

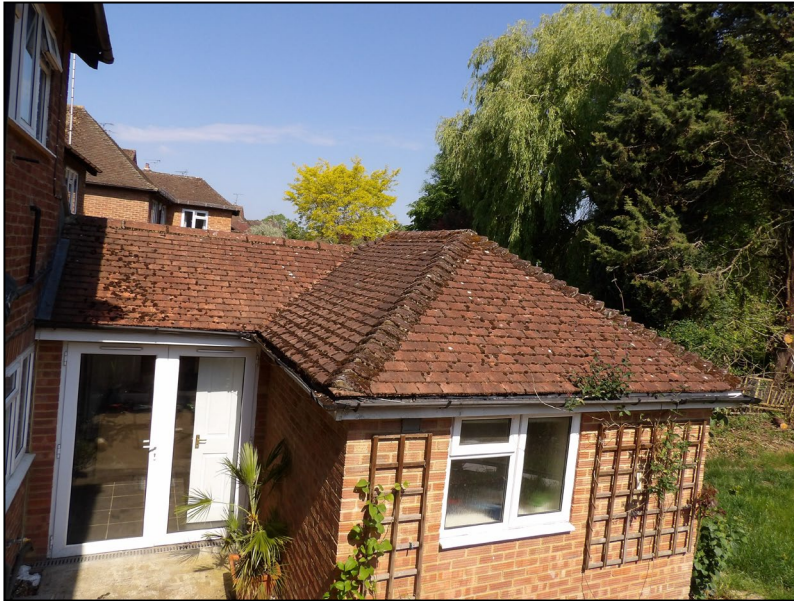
At the rear is a single storey extension (see Figure 9 on page 10), the roof of which is covered in close fitted tiles with no gaps. The ridge and hip tiles are sealed with no missing mortar and the lead flashing affixing it to the main property is flat with no gaps, see Figure 10 on page 10. The soffits and fascias offer no roosting opportunities as they are flat to the wall place with no gaps or splits, see Figure 11 on page 10.

Figure 9. Rear, single storey extension. 26 Priest Avenue, Wokingham. 13.05.25

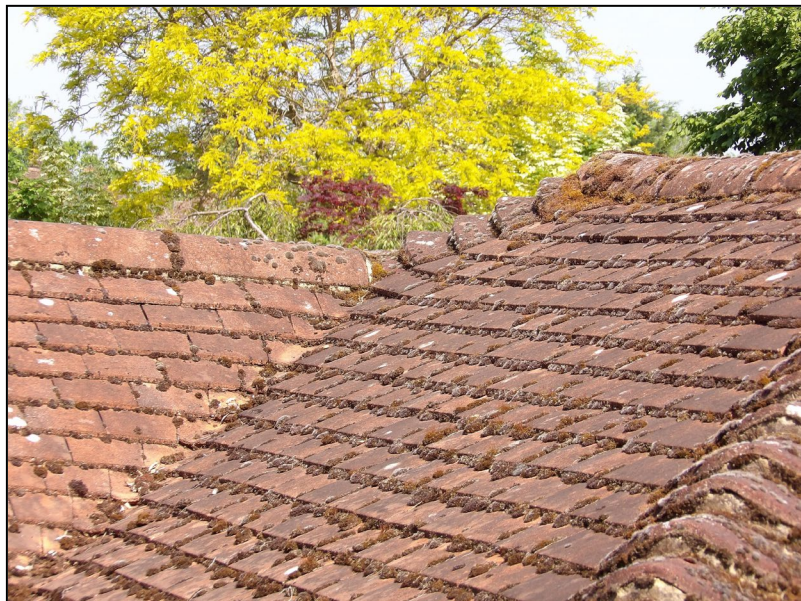
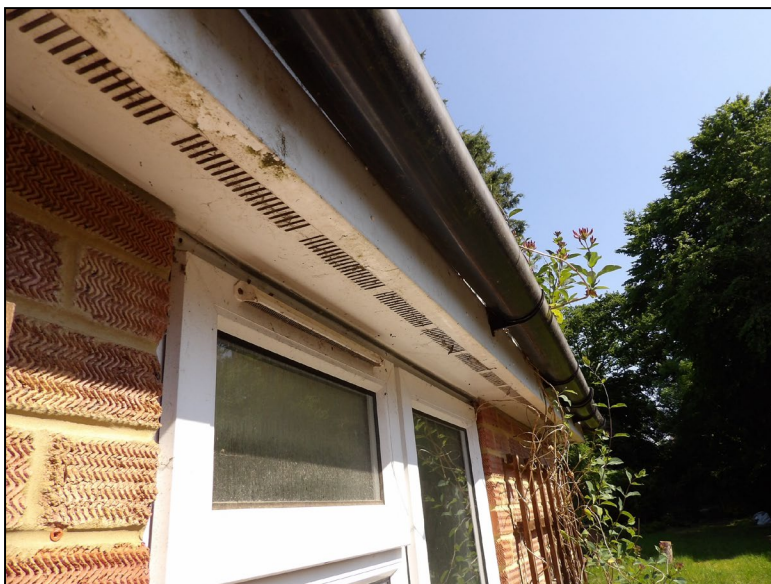
Figure 10. Example sealed roof tiles on rear extension. 26 Priest Avenue, Wokingham. 13.05.25

Figure 11. Example sealed soffits and fascias on rear extension. 26 Priest Avenue, Wokingham. 13.05.25

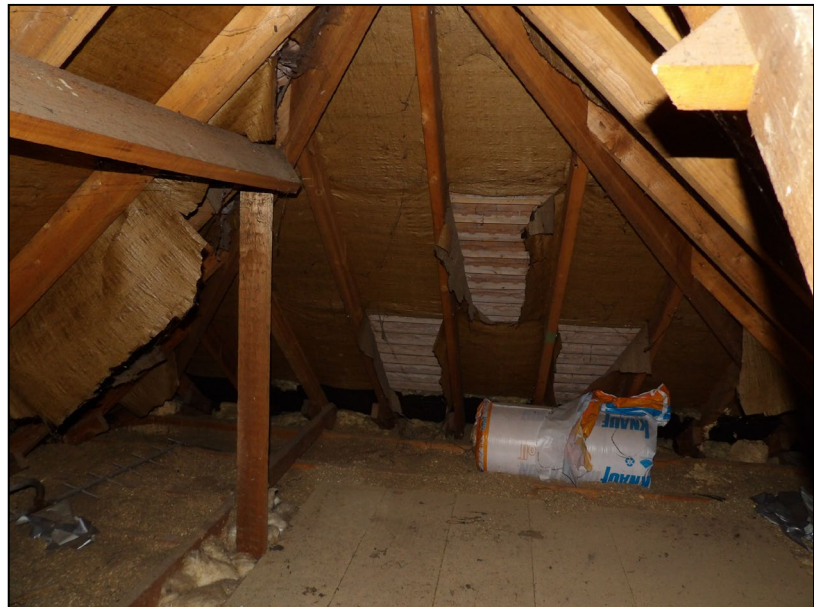
The loft space in the property was accessed via a loft ladder and is in a fair condition. The loft space is lit, partially boarded and insulated (see Figure 12 below), and the roof tiles are lined with tar paper, some of which was torn, see Figure 12 below. The loft space in the rear extension was accessed via steps. The loft space is not lit, not boarded and insulated (see Figure 13 below), and the roof tiles lined with bitumen felt, all of which that could be seen was in a good condition.

Figure 12. Example loft space and torn tar paper. 26 Priest Avenue, Wokingham. 13.05.25

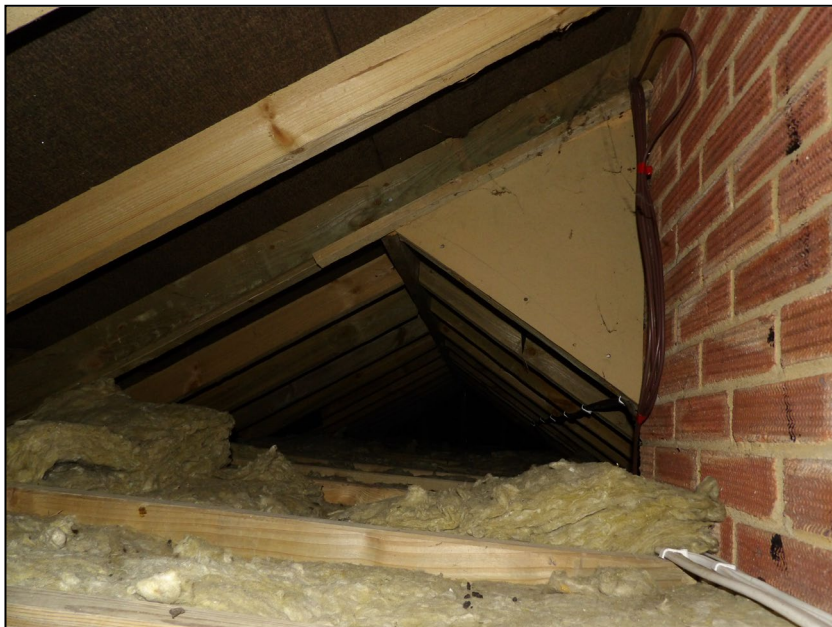
Figure 13. Example loft space in rear extension. 26 Priest Avenue, Wokingham. 13.05.25
