# Preliminary Ecological Appraisal and Roost Assessment

58 Finchampstead Road, Wokingham, Berkshire, RG40 2NS

This report is prepared to inform a planning application with the Wokingham Borough Council. The proposal is described as: proposed erection of 4no detached dwelling houses following demolition of the existing main dwelling (B1) only.

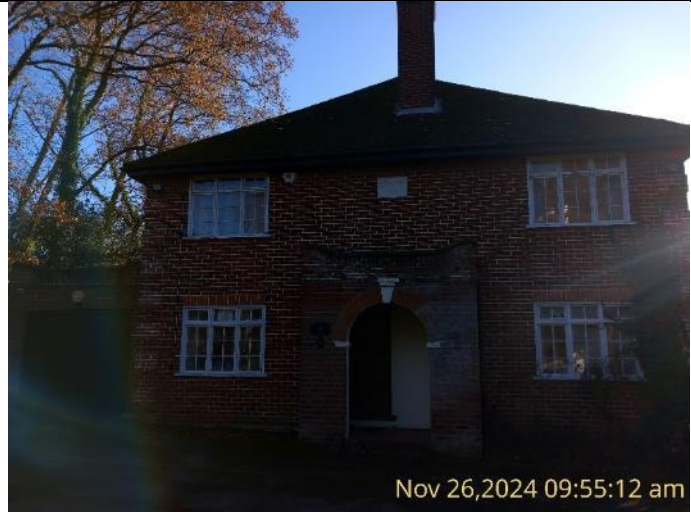
| <p><i>Summary</i></p> <p>B1 is a large brick-built two-storey residential dwelling. The roof is pitched and hipped and clad in clay tiles, there are two chimneys on the roof of B1. There is one loft space within the interior of B1 which was fully boarded and accessible for survey. There are numerous gaps in the brickwork and timber soffits, as well as gaps in the clay tiles and areas of raised lead flashing. B1 will be demolished to facilitate the proposed development.</p> <p>B1 is assessed as having '<b>moderate</b>' potential to support roosting bats.</p> | | | |

| <i>Recommendations</i> | <p><b>Roosting habitat</b></p> <p><b>Two</b> bat emergence/re-entry surveys are required on B1 during the active bat season (May – September) to confirm presence/likely-absence of bats roosting in or on the building. These survey visits should be completed during the optimal survey period mid-May to August inclusive. The survey visits should be at least three weeks apart.</p> <p>Sub-optimal: early May and September. Would require greater justification of timing e.g., weather conditions, known local bat activity.</p> |

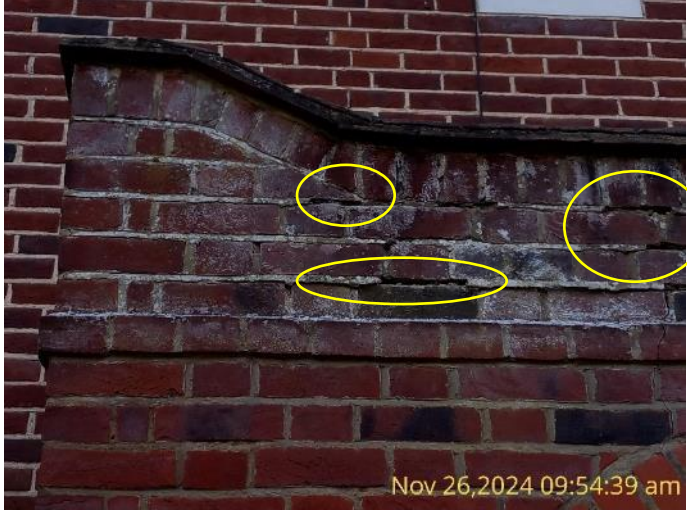
| Walls | Brick and mortar | <p><b>Condition/description</b><br/>Numerous gaps in the brickwork where mortar is missing. The extension on the northwest of B1 has pulled away from B1, creating gaps.</p> <p><b>Suitability/access/evidence of bats</b><br/>Gaps in the brickwork provide suitable roosting features for crevice dwelling bats. Binoculars were used to assess these gaps, and they were deemed deep enough to support roosting bats. Please see Figure 1, Figure 2 &amp; Figure 3 in Appendix 4 for additional photos.</p> | |

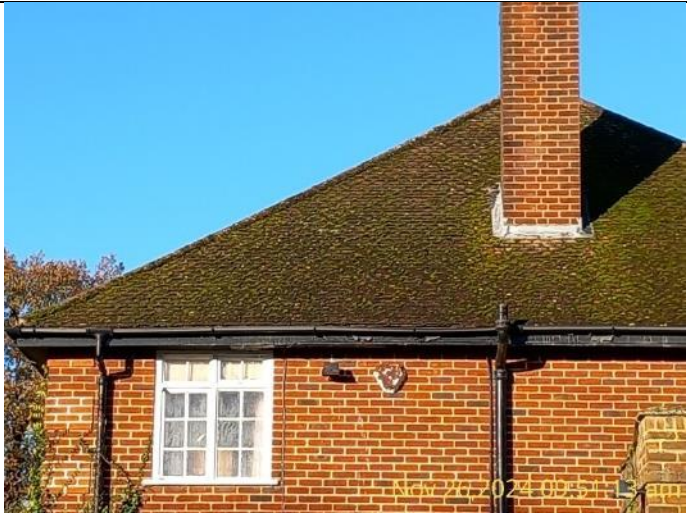
| Roof | Clay tiles | <p><b>Condition/description</b><br/>Pitched and hipped roof. Heavily moss covered with some raised examples. Flat roof could not be seen.</p> <p><b>Suitability/access/evidence of bats</b><br/>Space under tiles could accommodate crevice dwelling bats. Please see Figure 4 in Appendix 4 for additional photos.</p> | |

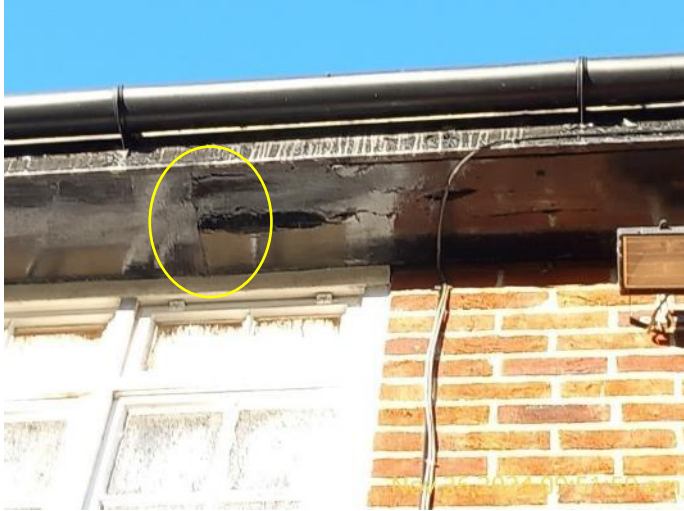
| Soffit boxes | Timber | <p><b>Condition/description</b><br/>There are two gaps in the soffit boxes on the eastern elevation of B1. There is an additional gap on the northeastern elevation. The rest of the soffit boxes appear to be in moderate condition, with areas of peeling paint.</p> <p><b>Suitability/access/evidence of bats</b><br/>Provides possible bat access into internal void and crevices on wall tops. No evidence found but recent and current rain would wash this away externally.</p> | |

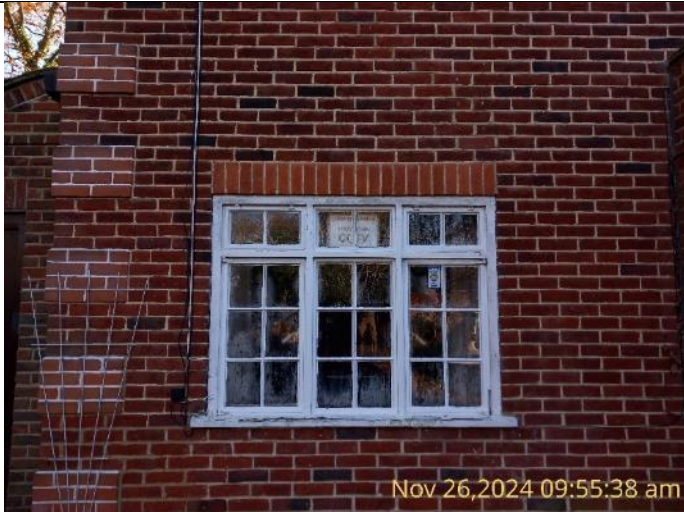
| Window/doors frames and lintels | Timber | Tight fitting | |

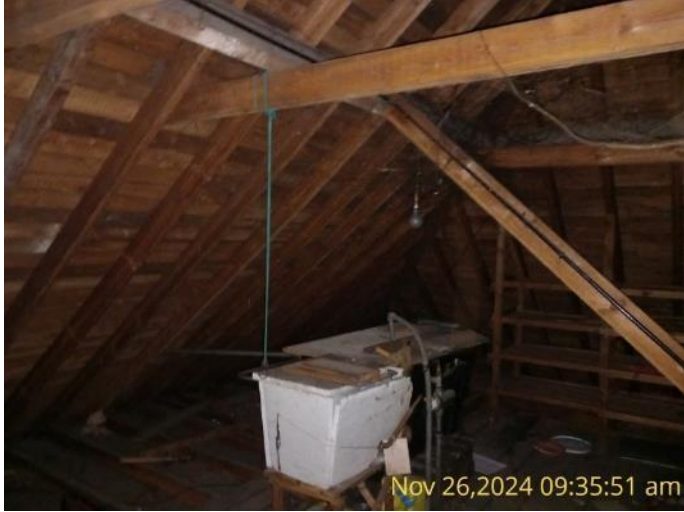
| Internal voids | Timber rafters and ridge beam. Open floor to ridge. Timber sarking on underside of tiles. chimney stacks fully visible internally. | <p><b>Condition/description</b></p> <p>Abiotic recordings within the interior of the loft space at the time of the survey were recorded at 8.7°C and 92.9% relative humidity. The internal loft space measures approx. 13m long, 11m wide. The internal timbers appear to be original and have traditional mortise and tenon joints. The timber sarking appears to be in good condition, with no gaps or cracks present. A small amount of daylight could be seen entering the loft space on the southern elevation. This is due to the growth of vines from the outside (see Figure 5 in Appendix 4).</p> <p><b>Suitability/access/evidence of bats</b></p> <p>No bat droppings were found within the loft space, nor any other evidence of bat presence.</p> | |

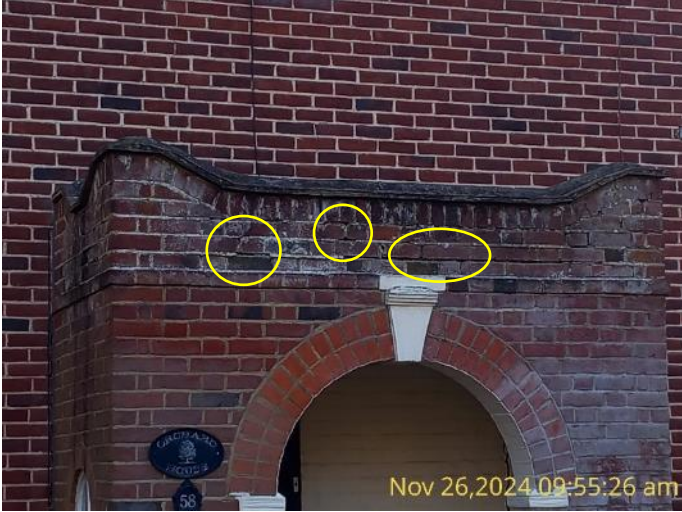
| Photograph | Description |
|---|---|
| | <p>Figure 1: B1 – northwest elevation</p> <p>The flat-roof single storey extension on the northwest elevation of B1 has missing mortar above the arch (see circles). These gaps provide suitable roosting features for crevice dwelling bats.</p> |

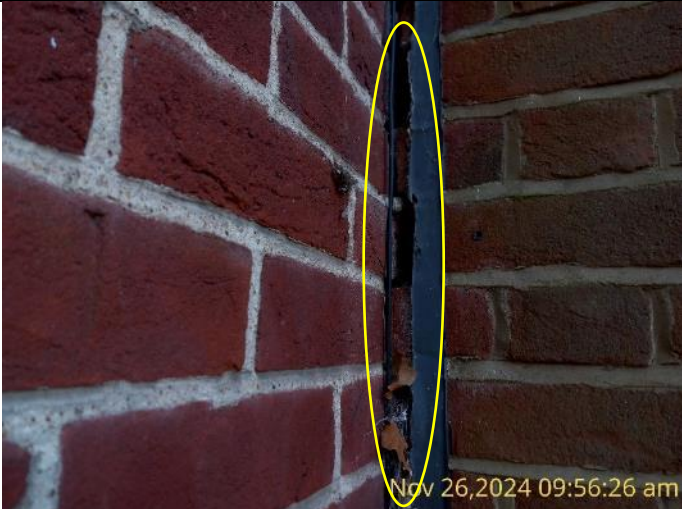
| Photograph | Description |
|---|---|
| | <p>Figure 2: B1 – northwest elevation</p> <p>The flat-roof single storey extension on the northwest elevation of B1 has pulled away from the main two-storey construction. There are significant gaps between the main residence and the extension. These gaps are suitable for crevice dwelling bats to utilise for roosting.</p> |

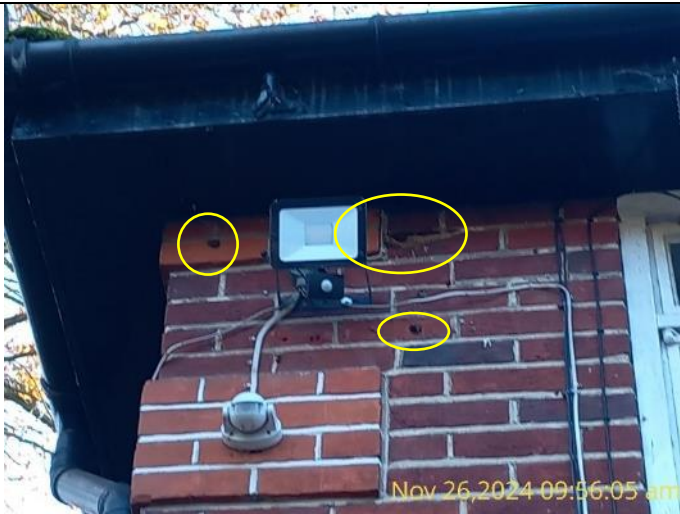
Figure 3: B1 – northwest elevation  
There are holes in the brickwork on this elevation which provide suitable roosting features for crevice dwelling bats.

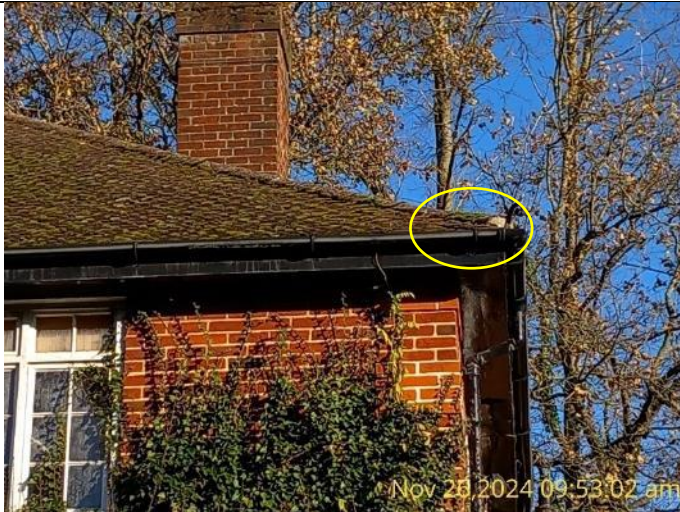
Figure 4: B1 – south elevation  
There are several (<10) raised tiles across the entirety of B1. These raised areas provide suitable gaps for crevice dwelling bats.
