## TIER 1 CONTAMINATED LAND PRELIMINARY RISK ASSESSMENT

400 THAMES VALLEY PARK DR, EARLEY, READING RG6 1PT

REFERENCE: P1202-02/R1/V2

REPORT PREPARED BY: EPS CONSULTING

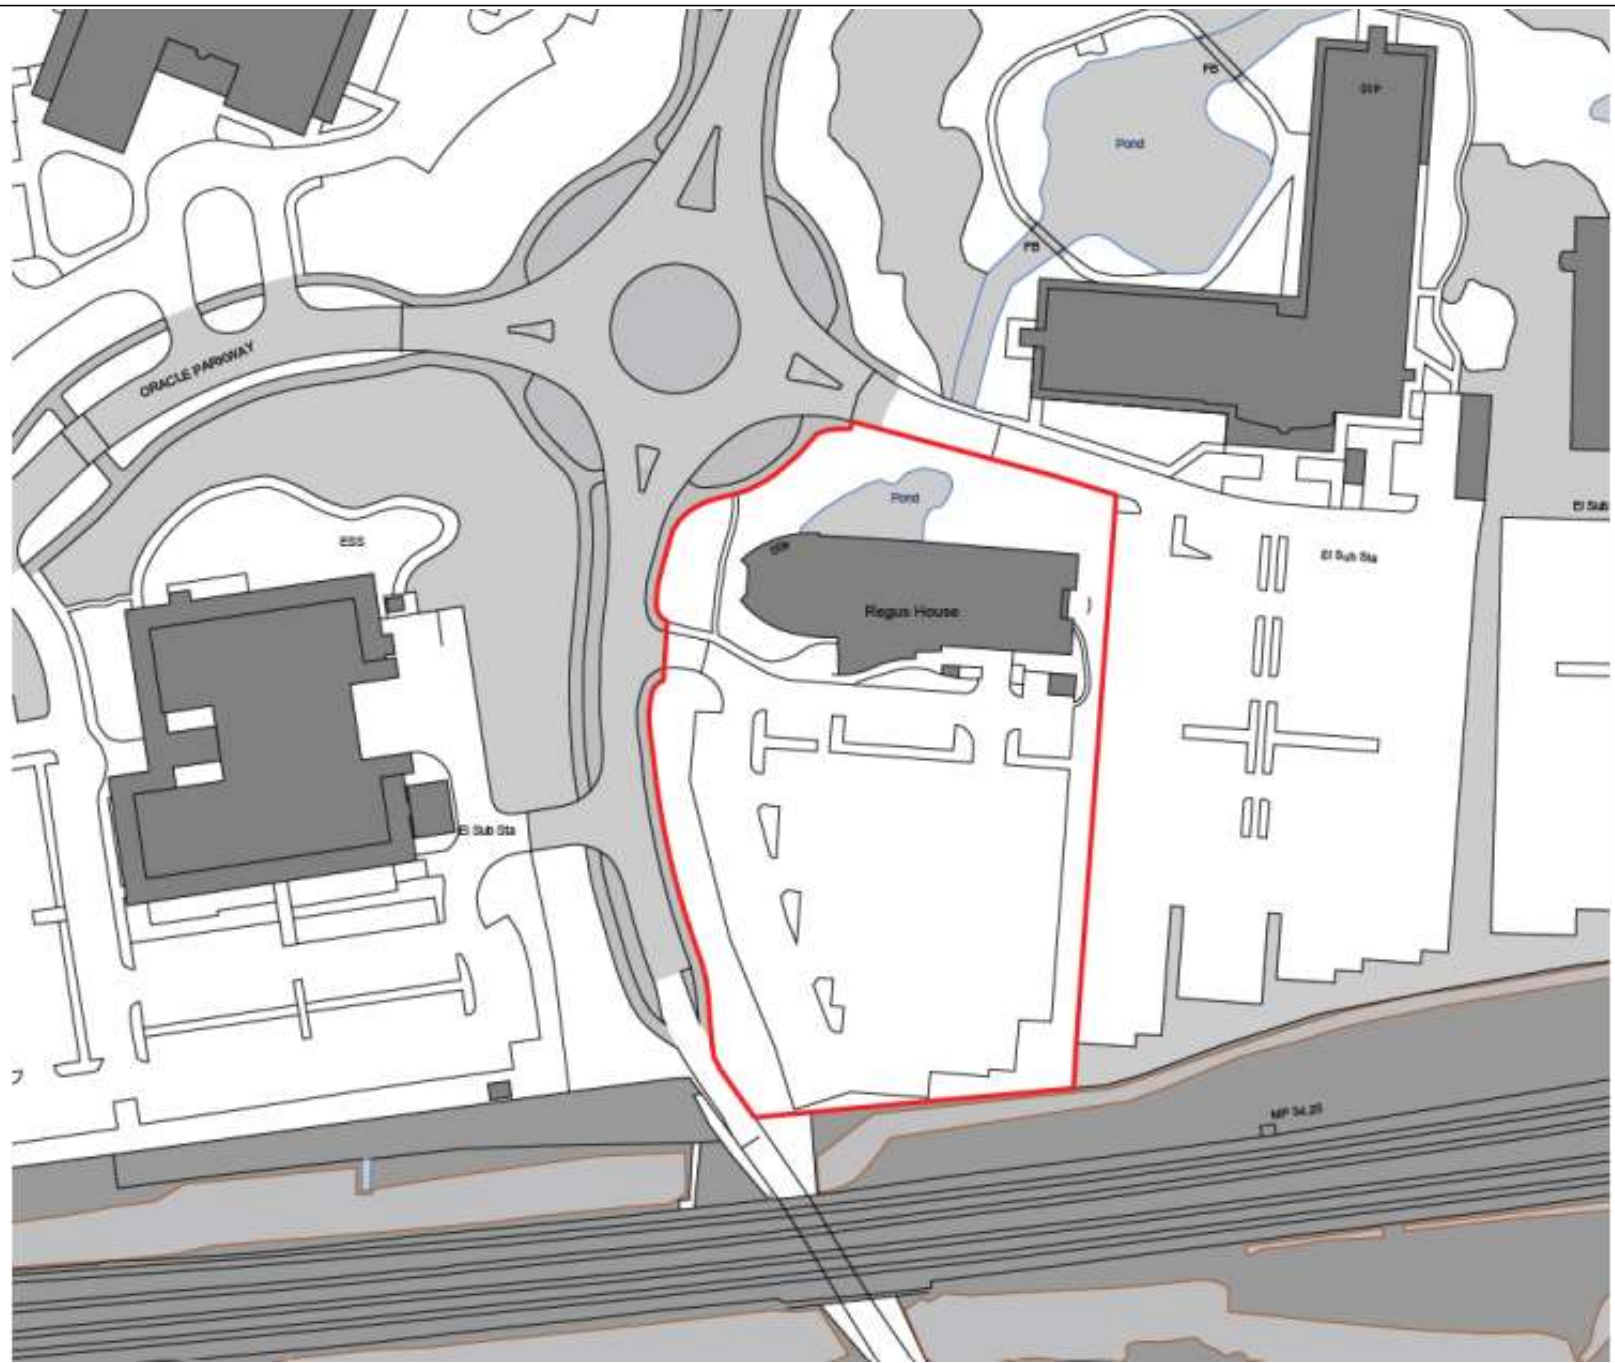
Figure 1  
Site Location and Red Line  
Boundary Plan

A Site Location and Red Line Boundary Plan is presented as Figure 1 within Appendix I.

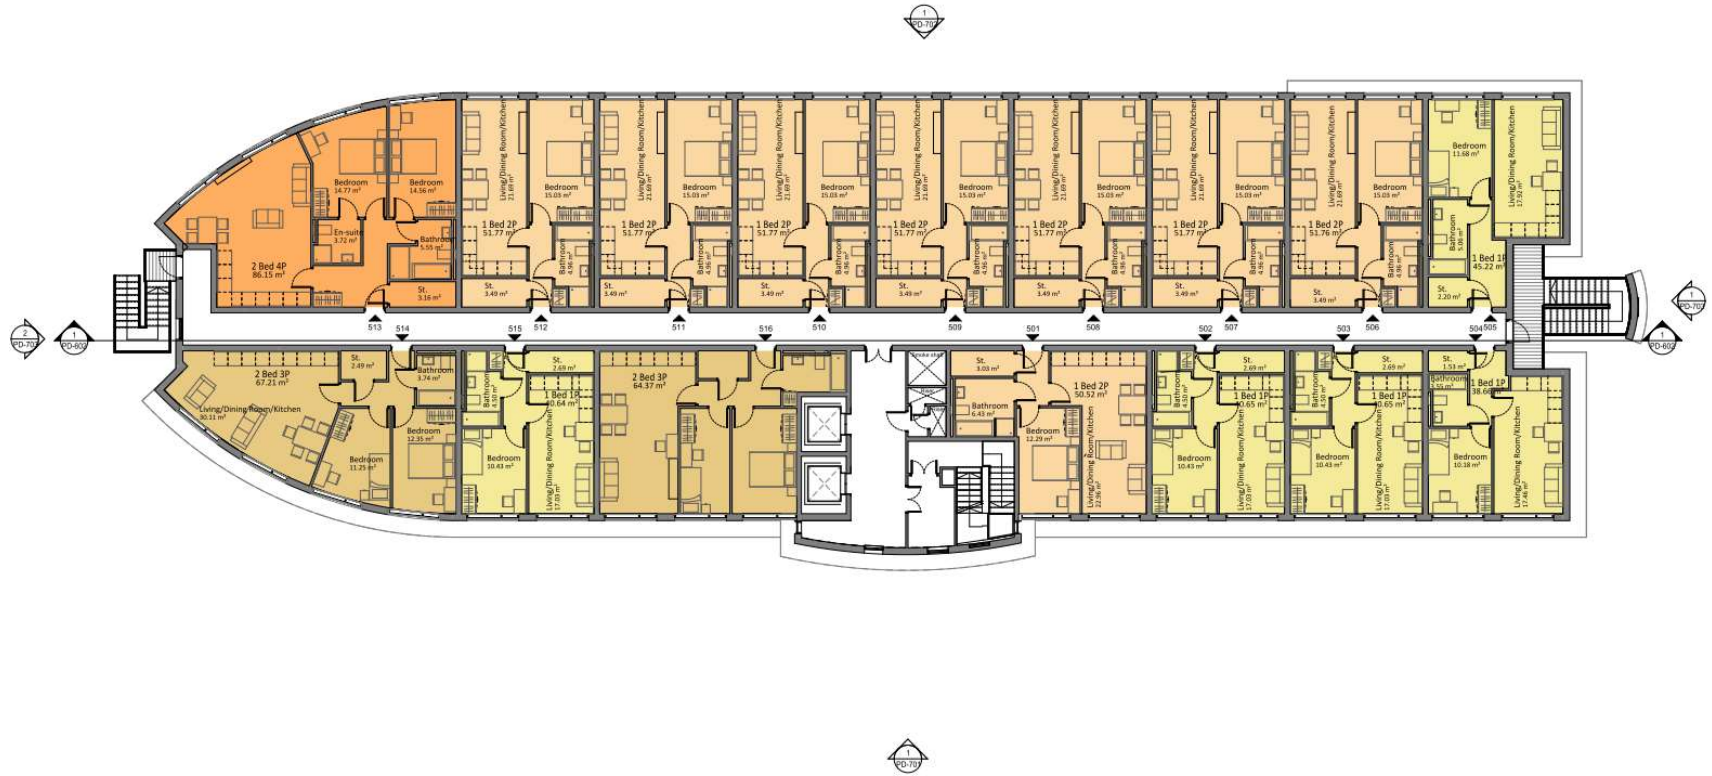
A Proposed Fourth and Fifth Floor Plan is presented as Figure 2 within Appendix I.
