## **Demolition Asbestos Survey**

**Client Specified Areas  
Arborfield STW - ARBOS1ZZ  
School Lane  
Barkham  
Berkshire  
RG41 4TS**

**Report Ref:  
M100.01-JB-ARBOS1ZZ-100-  
RP-CE-8011**

**November 2025**

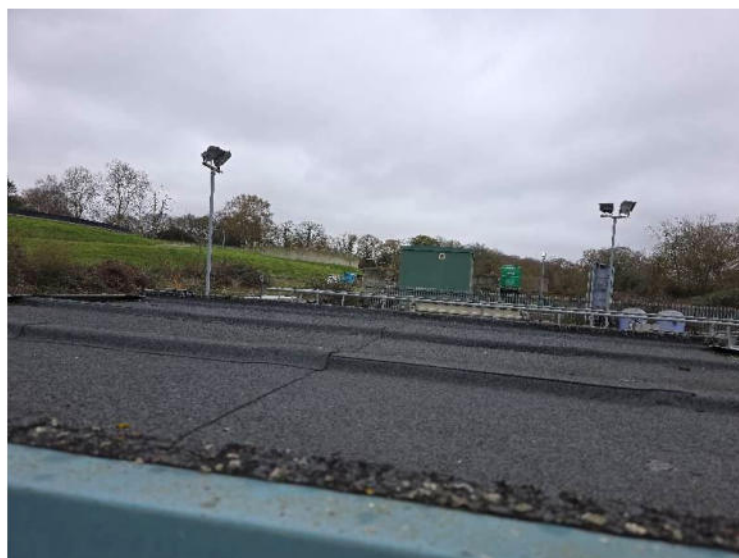
| <b>Extent:</b> | 7 sqm | <b>Lab Analysis Result:</b> | Not Detected |
| <b>Location:</b> | Felt lining roof | | |

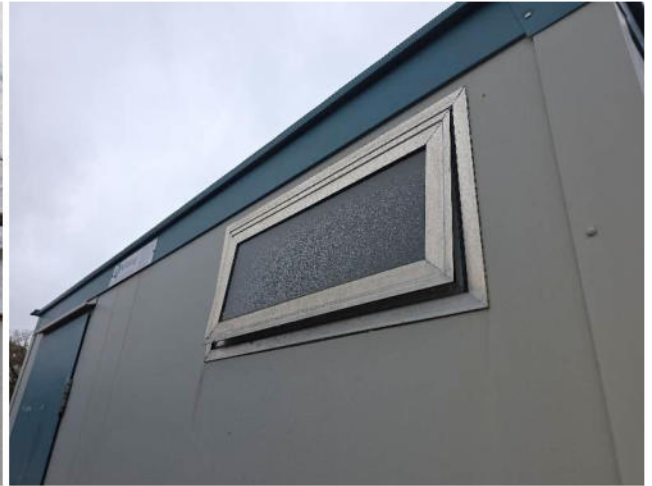
| <b>Extent:</b> | 2 lin m | <b>Lab Analysis Result:</b> | Chrysotile |
| <b>Location:</b> | Putty beneath metal-framed windows | | |

| Room Ref | Asbestos | Sample Ref | Form | Location | Extent |
|---|---|---|---|---|---|
| | | <b>Comments:</b> Metal lined shell, metal windows, MMMF insulation to underside of cabin (beneath polythene sheeting), modern foam insulation to plastic pipework. | | | |

All ACM that maybe disturbed by proposed works should be removed under controlled conditions in accordance with the Control of Asbestos Regulations (CAR) 2012.

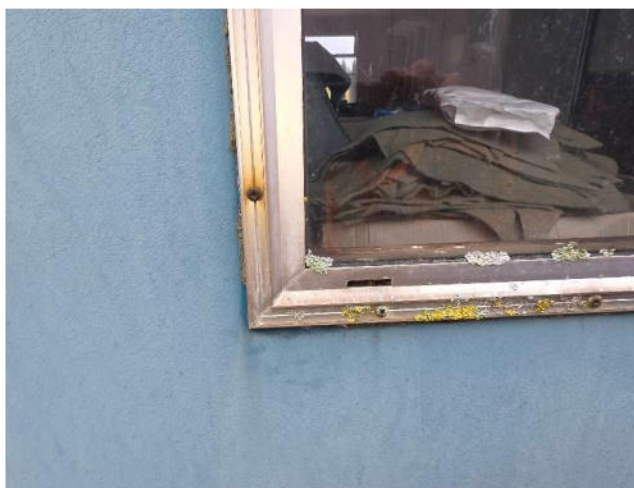
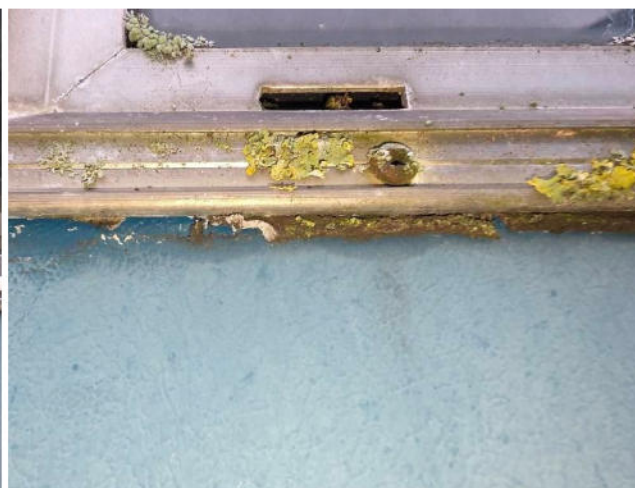
| <b>Extent:</b> | 15 lin m | <b>Lab Analysis Result:</b> | Chrysotile |
| <b>Location:</b> | Putty beneath metal-framed windows and door | | |

| Room Ref | Asbestos | Sample Ref | Form | Location | Extent |
|---|---|---|---|---|---|
| | | <b>Comments:</b> Metal shell, metal windows, metal roof, MMMF insulation beneath timber floor (covered with polythene sheeting). | | | |

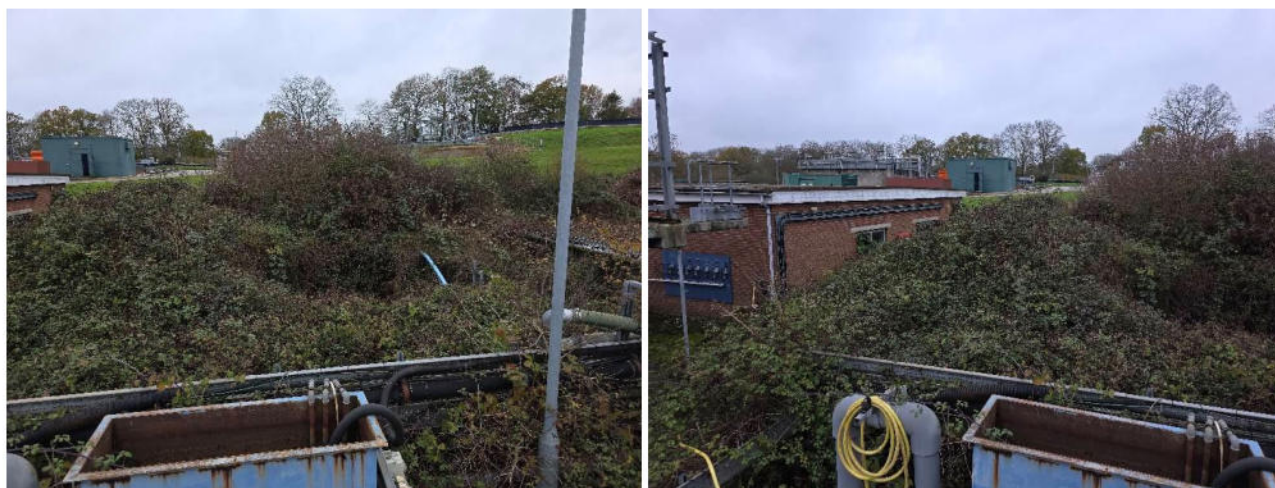
| <b>Location:</b> | No safe access to inspect areas overgrown with vegetation | | |

| Room Ref | Asbestos | Sample Ref | Form | Location | Extent |
|---|---|---|---|---|---|
| | | <b>Comments:</b> No safe access to inspect without prior removal of vegetation. | | | |

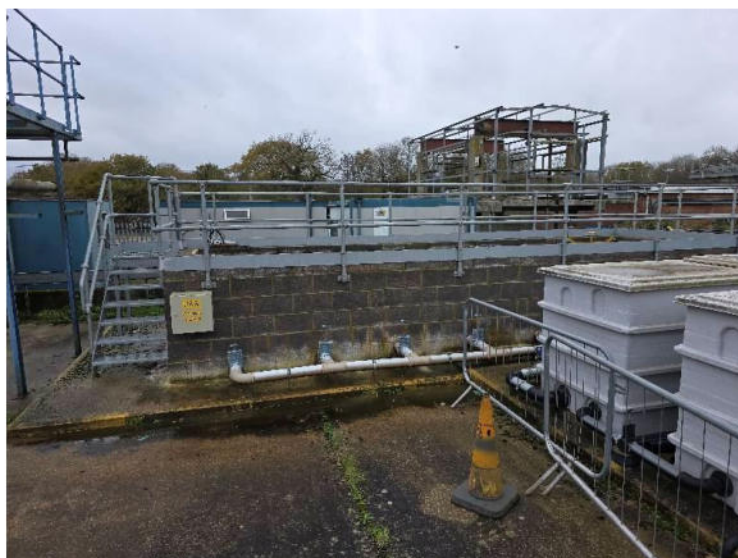
| <b>Location:</b> | No access within covered chambers/ tanks | | |

| Room Ref | Asbestos | Sample Ref | Form | Location | Extent |
|---|---|---|---|---|---|
| | | <b>Comments:</b> No access to inspect within covered chambers. | | | |

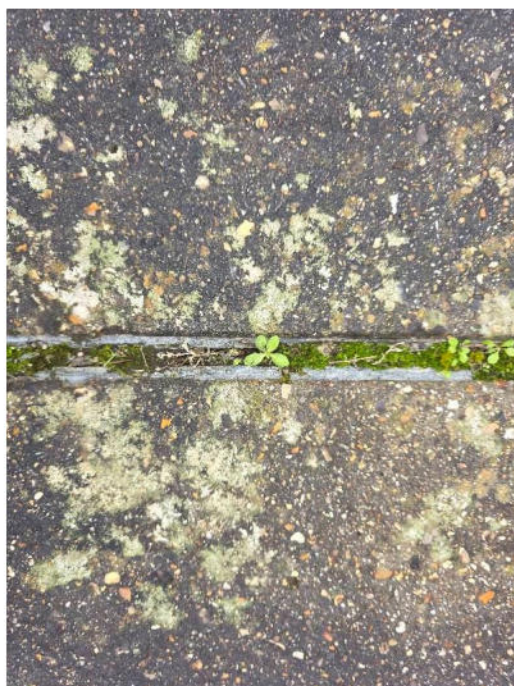
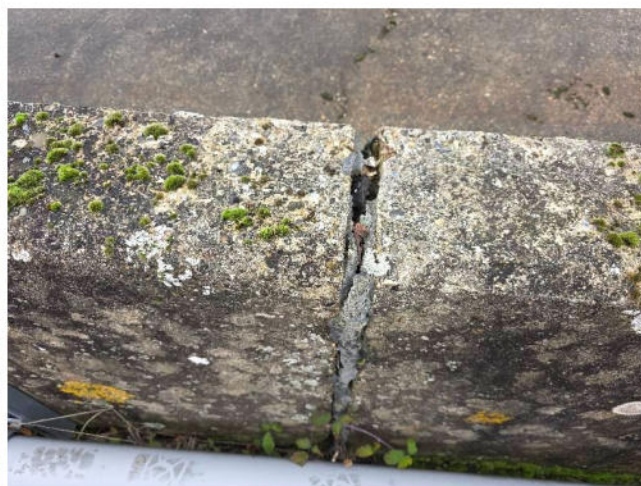
| <b>Extent:</b> | 40 lin m | <b>Lab Analysis Result:</b> | Chrysotile |
| <b>Location:</b> | Sealant within expansion joints in concrete wall and floor slabs throughout area | | |

| Room Ref | Asbestos | Sample Ref | Form | Location | Extent |
|---|---|---|---|---|---|
| | | <b>Comments:</b> Concrete floor, modern plastic pipework throughout, fibreglass tanks, modern control units throughout area, rubber gaskets to pipework flanges. | | | |

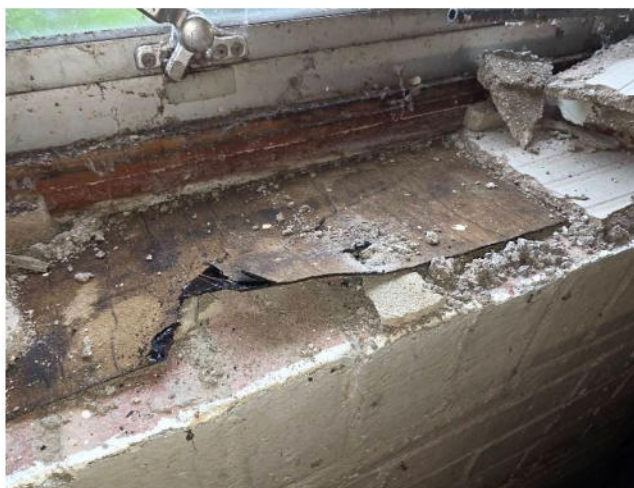
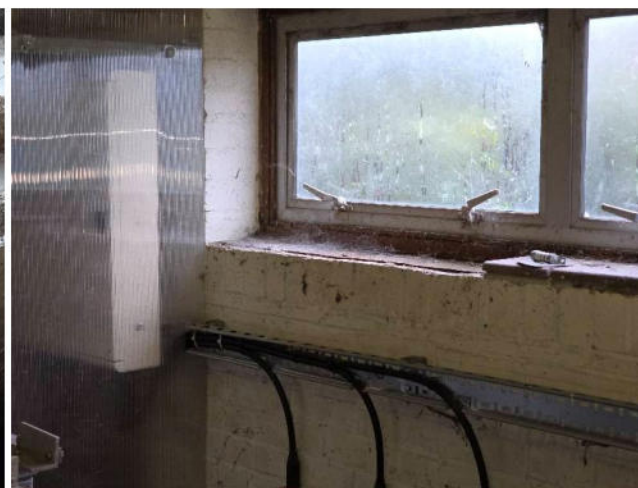
| <b>Form:</b> | Bonded Materials | <b>Lab Analysis Result:</b> | Chrysotile |
| <b>Location:</b> | Damp proof membrane beneath masonry tiles lining window | | |

| Room Ref | Asbestos | Sample Ref | Form | Location | Extent |
|---|---|---|---|---|---|
| | | <b>Comments:</b> Brick walls, plasterboard ceiling, timber forming roof, structural steel beam supporting roof, MMMF insulation within ceiling void, timber-framed metal windows with rubber seals, masonry tiles lining floor and window sills. | | | |

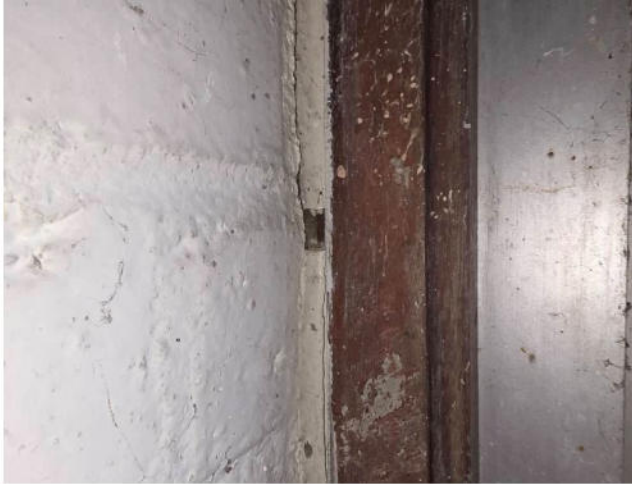
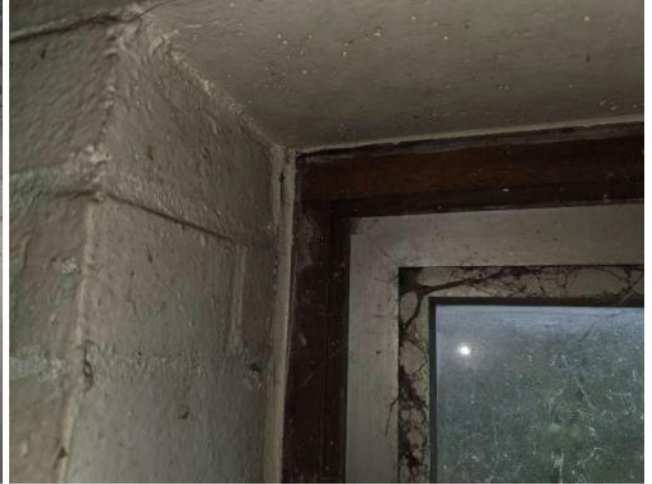
| <b>Extent:</b> | 12 lin m | <b>Lab Analysis Result:</b> | Chrysotile |
| <b>Location:</b> | Mastic sealant to window frames | | |

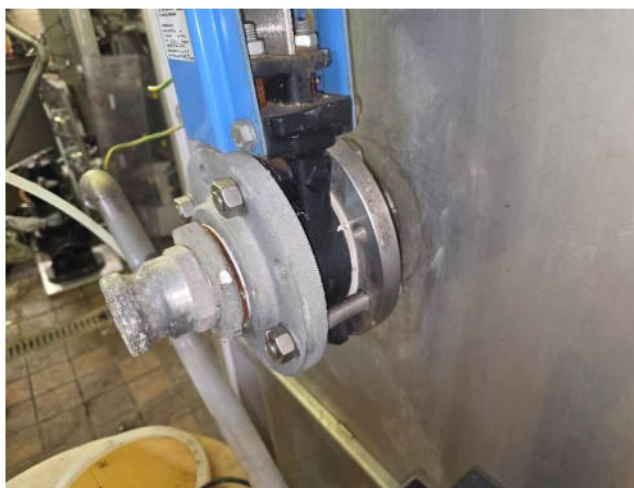
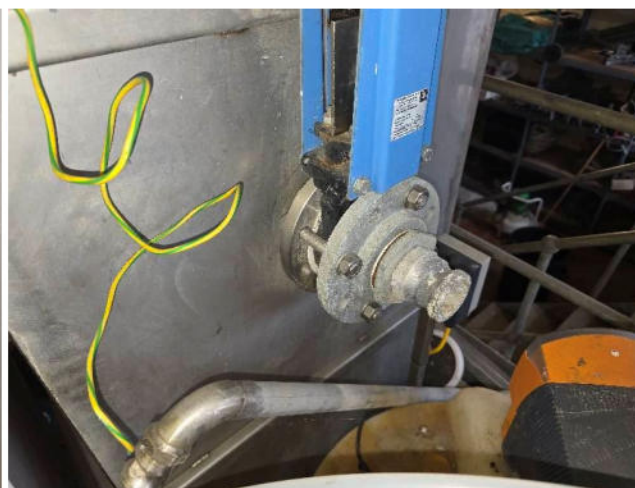
| <b>Form:</b> | Gaskets | <b>Lab Analysis Result:</b> | Not Detected |
| <b>Location:</b> | Gaskets to metal tank | | |

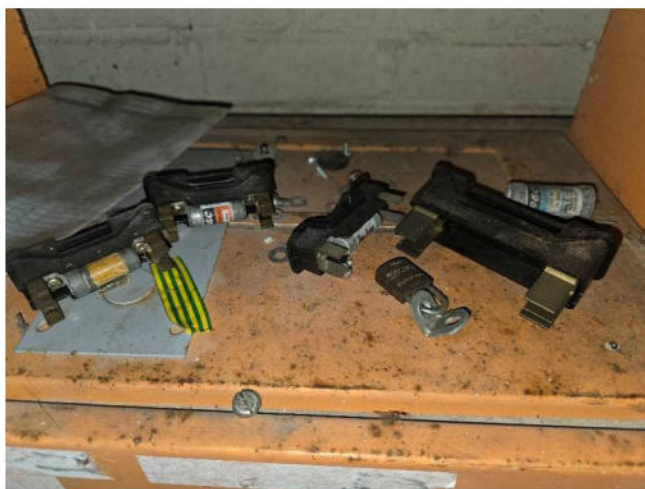
| <b>Extent:</b> | >10 No. | <b>Lab Analysis Result:</b> | Not Detected |
| <b>Location:</b> | Card flash suppressors within loose barrel surrounding electrical units | | |

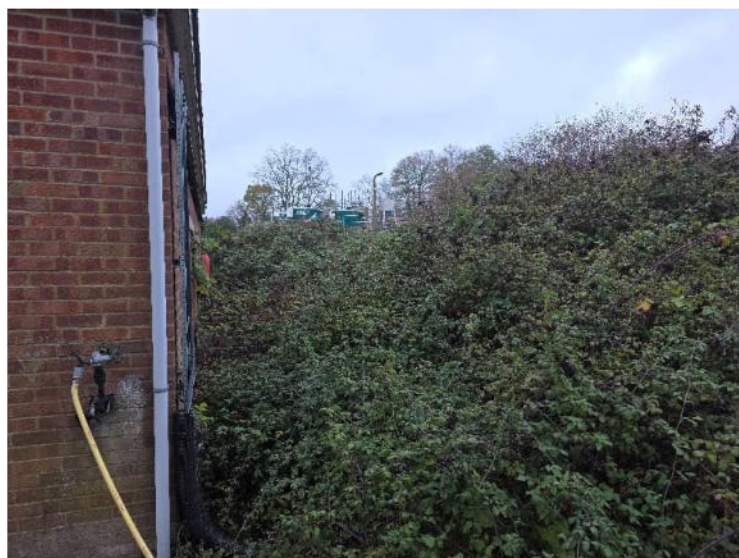
| <b>Location:</b> | Limited access to inspect 2No elevations of building due to overgrown vegetation | | |

| Room Ref | Asbestos | Sample Ref | Form | Location | Extent |
|---|---|---|---|---|---|
| | | <b>Comments:</b> Limited access to inspect without removal of vegetation. | | | |

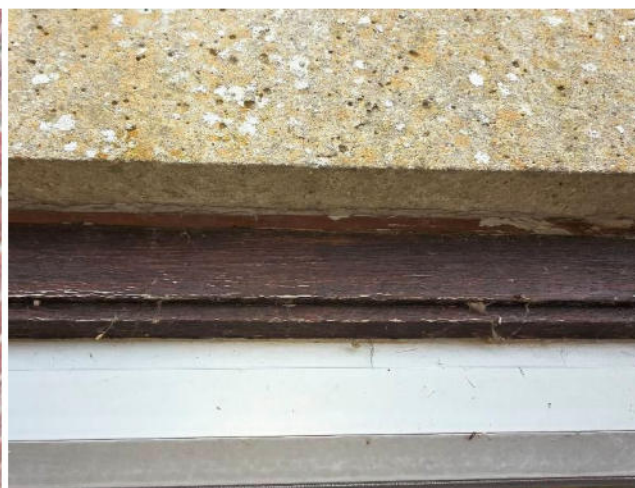
| <b>Form:</b> | Bonded Materials | <b>Lab Analysis Result:</b> | Chrysotile |
| <b>Location:</b> | Brown mastic sealant to door and window frames | | |

| Room Ref | Asbestos | Sample Ref | Form | Location | Extent |
|---|---|---|---|---|---|
| | | <b>Comments:</b> Brick walls, timber-framed doors and windows, concrete lintels over windows and doors, concrete base, uPVC forming fascias and soffits, timber roof with modern felt, plastic rainwater goods. | | | |

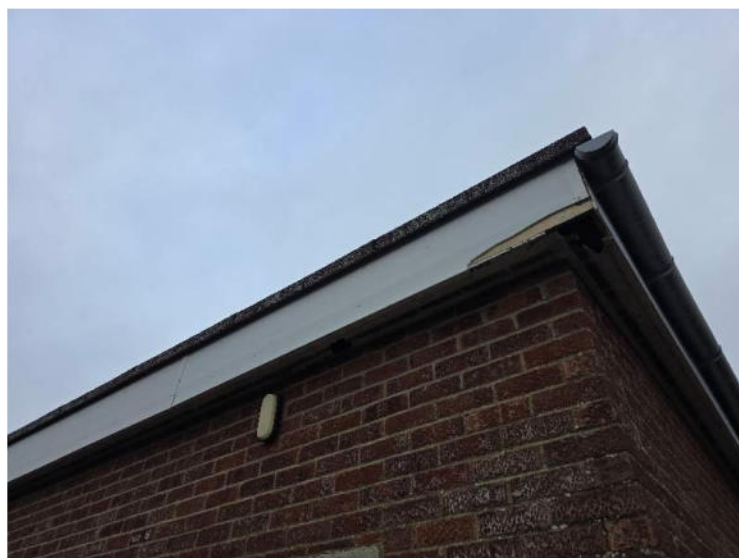
| <b>Form:</b> | Bonded Materials | <b>Lab Analysis Result:</b> | Not Detected |
| <b>Location:</b> | Felt lining flat roof | | |
