# Arborfield STW

Wood Lane, Barkham, Wokingham

## Ecological Technical Note

March 2026

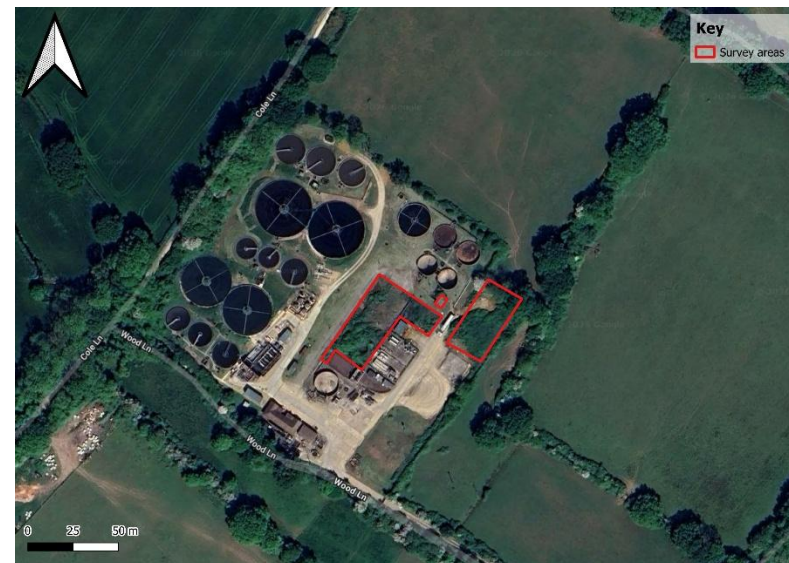
Figure 1: Boundary of areas surveyed during 2026 update survey

An assessment of the habitats present within areas of interest on Site were undertaken, where enabling works are required prior to the main works, which will require planning approval. The areas of interest are highlighted in Figure 1 below.

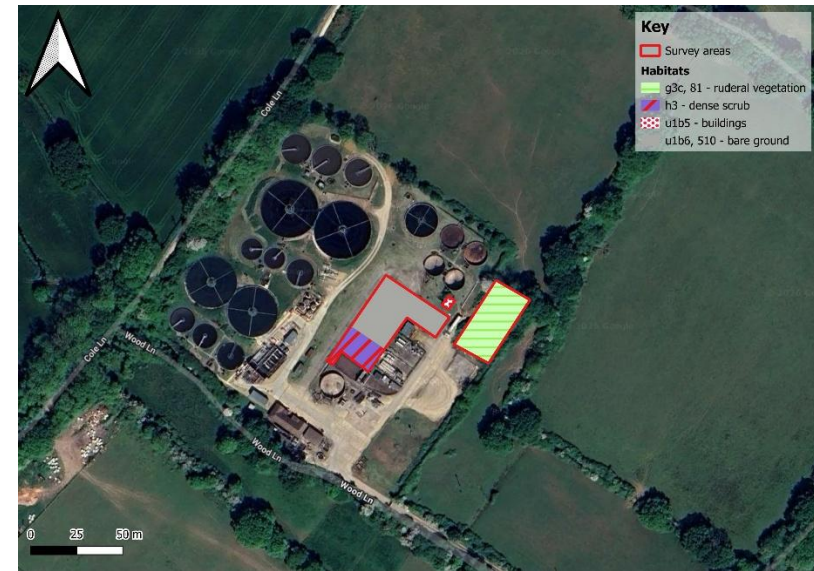
Figure 2: Habitat map of surveyed areas

The habitats identified on Site during the updated survey are identified in Figure 2 and described below.

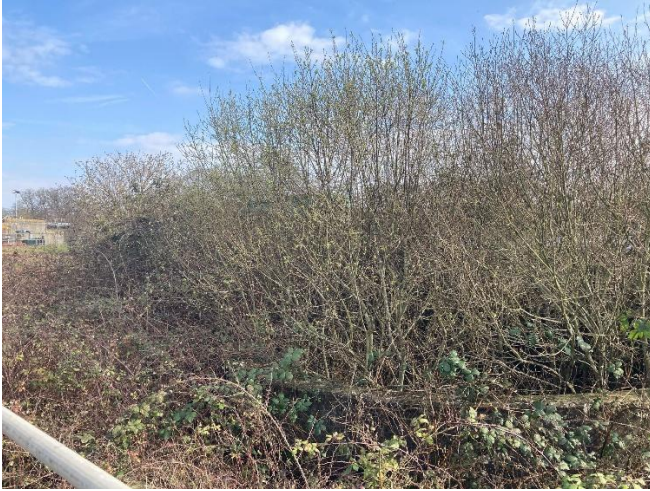
An area of dense scrub, dominated by bramble (*Rubus fruticosus*) and willow (*Salix spp.*) is present within an area of old settling beds with two concrete tanks. The area is what remains of the larger sludge/drying beds (see 2.2.2) which have previously been cut back. The vegetation is dense and uniform in age.

Figure 3: Dense scrub within old bed

The area of dense scrub to be impacted should first be checked for active nests by an ecologist or other suitably qualified individual. If nesting activity is identified, certain aspects of work in the vicinity of the nest will need to cease

until the birds have finished nesting and the young have fledged.

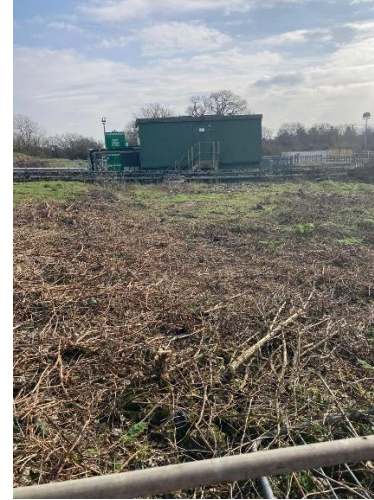
The vegetation has previously been removed, within the last month, from two old sludge/drying beds. The habitat previously present within this area, is considered to be dense scrub, as described in 2.2.1. The habitat now currently present is predominantly bare ground comprised of media rock which continue to 1.5m where they meet a concrete bed.

Figure 4: Bare ground where vegetation has previously been removed

Any excavation within the sludge beds and movement of soil within the mound should be made safe each night or fitted with escape ramps (e.g. a plank at no steeper than a 30° angle).

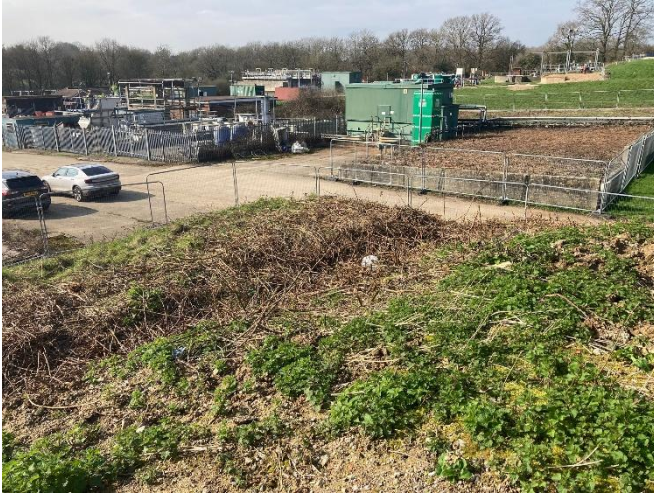
A large mound of rubble which has been recently cut back is present on Site. The mound is comprised of rubble, stones, site debris and soil. The area has recently been removed of scrub. This has allowed ruderal vegetation to grow through whilst retaining many areas of bare ground and moss-covered ground.

The mound is now comprised of nettles (*Urtica dioica*), cleavers (*Galium aparine*), lords and ladies (*Arum maculatum*), lesser celandine (*Ficaria verna*), germander speedwell (*Veronica chamaedrys*), bramble (*Rubus fruticosus* agg.), cow parsley (*Anthriscus sylvestris*), burdock (*Arctium minus*), bristly oxtongue (*Helminthotheca echioides*), ribwort plantain (*Plantago lanceolata*), and broadleaved dock (*Rumex obtusifolius*).

Figure 5: Ruderal vegetation on mound present on Site

- Vegetation removal must be undertaken during the active season (March – September inclusive)
- Areas of dense rubble and debris should be carefully removed by hand or with small machinery to ensure that any reptiles potentially sheltering underneath can escape
- If any reptiles are identified during vegetation clearnace, all works should cease and the Ecologist called for advice.

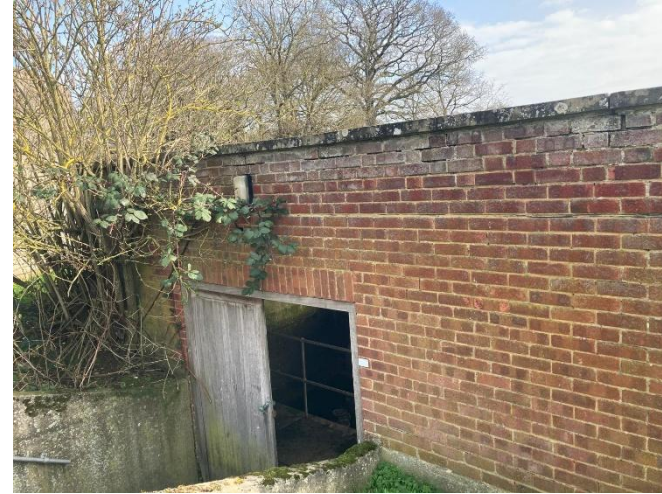
A flat roofed brick-built building set into the ground is present on Site. The building is approximately 2m height and 7m wide. The building has a smashed window on the southwest elevation and an elder growing from the northern corner. The windows on the southeastern elevation have wooden frames, which are coming away from the brick of the building. Double doors are present on the western elevation, one of which is permanently open. Internally the building is very damp and dirty with Thames Water infrastructure present.

Figure 6: Building present on Site

The additional building should be subject to one emergence survey, as per best practice guidance for buildings with low suitability for roosting bats. It is considered that this can be conducted alongside the further surveys recommended for B1 and B2 in the Mott MacDonald report.

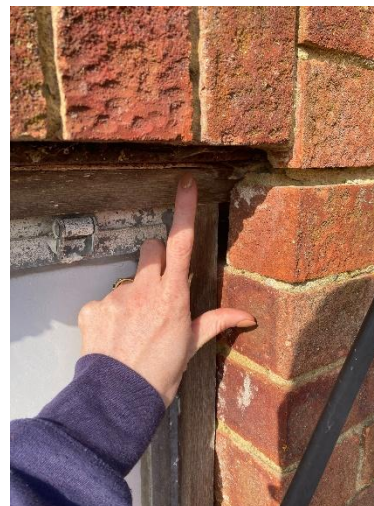
in 2.2.4. The internal of the building provided no suitability for roosting bats as the ceiling and walls are lined and no cracks/crevices are present. However, externally, gaps around the window frames on the southeastern elevation provide suitability for roosting bats. Three of these features were identified on the building and therefore, the building is considered to be of **low suitability for roosting bats**, as a number of small features were identified.

Figure 7: Example of potential roosting feature within building on Site

The results of the survey to the additional building, B1 and B2 will determine the mitigation measures required prior to demolition.

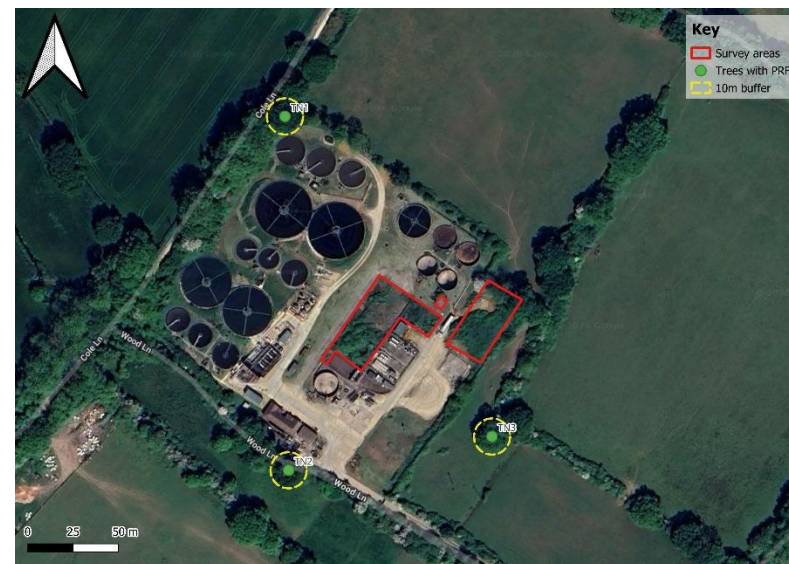
Figure 8: 10m buffer around three trees detailed as containing potential roosting features

Further surveys for roosting bats in trees have been recommended within the Mott MacDonald report. However, the trees are outside of the scope for the enabling works. Therefore, it is considered that these further surveys are not required and a 10m buffer should be retained around the trees, to ensure no disturbance throughout the works.
