# Preliminary Roost Assessment

Stablehouse Barn, White Hill, Remenham, Henley-on-Thames RG9 3HN

This report is prepared to inform a planning application with Wokingham Borough Council. This proposal can be described as the addition of solar panels on a section of the southern elevation.

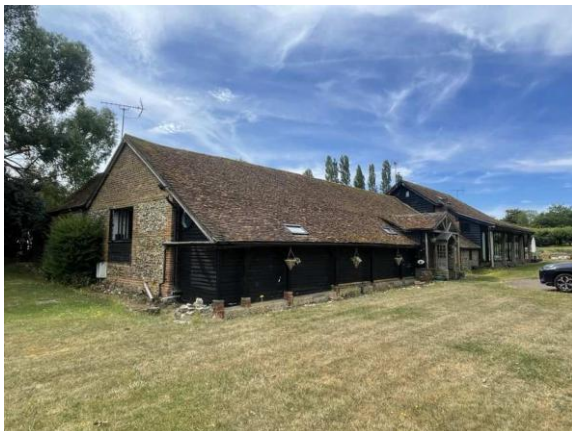
*B1- northern and eastern elevations*

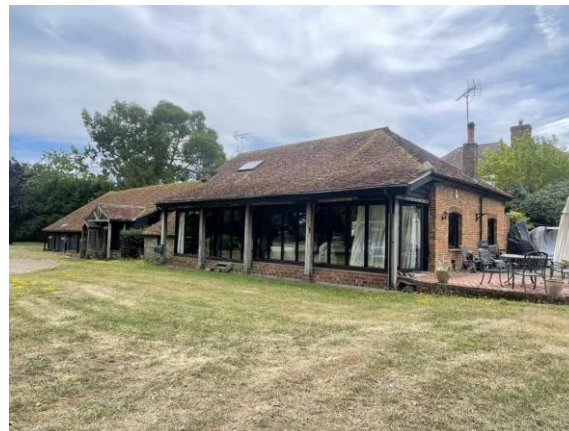
*B1- northern and western elevations*

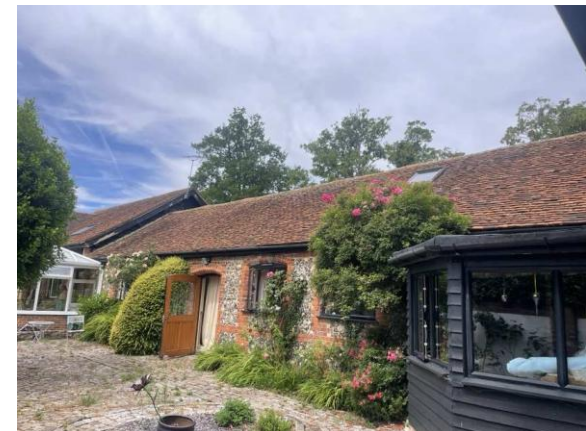
*B1- southern elevation*

The proposed development includes the addition of solar panels on a section of the southern elevation. The addition of these solar panels will block access to the raised tiles on this section of roof. This could result in the destruction of any bat roosts present and could cause disturbance, death or injury to bats.

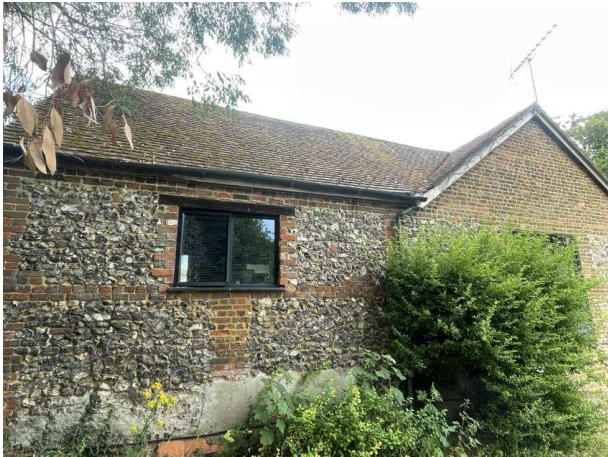
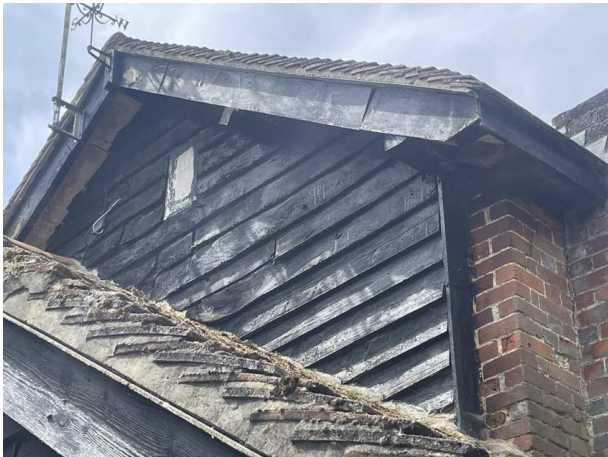
| Feature | Materials/Details | Condition / description / suitability | Photograph |
|---|---|---|---|
| Walls | Brick and timber | <p><b>Condition/description</b></p> <p>The brickwork around the building appears in good condition with no gaps or cracks within which crevice-dwelling bats could roost.</p> <p>Sections of the building (all elevations) are clad in wooden weatherboarding which is in relatively good condition, with the exception of two raised sections on the eastern gable and southern gable end.</p> <p><b>Suitability/access/evidence of bats</b></p> <p>Raised external boards provide ideal roosting habitat for crevice dwelling bats. No evidence found but recent and current rain would wash this away externally.</p> | <p><i>B1 walls</i></p> <p><i>Raised wooden cladding on eastern gable</i></p> |

Two bat emergence surveys are required on B1 during the active bat season (May – September) to confirm presence/likely-absence of bats roosting in or on the building.

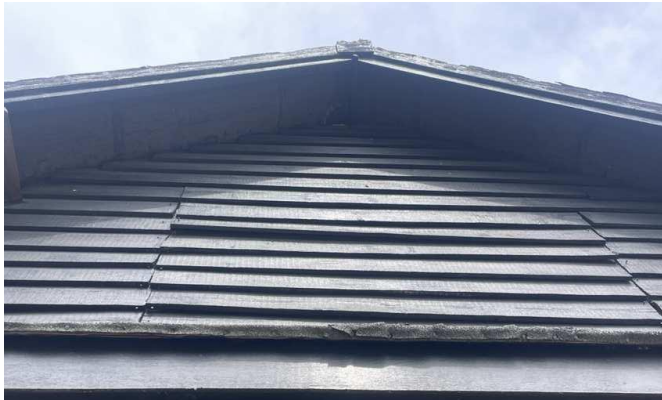
| | | | <p><i>Raised wooden cladding on southern gable</i></p> |

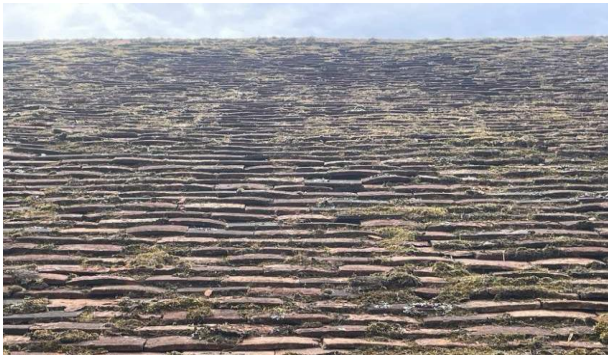
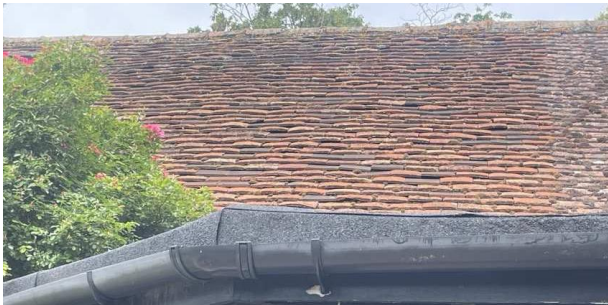
| Roof | Clay tiles | <p><b>Condition/description</b></p> <p>B1 has a cross-pitched, hipped and gabled roof clad in clay roof tiles. The roof tiles are in relatively poor condition with many raised under which bats could roost.</p> <p>There are flat roof sections located on the southern elevation of the building. The flat roofs are bitumen felt lined and are in very good condition with no gaps in which bats could roost.</p> <p><b>Suitability/access/evidence of bats</b></p> <p>Space under tiles could accommodate crevice dwelling bats. No evidence found but recent and current rain would wash this away externally</p> | <p><i>B1 roof on northern elevation</i></p> <p><i>B1 roof on southern elevation</i></p> |

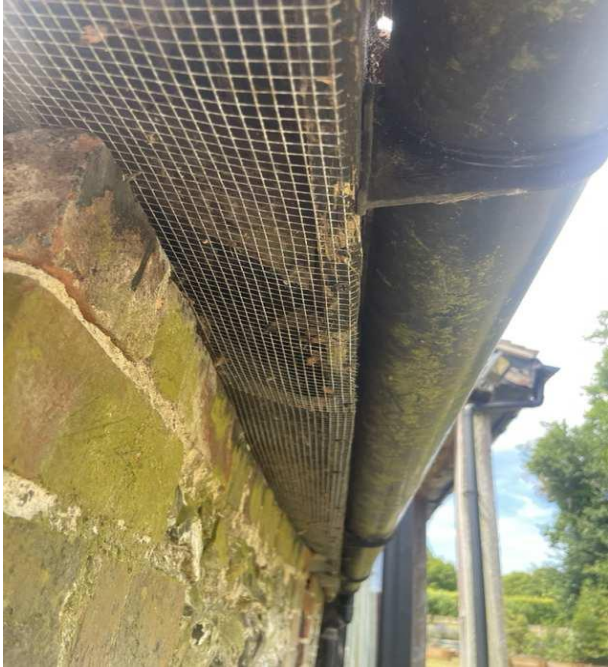
| Eaves | Overhanging | <p><b>Condition/description</b></p> <p>The eaves on the northern elevation were overhanging, however, they were covered with a thin wire mesh, which prevented access internally.</p> <p><b>Suitability/access/evidence of bats</b></p> <p>No suitable roosting features were recorded.</p> | <p><i>B1 eaves</i></p> |

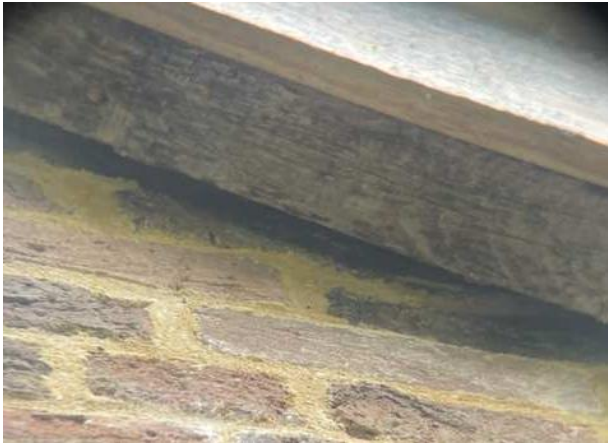
| Barge boards | Timber | <p><b>Condition/description</b></p> <p>The southern, eastern and western elevations of B1 had timber soffits and barge boards. The soffits on the southern elevation were well sealed. However, there were gaps between the soffits and wall on the western elevation. Additionally, there was a gap between the wall and barge board on the eastern elevation.</p> <p><b>Suitability/access/evidence of bats</b></p> <p>Gaps behind the soffits on the western</p> | <p><i>Gap between wall and barge board on the eastern elevation</i></p> |

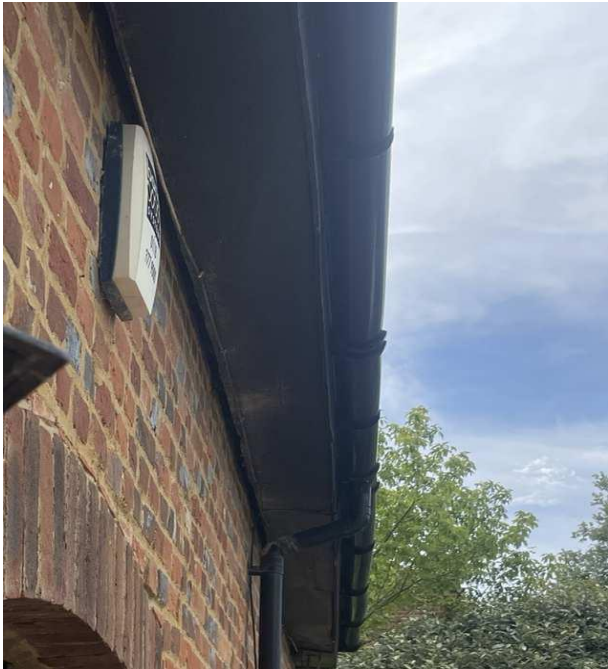
| | | <p>elevation and barge boards on the eastern elevation provide potential crevice roosting opportunities for bats. No evidence found but recent and current rain would wash this away externally. Could support individual or small numbers of crevice dwelling bats.</p> | <p><i>Gap between wall and soffit on the western elevation</i></p> |

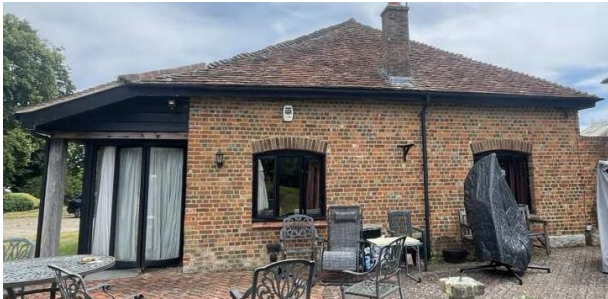
| Windows | uPVC | <p><b>Condition/description</b><br/>The windows and doors are in good condition with no defects.</p> <p><b>Suitability/access/evidence of bats</b><br/>No suitable roosting features were recorded.</p> | <p><i>B1 window / doors frames and lintels</i></p> |

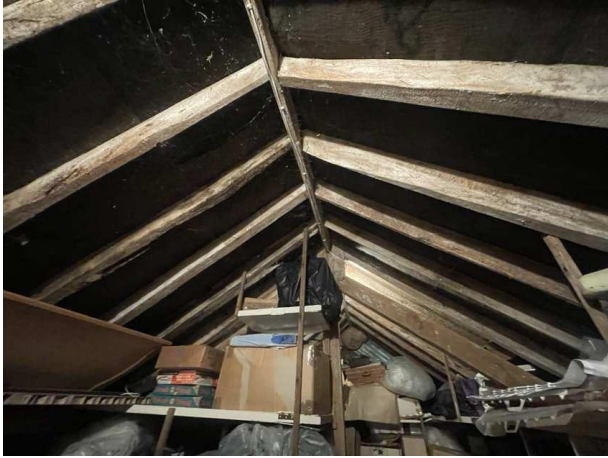
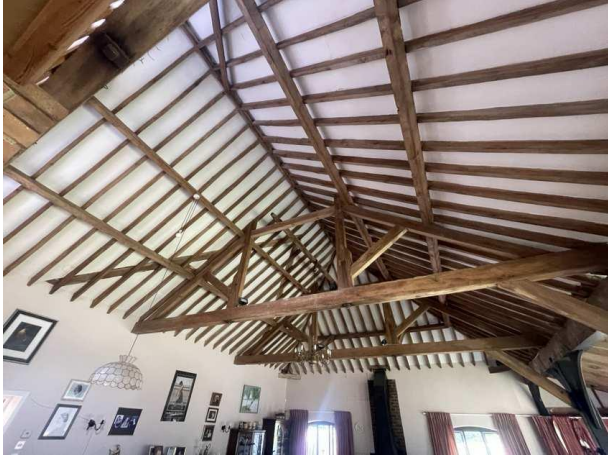
| Internal void 1 | Bitumen felt lining.<br>Timber rafters | <p><b>Condition/description</b></p> <p>There is one loft space within the centre of B1. The remaining roof was vaulted. The roof structure is built from timber beams including the ridge beam. The roof is lined with bitumen felt which is in good condition with no gaps or tears. The floor of the loft space is lined with mineral wool insulation and there are timber boards in places. There are cobwebs around the ridge beam and roof to floor cobwebs which could indicate a lack of internal flying activity from void dwelling bats, such as brown long-eared bats. Daylight enters the loft space through the open, but sealed with wire mesh eaves on the northern elevation.</p> <p><b>Suitability/access/evidence of bats</b></p> <p>No evidence of protected species was recorded.</p> | <p><i>B1 internal void 1</i></p> <p><i>Remaining roof voids were vaulted</i></p> |
