71 London Road
Wokingham

Report for:
Christopher James Architecture
27 Chaucer Way
Woosehill
Wokingham
Berkshire
RG41 3BG

INTRODUCTION

As instructed, AA Environmental Limited (AAe) carried out a detailed visual inspection of the above property on Tuesday 18 February 2025. The purpose of the survey was to confirm the presence or likely absence of bats utilising the building(s) and provide appropriate mitigation measures, as necessary. A series of photographs has been attached for reference.

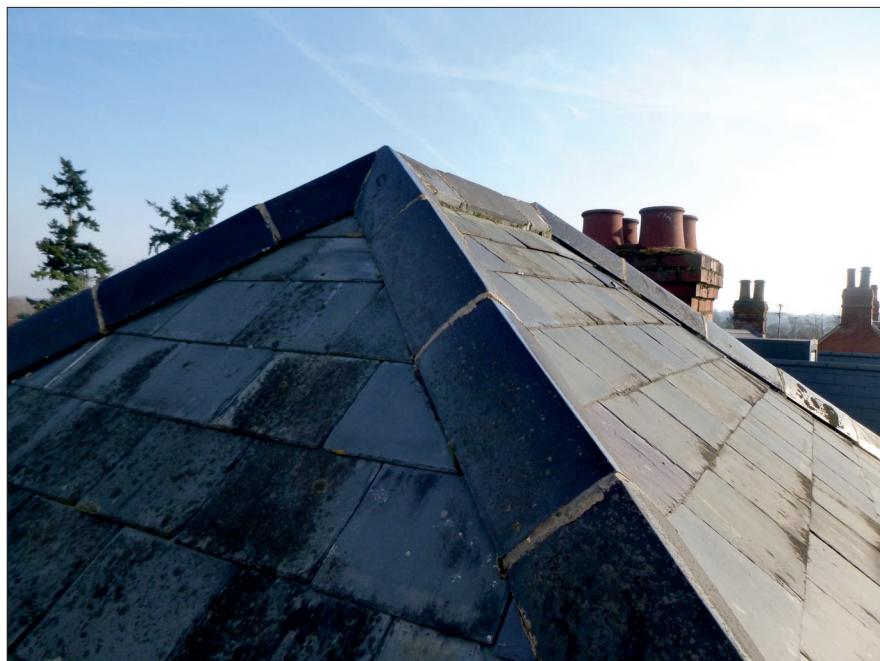
Photograph 1: Showing the close inspection of the roof and ridge tiles on the main residential dwelling, with well-sealed slate tiles.

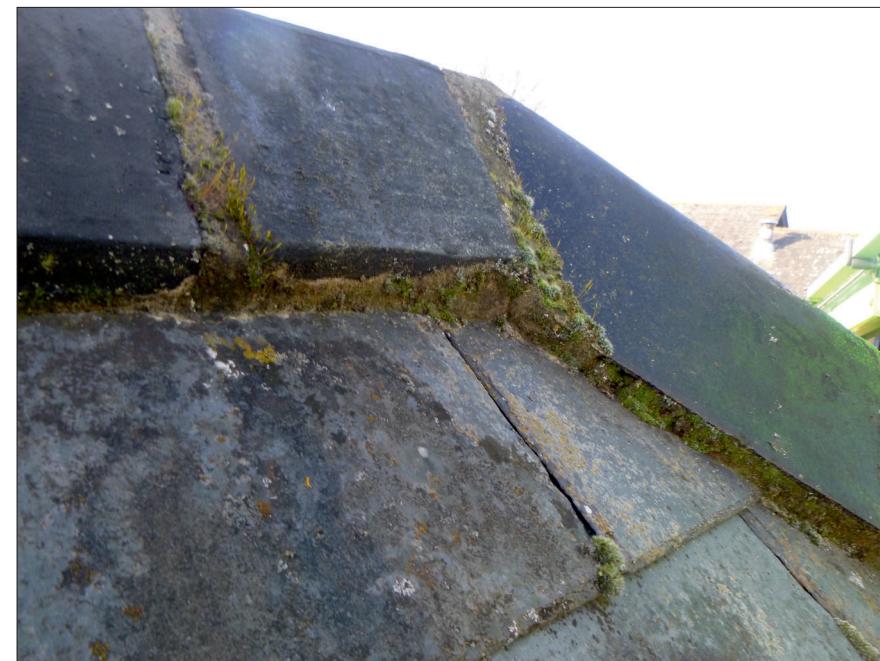
Photograph 2: Showing the close inspection of the ridge and roof tiles, mostly well-sealed, with any restricted gaps found to be filled by moss and general debris.

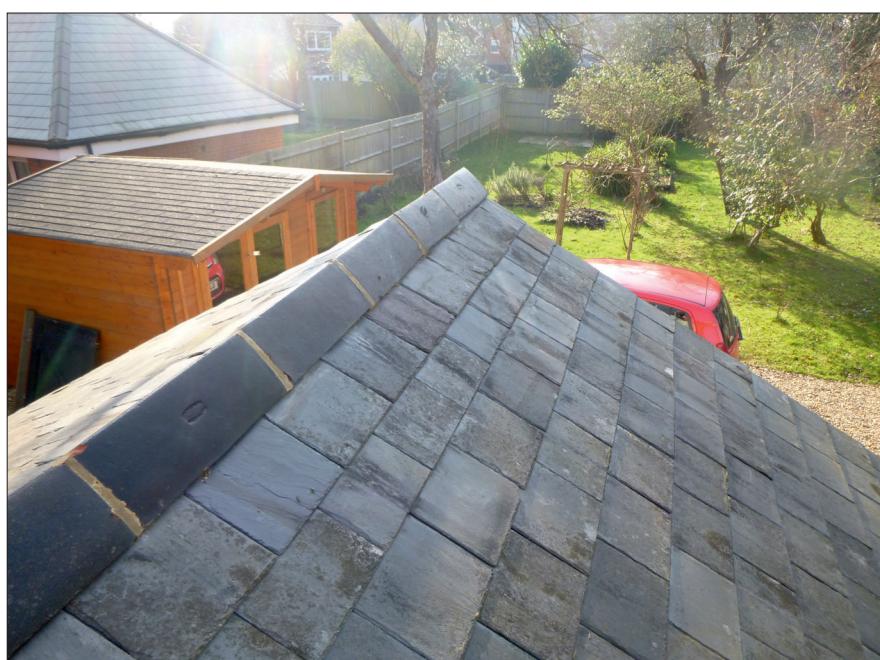
Photograph 3: Showing the close inspection of the roof and ridge tiles on the single-storey rear-extension.

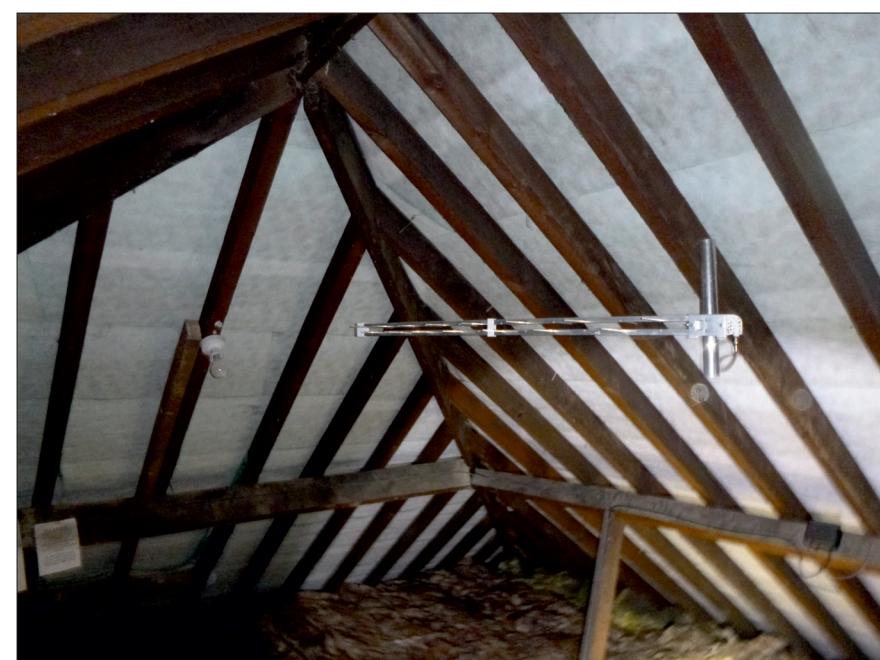
Photograph 4: Showing the single roof space, recorded within the main residential dwelling.

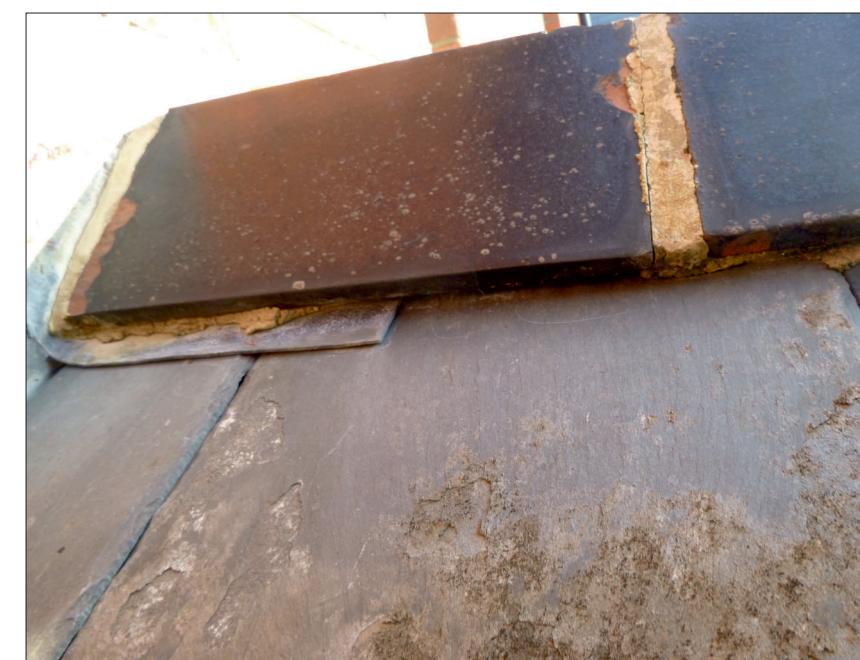
Photograph 8: Showing the well-sealed lead flashing and restricted gap on the single-storey rear extension, thoroughly investigated and found to be shallow and cobwebbed throughout.
