Springfields  
Basingstoke Road  
Spencers Wood  
Berkshire  
RG7 1PH

## Updated Preliminary Roost Assessment

Report ref.: R2710\_UpdPRA\_a

February 2026

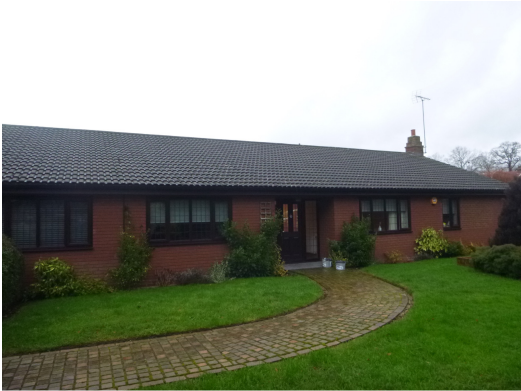
- 5.2.2** The property was a detached bungalow of brick, cavity wall construction with a pitched, gabled roof covered with interlocking concrete tiles; a conservatory was attached to the rear (southern) elevation (**Photographs 1 & 2**).

*Photograph 1. Front of property viewed from north.*

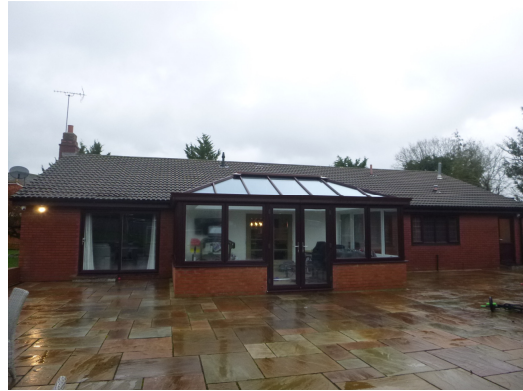
*Photograph 2. Rear of property viewed from south.*

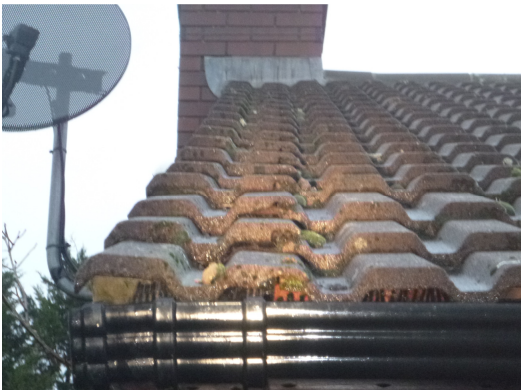
- 5.2.3** The roof was covered in interlocking concrete tiles, which were slightly lifted above the southwest gable where the roof battens were visible (**Photograph 3; Target note 1**). There were also slight gaps under raised tiles around a pipe passing through the roof on the rear elevation that created gaps that could allow potential access for crevice dwelling bats or access for species that principally occupy roof voids (**Photograph 4; Target note 2**).

*Photograph 3. Lifted interlocking tiles with roof battens visible (rear elevation).*

- 7.1.2** The proposals will involve the direct removal of the potential access / crevice roosting features identified across the southwest gable, comprising the lifted roof tiles. As such, the works could therefore lead to direct/indirect disturbance, injury and/or death of bats.

- 8.1.1** An endoscopic inspection of the features along the southwest gable should be carried out to look for evidence of roosting bats and to confirm presence or absence. The work should be carried out by a suitably qualified ecologist, registered under Natural England Class Licence CL18 or above.

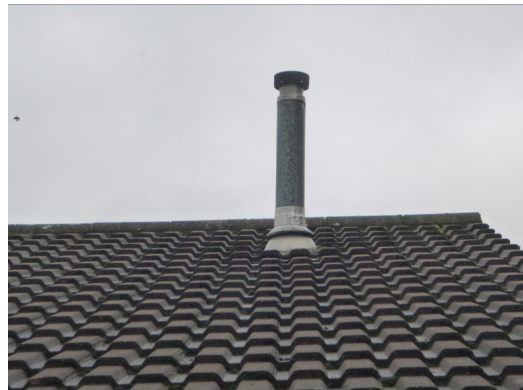
*Photograph 4. Slightly raised tiles around flue (rear elevation).*

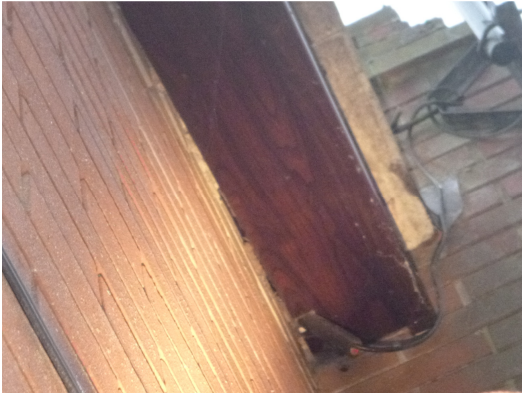
- 5.2.4** Whilst the soffit was sealed to the brickwork across the front and rear elevations, a heavily cobwebbed gap was situated between the soffit and southwest gable (**Photograph 5; Target note 3**). Timbers could also be seen behind the soffits suggesting that the gap was of limited extent. Whilst a slight gap was situated along the

*Photograph 5. Heavily cobwebbed gap between soffit and brickwork gable (southwest elevation).*

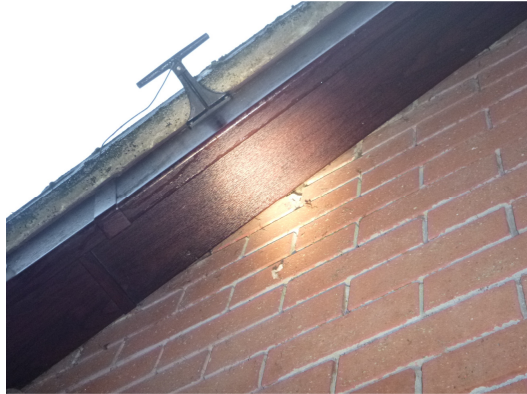
northeast gable, close inspection with a high-powered torch confirmed the feature to be superficial (**Photograph 6; Target note 4**). There was a gap of limited extent beneath the lead flashing at the base of the chimney on the front elevation, which showed no evidence of the presence of bats (**Photograph 7; Target note 5**).

*Photograph 6. Superficial gap within crumbling brickwork (northeast elevation).*

**6.1.2** External features that resemble potential roosting sites/access points that are likely to have sufficient space, shelter, protection, conditions and surrounding habitat to support use by individual or small numbers of small crevice-dwelling bats, such as the locally recorded common pipistrelle (*P. pipistrellus*) were restricted to lifted roof tiles towards the verge on the rear roof elevation (**Photographs 3; Target note 1**). There was a slight gap under lead flashing around the chimney and gaps behind the soffit along the southwest gable (**Photographs 5 & 7; Target notes 3 & 5**). Both features were ruled out as they were considered to be of limited extent. Timbers were visible behind the gap in the soffit along the southwest gable end which was a heavily cobwebbed, and the soffits were open into the loft where no evidence was found internally. The gap in the lead flashing around the chimney was of limited extent. Whilst slight gaps were situated under tiles around a pipe that passed through the roof on the rear elevation, this feature was accessible during the internal survey with no signs of recent or historic use by bats (**Photographs 4 & 11; Target notes 2 & 6**). Furthermore, whilst the brickwork was crumbling at the southeast corner, close inspection with a high-powered torch confirmed this feature to be superficial (**Photograph 6; Target note 4**).

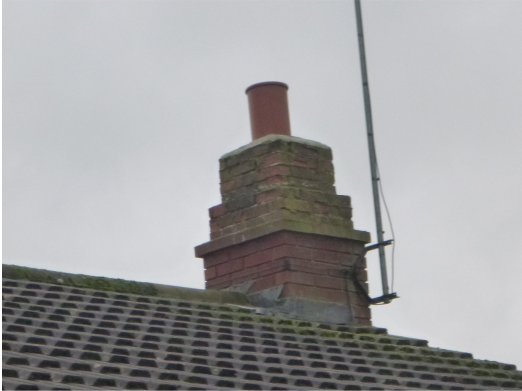
*Photograph. 7 Gap of limited extent under slightly raised chimney lead flashing (front elevation).*

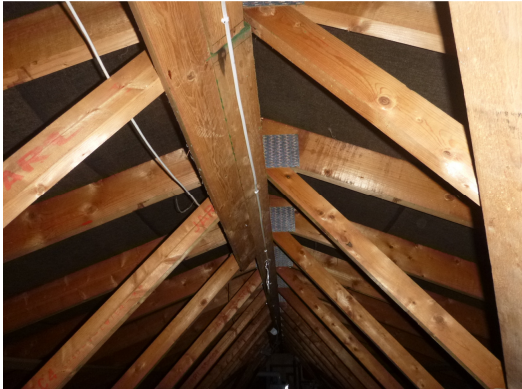
**5.2.5** The roof void was accessible via a first floor loft hatch. A boiler and water tank were mounted to boarding in the void. The void had a floor-to-ridge height of approximately two metres and was of trussed rafter construction (**Photograph 8**). The roof was lined with bitumen and hessian felt, which was intact and tightly fitted (**Photograph 9**); a small section had been replaced with a white breathable membrane where a former chimney had been removed (**Photograph 10**). Gaps in the felt were visible around pipes passing through the roof where the underside of the roof tiles were visible (**Photograph 11; Target note 6**).

*Photograph 8. Roof void of trussed construction.*

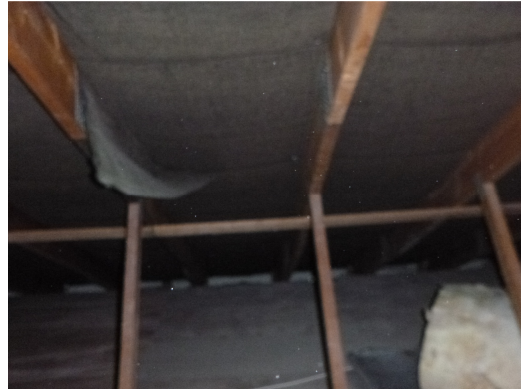
**5.2.6** The floor was boarded throughout and the soffit box was visible at the eaves (**Photograph 9**). The northeast and southwest facing gables had gaps along their edges which were filled with fibreglass insulation (**Photograph 12**). Whilst rodent

*Photograph 9. Roof lining and open soffits (roof void).*

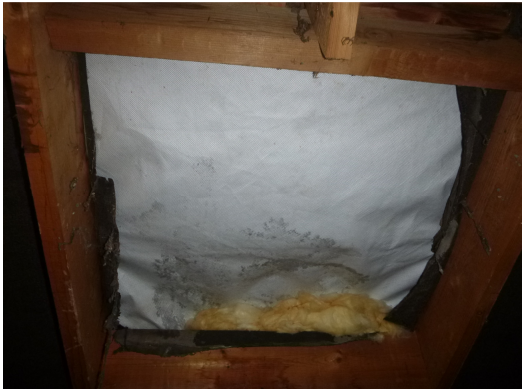
*Photograph 10. Removed chimney replaced by a breathable roofing membrane (roof void).*

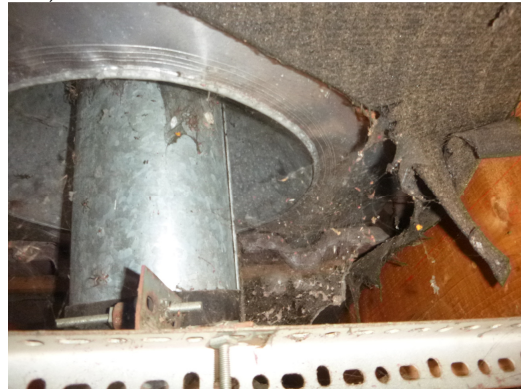
*Photograph 11. Tiles visible around pipe (roof void).*

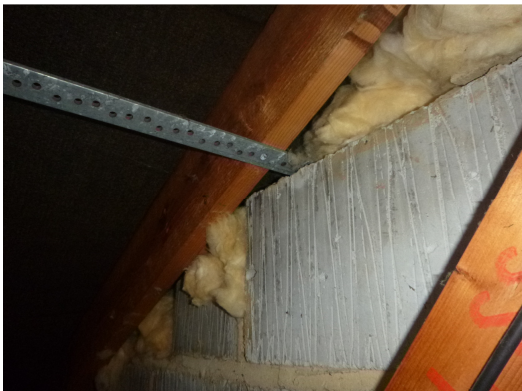
*Photograph 12. Gaps around the edges of the blockwork gables filled with fibreglass (roof void).*

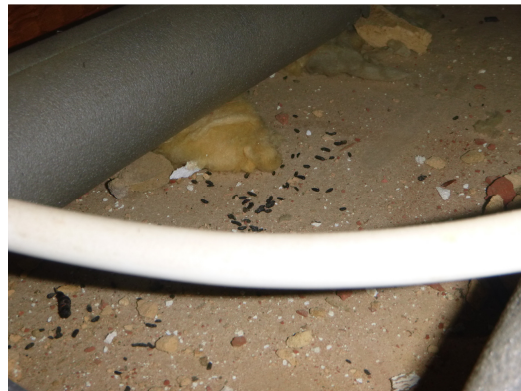
droppings were scattered throughout the void, no evidence of roosting bats was observed inside the roof void (**Photograph 13**).

*Photograph 13. Rodent droppings (roof void).*
