31 Allnatt Avenue,
Winnersh,
RG41 5AU.

PHASE 1 BAT SURVEY (Provisional roost assessment)

September 2025

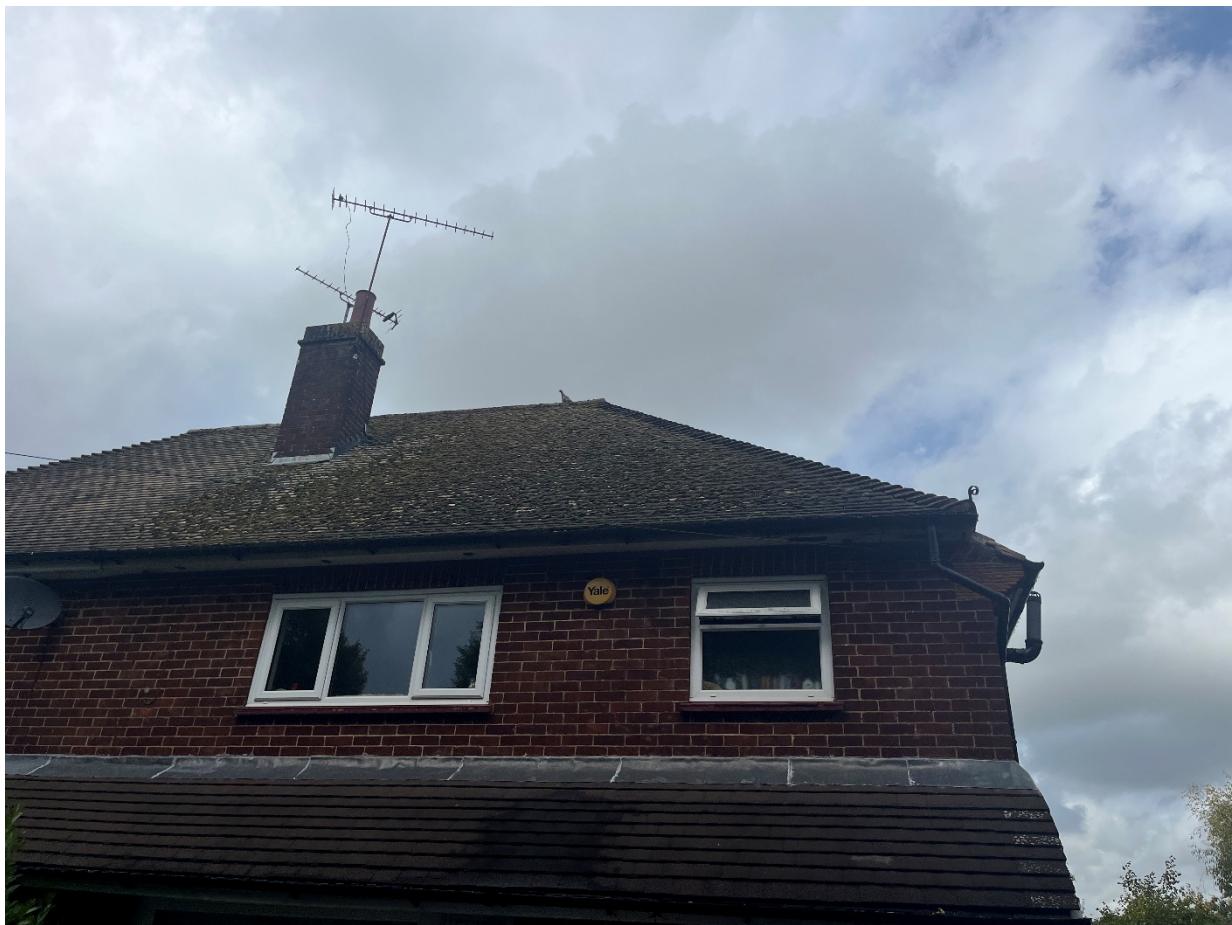
The property is a semi-detached house dating to the mid 20th Century, with plain brick walls and cement tiled roof clay tiles (see figures 3-5). The hipped roof has close fitting tiles and these and the leading and ridge tiles are in good order with no gaps. The eaves are closed off with modern uPVC soffits which are closed off leaving no gaps.

Figure 3. Southern elevations looking north

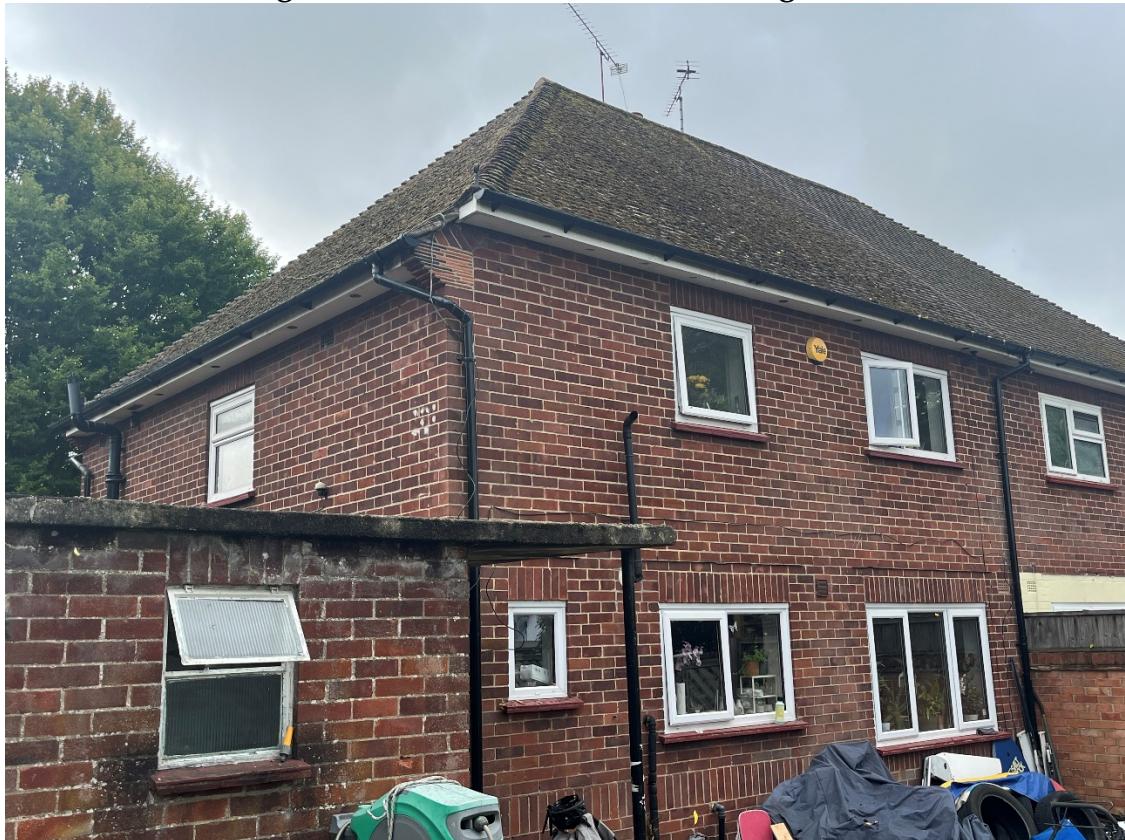
Figure 4. Northern and eastern elevations looking southwest

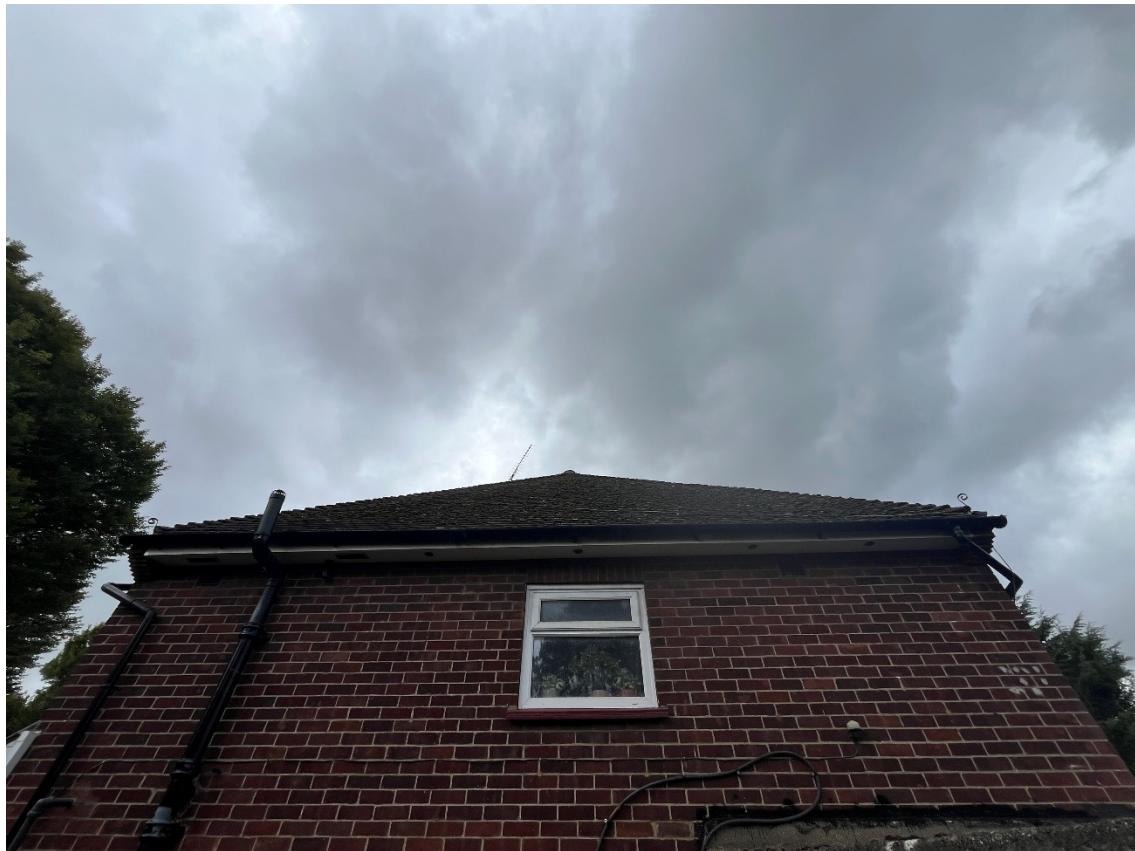
Figure 5. North gable and roof hip looking west

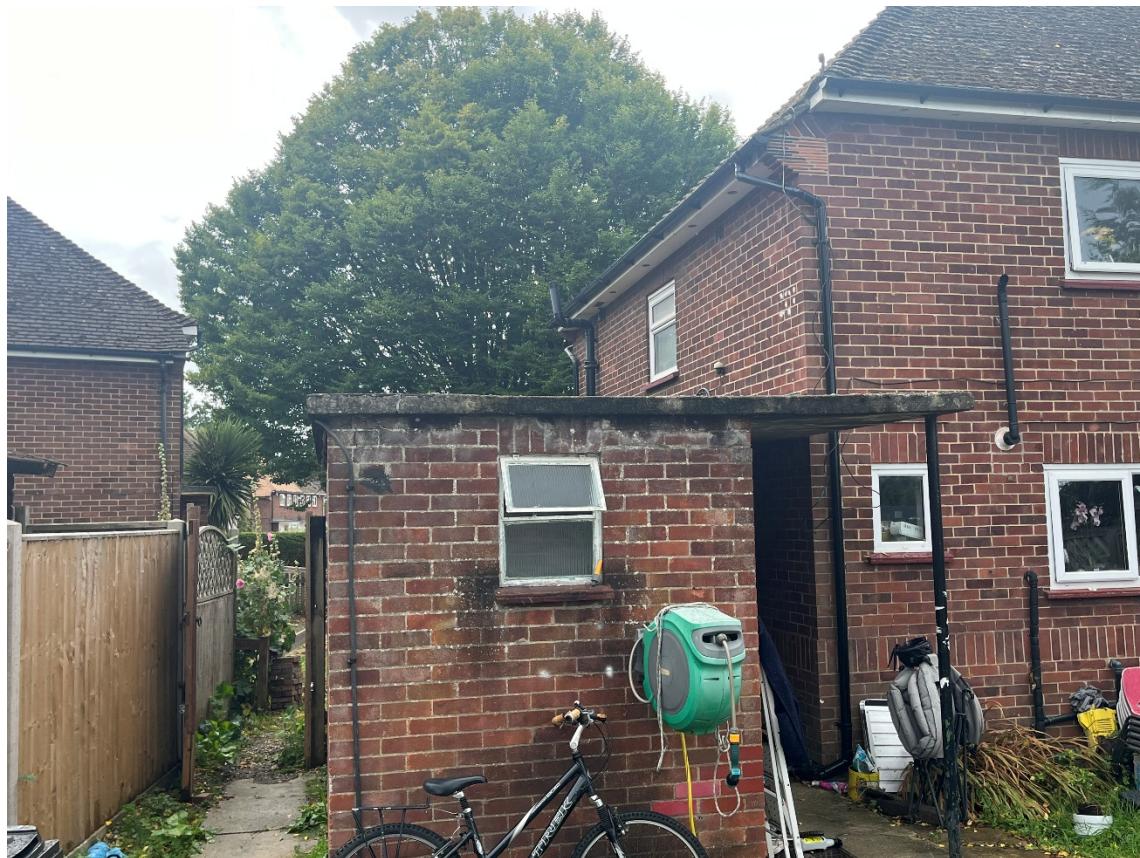
The attached utility room has a flat roof faced with concrete slabs and has an anterior permanently illuminated via sidelights and has negligible potential for bats (see figure 6).

Figure 6. Utility room looking south

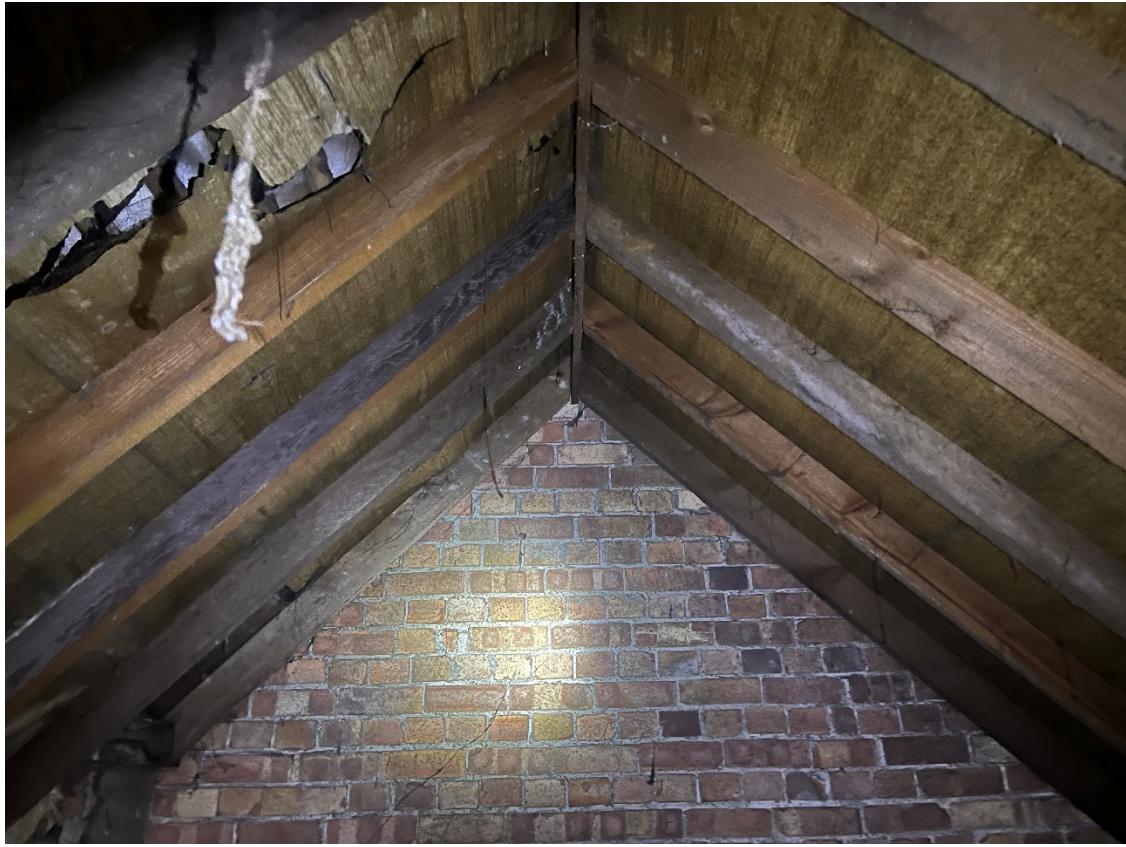
The loft was accessed via a hatch on the landing, and the roof space is open with the roof lined with waxed felting which is in poor order with a few areas where the lining has failed and the tiles visible from within. There were no signs of any bat activity within (see figure 7)

Figure 7. House loft looking west
