23 Fidlers Walk  
Wargrave  
Reading  
RG10 8BA

## Preliminary Roost Assessment

Report ref.: R3035\_PRA\_a

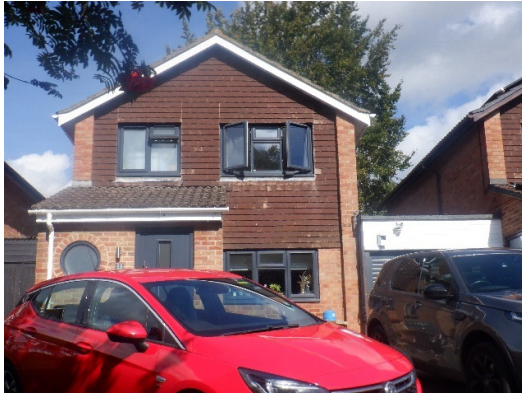
**5.2.2** The property was a link-detached two storey house of brick construction with a pitched roof. There was an attached single storey garage which links to the neighbouring property. There was a single-storey side rear extension connected onto the garage. To the front

there was a single storey porch with pitched roof (**Photographs 1 & 2**).

*Photograph 1. Front elevation, viewed from the south.*

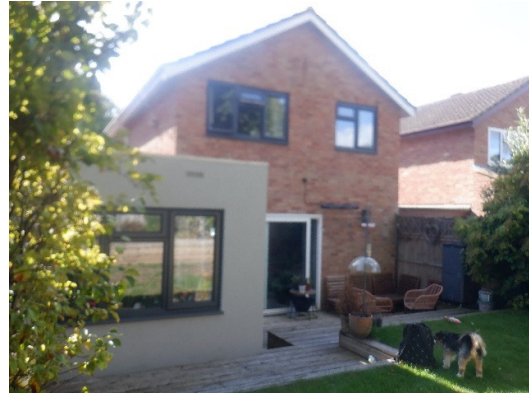
*Photograph 2. Rear elevation, viewed from the north.*

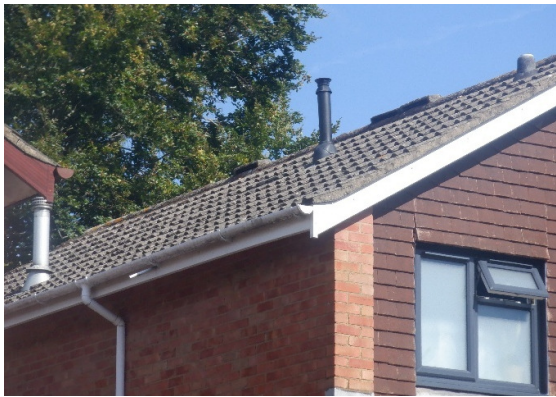
- 5.2.3** The property's pitched roof was covered with interlocking roof tiles that were in place and tightly interlocking. The mortar along the ridge and verge was intact at both the front and rear of the property (**Photographs 3 & 4**).

*Photograph 3. Tight fitting interlocking concrete tiles with tight ridge and verge (front western elevation)*

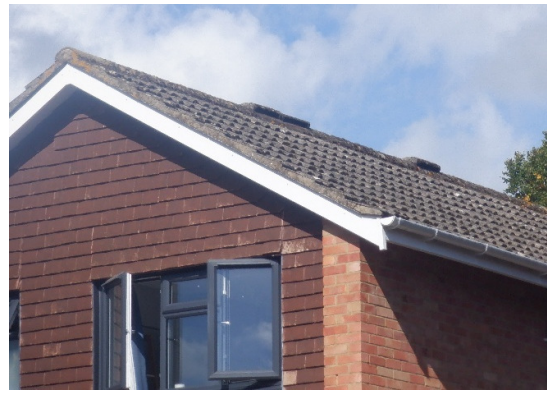
*Photograph 4. Ridge and hip mortar fully intact (front eastern elevation).*

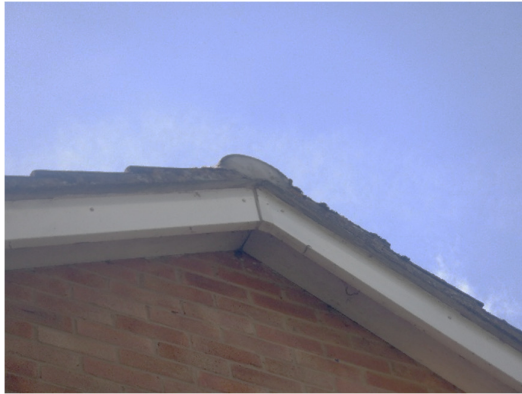
- 5.2.4** There was a minor gap at the apex of the northern gable behind the soffit box, and when closely investigated with a high powered torch showed no visible evidence of use by bats (**Photograph 5; Target note 1**). The soffits were tightly fitted against the brickwork (**Photographs 6**).

*Photograph 5. Minor gap at the apex (rear elevation).*

- 6.1.2** The detached property had the following suitable/potential bat access points and roost features:
- Gap in the apex behind the soffit on the rear elevation (**Photographs 5; Target note 1**);

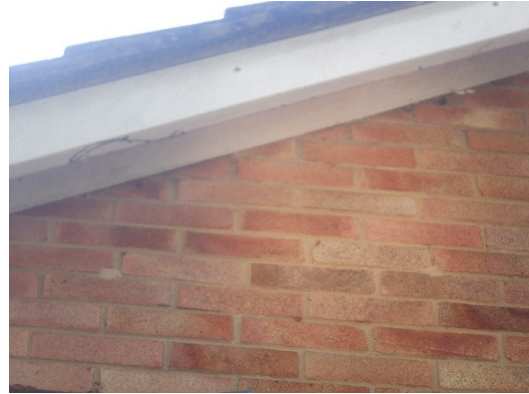
*Photograph 6. Tightly fitted soffits (rear elevation).*

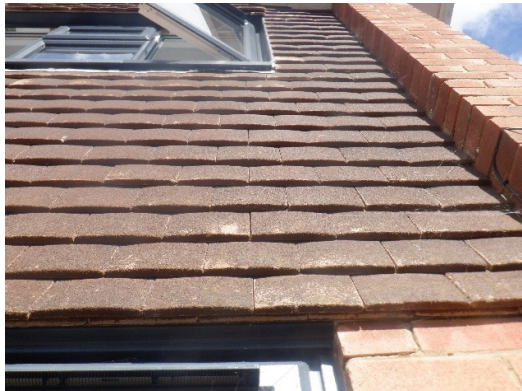
- 5.2.5** The hanging tiles to the front of the property were mostly flat, tightly fitted and in good condition. There was one lifted tile above the first floor window, which was investigated with a high powered torch. The space behind the lifted tile was blocked leaving the crevice open and unsuitable for bats (**Photographs 7 & 8; Target note 2**).

*Photograph 7. Tightly fitted flat hanging tiles (front elevation).*

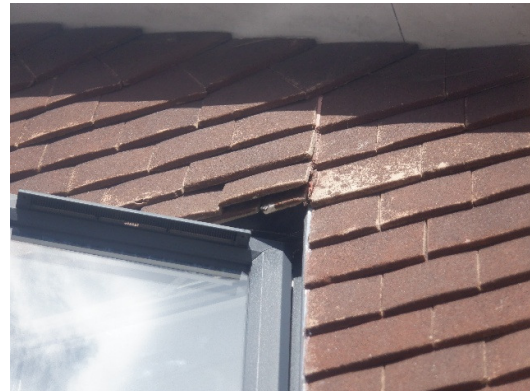
*Photograph 8. Lifted hanging tile above the first floor window (front elevation).*

- A lifted hanging tile and a broken hanging tile, as well as raised lead flashing on front elevation (**Photograph 8, 9 & 10; Target note 2, 3 & 4**);

**6.1.5** The lifted and broken hanging tiles are not due to be impacted by the proposed plans, and furthermore the space under the tiles were inspected and shown to be of limited extent with inadequate space and conditions for roosting bats.

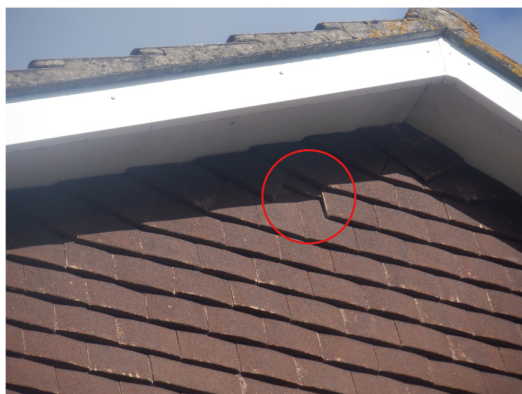
- 5.2.6** There was one broken hanging tile towards the apex of the front gable, although broken it was still in place and did not lead to a suitable crevice (**Photograph 9; Target note 3**). The lead flashing against the first floor windows was also slightly lifted, however deemed unsuitable when investigated with a high powered torch (**Photograph 10; Target note 4**).

*Photograph 9. Broken hanging tile with no crevice (front elevation).*

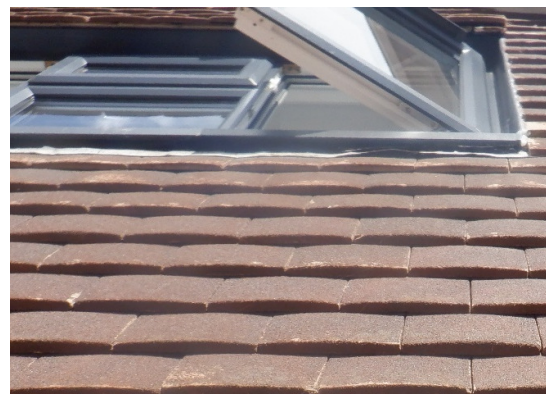
*Photograph 10. Lifted lead flashing (front elevation)*

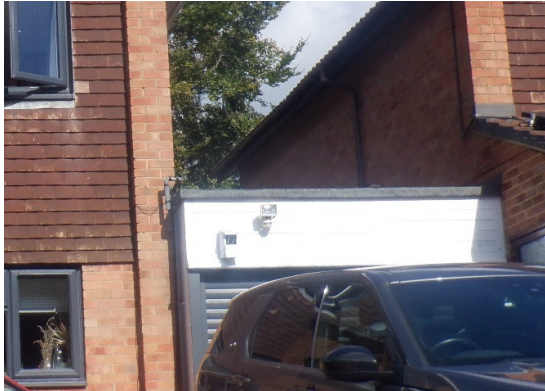
- 5.2.7** The garage had a tightly fitted flat roof covered with bitumen felt with tightly fitted uPVC cladding along the front (**Photographs 11**). To the rear the building was rendered (**Photographs 12**).

*Photograph 11: Linked garage with uPVC cladding (front elevation)*

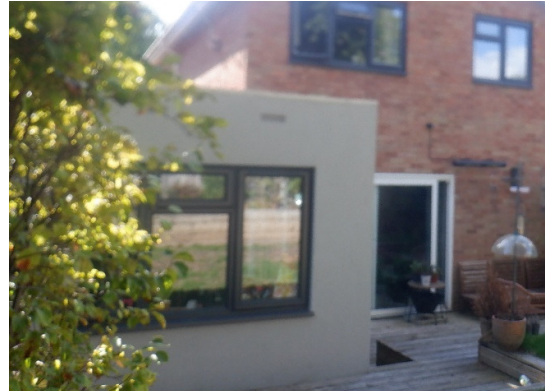
*Photograph 12. Rendered extension to the garage (rear elevation).*

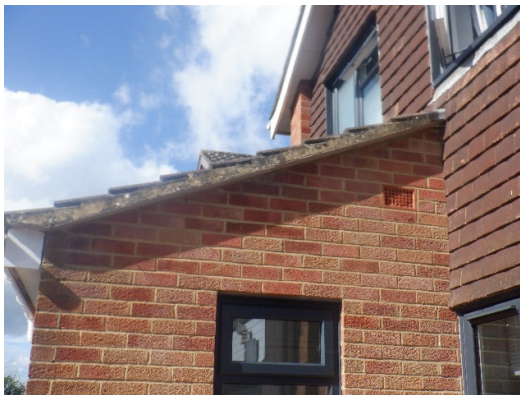
- 5.2.8** To the front the porch had a small pitched roof. The verge mortar was in good condition and the roof tiles were tightly interlocked (**Photograph 13 & 14**). The lead flashing which ran along the top of the porch roof and the hanging tiles was cobwebbed with mortar underneath. The gaps were inspected and didn't lead into any suitable crevice for roosting bats (**Target note 5**).

*Photograph 13: Porch verge mortar (eastern elevation)*

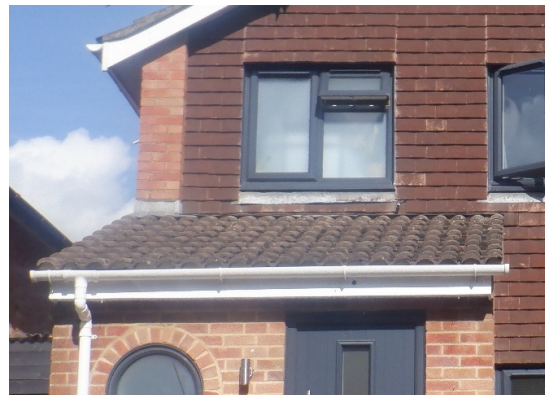
*Photograph 14. Flat interlocking porch tiles and top lead flashing (front elevation).*

- Raised lead flashing along the top of the porch (**Photographs 14; Target notes 5**);
  - Torn bitumen roof lining internally around 3 historic flue pipes (**Photograph 16 & 17; Target note 6**); and

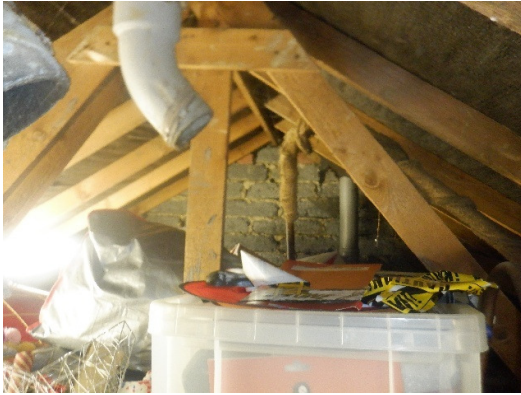
- 5.2.9** The building had one roof void that covered its second-storey footprint and was accessible via a first-floor loft hatch. The void was of 'cut and pitch' construction with a ridge beam, rafters and supporting trusses, and had an approximate floor-to-ridge height of 1.5 metres

*Photograph 15. Roof void showing 'cut and pitch' construction.*

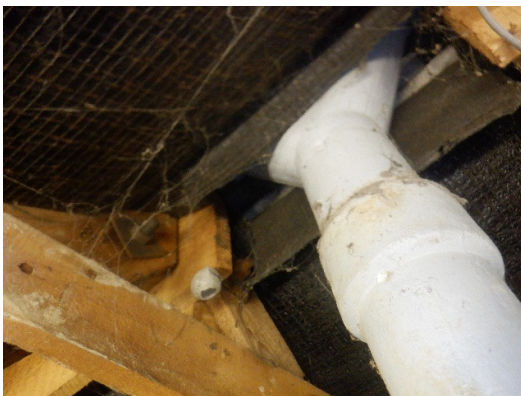
- 5.2.10** The roof was lined with a hessian-reinforced bitumen felt. It was mostly intact with occasional openings surrounding the three old flue pipes which were internally blocked (**Photograph 16 & 17; Target note 6**). The floor was boarded and insulated with fibreglass, which filled the eaves (**Photograph 18**).

*Photograph 16. Loosely fitted bitumen felt along the ridge*

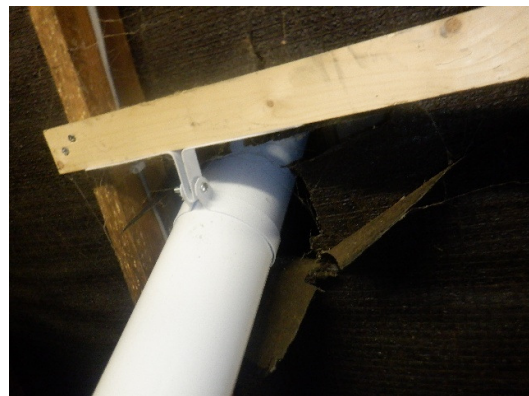
*Photograph 17. Torn bitumen felt along the ridge*

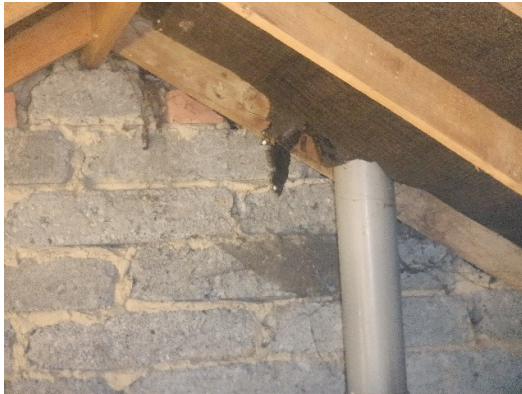
- 5.2.11** Both the northern and southern gables had some small gaps in the blockwork, but no

daylight was visible and both were also cobwebbed. There was a small wasps' nest, but no evidence of bats or rodents (**Photographs 19 & 20; Target notes 7**).

*Photograph 19. Small gaps in blockwork, heavily cobwebbed (southern elevation)*

- Gaps internally in gable end blockwork (**Photograph 19 & 20; Target note 7**).
- 6.1.3** No droppings were observed within the house's roof void of the building, which had features such as loose felt that could allow bats in, and some missing blockwork at the gable ends. Therefore it is unlikely to support principally void-dwelling species, such as the locally recorded brown long-eared (*Plecotus auritus*).

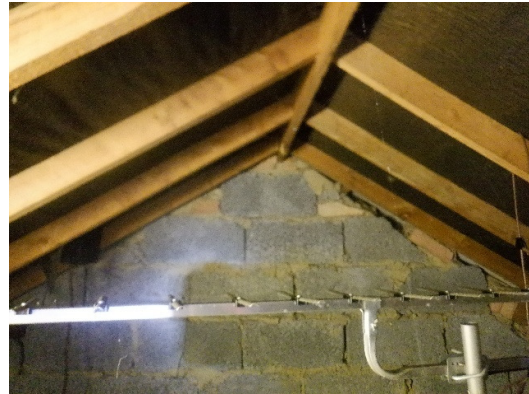
*Photograph 20. Small gaps in blockwork (northern elevation)*
