338 Barkham Road  
Wokingham  
Berkshire  
RG41 4DE

## Preliminary Roost Assessment

Report ref.: R2876\_PRA\_a

**March 2025**

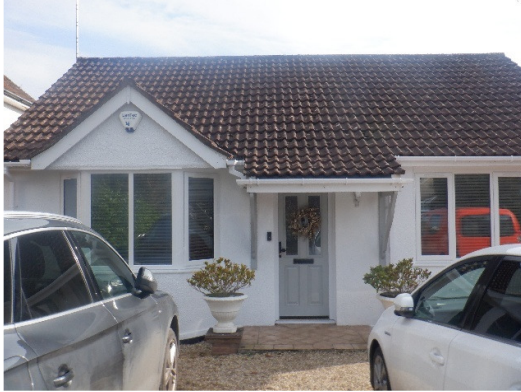
- 5.2.1** The property was a detached brick built residential dwelling with hipped roof rear extension and pitched roof extension to the front (**Photographs 1 - 2**).

*Photograph 1. Front of the bungalow viewed from the north.*

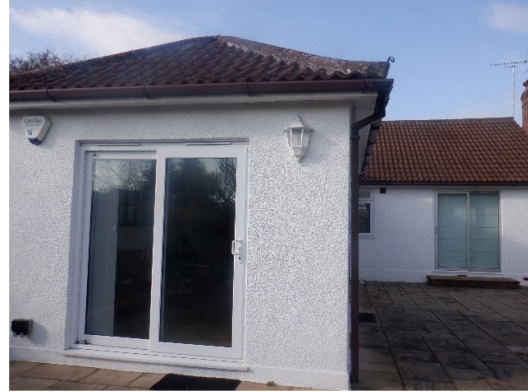
*Photograph 2. Rear of the bungalow viewed from the south.*

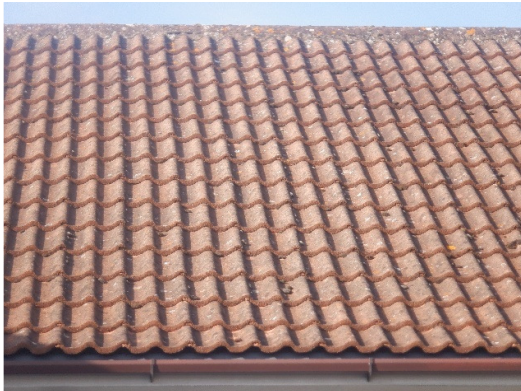
- 5.2.2** The interlocking roof tiles were flat and intact throughout. The ridge and hip tiles, and mortar beneath were intact (**Photographs 3 & 4**). Mesh was present at the base of the roof tiles (**Photograph 5**).

*Photograph 3. Interlocking and intact roof tiles.*

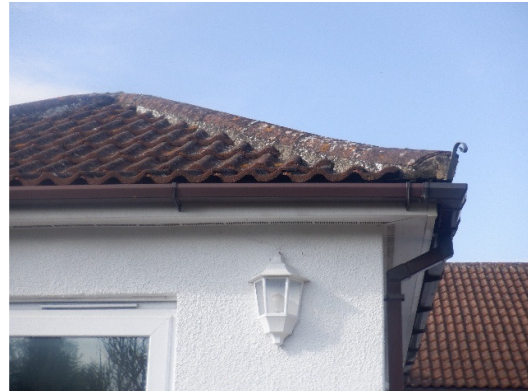
*Photograph 4. Ridge and hip tiles mortared.*

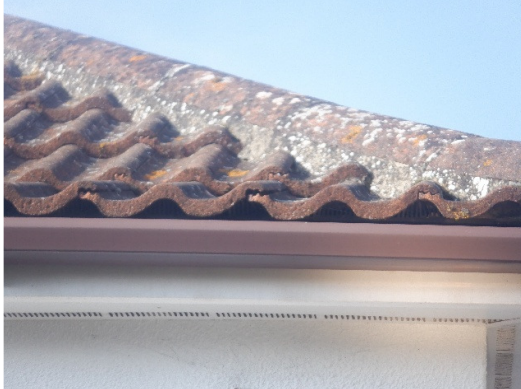
*Photograph 5. Mesh present at the base of the roof tiles.*

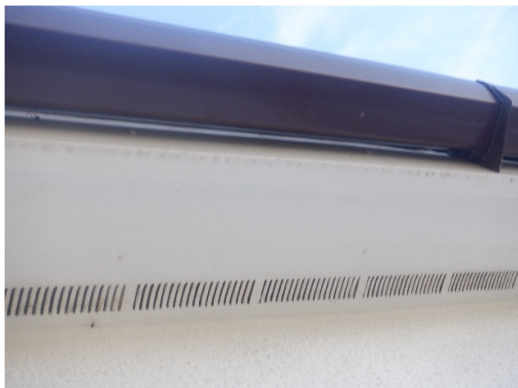
- 5.2.3** The uPVC soffits were mostly tight to the rendered walls and the fascias and barge

*Photograph 6. uPVC soffits tight at the eaves.*

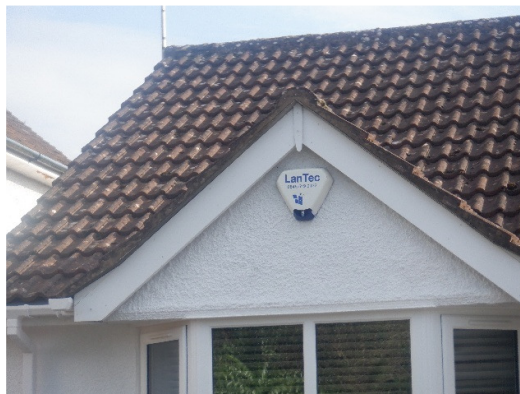
boards were tight on the front gable end and around the western facing gable end (**Photographs 6, 7 & 8**). A gap was present along the timber soffits at the eastern facing gable end, which on close inspection was superficial only with timber visible behind (**Photograph 9; Target note 1**).

*Photograph 7. Fascia tight to the rendered walls at the gable end to the front of the bungalow.*

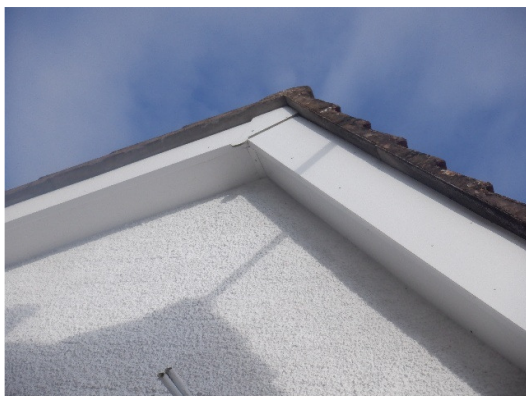
*Photograph 8. Fascia tight to the rendered walls at the gable end to the western side of the bungalow*

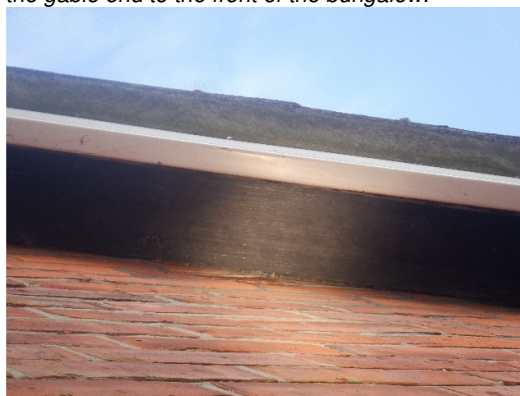
*Photograph 9. Superficial gap behind soffit at the eastern side of the bungalow.*

6.1.1 The property had a potential bat access point in the form of a slight gap behind the timber barge board (**Photograph 9; Target note 1**).

6.1.3 The potential bat access point was inspected and found to be superficial only, and therefore did not lead to crevice roost sites within the soffit box and cavity wall, or between the roof tiles and roofing membrane which would provide sufficient space, shelter, protection and conditions for opportunistic use by individual crevice-dwelling bats, such as the locally recorded common pipistrelle (*Pipistrellus pipistrellus*) and soprano pipistrelle (*pipistrellus pygmaeus*) bats. Therefore, the property has been assigned negligible potential suitability for bats overall (see **Appendix 1** for potential suitability categories).

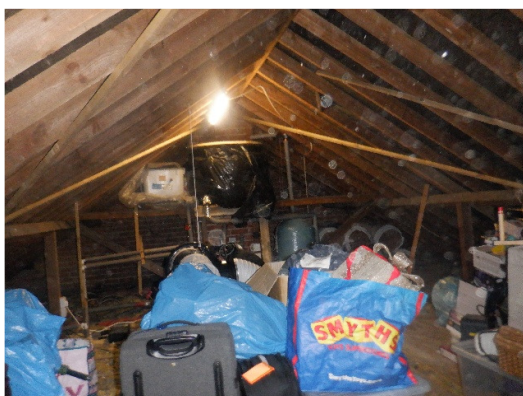
- 5.2.4** The building had one roof void covering the two-storey footprint of the bungalow. The space had a maximum height of approximately 2.5 m and was lined with bitumen reinforced liner which was intact and tight (**Photographs 10 & 11**). The ridge was lightly cobwebbed. An old chimney stack was present which had been partially removed from the roof (**Photograph 12**).

Photograph 10. Internal view of the roof void.

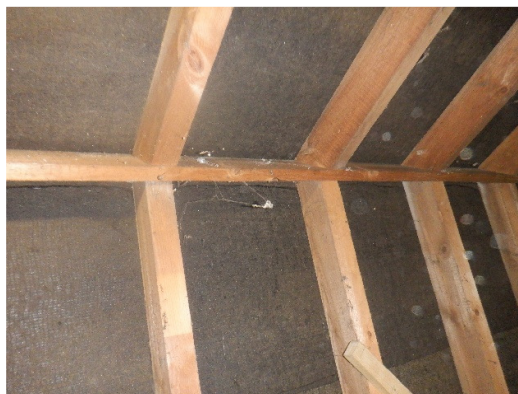
Photograph 11. Intact roofing felt..

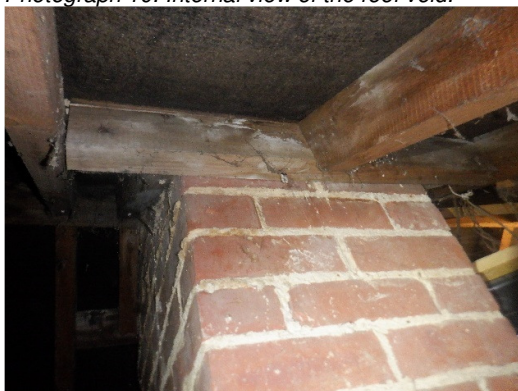
Photograph 12. Old chimney stack.

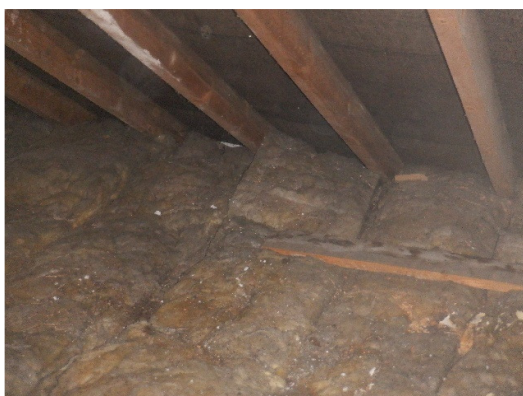
**5.2.5** The floor was covered in fibreglass insulation which filled the eaves along the front but did not go as far as the eaves which were open into the soffit box along the rear elevation (**Photographs 13 & 14**). The brickwork at the gables was intact with some gaps around the edges however no daylight visible, and they were heavily cobwebbed with a few small old wasp nests present (**Photograph 15; Target note 2**).

Photograph 13. Eaves filled to the front of the bungalow.

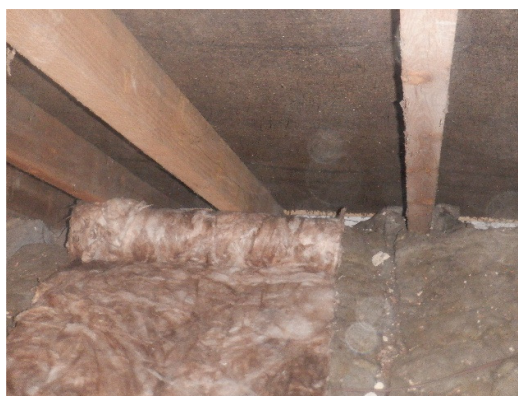
Photograph 14. Eaves open to the rear of the bungalow.

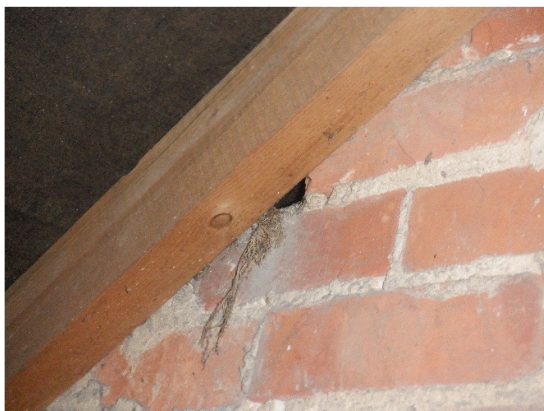
*Photograph 15. Slight gaps around brickwork around the gable end.*
