## **BS 5837:2012 TREE SURVEY FOR 109 BEAN OAK ROAD WOKINGHAM**

**Prepared on behalf of:  
Mr H Basra  
109 Bean Oak Road  
Wokingham  
RG40 1RJ**

**Ref: SPH/5837-25/10.02**

**14 February 2025**

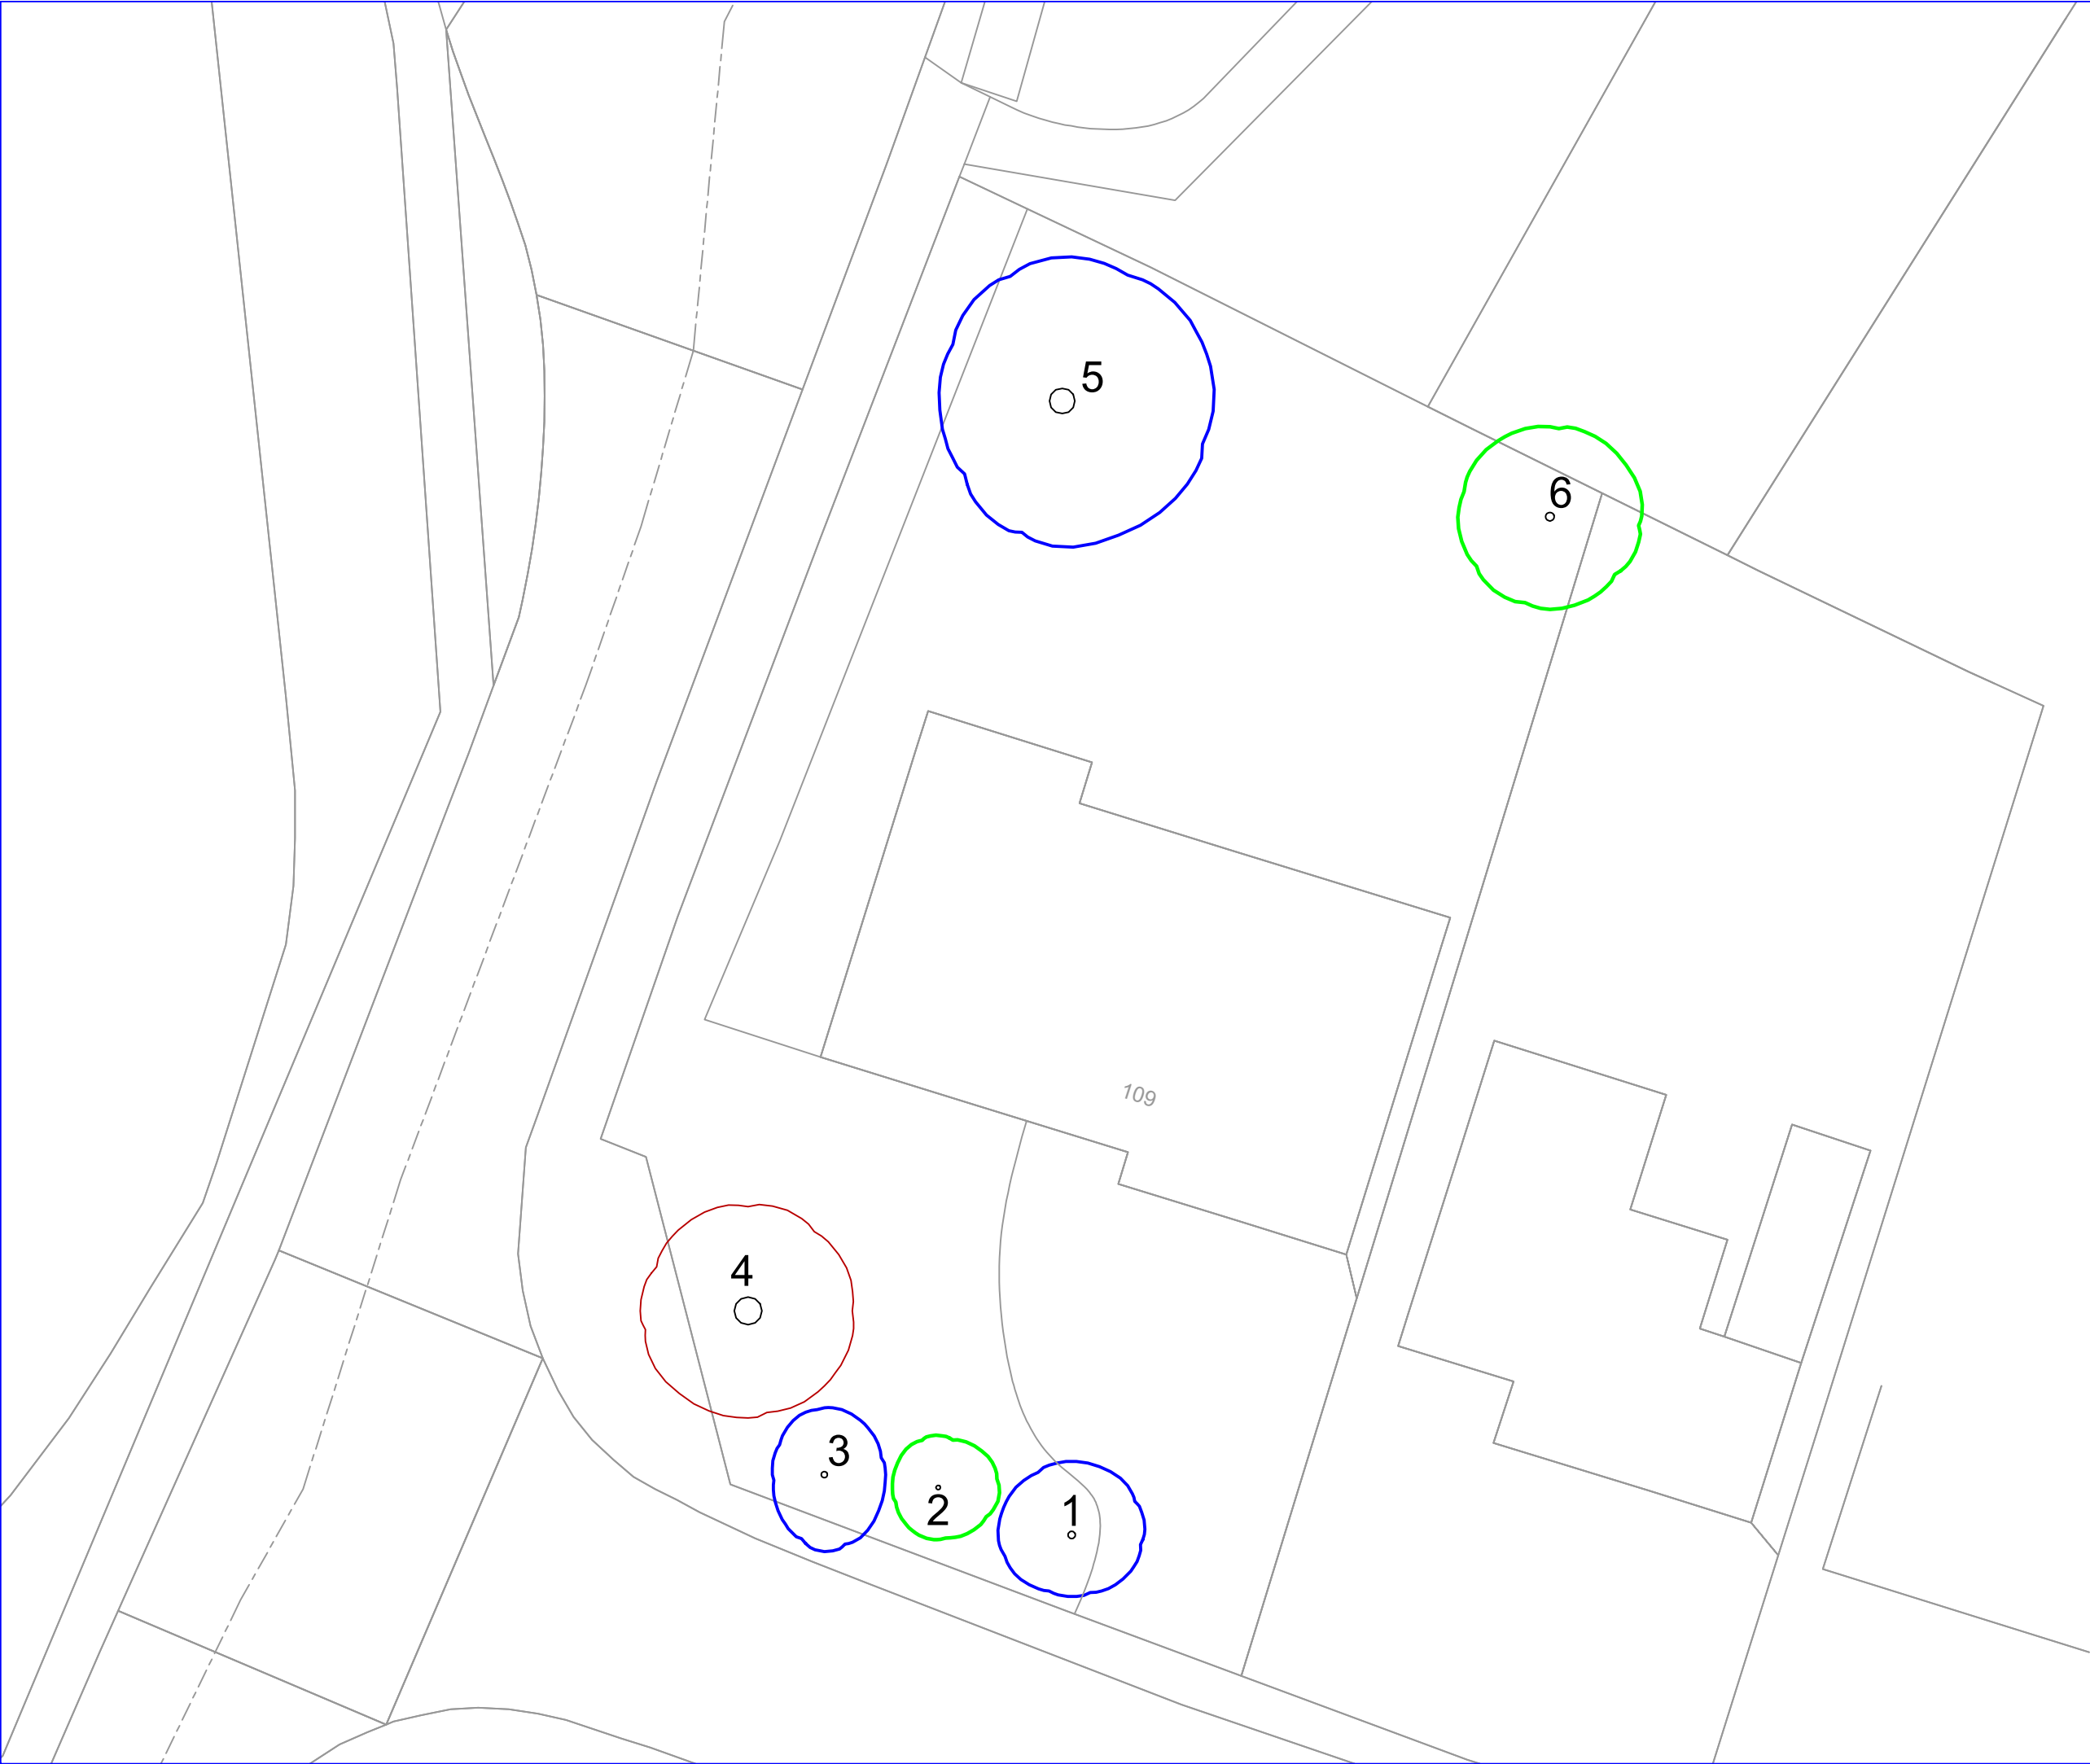
| Drg. No. | SPH/5837-25/10.02 | | Rev. |

- 3.2.2 For ease of identification the trees are shown on the tree location drawing ref SPH/5837-25/10.02 and have been allocated a tree number. These numbers are cross-referenced within the BS 5837:2012 survey schedule.

| Drawing Title | TREE LOCATION PLAN | | |

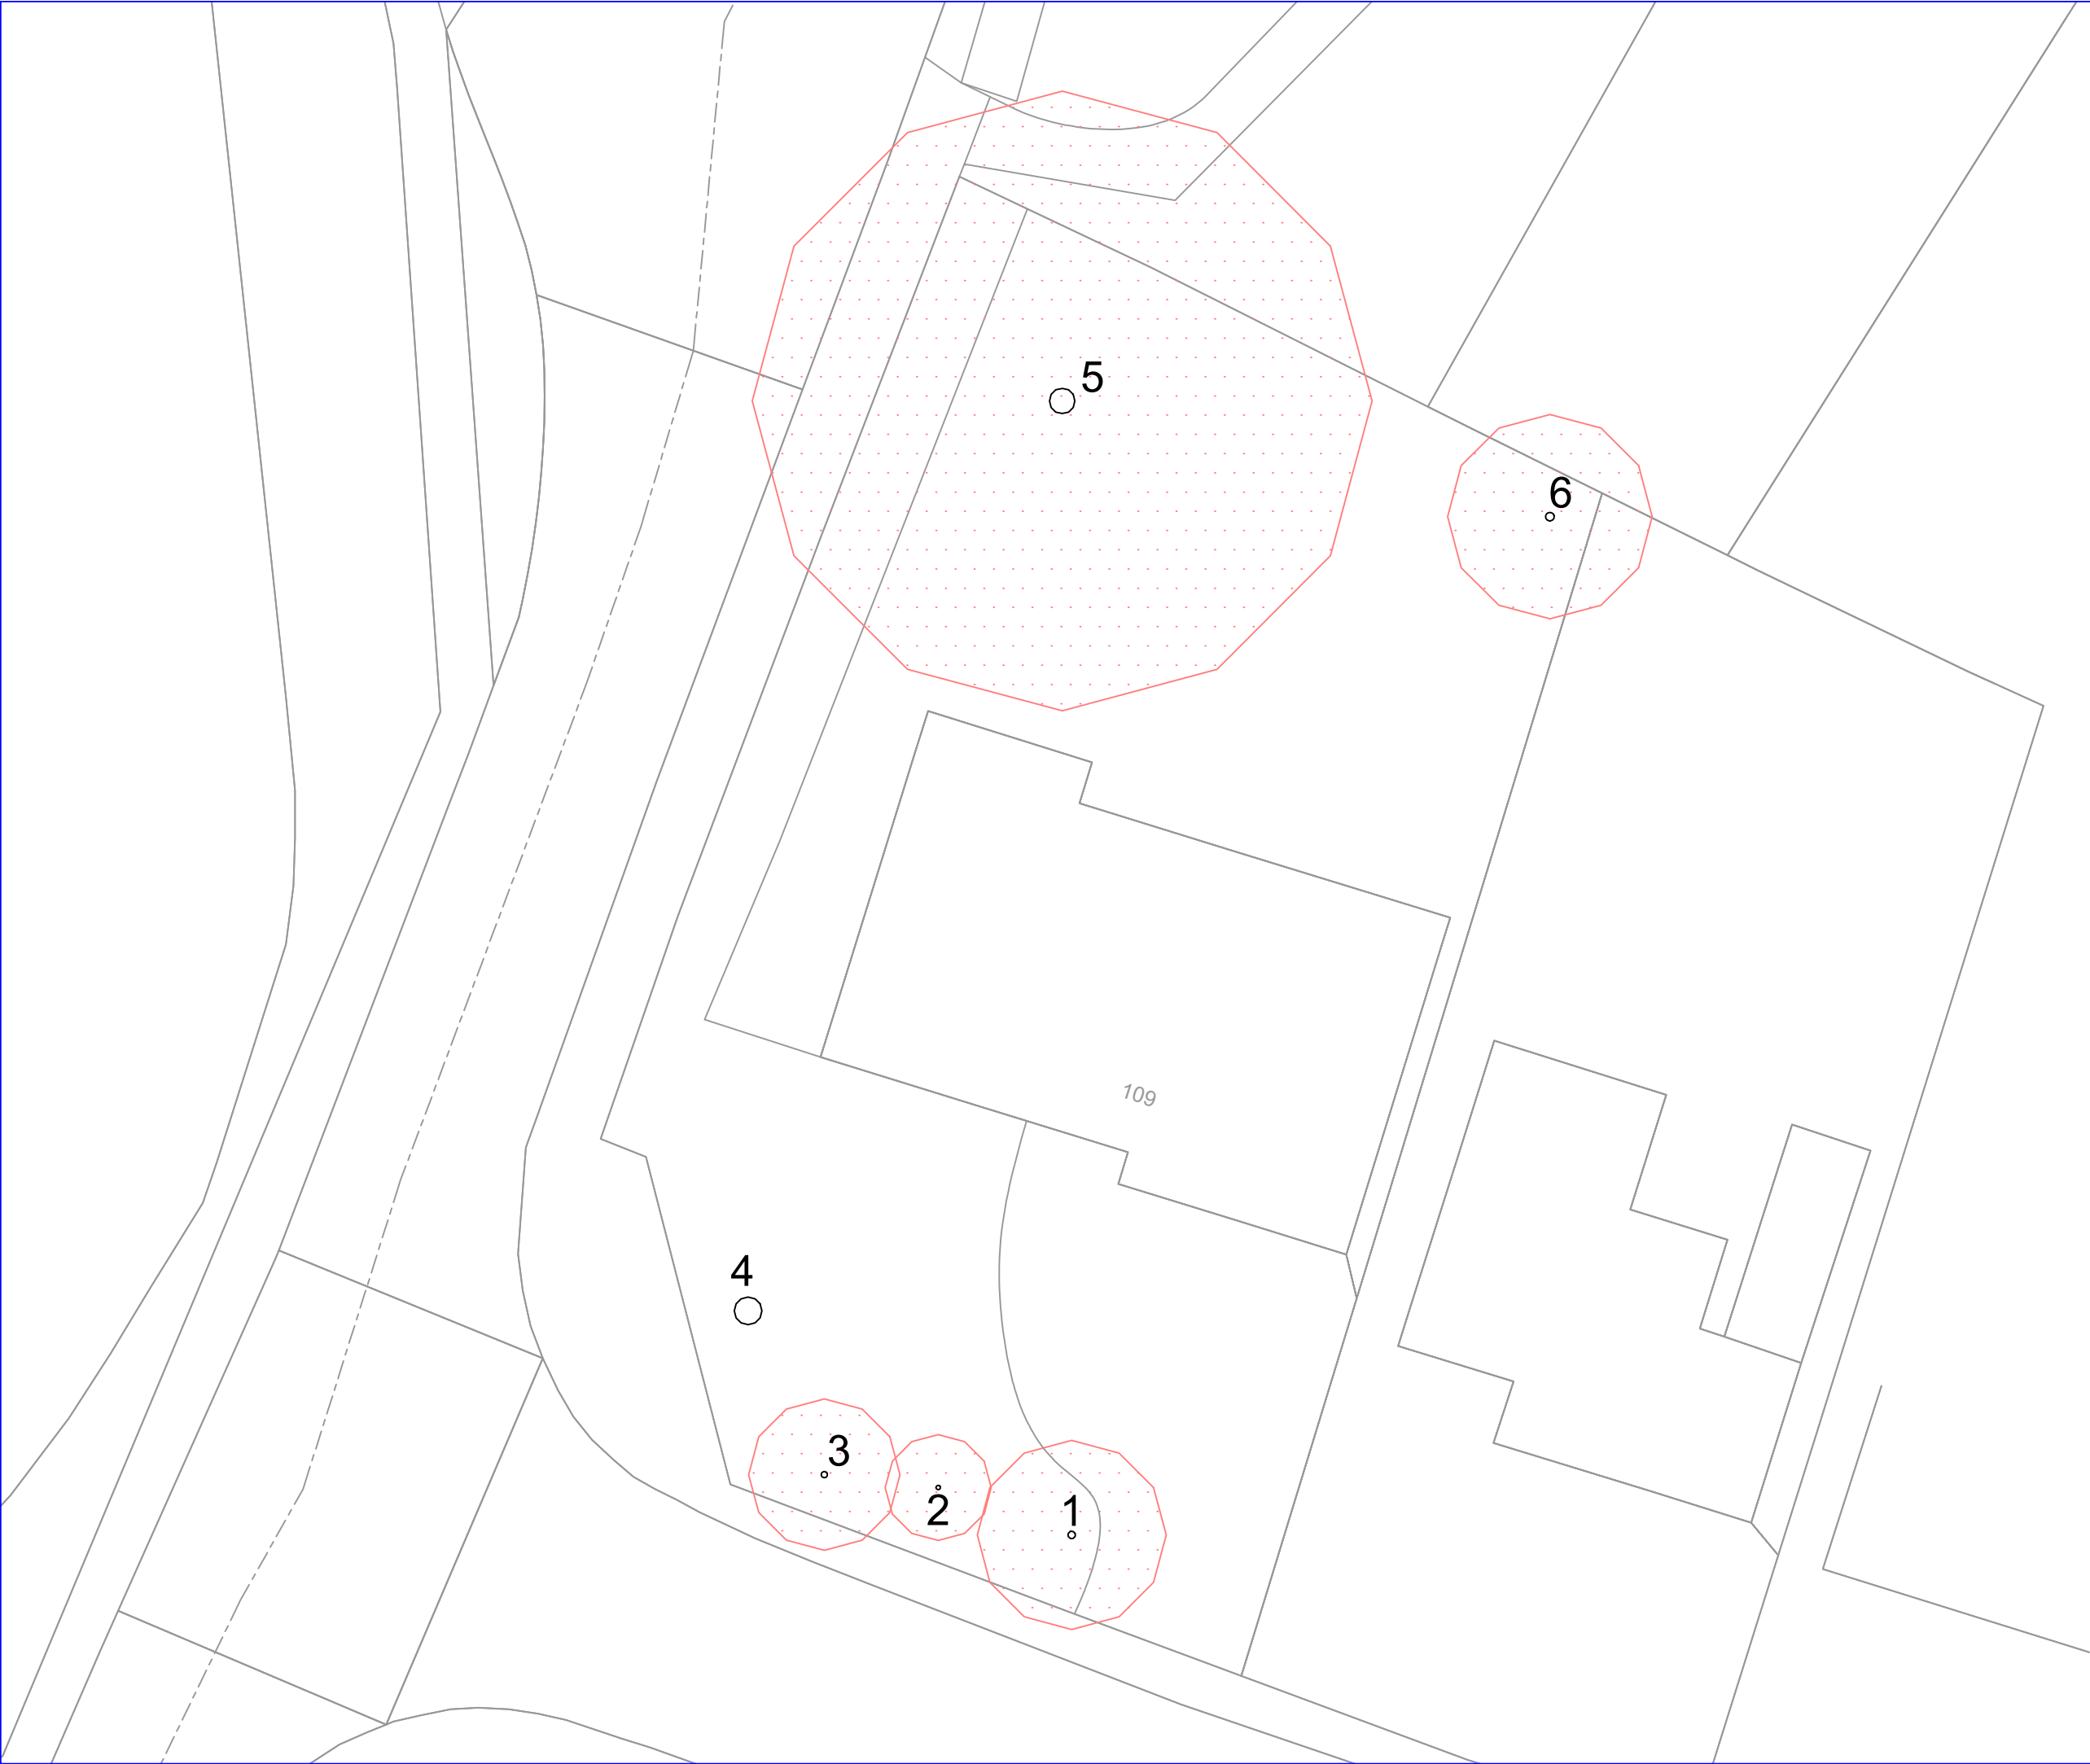
| Drg. No. | SPH/RPA-25/10.02 | Rev. | |

- 4.2.1 Using BS 5837:2012 the RPA has been calculated for the trees by reference to section 4.6.1 (a) and/or (b). The RPA is frequently described as a circle with a radius of prescribed distance within which no unspecified activity should occur and a high level of care is needed during any activities that are authorised within them, if it is to be successfully retained.

- 4.2.2 Specified intrusions into the RPA can take place only where the ground is adequately protected in accordance with the requirements of section 6 (6.2.3.3) of the BS or as may be agreed with the Local Planning Authority (LPA). The RPAs have been plotted as dodecagons taking account of the site constraints on drawing SPH/RPA-24/10.02.

| Drawing Title | ROOT PROTECTION AREA PLAN | | |

- 5.1 To protect the retained trees from construction activities, they must be protected by suitable protection barriers and ground protection; the accompanying root protection area drawing shows the RPA.
- 5.2 The tree protection barrier (TPB) is designed to provide construction exclusion zones around the RPA of the trees to be retained.
- 5.3 The tree protection fencing should be fit for the purpose of excluding construction activity and appropriate to the degree and proximity of work taking place around the retained tree. The default specification for protective barriers is that specified in BS 5837:2012 Figure 2, section 6; and is reproduced at Appendix 5. All weather signs must be attached by cable ties to each Heras panel as set out in Appendix 6.

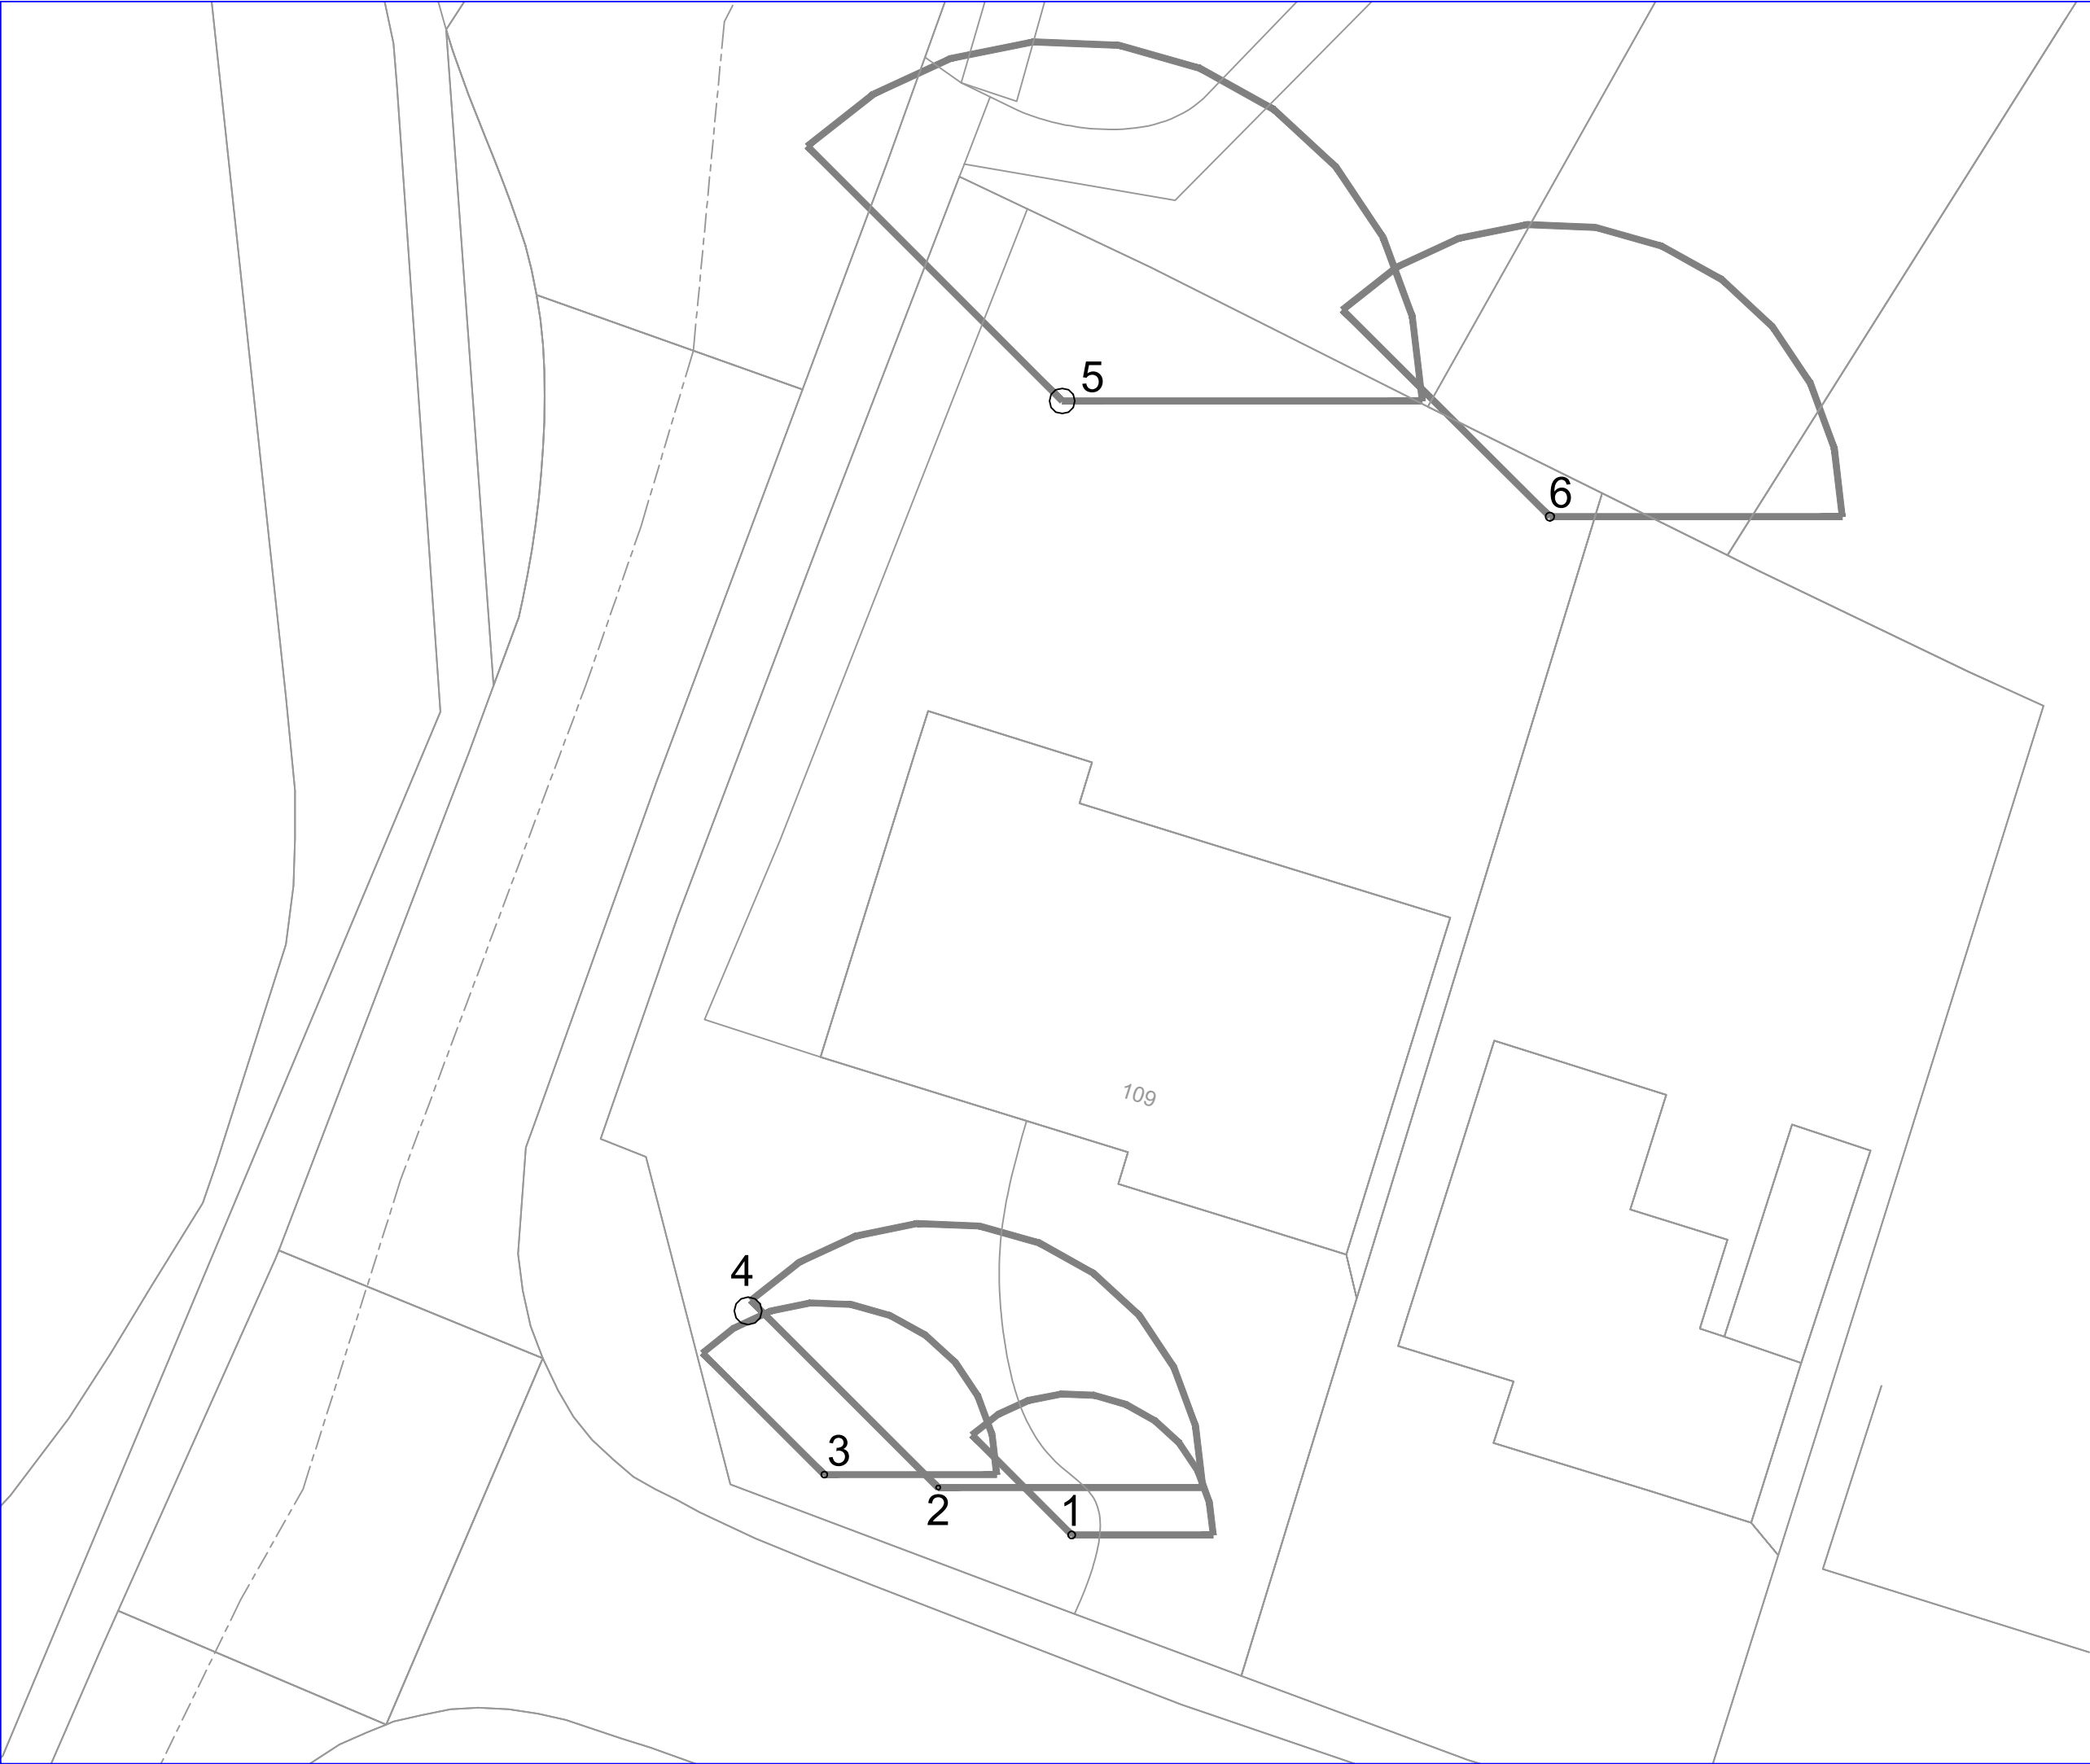
| Drg. No. | SPH/SC-25/10.02 | | Rev. |

- 4.3.1 Large trees that cast dense shade may result in pressure to prune or remove them. Whilst either shade or sunlight might be desirable depending on the potential use; the design should avoid unreasonable obstruction of light. The shade constraints posed by the trees are plotted onto drawing ref SPH/SC-25/10.02.

| Drawing Title | SHADE CONSTRAINTS PLAN | | |

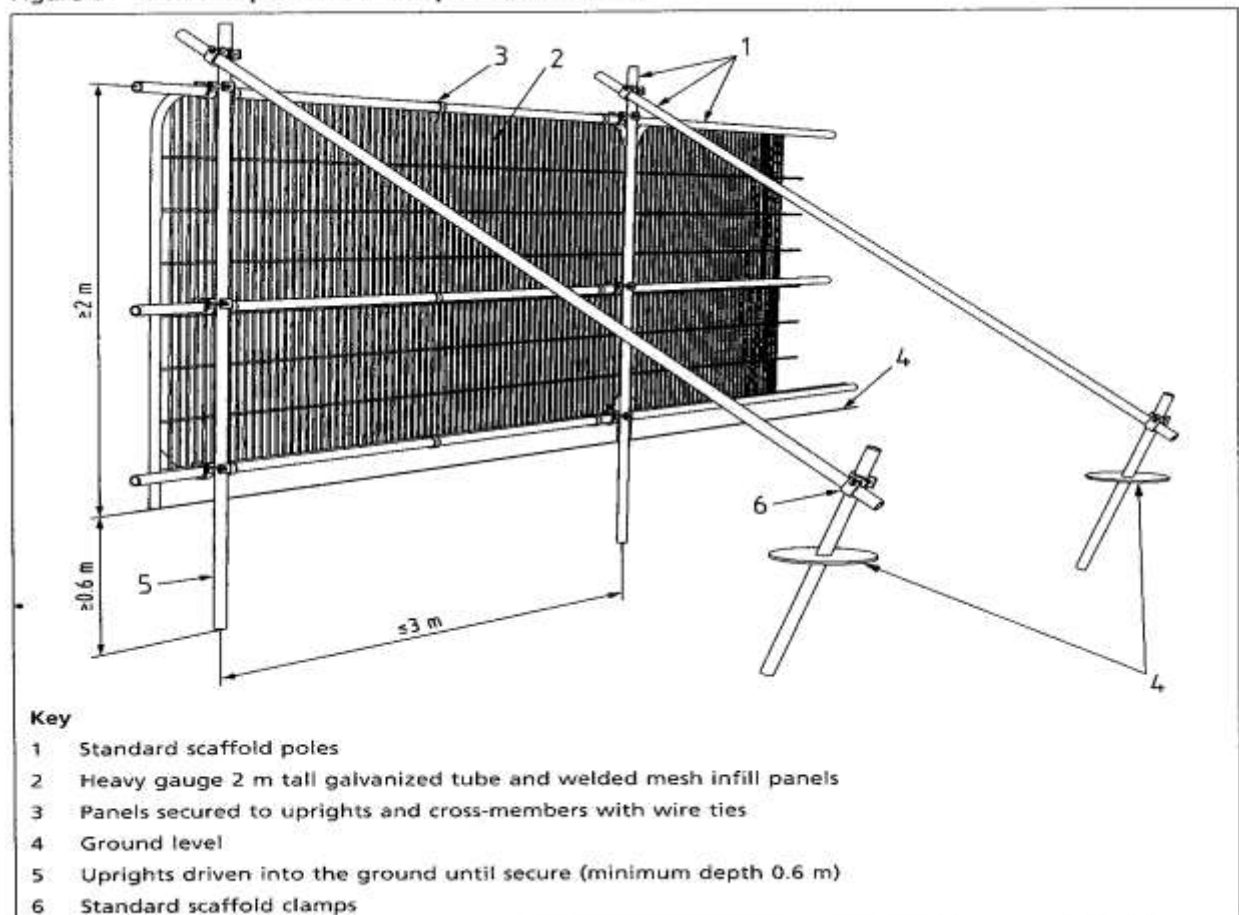
Figure 2 Default specification for protective barrier

**Root Protection Areas (RPAs), enclosed by Default Temporary Protective Fencing, as detailed below and to be agreed with the Local Planning Authority (LPA), shall:**

1. Be protected throughout the development process, as specified and detailed in BS 5837:2012 Section 6.2, Fig 2
2. Be erected prior to any construction, demolition or excavation works and remain in place for the duration of the project.
3. Preclude any delivery of site accommodation and or materials and or plant machinery.
4. Preclude all construction related activity, with the sole exception of specified arboricultural works and any other works carried out under supervision that has been agreed by all parties, and:
5. Preclude the storage of all development related materials and substances including fuel, oils, additives, cement and or any other deleterious substances.
6. Any incursions into RPAs must be by prior arrangement, following consultation with the LPA.
