# ROAVR | GROUP

**Project:** 25\_5837\_01\_24  
**Site:** Chilterns, Thames Drive, Charvil, Reading, RG10 9TP  
**Client:** Lauren Lewis & Alex Bailes

| Report Type: | Tree survey, arboricultural impact assessment, and arboricultural method statement |

# Arboricultural impact assessment

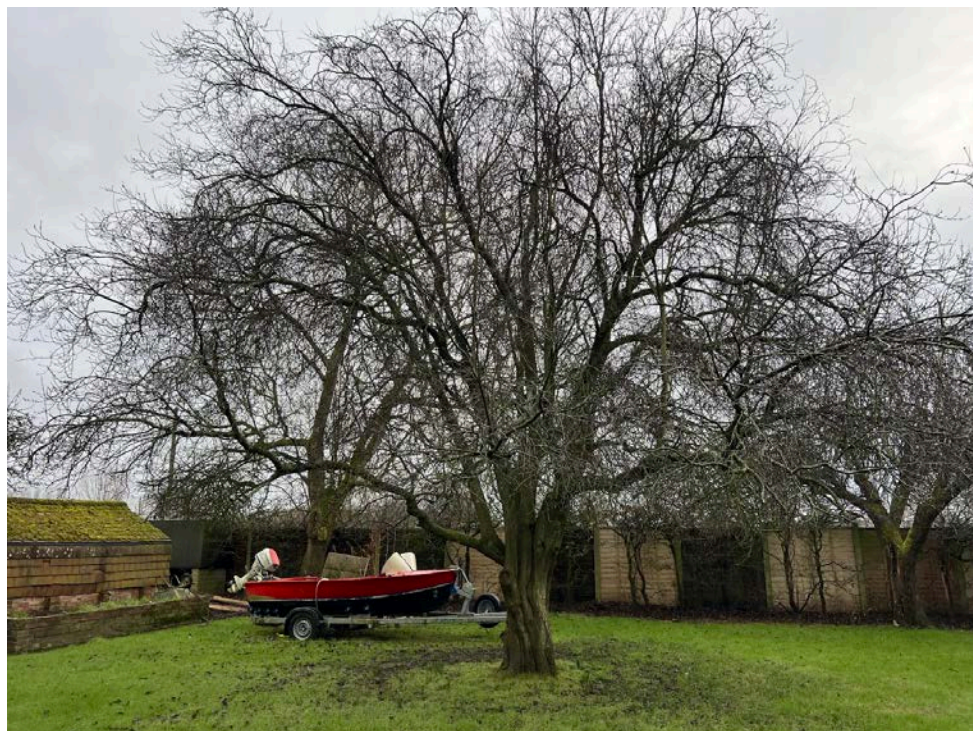
*Photographic plate showing trees T1 (right), T2 (centre) and T3 (left). (ROAVR, 2024)*

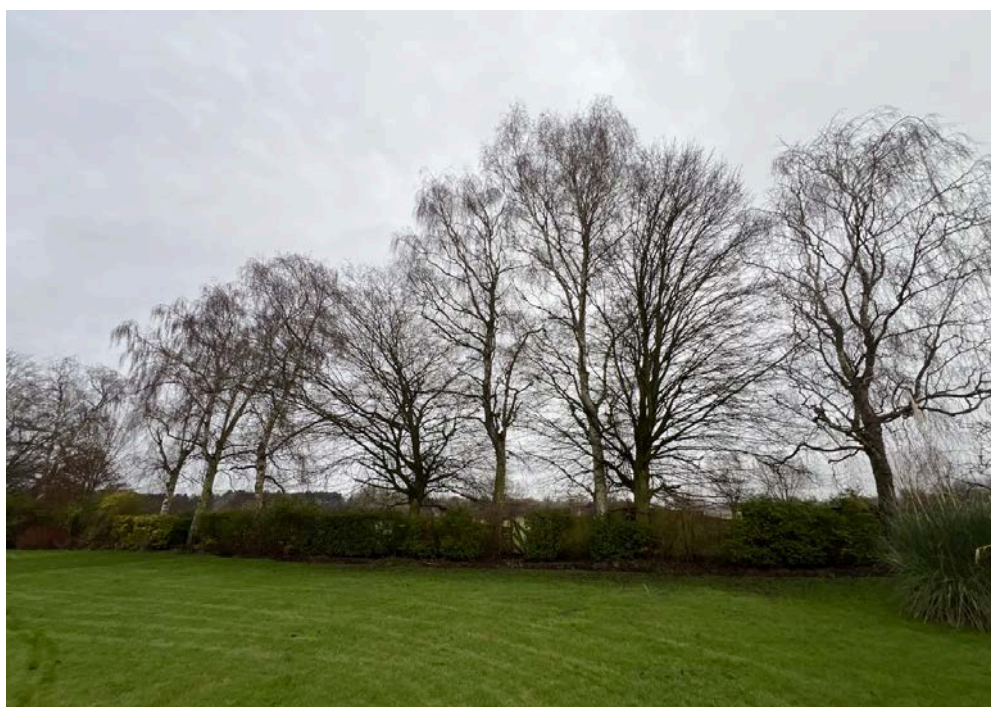
*Photographic plate showing trees T6 (right) to T12 (left). (ROAVR, 2024)*

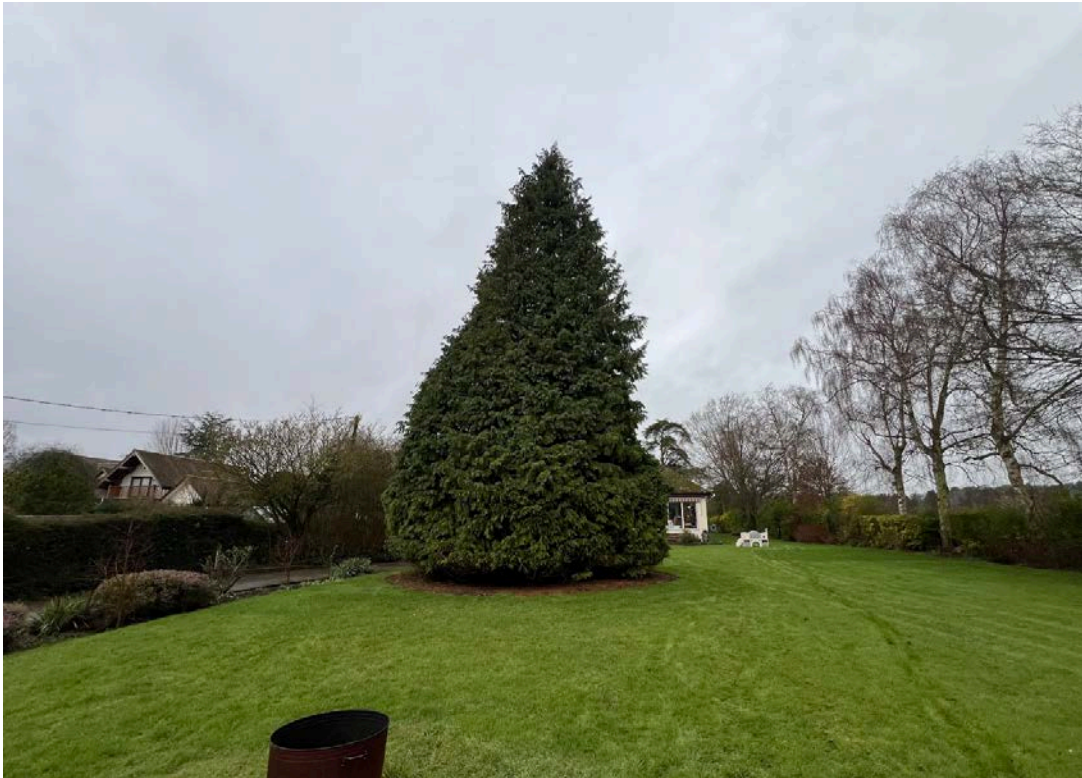
*Photographic plate showing T13 (centre). (ROAVR, 2024)*

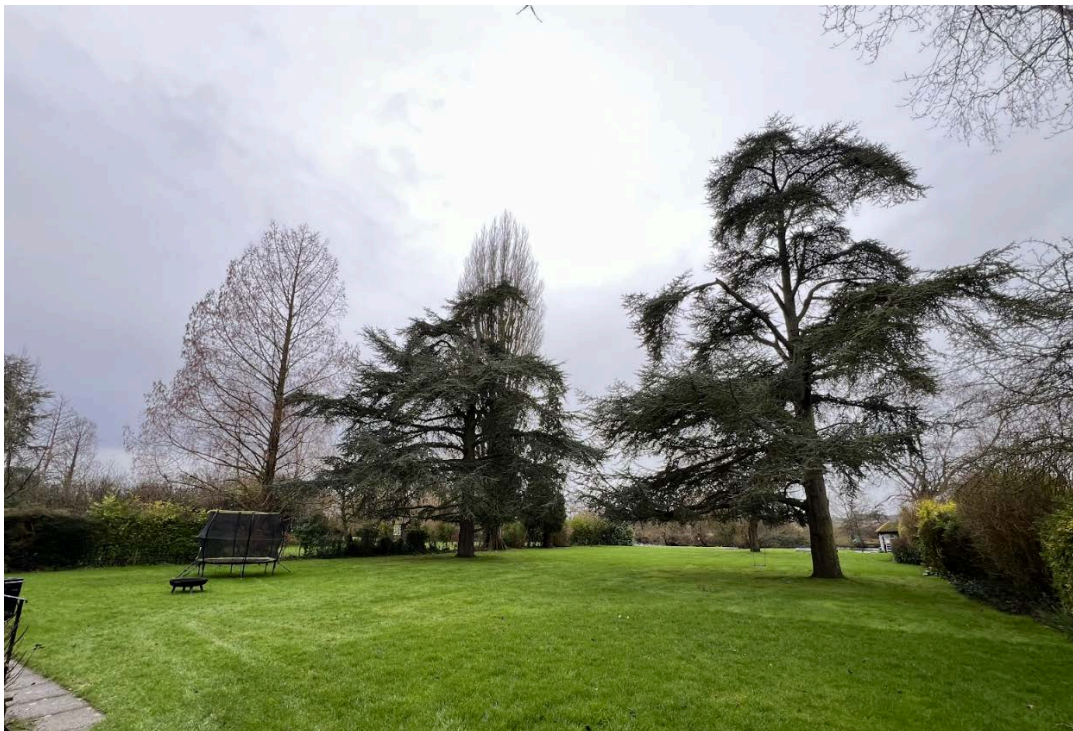
*Photographic plate showing trees T36 (left), T35 (centre and T27 (right). (ROAVR, 2024)*

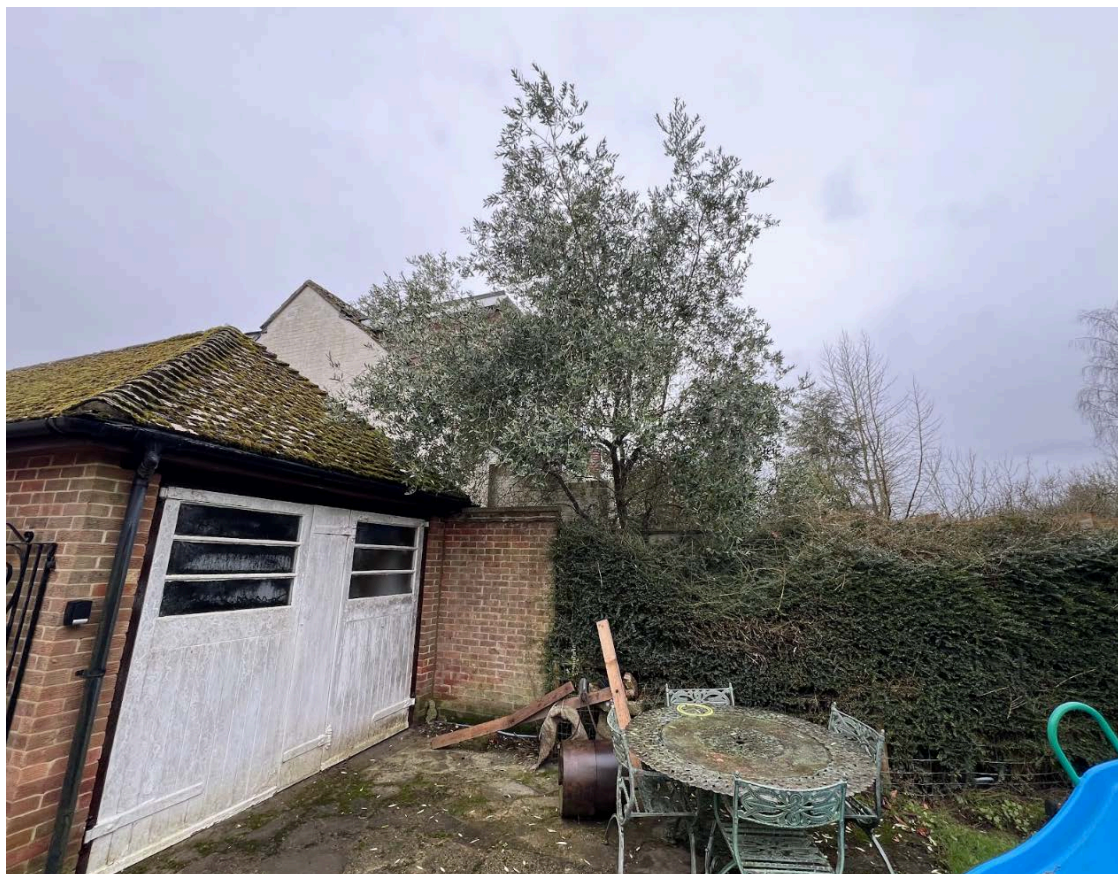
*Photographic plate showing T37. (ROAVR, 2024)*

- The existing gatehouse and dwelling is to be demolished. Works occur in proximity to T37 (Olive).
- No direct incursion into RPAs, but precautions must be taken to avoid accidental damage during demolition.
