# 10 Luckley Wood, Wokingham

Preliminary Roost Assessment

5<sup>th</sup> November 2024

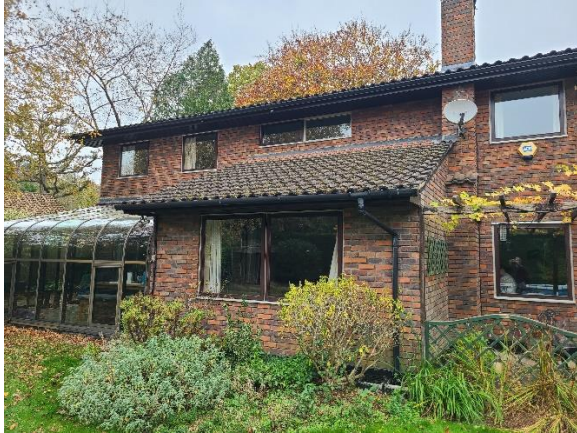
| Building | External description | Internal description |
|---|---|---|
| Building 1 – 10 Luckley Wood | Gable roofed, north-facing, detached house in a residential neighbourhood, with a lean-to extension and glass conservatory on the southern elevation.<br>Roof was constructed using interlocking concrete tiles, with deep eaves well sealed with wooden soffits and fascia. Leading and pointing appeared to be in good condition with no PRF visible.<br>Walls of the building were constructed using red clay brick and mortar, with no visible PRF in the walls of the building.<br>No evidence of bats recorded externally. | Small roof void present in main house with type 1F roofing felt over wooden rafters found to be in excellent condition. Some small area of natural light were visible around the eaves of the building. This was through ventilation grills, inaccessible to any mammal.<br>The roof void in the small lean-to extension was not accessible from the interior of the building.<br>No evidence of bats recorded internally. |

Photo 1 – external view of building 1 southern elevation.

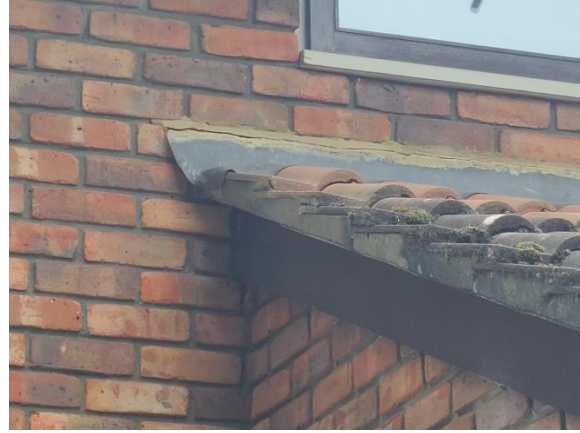
There was no evidence of bats recorded externally or internally. The fabric of the building was in very good repair with no visible PRFs.

Photo 2 – external view of building 1 leading and pointing in good condition.

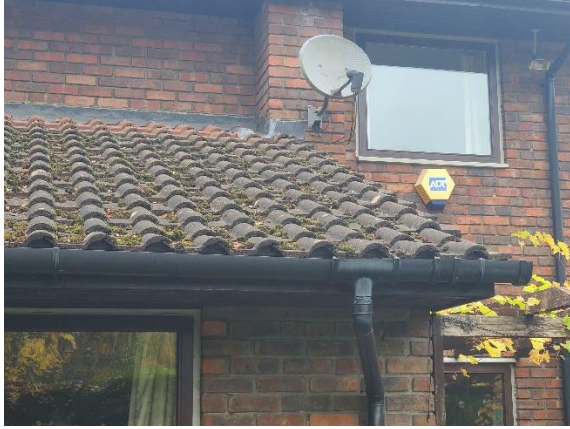
Photo 3 – external view of building 1 interlocking roof tiles.

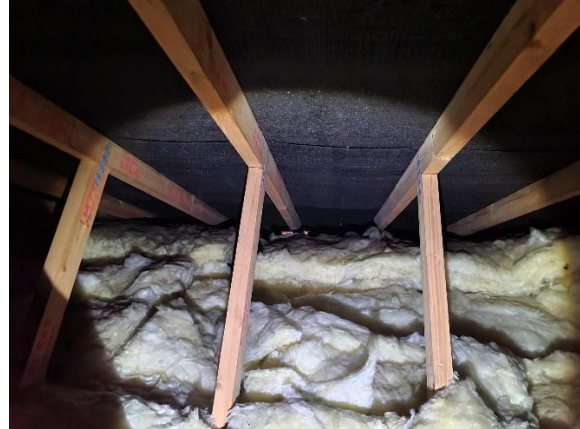
There was an absence of PRF in the structure of the building. There were some small areas of natural light in the main roof void presenting via meshed ventilation points, however as this main roof void is not subject to these development proposals it is not considered relevant.

Photo 4 – internal view of building 1 main roof void.
