## **PRELIMINARY ECOLOGICAL APPRAISAL (DBW) AT 22 BEAVER WAY WOODLEY**

**Ref: SPH/NP/PEA-24/17.12**

Urban Tree Experts was commissioned by Mr C Moseley to conduct a preliminary ecological appraisal (daytime bat walkover [DBW]), of 22 Beaver Way, Woodley, RG5 4UD. This is to support a forthcoming planning application to Wokingham Borough Council.

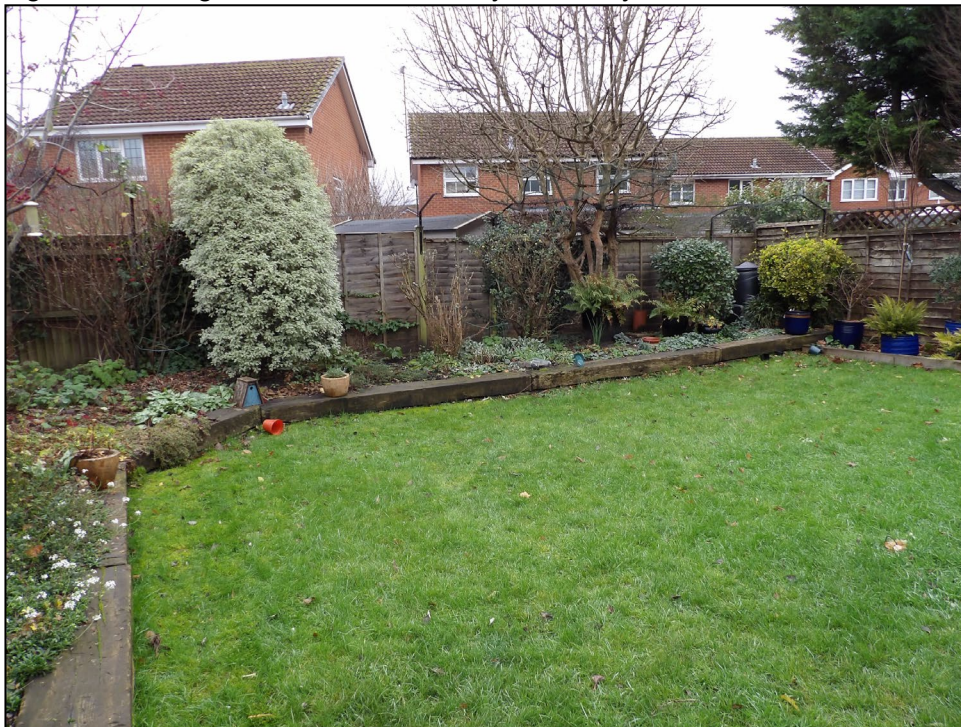
The application site comprises a detached, 2 storey brick-built dwelling with a part integral/part attached garage. The remainder of the site comprises a front garden with driveway/parking area and lawn with flower bed and shrubs, see cover photograph. The rear garden, which has an area of patio, is mainly laid to lawn with a flower bed containing shrubs and trees on the boundary, see Figure 3 below. The site itself offers some foraging and commuting habitat for bats and there is ecological connectivity to the wider landscape via the garden network.

Figure 3. Rear garden. 22 Beaver Way, Woodley. 17.12.24

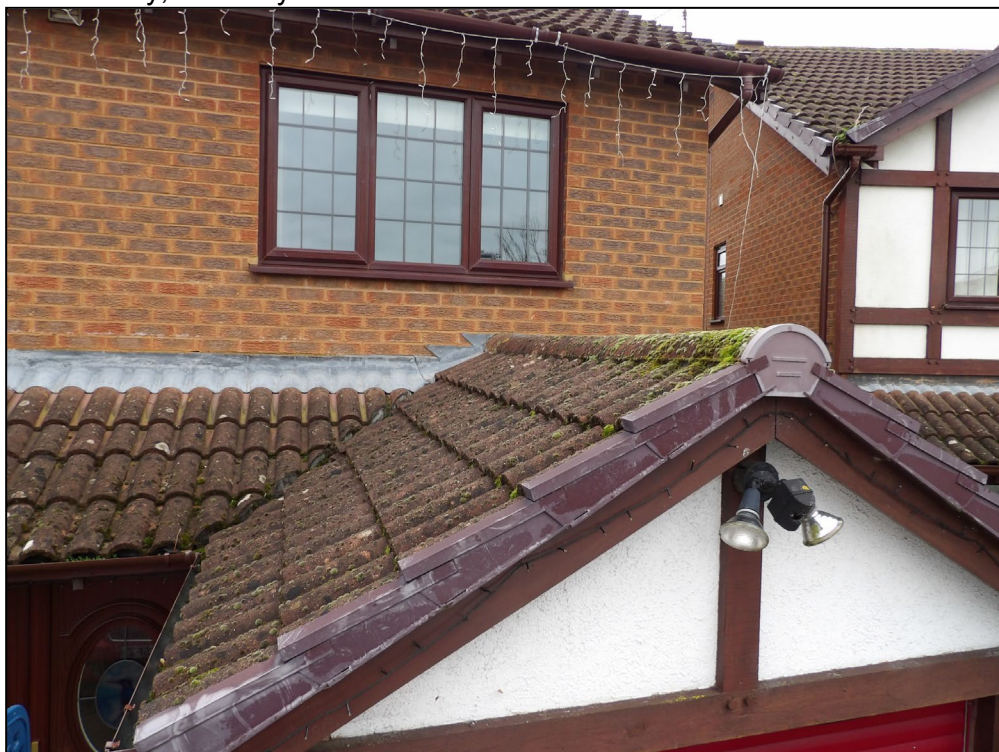
The part integral/part attached garage is also constructed of brick with a roller shutter door. The part pitched roof is also covered in close fitted composite tiles, all of which are in a good condition (see Figure 8 on page 10), and the verges are sealed with verge clips. This section of the building is not being affected by the proposed works.

Figure 8. Example sealed roof and ridge tiles and verges on part attached garage. 22 Beaver Way, Woodley. 17.12.24

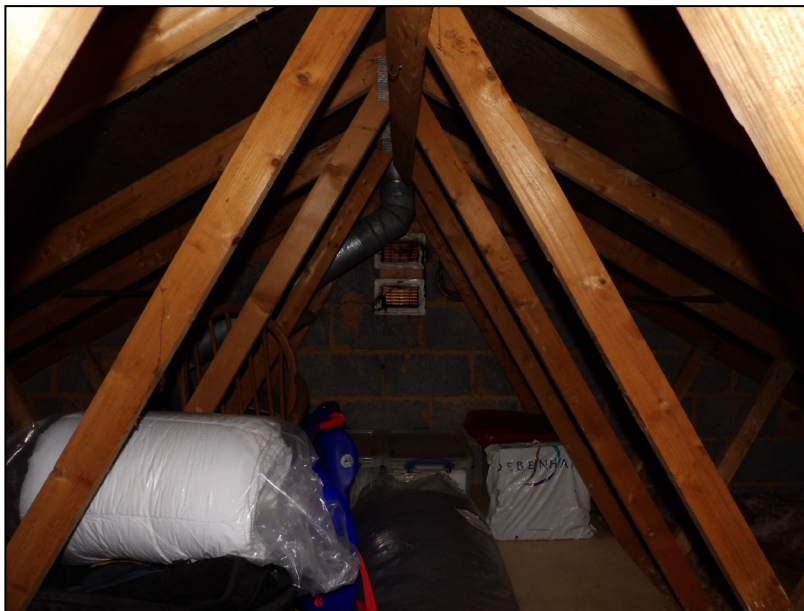
The loft was accessed through a hatch via a ladder and is in a good condition. The loft is used for storage however this did not hinder the inspection. The loft is lit, partially boarded and insulated, see Figure 9 below. The roof tiles are lined with bitumen felt, which is all tightly fitted and had no rips or tears in which roosting bats could utilise, see Figure 10 below.

Figure 9. Example of loft space. 22 Beaver Way, Woodley. 17.12.24
