## **PRELIMINARY ECOLOGICAL APPRAISAL (DBW) AT 22 BEAVER WAY WOODLEY**

**Prepared for:  
Mr C Moseley  
22 Beaver Way  
Woodley  
RG5 4UD**

**6 January 2025**

**Ref: SPH/NP/PEA-24/17.12**

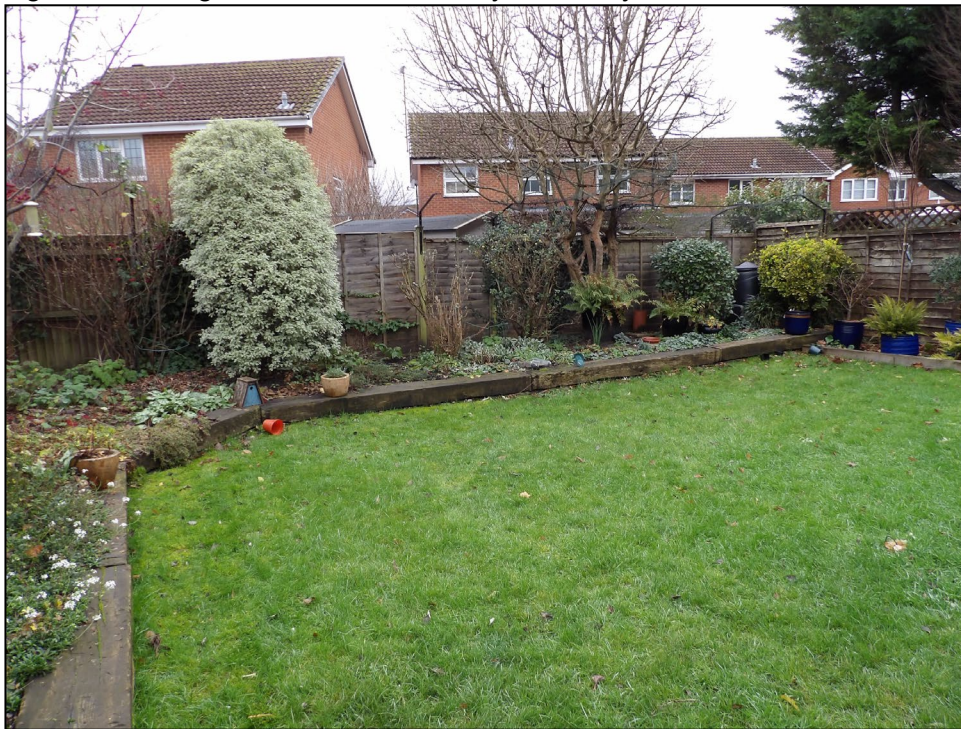
The application site comprises a detached, 2 storey brick-built dwelling with a part integral/part attached garage. The remainder of the site comprises a front garden with driveway/parking area and lawn with flower bed and shrubs, see cover photograph. The rear garden, which has an area of patio, is mainly laid to lawn with a flower bed containing shrubs and trees on the boundary, see Figure 3 below. The site itself offers some foraging and commuting habitat for bats and there is ecological connectivity to the wider landscape via the garden network.

Figure 3. Rear garden. 22 Beaver Way, Woodley. 17.12.24

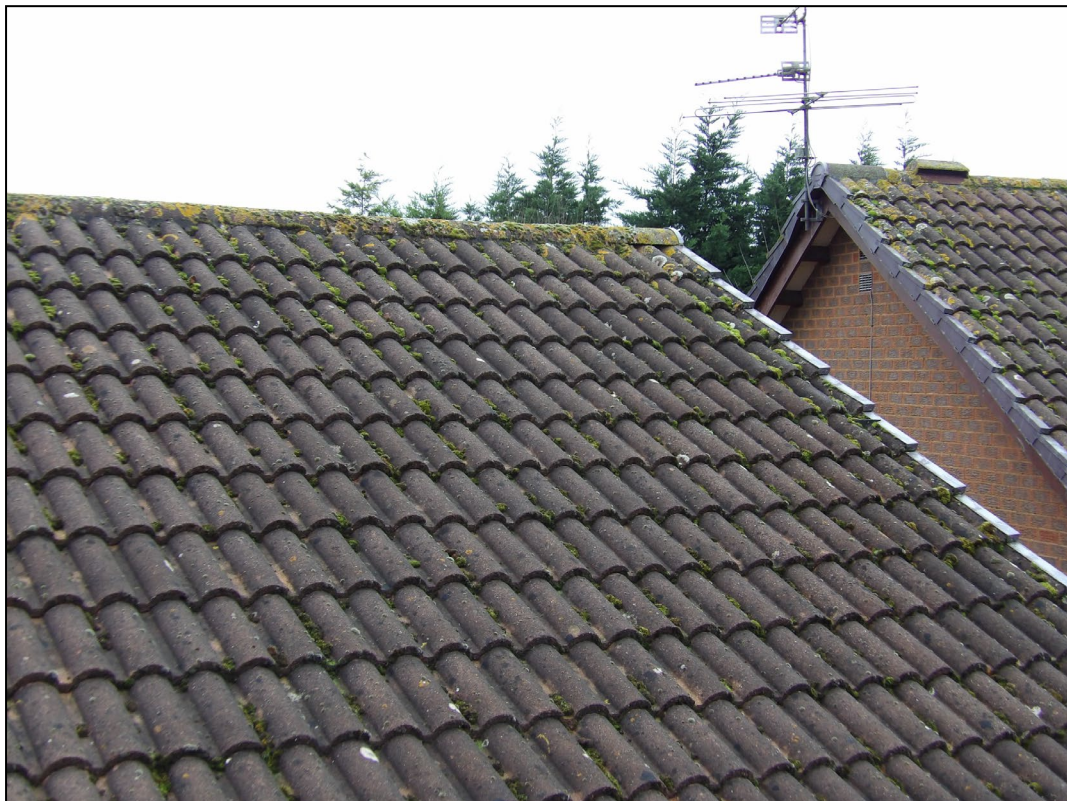
The property is a detached, brick-built building that is in a good condition externally. The pitched roof is covered in close fitted composite tiles, none of which are missing or broken, see Figure 4 below. The ridge tiles are all in a good condition (see Figure 4 below), as are the ridge tiles and valleys on the dormer window on the front elevation, see Figure 5 on page 9. The verges are covered with verge clips, all of which are well fitted with no gaps (see Figure 4 below), and the wooden eaves and fascias are all tightly fitted to the walls and had no cracks or splits which could be used by roosting bats, see Figure 6 on page 9. On the rear elevation is a mono pitched roof also covered in close fitted composite tiles and the lead flashing attaching it to the main property is well fitted with no gaps that could be exploited by crevice dwelling bat species, see Figure 7 on page 10.

Figure 4. Example of roof/ridge tiles and verge clips. 22 Beaver Way, Woodley. 17.12.24

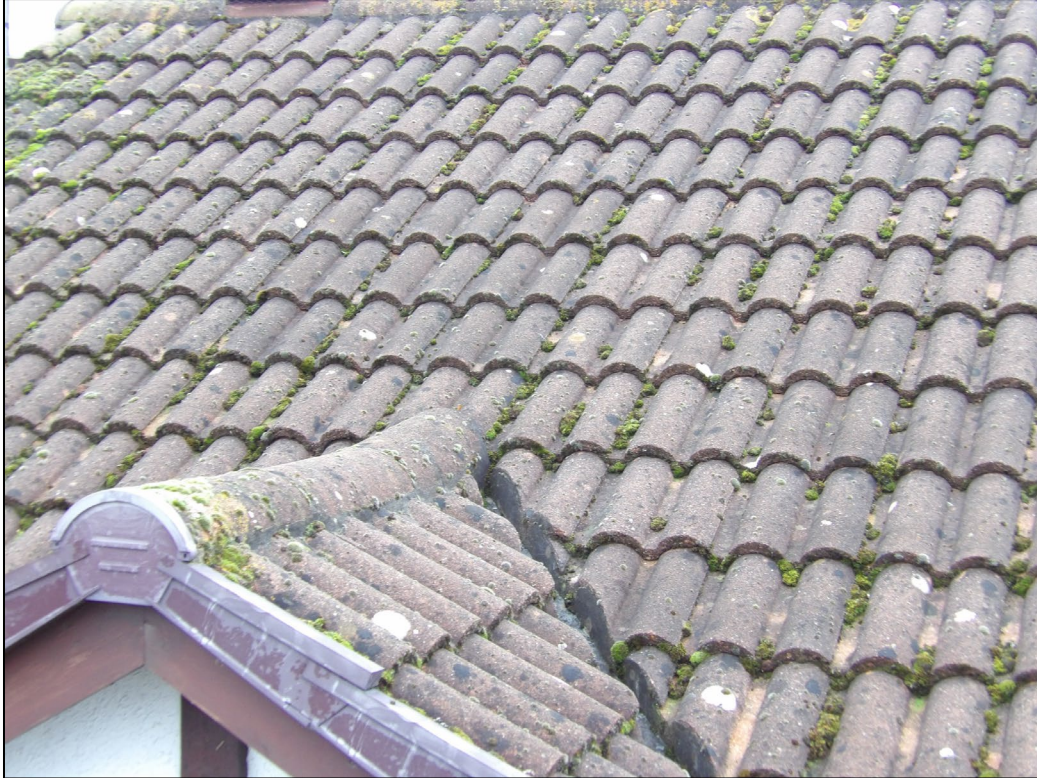
Figure 5. Sealed roof/ridge tiles, valleys and verges on dormer on front elevation. 22 Beaver Way, Woodley. 17.12.24

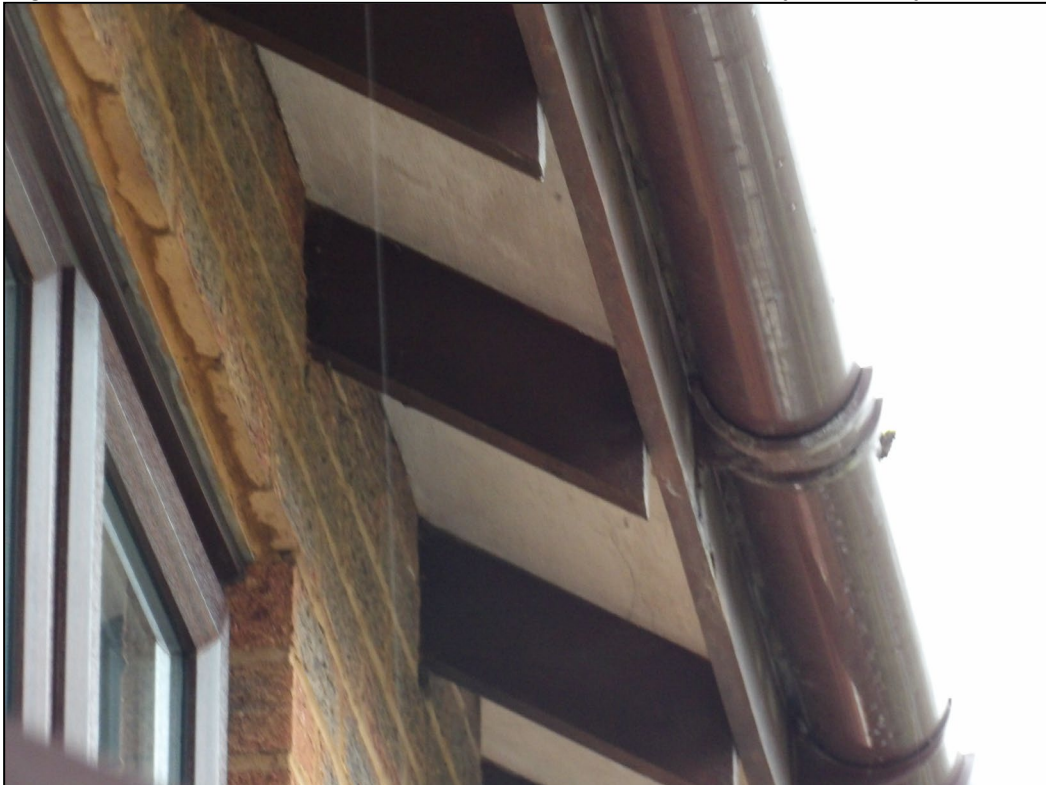
Figure 6. Example sealed eaves and fascias. 22 Beaver Way, Woodley. 17.12.24

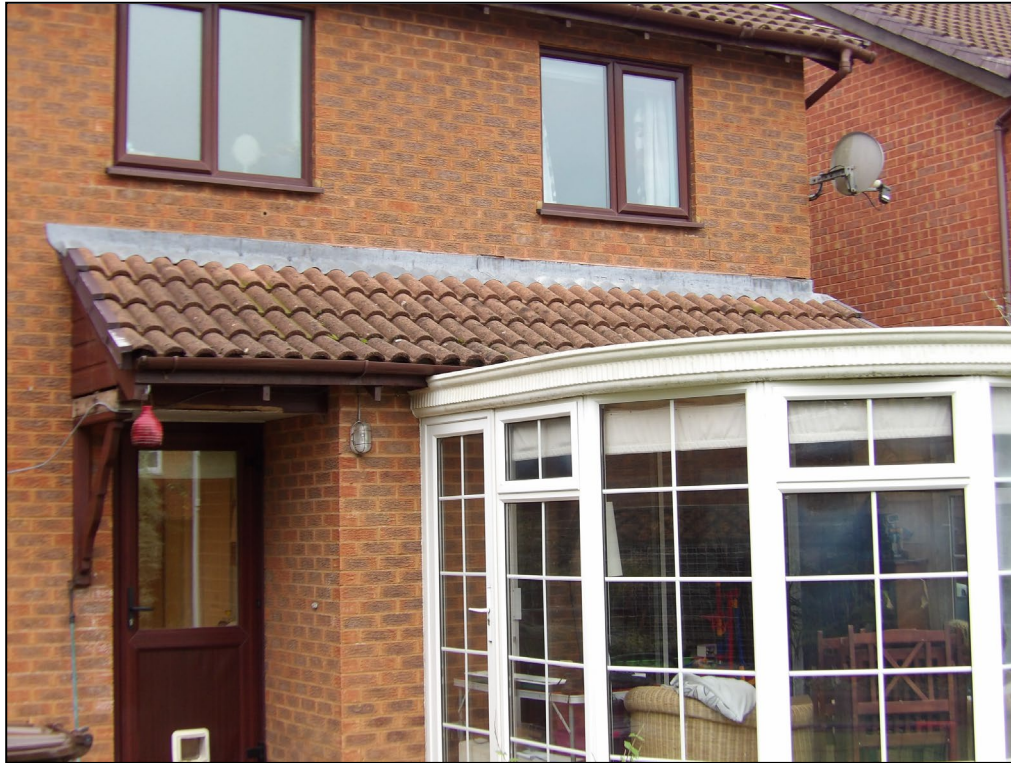
Figure 7. Rear mono pitched roof. 22 Beaver Way, Woodley. 17.12.24

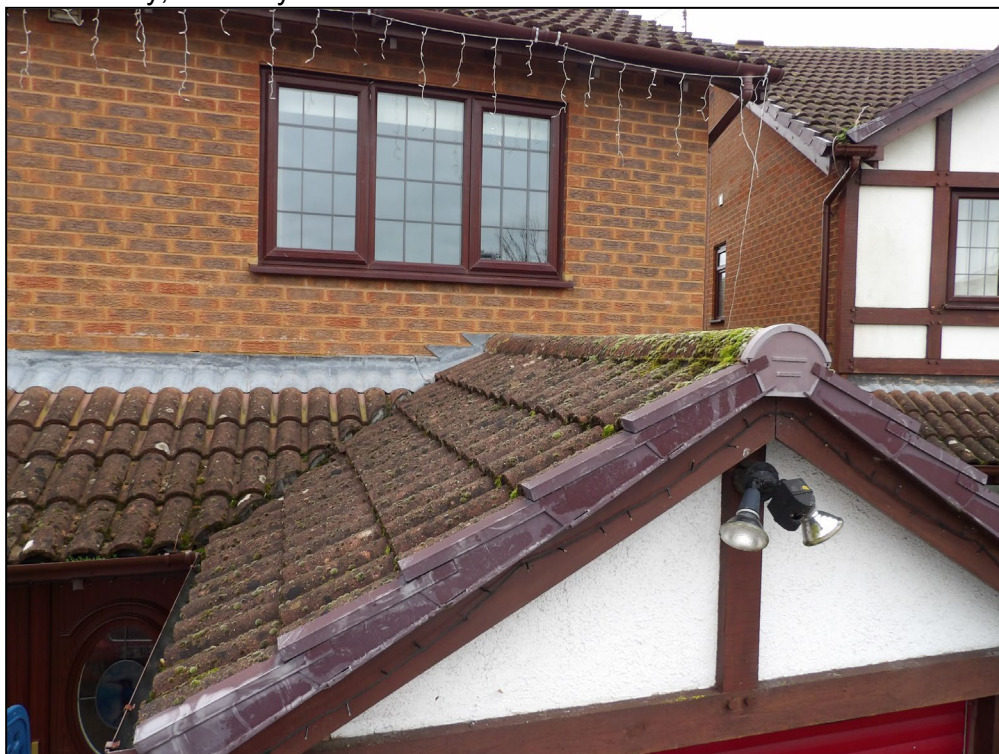
The part integral/part attached garage is also constructed of brick with a roller shutter door. The part pitched roof is also covered in close fitted composite tiles, all of which are in a good condition (see Figure 8 on page 10), and the verges are sealed with verge clips. This section of the building is not being affected by the proposed works.

Figure 8. Example sealed roof and ridge tiles and verges on part attached garage. 22 Beaver Way, Woodley. 17.12.24

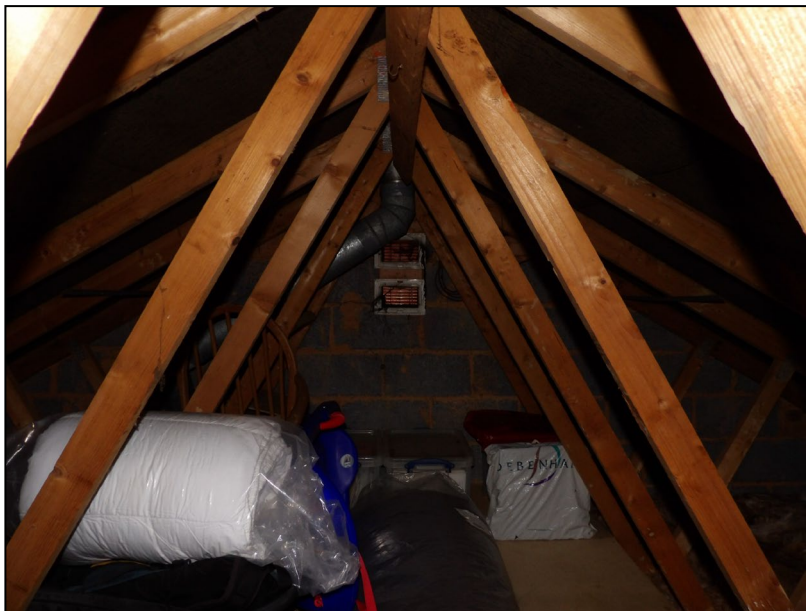
The loft was accessed through a hatch via a ladder and is in a good condition. The loft is used for storage however this did not hinder the inspection. The loft is lit, partially boarded and insulated, see Figure 9 below. The roof tiles are lined with bitumen felt, which is all tightly fitted and had no rips or tears in which roosting bats could utilise, see Figure 10 below.

Figure 9. Example of loft space. 22 Beaver Way, Woodley. 17.12.24

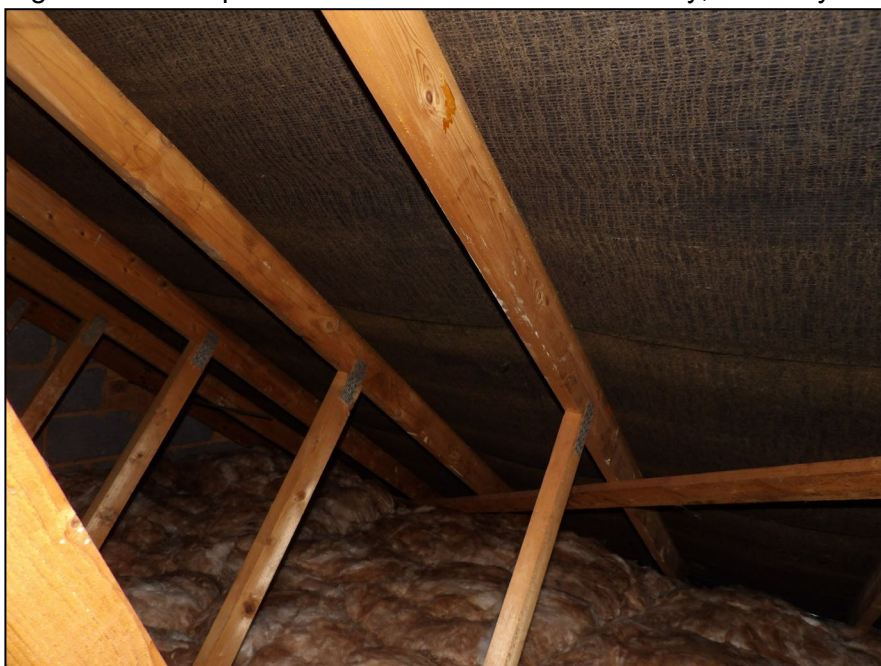
Figure 10. Example of bitumen in loft. 22 Beaver Way, Woodley. 17.12.24
