## **ECOLOGICAL SURVEY REPORT (BATS) AT BROOK HOUSE HOLLYBUSH RIDE, FINCHAMPSTEAD**

**Prepared for:  
Mr C Hudson  
Brook House  
Hollybush Ride  
Finchampstead  
RG40 3QR**

**16 July 2024**

**Ref: SPH/ESR-24/23.06**

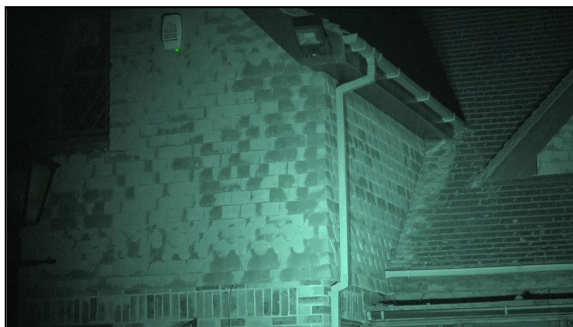
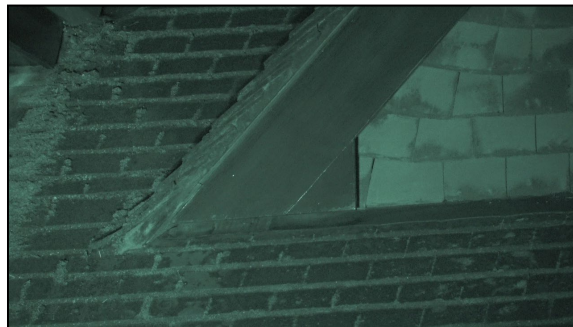
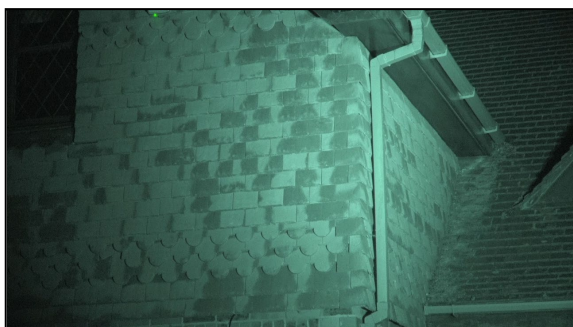
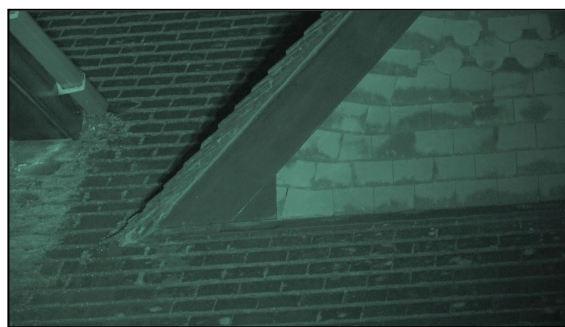
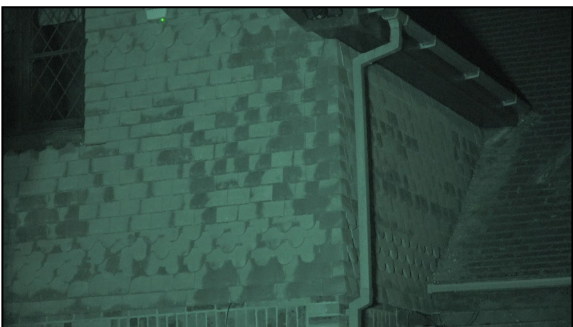
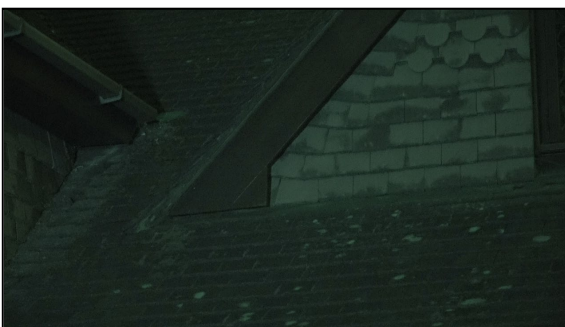
Figure 2 – Brook House, Finchampstead, screenshot from night vision camera.

During the surveys bat activity was monitored using a BatLogger M bat detector together with two Sony Handycam night shot video camera with high intensity IR lamps. A screenshot from the video cameras from each survey is included at Figure 2 on page 7.

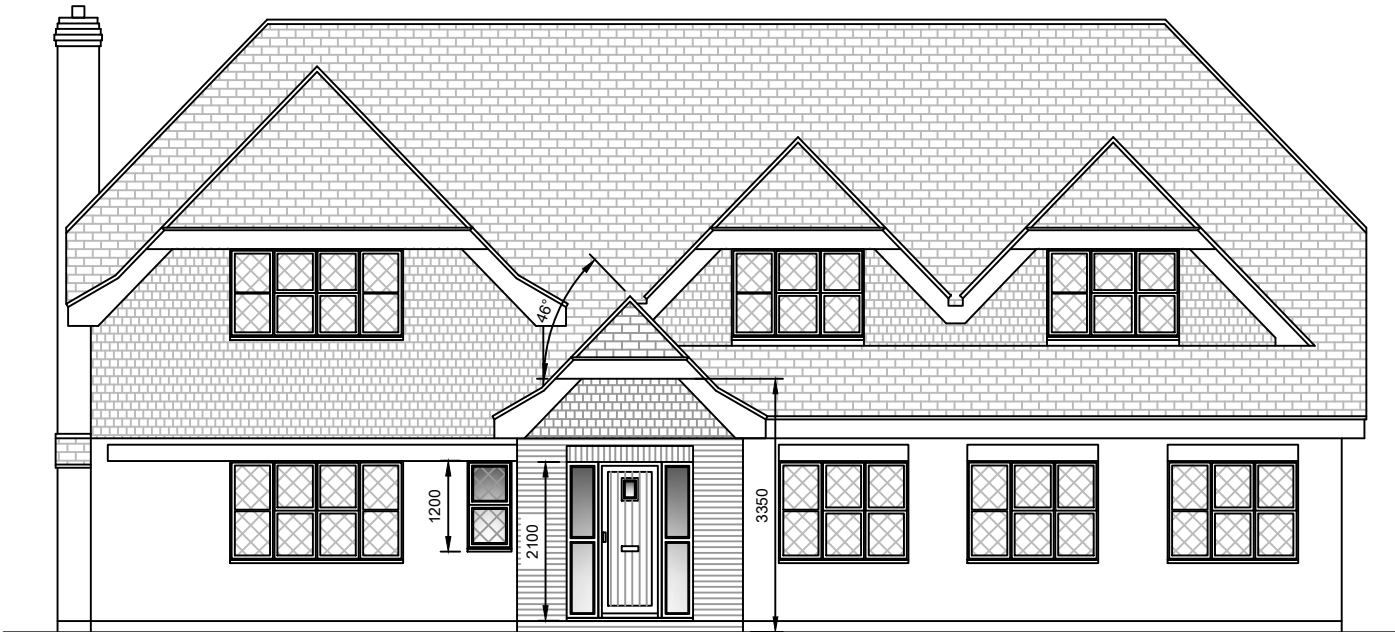
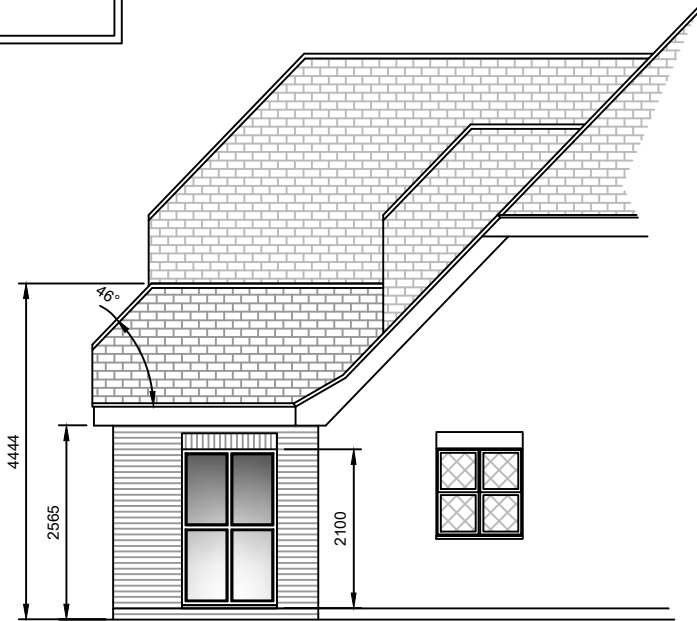
Front Elevation

- Brickwork finish to walls to match existing.
- Tile hung finish to walls above door to match existing.
- Roof tiles to match existing.
- Timber windows & doors. Obscure glazing to WC.
