## **PRELIMINARY ECOLOGICAL APPRAISAL (DBW) AT BROOK HOUSE, HOLLYBUSH RIDE FINCHAMPSTEAD**

**Prepared for:  
Mr C Hudson  
Brook House  
Hollybush Ride  
Finchampstead  
RG40 3QR**

**21 December 2023**

**Ref: SPH/ET/PEA-23/05.12**

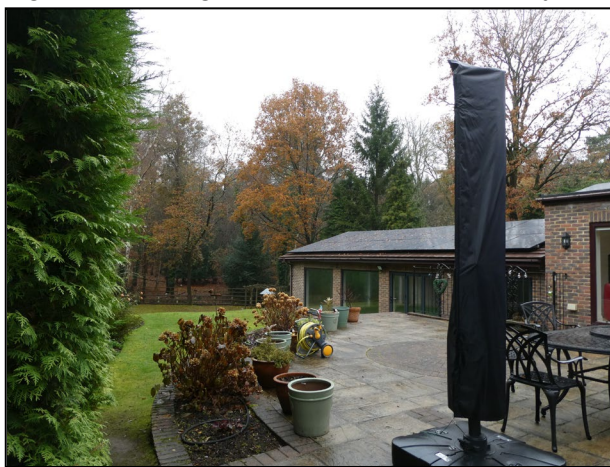
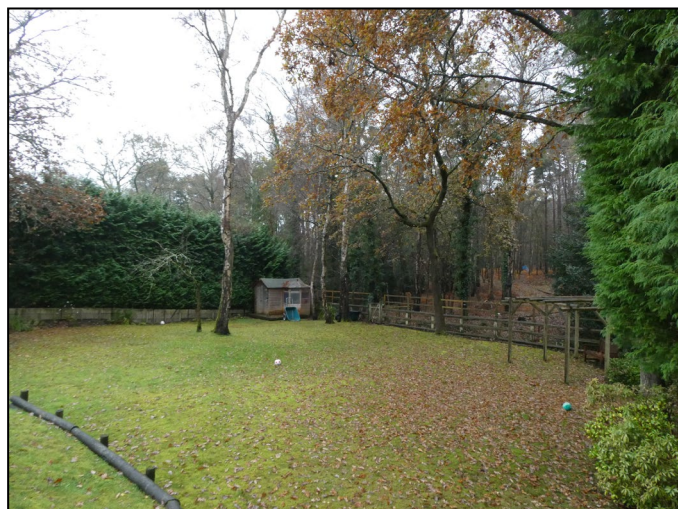
Figure 3. Rear garden. Brook House, Hollybush Ride, Finchampstead. 05.12.23

The application site comprises a detached, brick-built property with rear single storey extension and detached garage. The remainder of the site comprises a paved driveway/parking area with lawn, all surrounded by hedgerows and interspersed with mature trees. The rear garden contains a paved seating area and lawn surrounded by hedge/shrubs and backs onto woodland, see Figure 3 below. The site itself offers some foraging and commuting habitat for bats and there is direct ecological connectivity to the wider landscape that also provides good habitat for foraging and roosting bats.

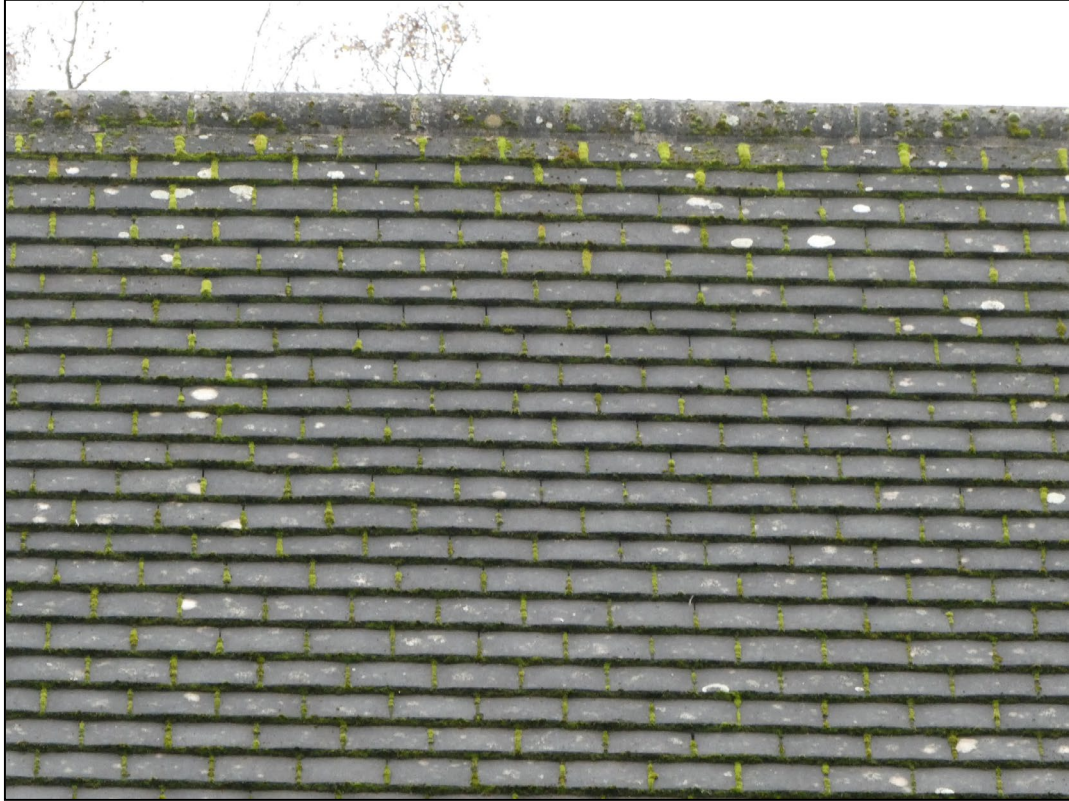
The property is a large, detached brick-built building which is in a good condition externally. The multi-pitched roof of the property is covered in composite tiles and solar panels, all of which appear to be in a good condition, none of which are missing or broken, see Figure 4 on page 9. The ridge tiles are all tightly fitted with no gaps in which bats could utilise for roosting and the verges and bonnet tiles are all well sealed and have no missing mortar which roosting bats could exploit, see Figure 5 on page 9. The lead flashing around the chimney is in good condition and provides no access for roosting bats and the soffits and fascias are all in good condition and tight to the walls with no gaps, see Figure 6 on page 10.

Figure 4. Example of roof and ridge tiles. Brook House, Hollybush Ride, Finchampstead. 05.12.23

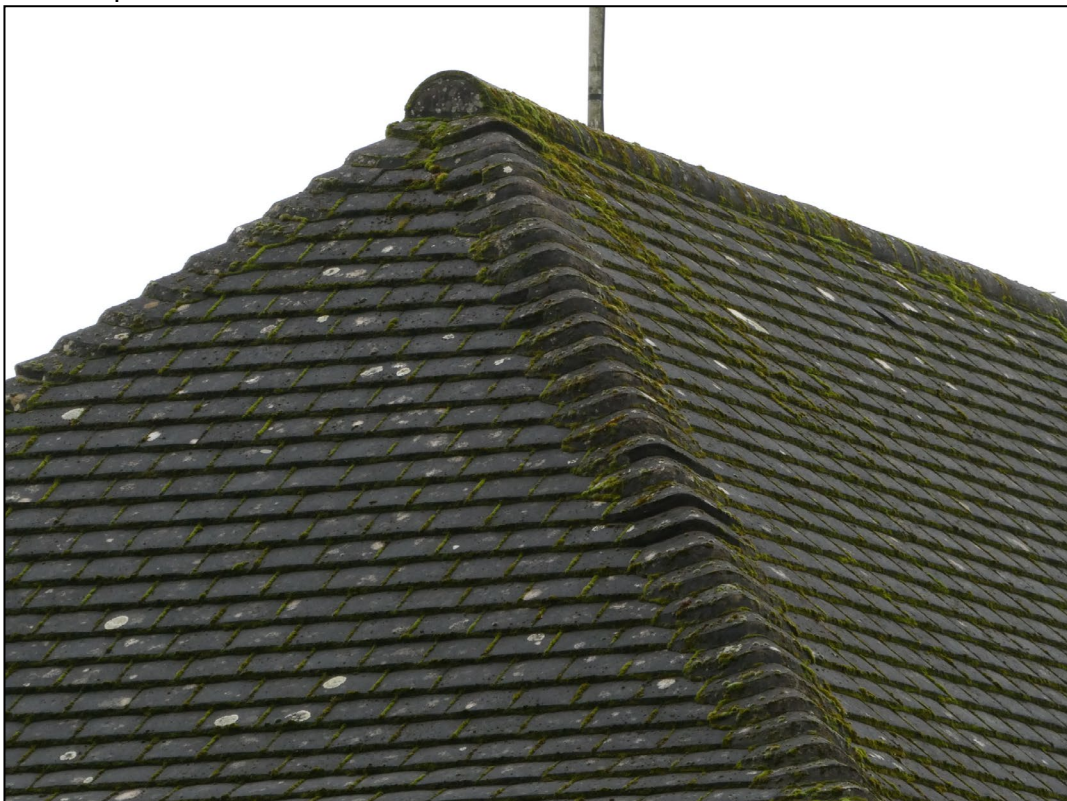
Figure 5. Example of sealed bonnet tiles. Brook House, Hollybush Ride, Finchampstead. 05.12.23

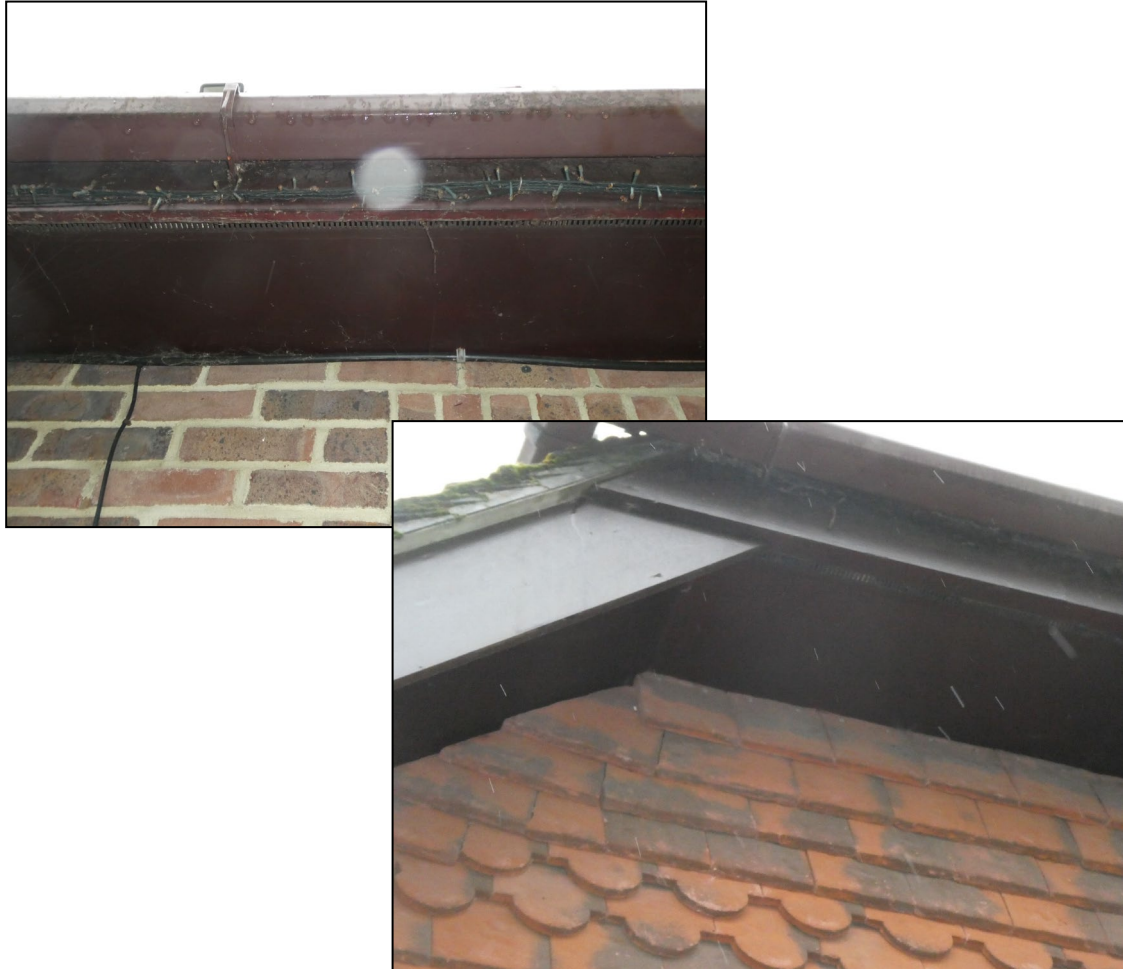
Figure 6. Example sealed soffits/fascias. Brook House, Hollybush Ride, Finchampstead. 05.12.23

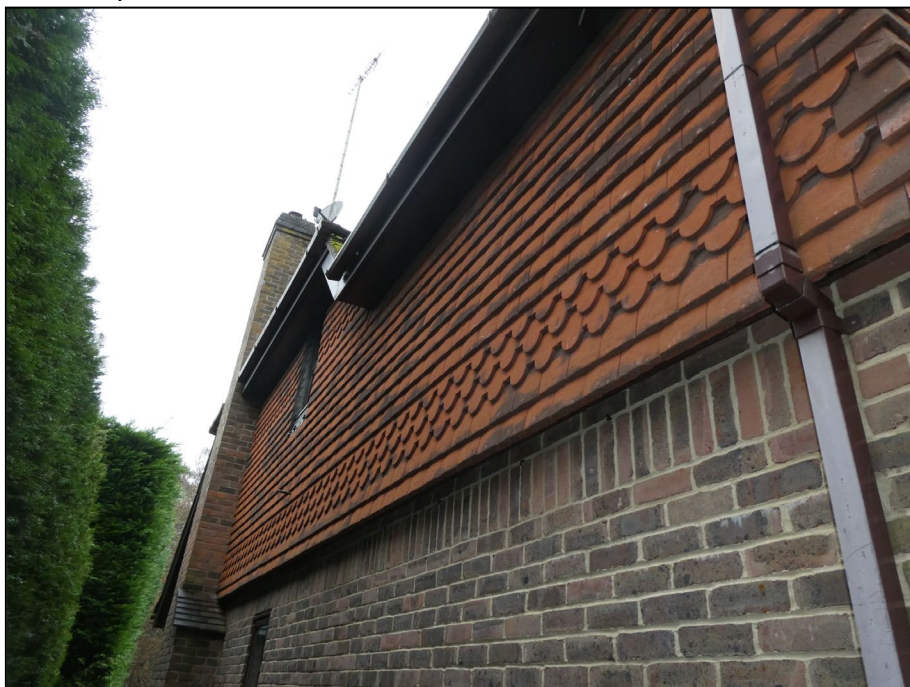
There are hanging tiles over three elevations of the property, the majority of which are tightly fitted with no gaps (see Figure 7 on page 10) however, on the corner of the front elevation, adjacent to the proposed works, the corner tiles have gaps suitable for crevice dwelling bat species, and bat roosting at this location cannot be excluded, see Figure 8 on page 11.

Figure 7. Example of tight-fitting hanging tiles. Brook House, Hollybush Ride, Finchampstead. 05.12.23

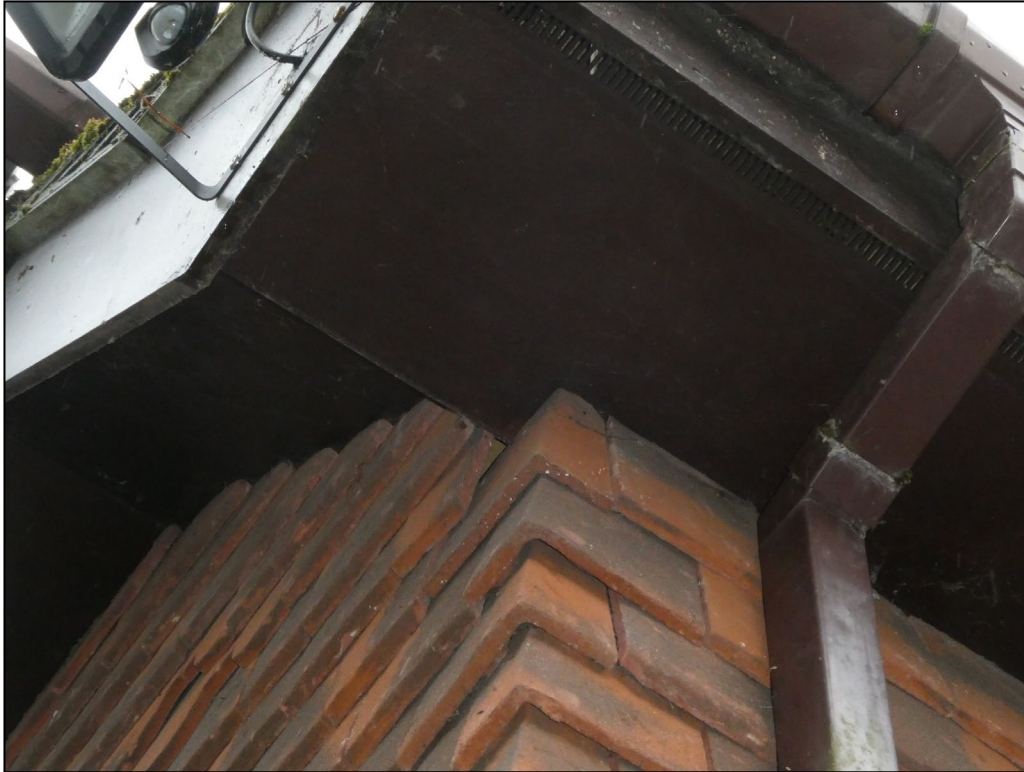
Figure 8. Front corner hanging tiles with gaps. Brook House, Hollybush Ride, Finchampstead. 05.12.23

The property is in a good condition internally and externally. There are a number of gaps in the hanging tiles at the corners on the front elevation to be affected by the proposed works and where the front dormer window meets the roof which provide crevice like features suitable for bats to roost and may provide access into the loft for bats. Low numbers of bat droppings are normally associated with low numbers or individual bats and there is no evidence of maternity roosting or hibernation use and the building has in our opinion, been used opportunistically as a day/summer roost by a low number of pipistrelle *sp.* and/or brown long eared bats.

Based on the Bat Workers Manual and the Bat Surveys Good Practice Guidelines, three dusk emergence surveys need to be undertaken on the property, between May and September, to assess the current status of roosting bats, in order to inform appropriate mitigation for the proposed works. The features identified will require two survey positions both equipped with bat detectors and night vision cameras in order to cover the potential bat roosting features.

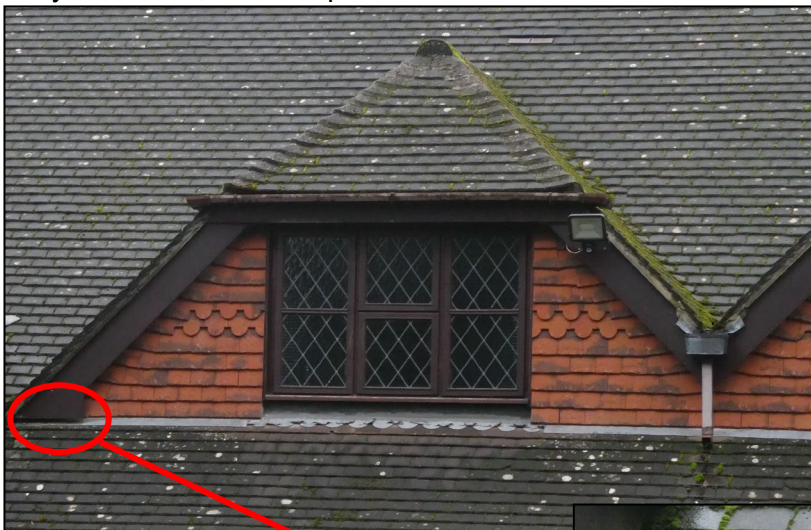
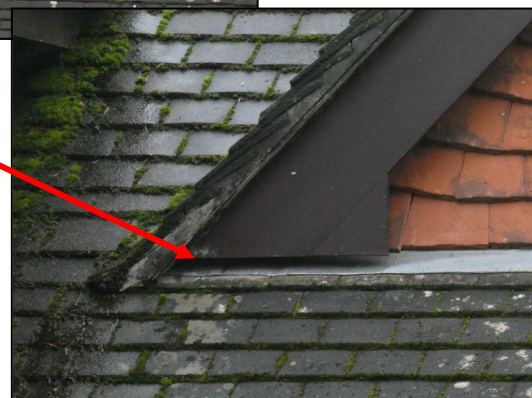
There were dormer windows on both the front and rear elevations of the property. The rooves are covered in close fitted composite tiles and the fronts are covered in hanging tiles, which all overlap. There are, however, some gaps at the base of the dormer windows where they meet the roof tiles on the front elevation which could provide potential roosting opportunities for bats or provide access into the building for roosting bats, see Figure 9 on page 11.

Figure 9. Example dormer windows and gaps on front elevation. Brook House, Hollybush Ride, Finchampstead. 05.12.23

Following the detailed external and internal inspection, we were unable to positively identify any obvious access or egress points for bats on the main roof and therefore bats may be accessing via the hanging tile gaps or via the gaps under the dormers. It is possible that during maintenance/repair works in the past, any access or egress points may have been inadvertently repaired/blocked up.

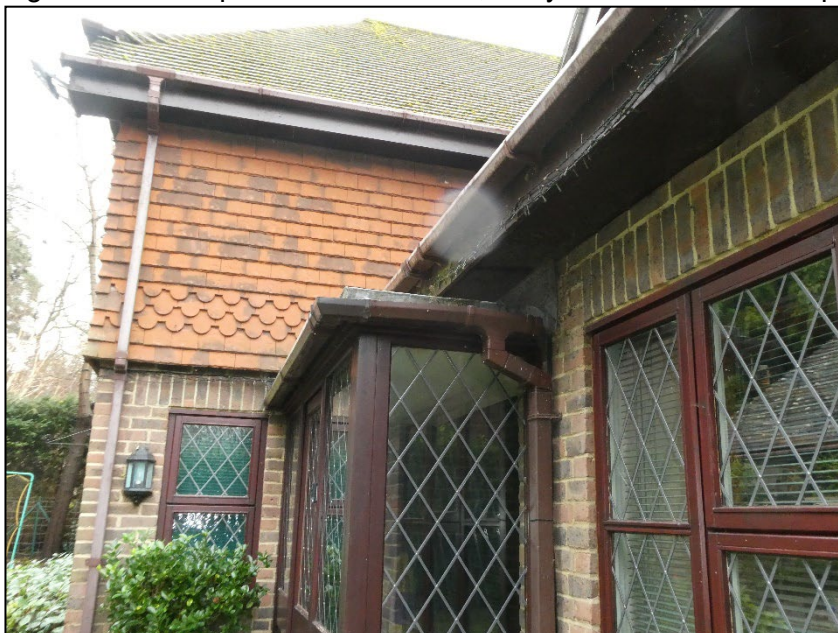
The current front porch is constructed of wood with large leaded glass panel and a flat roof, all of which is in a good condition with no gaps, see Figure 10 on page 12.

Figure 10. Front porch. Brook House, Hollybush Ride, Finchampstead. 05.12.23

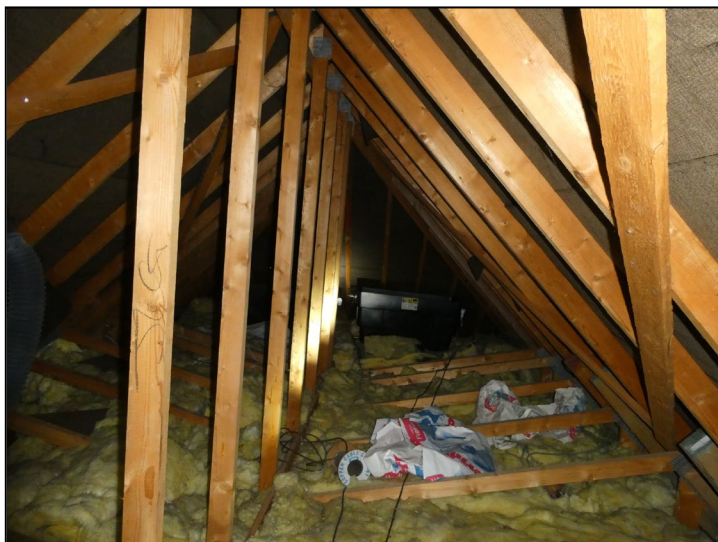
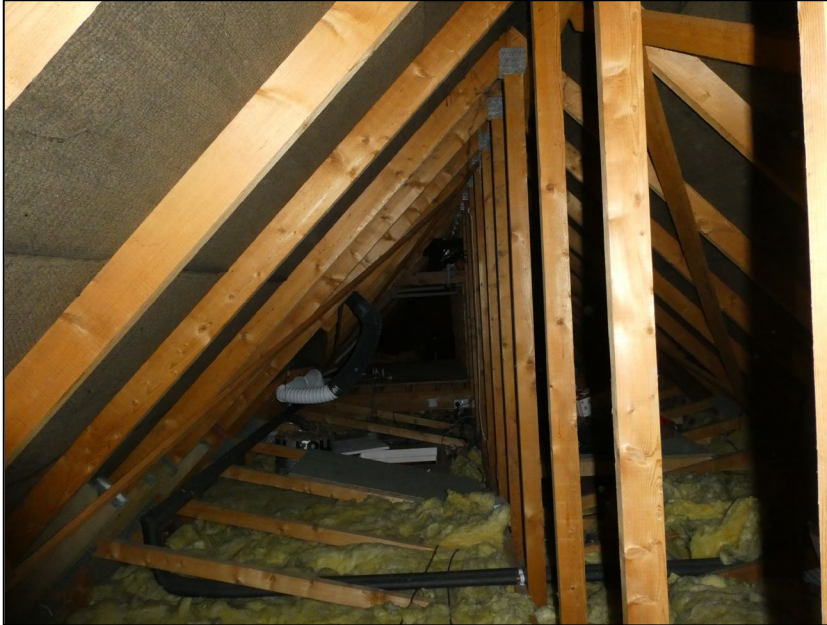
The loft space was accessed via a ladder through a hatch and is in a good condition. The loft was not lit, partially boarded and insulated, see examples at Figure 11 below and on page 13. The roof tiles are lined with bitumen felt, all of which was in a good condition with no rips or tears. A small number of bat droppings, of a similar size and consistency to those of pipistrelle *sp.* and/or brown long-eared bats were recorded scattered throughout the loft space, indicating bats are or have been using the loft space for roosting, see Figure 12 on page 13.

Figure 11. Example of loft space. Brook House, Hollybush Ride, Finchampstead. 05.12.23

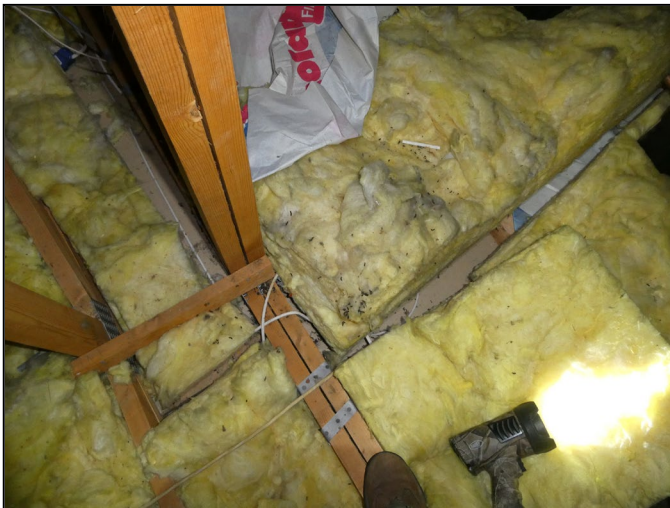
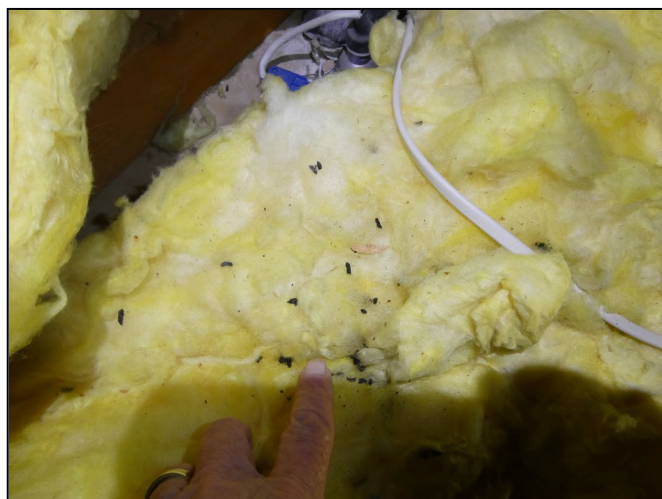
The buildings suitability to support roosting bats was assessed and potential roost features identified during the preliminary inspection. In addition, a small number of bat droppings were recorded within the loft space, they are of a similar size and consistency to those of pipistrelle *sp.* and/or brown long-eared bats, indicating that bats are or have been using the building for roosting.

Figure 12. Example of bat droppings. Brook House, Hollybush Ride, Finchampstead.  
05.12.23

It is recommended that a sample of the droppings are sent for DNA analysis.
