## **Bat Emergence and Re-Entry Surveys (BERS)**

62 Reading Road, Woodley, Berkshire, RG5 3DB

This report is prepared to inform a planning application for the proposal described as: Proposed erection of a new dwelling following the demolition of the existing.

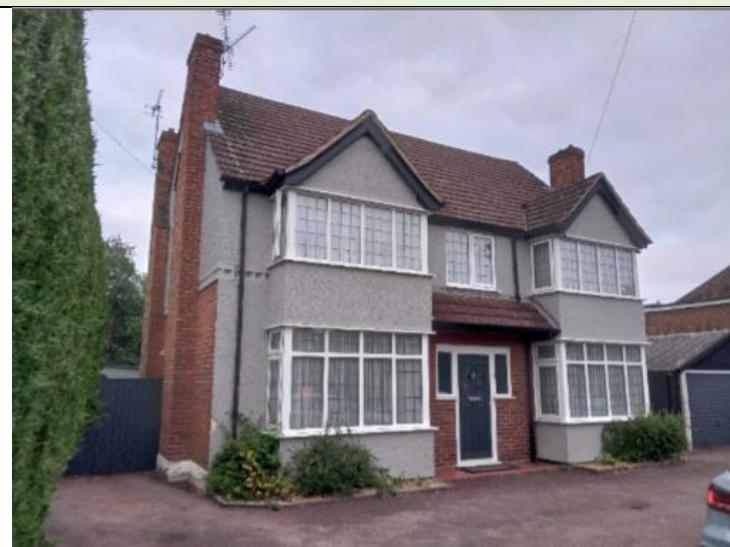
Photo 1: Full elevation photo showing surveyor's view of position 1.

<p><i>IR position 1</i> 1 x Nightfox Whisker + 1 x Nightfox XB5 PRO</p> <p><i>Recording the northwest and southwest elevations and manned by surveyor 1.</i></p>	<p><b>No emergences recorded.</b></p> <p>No additional bat activity was recorded or observed upon full footage review.</p>

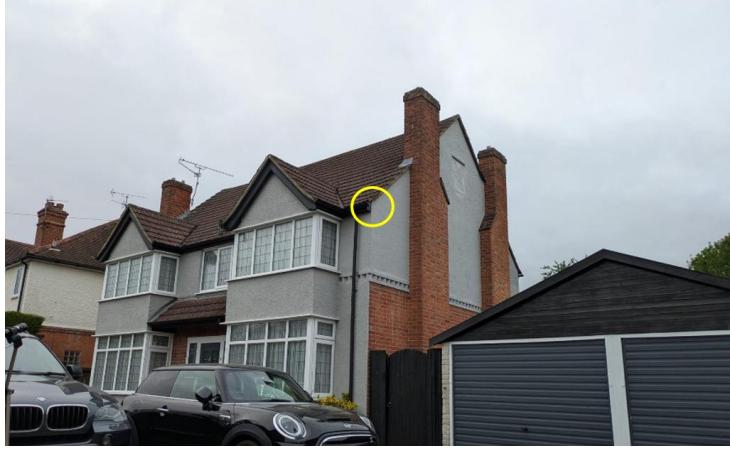
<p>Photo 3: Full elevation photo showing surveyor's view of position 2 and the emergence point.</p>

<p><i>Surveyor 2 - SM</i></p>	<p><b>A common pipistrelle emergence was observed from a gap under a roof tile and above the soffit box on the south facing corner of B1 – also observed by surveyor 3.</b></p> <p>At 21:06 a common pipistrelle was observed emerging from the edge of a roof tile. At 21:26 a common pipistrelle was heard and seen flying southwest over the garage from surveyor position 3. A noctule bat was heard but not seen at 21:27, 21:31 and 21:57. A brown long-eared bat was heard but not seen at 22:00. At 21:45 a soprano pipistrelle was heard but not seen. Serotine activity was heard but not seen at 21:59, 22:05, 22:26 and 22:29. A common pipistrelle was heard but not seen at 22:25.</p> <p>These species were confirmed on site using Echo Meter Touch 2 bat detectors. No further bat activity detected throughout the remainder of the survey.</p>

<p><i>IR position 2</i></p> <p>1 x Nightfox Whisker + 1 x Nightfox XB5 PRO</p> <p><i>Recording the southeast and southwest elevations elevation and manned by surveyor 2.</i></p>	<p><b>One emergence was recorded as observed by surveyors 2 and 3 – see photo 4.</b></p> <p>No additional bat activity was recorded or observed upon full footage review.</p>

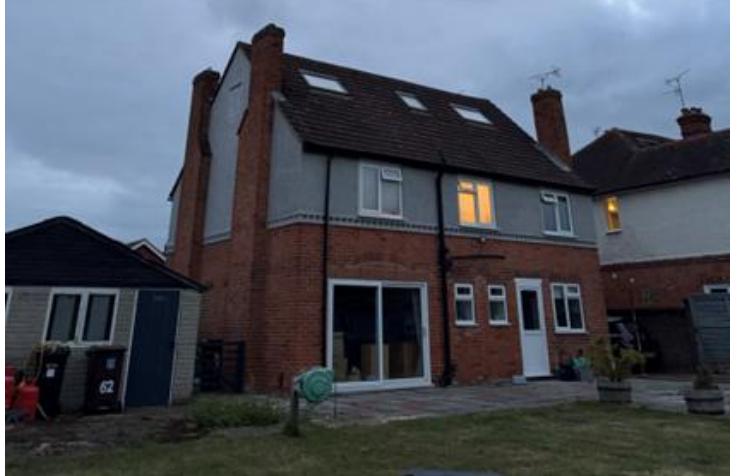
<p>Photo 6: Full elevation photo showing surveyor's view of position 3.</p>

<p><i>IR position 3</i></p> <p><i>1 x Nightfox Whisker + 1 x Nightfox XB5 PRO</i></p> <p><i>Recording northeast and southeast elevations and manned by surveyor 3.</i></p>	<p><b>No emergences recorded.</b></p> <p>Upon review of the IR camera footage, no additional footage of bats was found.</p>

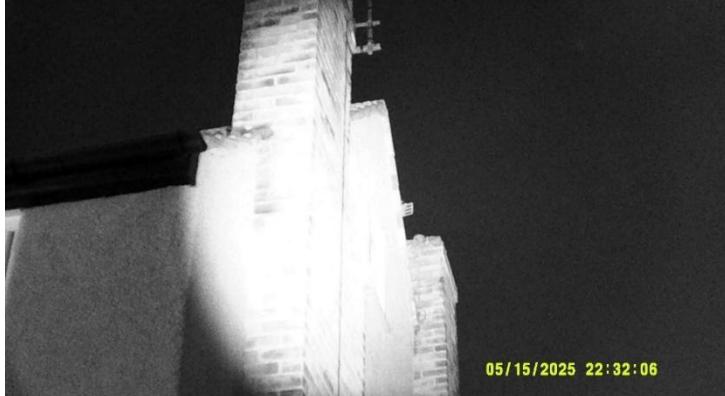
<p><i>IR position 4</i></p> <p><i>1 x Nightfox Whisker + 1 x Nightfox XB5 PRO + Magenta Bat4</i></p> <p><i>Unmanned camera checked by surveyor 3 during the survey.</i></p>	<p><b>No emergences recorded.</b></p> <p>Upon review of the IR camera footage, no additional footage of bats was found.</p>

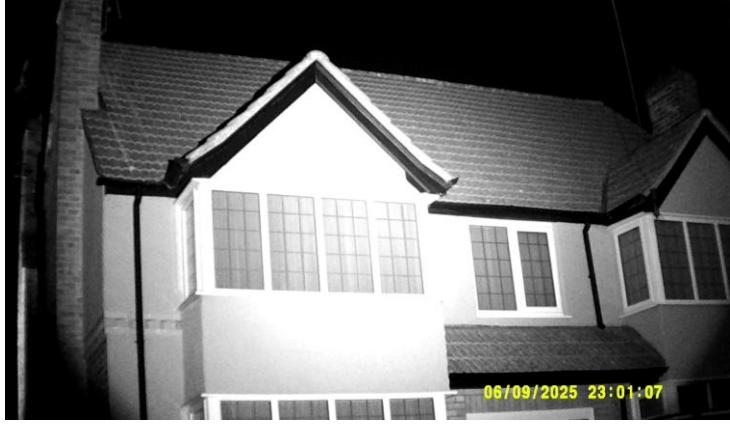
<p><i>IR position 1</i>  <i>1 x Nightfox Whisker +</i>  <i>1 x Nightfox XB5 PRO</i></p> <p><i>Recording the northwest and southwest elevations and manned by surveyor 1.</i></p>	<p><b>No emergences recorded.</b></p> <p>No additional bat activity was recorded or observed upon full footage review.</p>

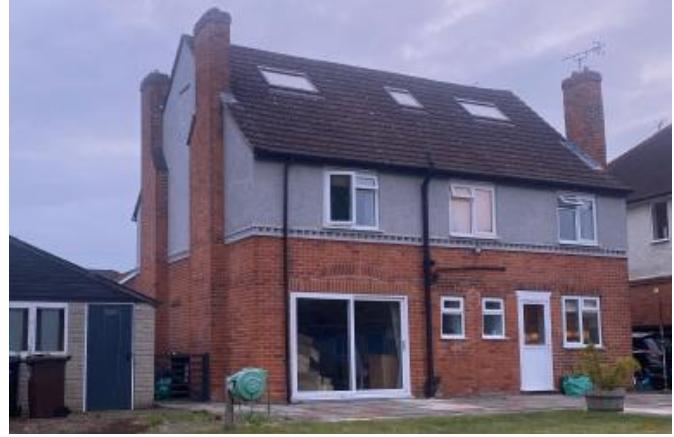
<p><i>Surveyor 3 - EE</i></p>	<p><b>No emergences observed.</b></p> <p>The first bat activity was a common pipistrelle at 21:30, followed by a soprano pipistrelle at 21:50. Both bats were foraging in the garden to the northeast of B1. At 21:30, a noctule was seen passing over B1.</p> <p>These species were confirmed on site using Echo Meter Touch 2 bat detectors.</p> <p>No further bat activity detected throughout the remainder of the survey.</p>

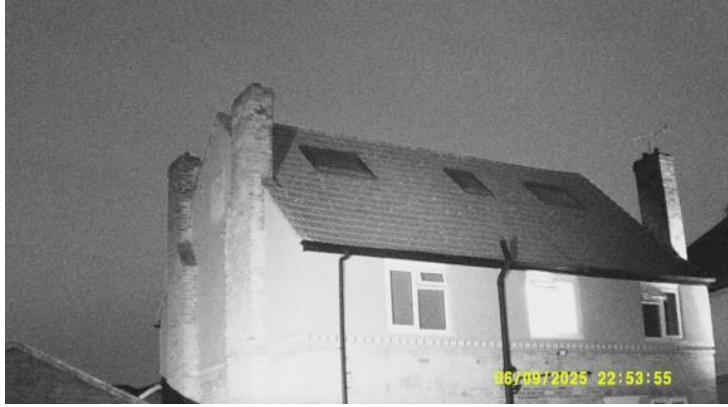
<p>Photo 14: Darkest point photo from IR camera 3.</p>
<p><i>IR position 4</i></p> <p><i>1 x Nightfox Whisker + 1 x Nightfox XB5 PRO + Magenta Bat4</i></p> <p><i>Unmanned camera checked by surveyor 3 during the survey.</i></p>	<p><b>No emergences recorded.</b></p> <p>Upon review of the IR camera footage, no additional footage of bats was found.</p>

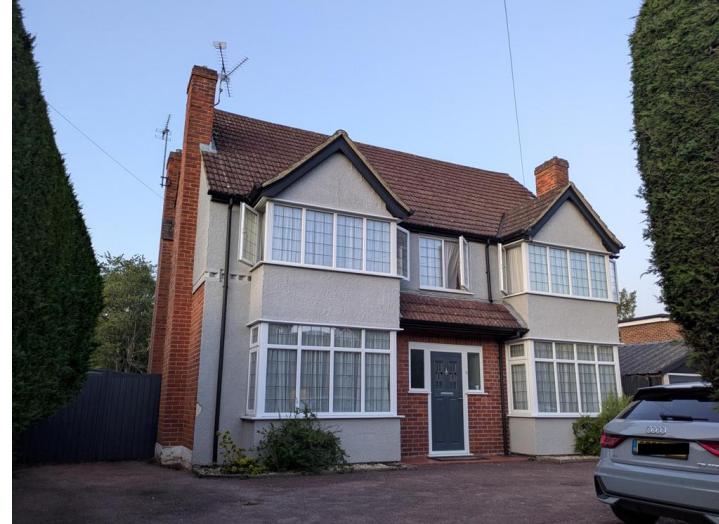
<p>Photo 16: Full elevation photo showing surveyor's view of position 1.</p>

<p><i>IR position 1</i>  <i>1 x Nightfox Whisker +</i>  <i>1 x Nightfox XB5 PRO</i></p> <p><i>Recording the northwest and southwest elevations and manned by surveyor 1.</i></p>	<p><b>No emergences recorded.</b></p> <p>No additional bat activity was recorded or observed upon full footage review.</p>

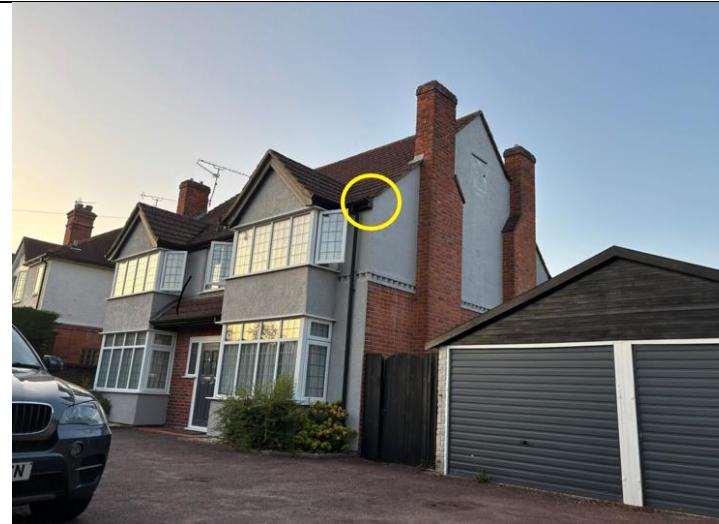
<p>Photo 18: Full elevation photo showing surveyor's view of position 2 and emergence point.</p>

<p><i>Surveyor 2 - OD</i></p>	<p><b>Two emergences of soprano pipistrelles were observed from a gap under a roof tile and above the soffit box on the south facing corner of B1, travelling northeast – also observed by surveyor 3.</b></p> <p>The first bat activity was a noctule that was heard but not seen at 21:36 and then again at 22:52. There were two emergences from the gap under a roof tile above the soffit box at 21:44 and 21:58. Both flew northeast over B2. At the time, these were not picked up by the Echo Meter Touch bat detector, but as they flew over surveyor 3, they were both identified as soprano pipistrelles. At 22:04, a soprano pipistrelle passed from northeast to southwest over B2 and Reading Road. One common pipistrelle passed along the same route at 22:23 and another two at 22:26. Common pipistrelles were heard but not seen at 22:36 and 22:40. The final activity of the survey was a soprano pipistrelle that was heard but not seen at 23:00.</p>

<p>These species were confirmed on site using Echo Meter Touch 2 bat detectors.</p> <p>No further bat activity detected throughout the remainder of the survey.</p>	
<p><i>IR position 2</i></p> <p>1 x Nightfox Whisker + 1 x Nightfox XB5 PRO</p> <p><i>Recording the southeast and southwest elevations elevation and manned by surveyor 2.</i></p>	<p><b>Two emergences of soprano pipistrelles were recorded at 21:44 and 21:58 from a gap under a roof tile and above the soffit box on the south facing corner of B1 travelling northeast- also observed by surveyor 3.</b></p> <p>No additional bat activity was recorded or observed upon full footage review.</p>

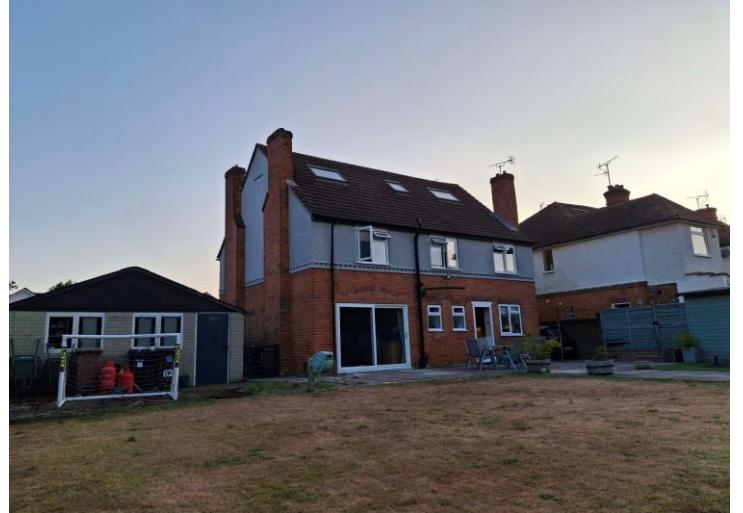
<p>Photo 22: Full elevation photo showing surveyor's view of position 3.</p>

Surveyor 3 - TD	<p><b>Two emergences of soprano pipistrelles were observed from a gap under a roof tile and above the soffit box on the south facing corner of B1, travelling northeast – also observed by surveyor 2.</b></p> <p>The first bat activity was a soprano pipistrelle that emerged from the south facing corner of B1 at 21:44 and passed over surveyor 3 flying northeast. A second soprano pipistrelle emerged from the same access point at 21:59 and also passed northeast towards the trees at the northeast boundary. At 21:57 and again at 22:24, soprano pipistrelles passed over the fence flying from southeast to northwest. At 22:02, a soprano pipistrelle passed from the north to the south. Two common pipistrelles passed west to east at 22:10 and 22:32. A common pipistrelle passed from southwest to northeast at 22:27. In addition to these observations, soprano pipistrelles were heard but not seen at 21:52, 22:50 and 23:00. A common pipistrelle was heard but not seen at 22:51.</p> <p>There were also high levels of foraging activity in the back garden and trees at the northeast boundary. Common pipistrelles were observed foraging in this area at 22:00, 22:15 and 22:40. Multiple soprano pipistrelles spent extended periods of time foraging in this area at 22:03 – 22:10, 22:16 – 22:22 and 22:28 – 22:30.</p> <p>These species were confirmed on site using Echo Meter Touch 2 bat detectors.</p>

No further bat activity detected throughout the remainder of the survey.	
<p><i>IR position 3</i></p> <p>1 x Nightfox Whisker + 1 x Nightfox XB5 PRO</p> <p><i>Recording northeast and southeast elevations and manned by surveyor 3.</i></p>	<p><b>Two emergences of soprano pipistrelles were recorded from a gap under a roof tile and above the soffit box on the south facing corner of B1 travelling northeast – also observed by surveyor 2.</b></p> <p>Upon review of the IR camera footage, no additional footage of bats was found.</p>

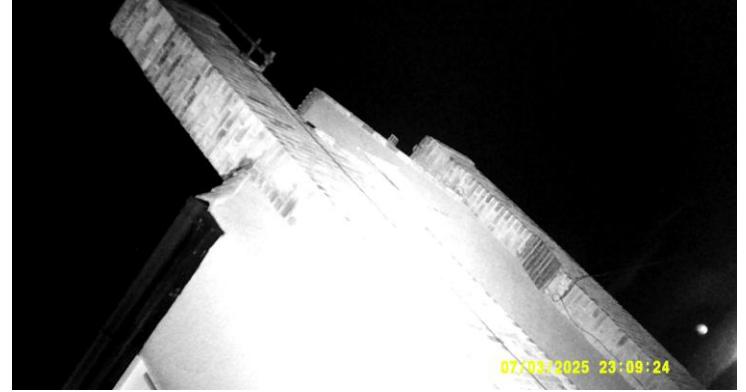
<i>IR position 4</i>  <i>1 x Nightfox Whisker +</i> <i>1 x Nightfox XB5 PRO +</i> <i>Magenta Bat4</i>  <i>Unmanned camera checked by surveyor 3 during the survey.</i>	<b>No emergences recorded.</b>  Upon review of the IR camera footage, no additional footage of bats was found.

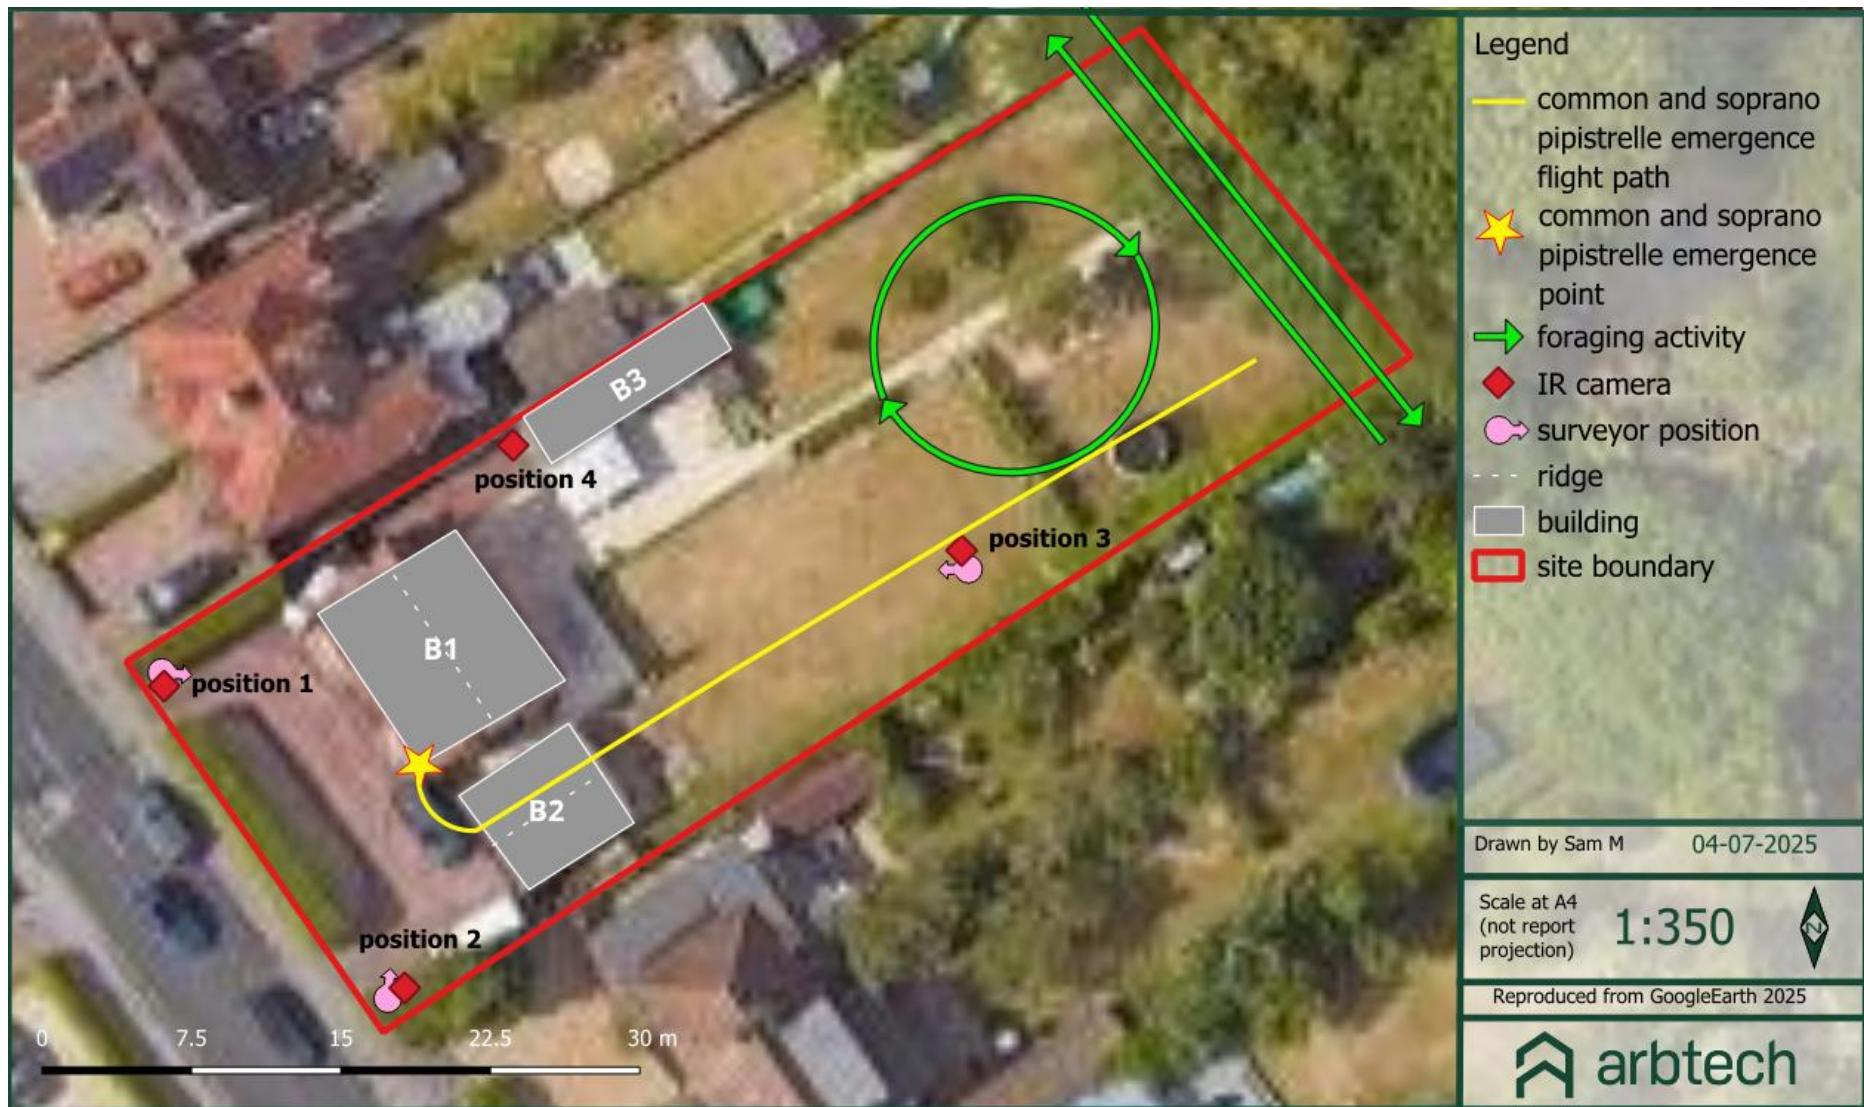
**Appendix 1: BERS plan**

**See surveyor locations in the BERS plan in Appendix 1 and proposed plans in Appendix 2.**

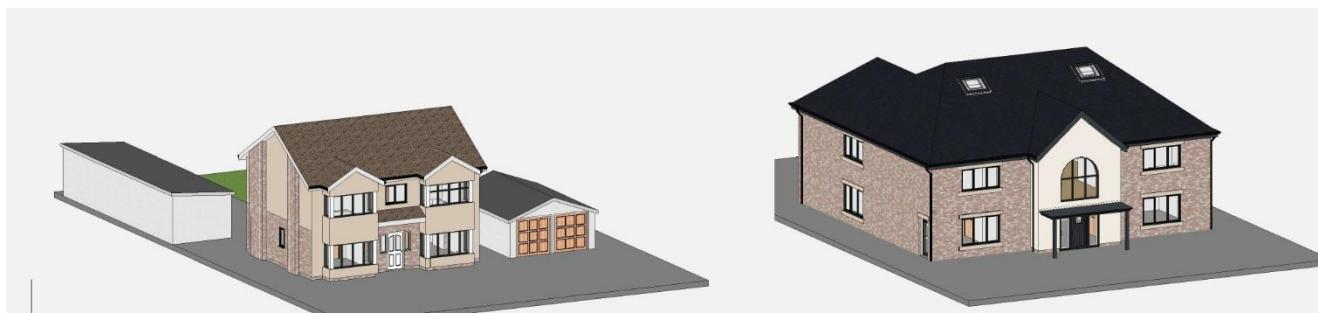
### Proposed New Build

EXISTING 3D VIEW

PROPOSED 3D VIEW
