## **PRELIMINARY ECOLOGICAL APPRAISAL (DBW) AT 65 EGREMONT DRIVE LOWER EARLEY**

**Ref: SPH/NP/PEA-25/09.12**

Urban Tree Experts was commissioned by Mr C Putigampu to conduct a preliminary ecological appraisal (daytime bat walkover [DBW]) of 65 Egremont Drive, Lower Earley, Reading, RG6 3BS. This is to support a forthcoming planning application to Wokingham Borough Council.

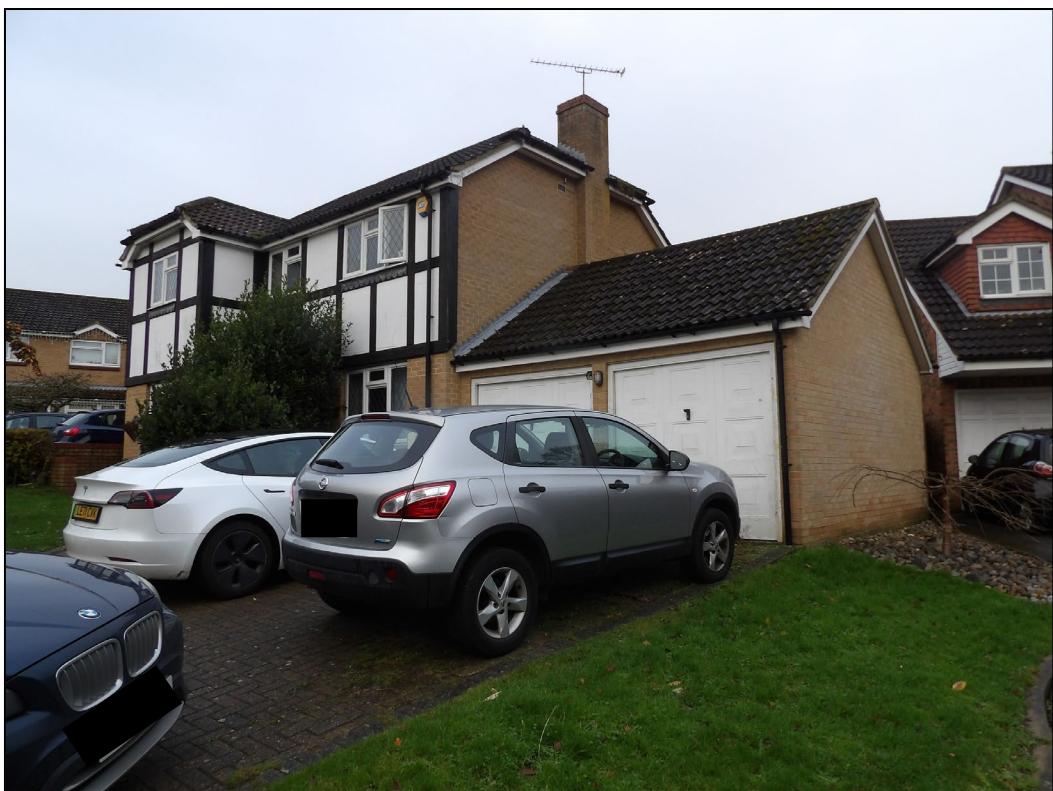
On the northern elevation is the attached garage, see cover photograph. The pitched roof is covered in composite interlocking tiles, none of which are broken or missing and the ridge tiles are firmly cemented in, see Figure 9 on page 11. The verge is sealed, as is the lead flashing affixing it to the main property (see Figure 10 on page 11) and the uPVC soffits and fascias are tight to the wall and do not offer any roosting opportunities, see Figure 10 on page 11.

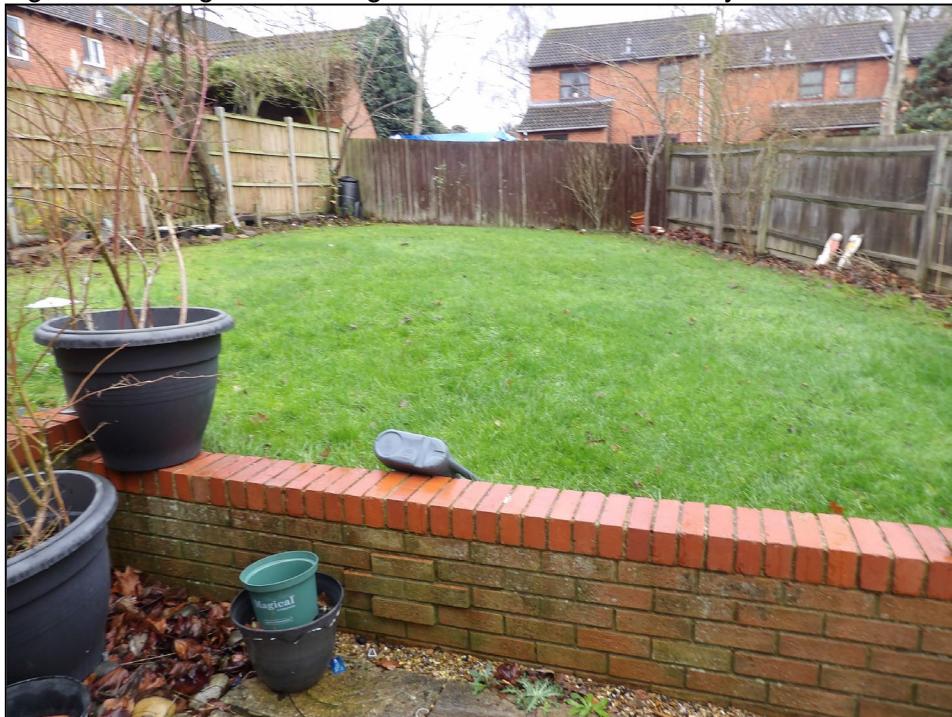
Figure 3. Rear garden. 65 Egremont Drive, Lower Earley. 09.12.25

The application site comprises a detached, 2 storey brick-built mock “Tudor” property with attached double garage. The remainder of the site comprises a paved driveway/parking area to the front with lawn and shrubs and a rear garden laid to lawn with occasional shrubs on the boundaries, see Figure 3 below. The site offers limited foraging or commuting habitat for bats, however there is some ecological connectivity to bat foraging and commuting habitat via the garden network.

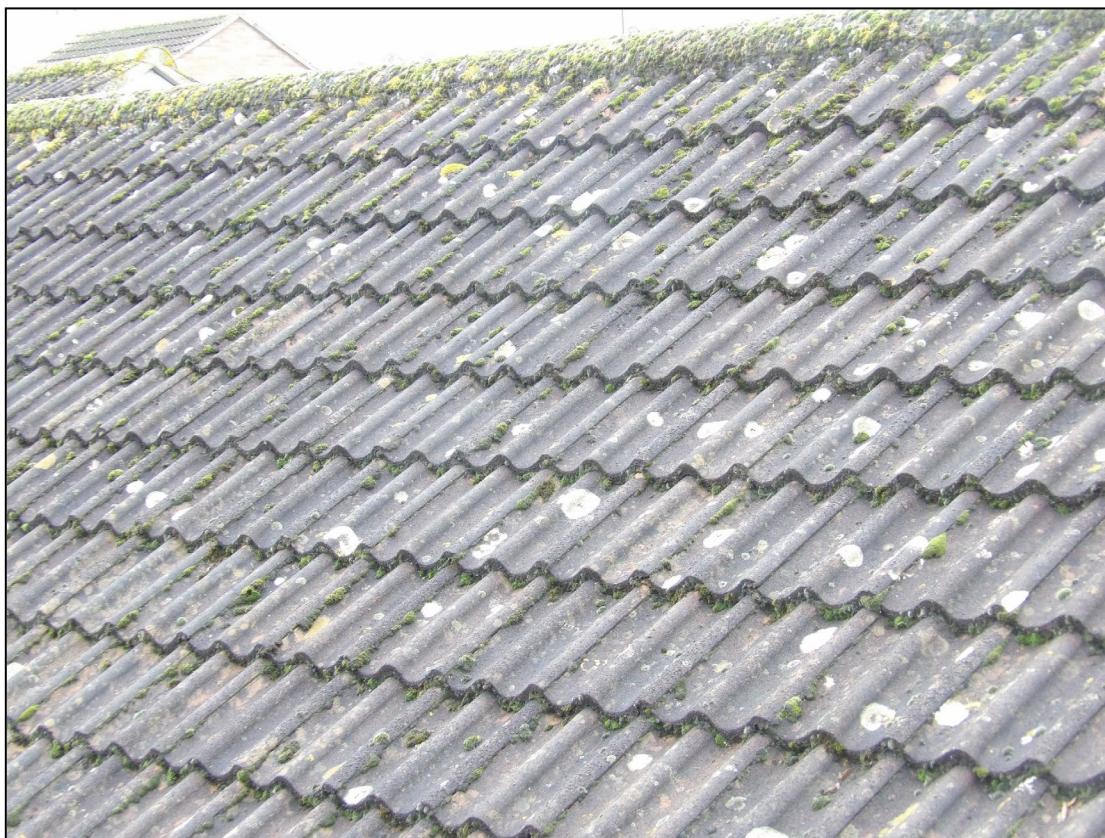
Figure 4. Example of interlocking roof tiles. 65 Egremont Drive, Lower Earley. 09.12.25

The property is a detached, brick-built mock “Tudor” two storey building which is in a good condition externally. The crossed half-hipped roof is covered in composite interlocking tiles, none of which are broken or missing, see Figure 4 below. The ridge and hip tiles and valleys are firmly cemented with no missing mortar or gaps that crevice dwelling bat species could exploit, see Figure 5 on page 9. The lead flashing around the chimney stack is flush (see Figure 6 on page 9) and there is no missing mortar from the verges, see figure 7 on page 10. The uPVC fascias and soffits are tight to the wall with no splits or gaps and offer no roosting opportunities for bats, see Figure 8 on page 10.

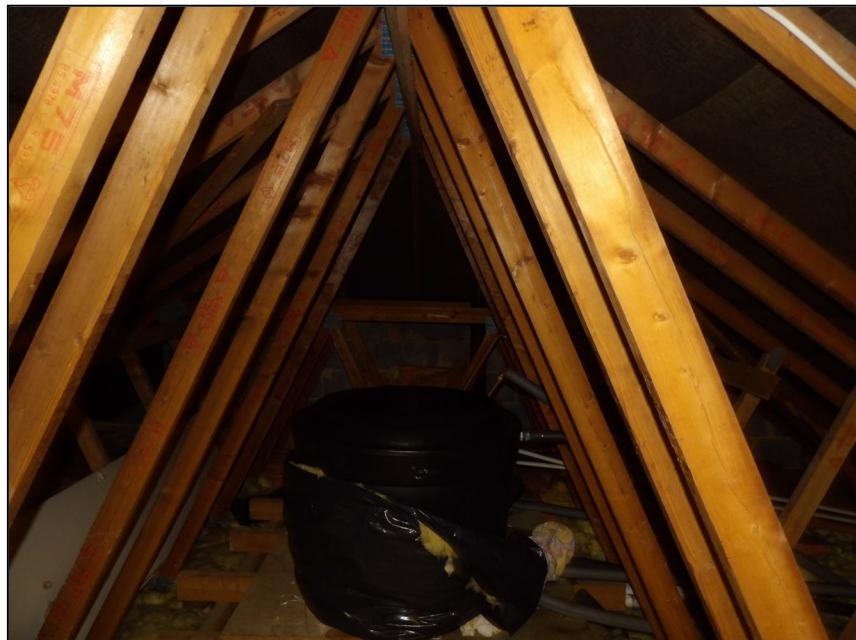
Figure 11. Example of main loft space.  
65 Egremont Drive,  
Lower Earley.  
09.12.25

The loft of the property was accessed via a loft ladder and is in a good condition. The loft space was partially lit, partially boarded and insulated and the roof tiles are lined with bitumen felt, all of which appeared to be in a good condition with no rips or tears, see Figure 11 below. The loft space within the garage was accessed via steps and is in a good condition. The loft space was not lit, partially boarded and insulated and the roof tiles are also lined with bitumen felt, all of which appeared to be in a good condition with no rips or tears, see Figure 12 below.

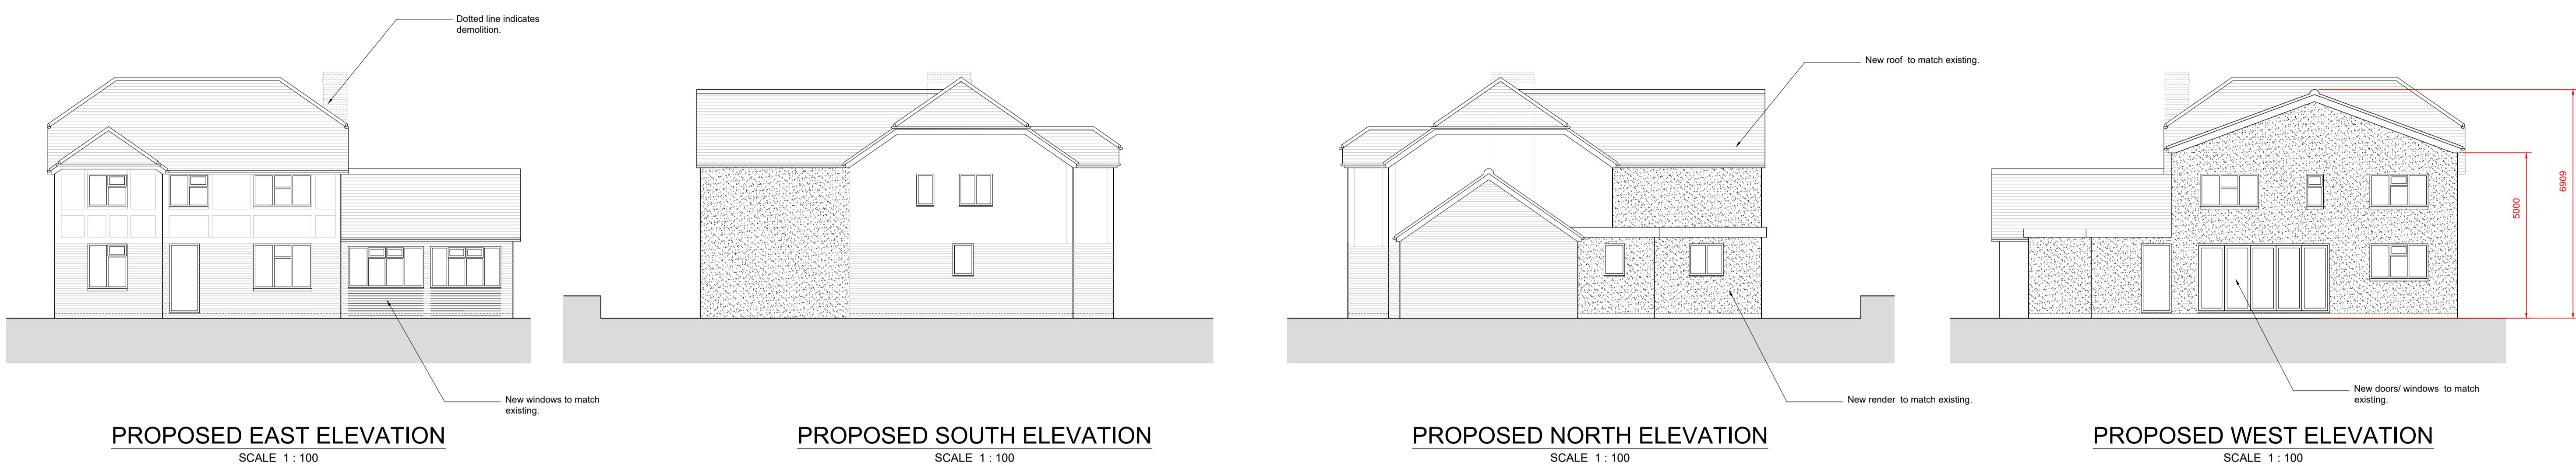
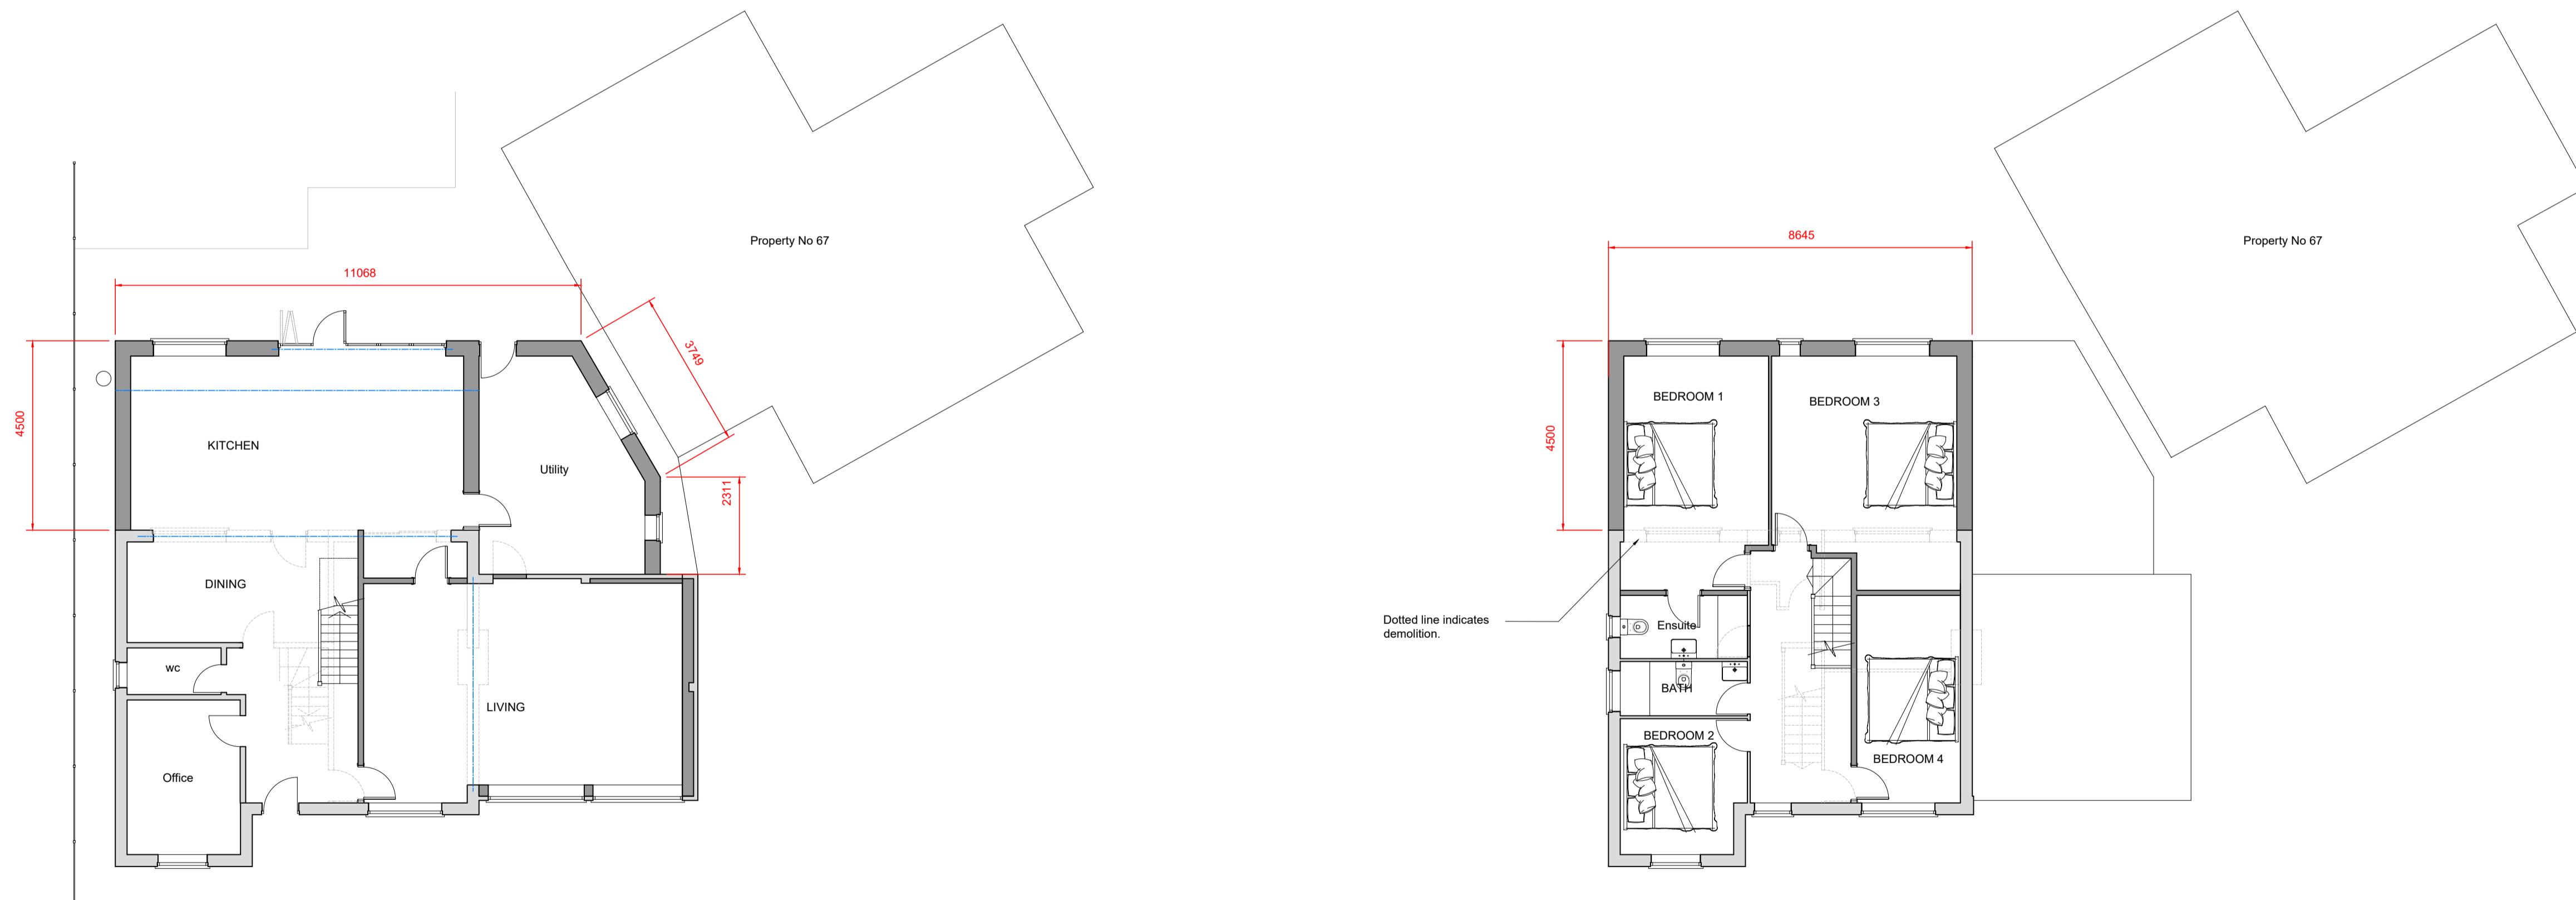
Drawing Title:  
PROPOSED PLANS AND ELEVATIONS

The survey was commissioned in connection with a forthcoming planning application to Wokingham Borough Council that will seek to construct a two storey rear and part single storey side extension and convert the garage into habitable accommodation, see plans at Appendix 1.

Project:  
Two storey rear and part single storey side extension  
and a Garage conversion.
