# **Preliminary Roost Assessment**

Former Arborfield Studios  
(Parcels W, Y and Z)

**Report on Behalf of:**  
Crest Nicholson Operations Ltd.

**PEG659-02C**

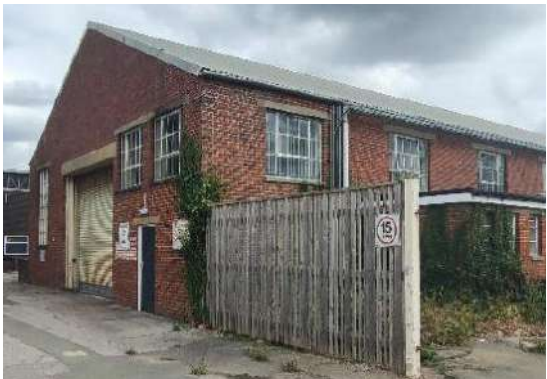
| Building Reference | Bat Suitability | PRFs Identified | Evidence of bats | Building Description | Photographs |
|---|---|---|---|---|---|
| B15 | Low | <p>Gaps in mortar on NW gable rakes</p> <p>Gaps behind barge boards on W gable end</p> <p>Gaps under corrugated sheet roof at eaves along N and S aspects</p> | None | <p>A large brick built structure with a pitched, corrugated sheet roof and metal windows throughout. 2 flat roof extensions were present on the western aspect (B15a &amp; B15b). There are no internal roof voids, though a false ceiling is present throughout. The northern length has separate rooms. All internals are bright and unsuitable for void roosting bat species.</p> | |

A minimum of one bat emergence survey visit is recommended for buildings B1, B5, B15, B16, B18, and B24.

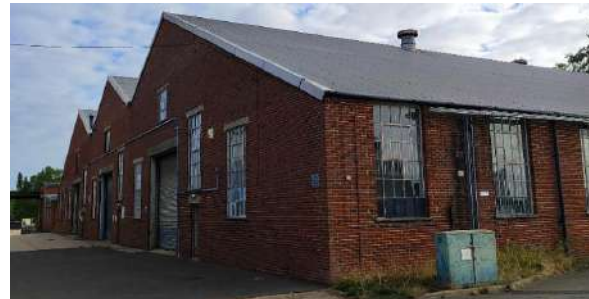
| Building Reference | Bat Suitability | PRFs Identified | Evidence of bats | Building Description | Photographs |
|---|---|---|---|---|---|
| B16 | Low | <p>Gaps behind barge boards on each end of the structures</p> <p>Weep holes in mortar (16a)</p> <p>Weep holes in mortar (16b)</p> <p>Gap in brickwork on southern aspect</p> | None | <p>Large industrial unit of brick and steel construction with multi-pitched metal sheet roof and a boiler room to the south of the eastern aspect (B16a) and toilets on the north of the eastern aspect (B16b). Internally there are 3 large hangars with separated rooms in a lower section to the north and south of the building. All internals are bright and open with windows on all aspects. Evidence of nesting birds present.</p> | |

Due to the suitability of the site to support nesting birds, and the presence of nesting material within B16 at the time of survey, it is recommended that any demolition undertaken within the nesting bird season (March – September inclusive) is immediately preceded by a nesting bird check undertaken by an experienced ecologist. This will ensure that no nesting birds are disturbed or harmed by the proposed works. If nesting birds are identified at this time or at any time during construction, then works to the area must halt and advice from an ecologist be sought.

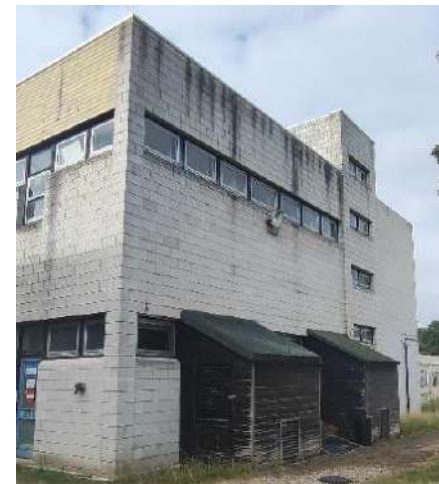
| Building Reference | Bat Suitability | PRFs Identified | Evidence of bats | Building Description | Photographs |
|---|---|---|---|---|---|
| B18 | Low | Gaps in cladding along east and western aspects | None | Two-storey office unit of breeze block construction with a flat, felted-timber roof. An additional narrow third-storey structure on roof which holds stairway and additional utilities. Internally the offices are bright and well sealed. | |

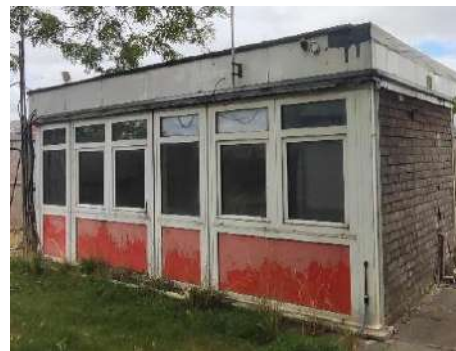
| Building Reference | Bat Suitability | PRFs Identified | Evidence of bats | Building Description | Photographs |
|---|---|---|---|---|---|
| B19 | Moderate | Gaps and crevices in tile cladding throughout.<br>Gaps in soffits | None | Single-storey office unit in a state of disrepair with a steel frame, tile cladding and a flat felted timber roof. Windows run along two aspects and plastic fascias and soffits are present. Internal access not possible due to structural safety concerns. View through windows shows bright internals with some ceiling collapse. | |

A minimum of two bat emergence survey visits are recommended for buildings B11, B12, B19, and B29

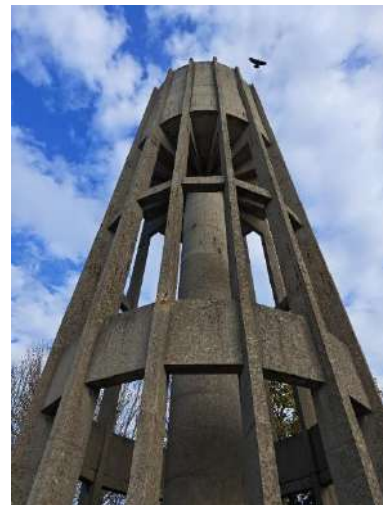
| Building Reference | Bat Suitability | PRFs Identified | Evidence of bats | Building Description | Photographs |
|---|---|---|---|---|---|
| B24 | Low | Central ladder access shaft. | None | Water tower of concrete construction with a central ladder and a flat roof. | |

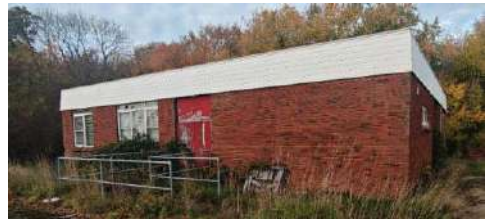
| Building Reference | Bat Suitability | PRFs Identified | Evidence of bats | Building Description | Photographs |
|---|---|---|---|---|---|
| B29 | Moderate | Gaps behind UPVC cladding throughout | None | Detached structure constructed of brick with uPVC-framed windows and timber doors. The building features a flat roof with uPVC cladding around the perimeter at roof level. No internal access was possible. | |

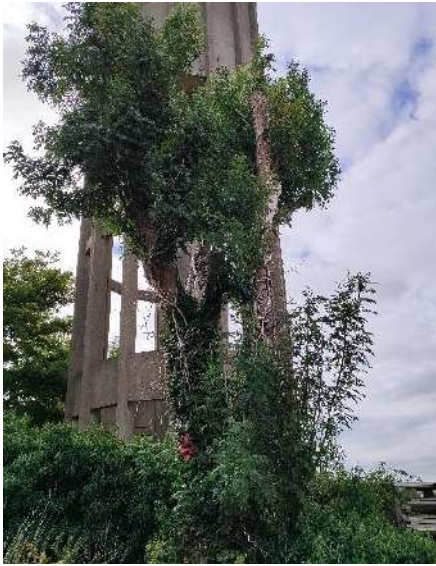
**Photograph 1: TN6.**

- 5.6 All trees within the Site were assessed from ground level to identify any with features suitable to support roosting bats. Seven trees in total (Figures 2&3 - TN6, TN9, TN11, TN12, TN14, TN16, TN35) were identified as FAR (Further Assessment Required). Without further assessment, the possibility that roosting bats are present cannot be ruled out. Table 4 and photographs 1-7 show the details of each tree identified.

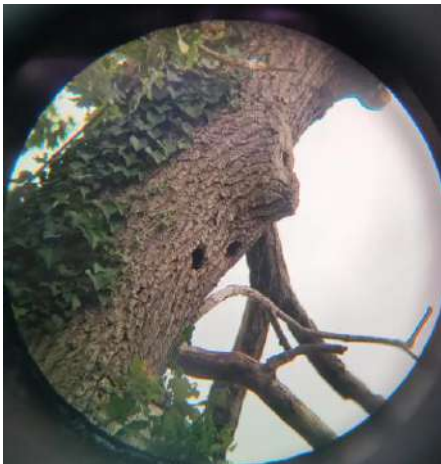
**Photograph 3: TN11.**

| Target Note | Species | PRFs | Categorisation | Photo No. |
|---|---|---|---|---|
| TN11 | Pedunculate Oak | Woodpecker holes, lifted bark, dead limbs with cracks/splits, ivy-clad trunk. | FAR | 3 |

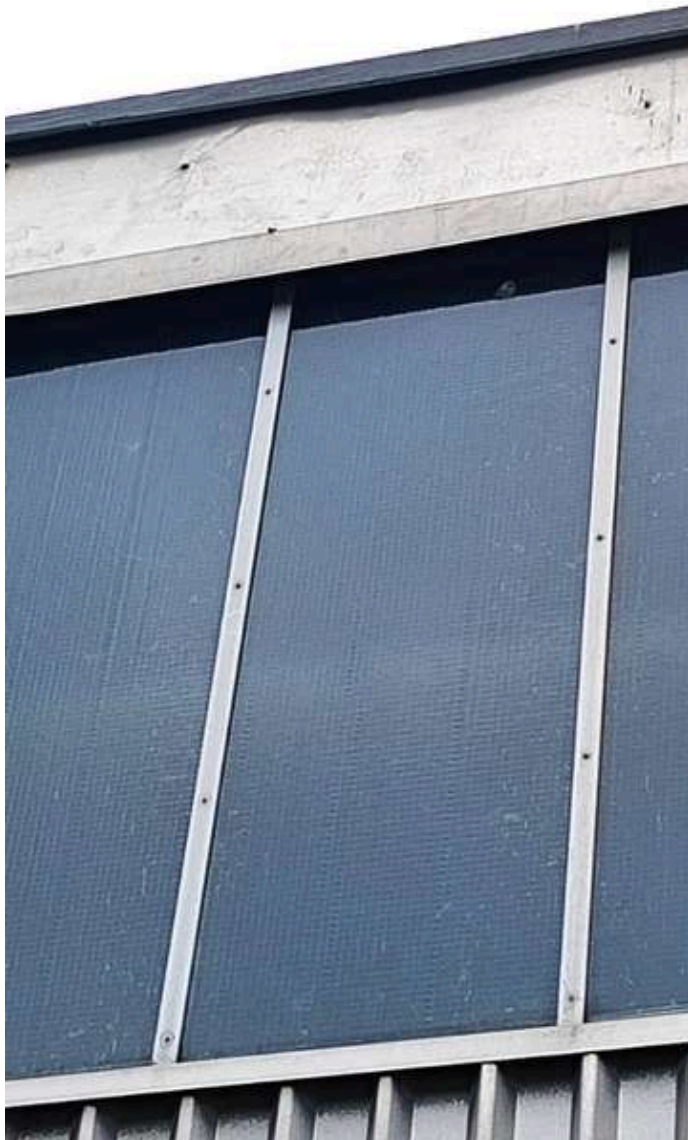
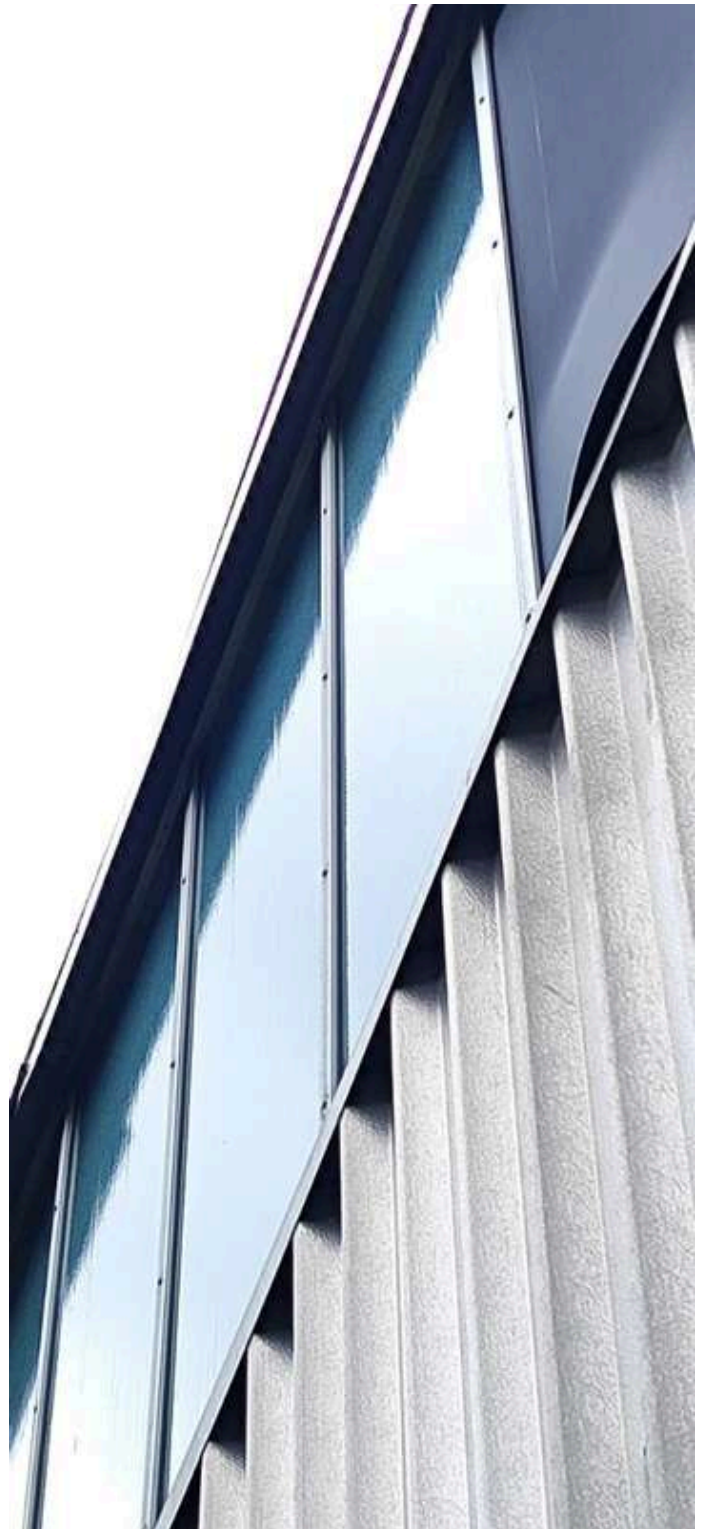
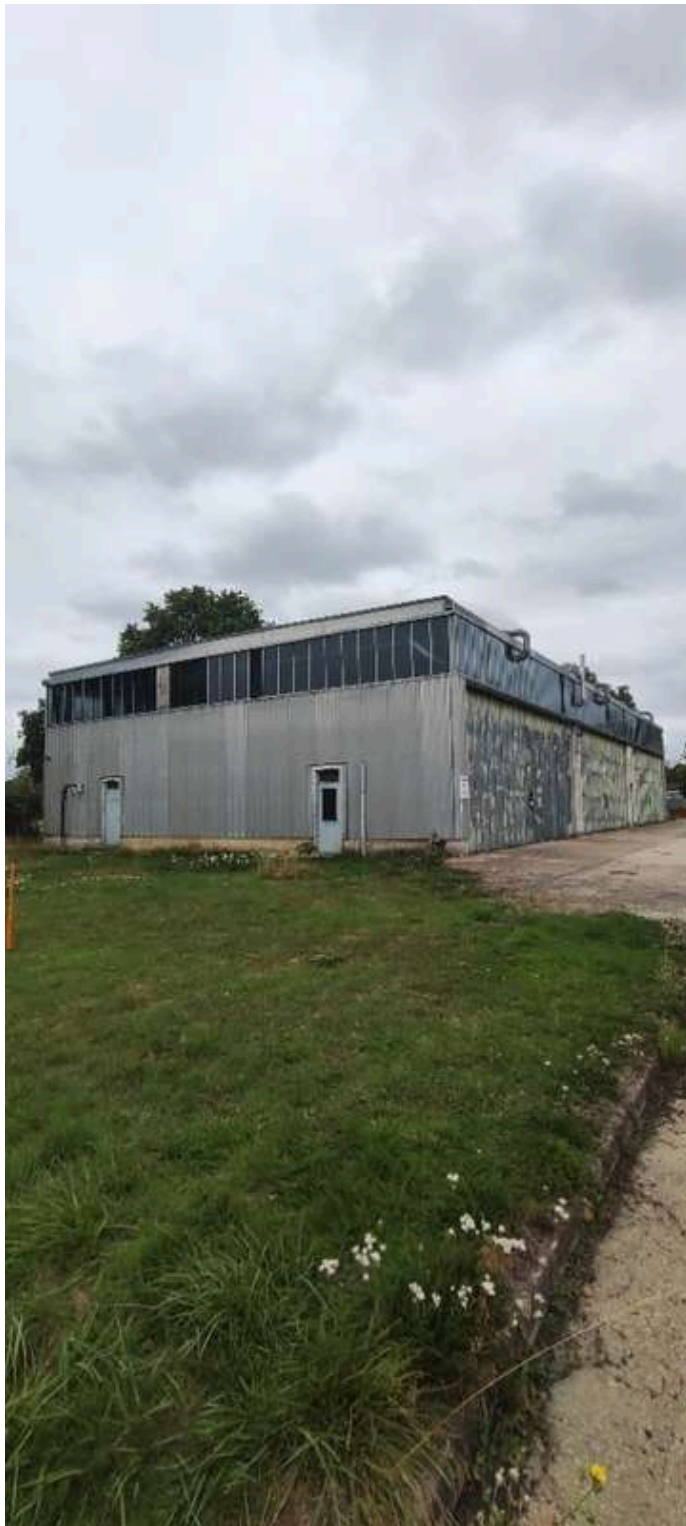
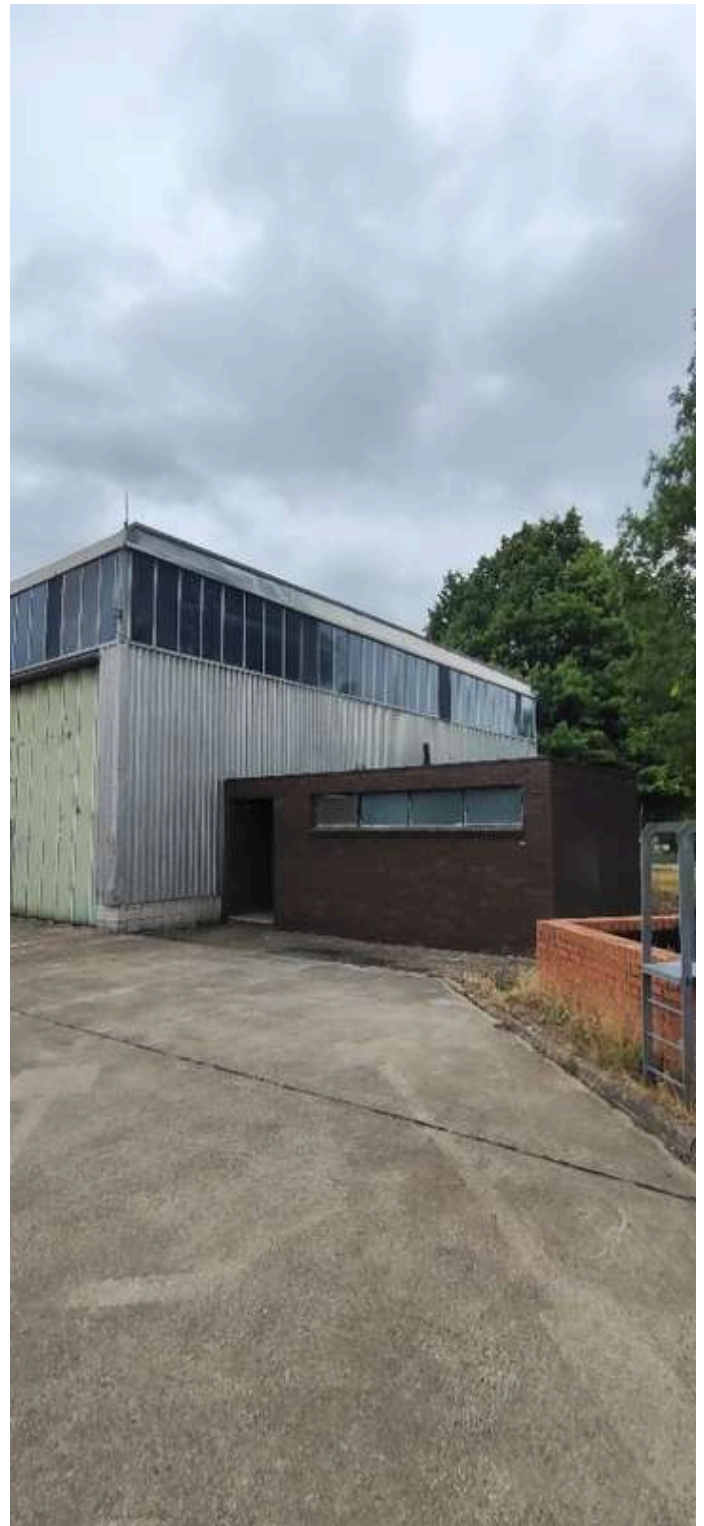
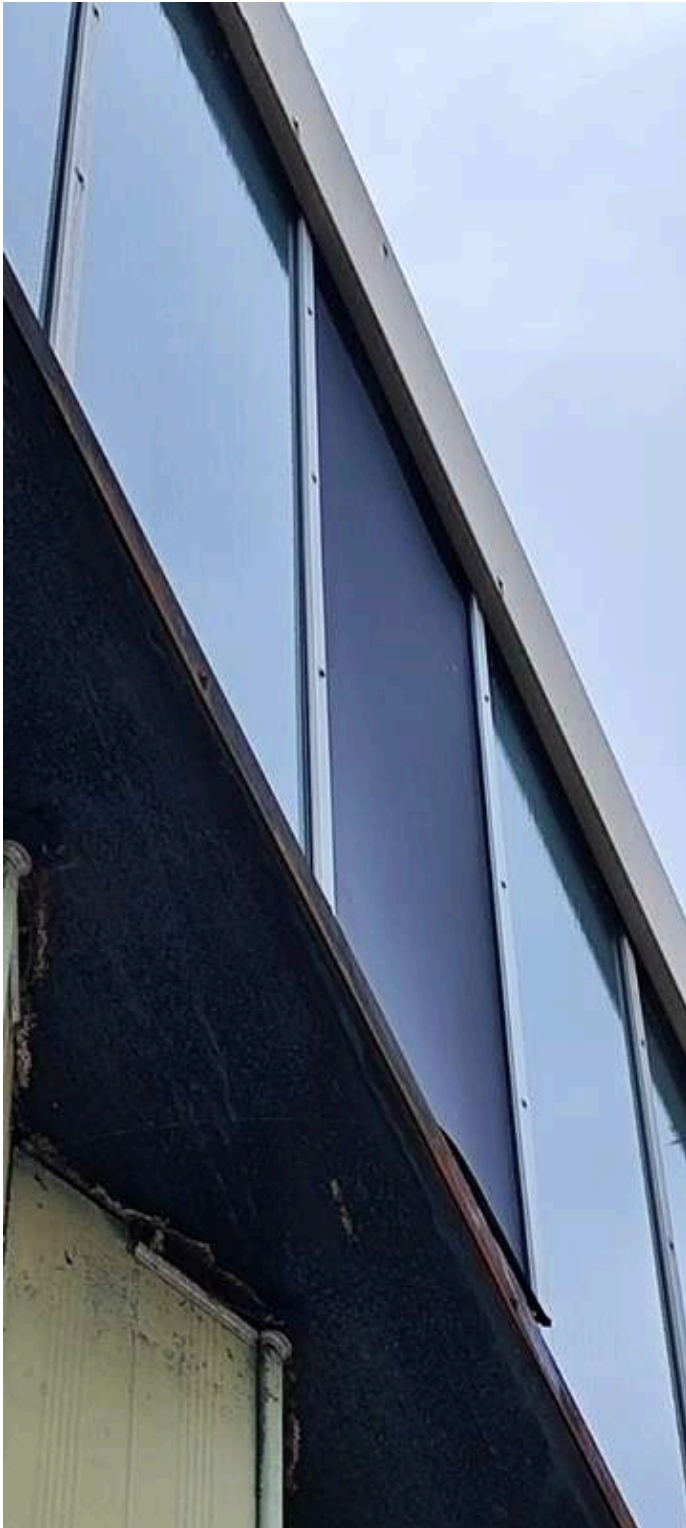
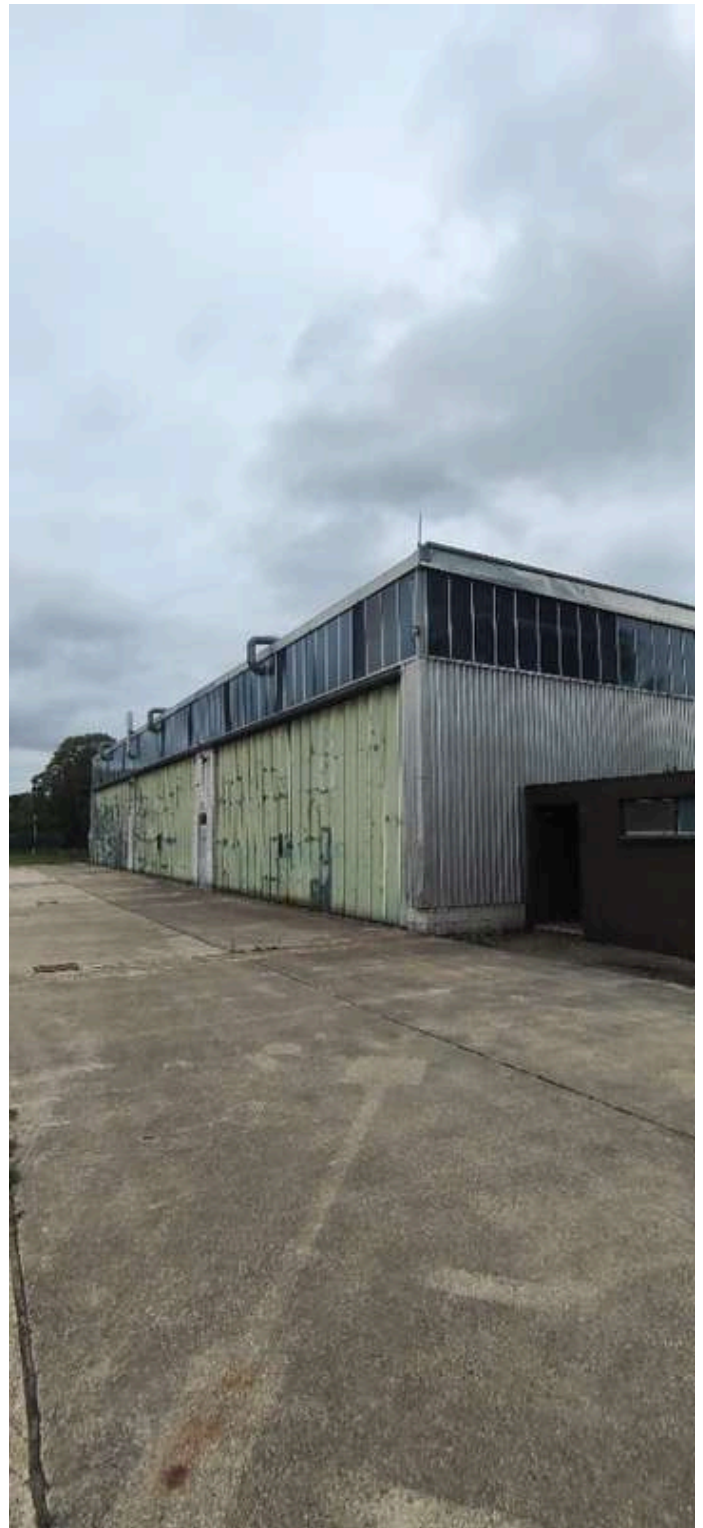
| <b>External Photos</b> | |

| <b>Further Notes</b> | External potential only due to internal conditions. No evidence of bats identified. |

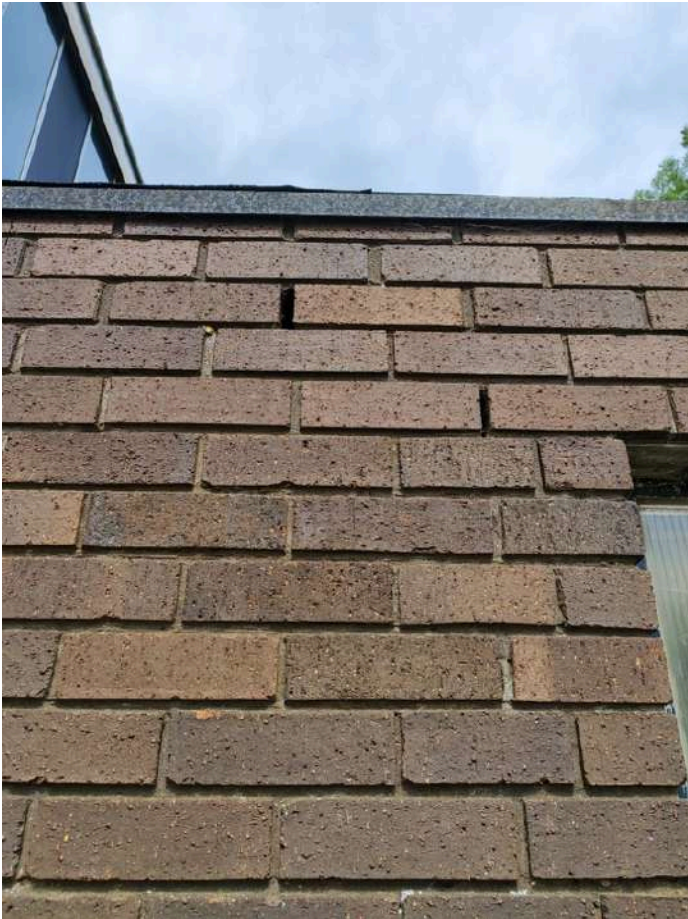
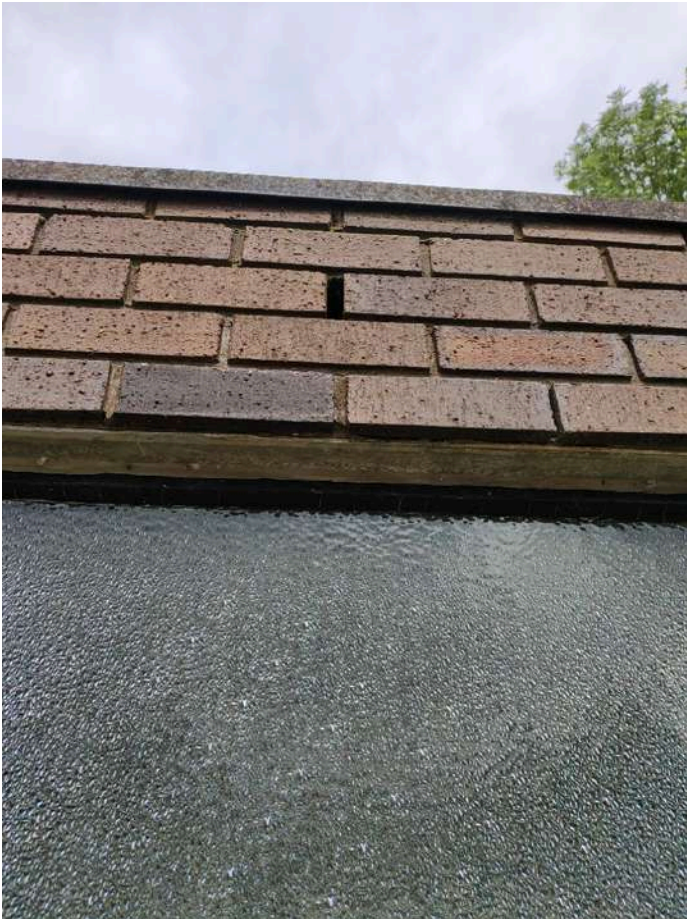
### PRF - A

| Description | Multiple weep holes are present around the top of the single storey brick extension. |

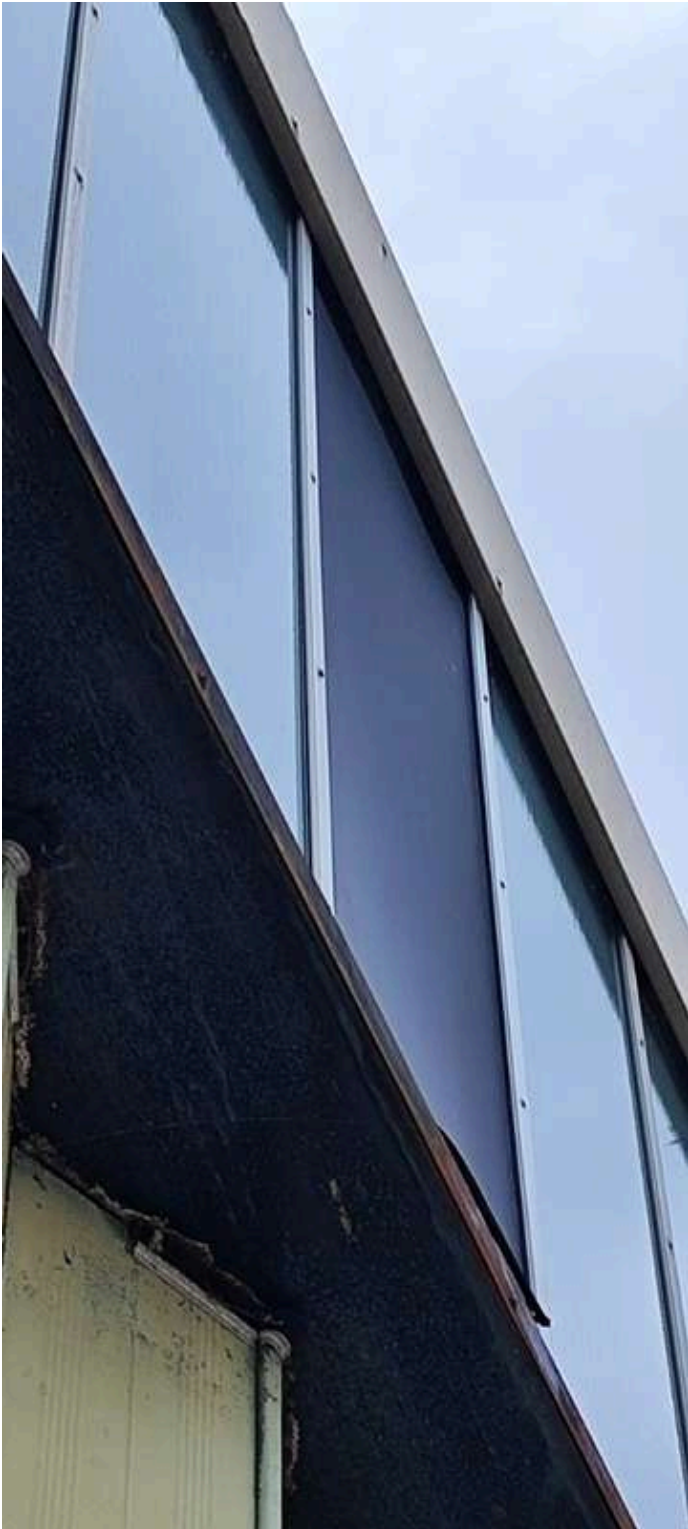
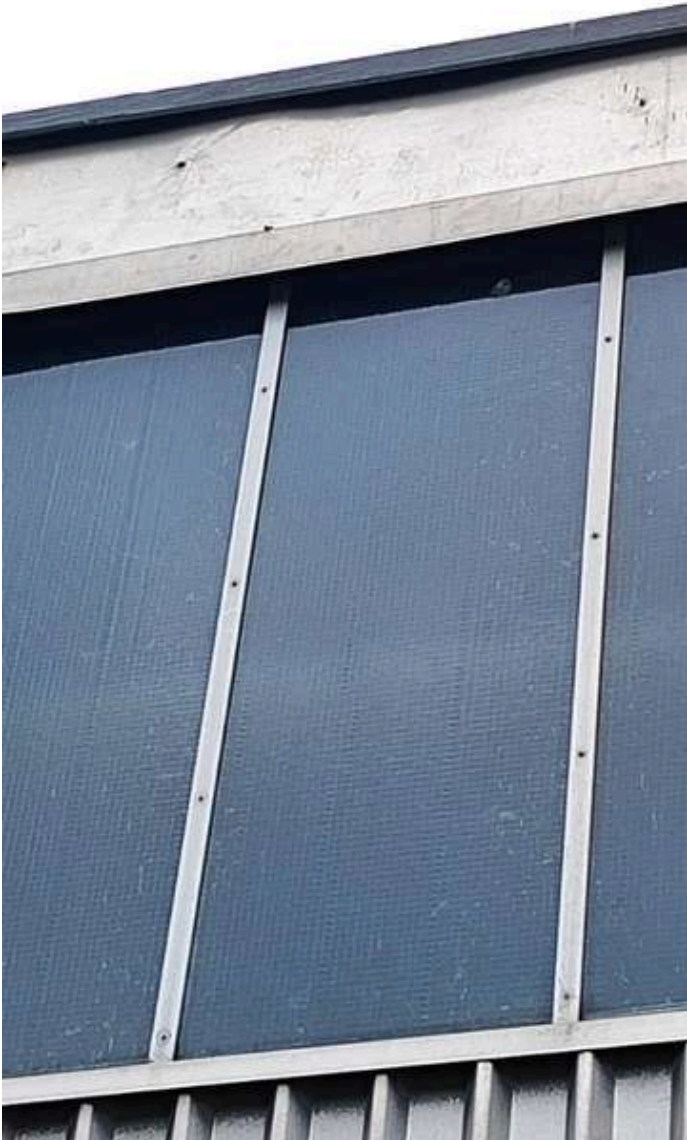
PRF - B

| Description | Gaps are present behind facias around the whole of B14. There is potential for small cavities with roost potential. |

| Bat Roosting Potential | Low |

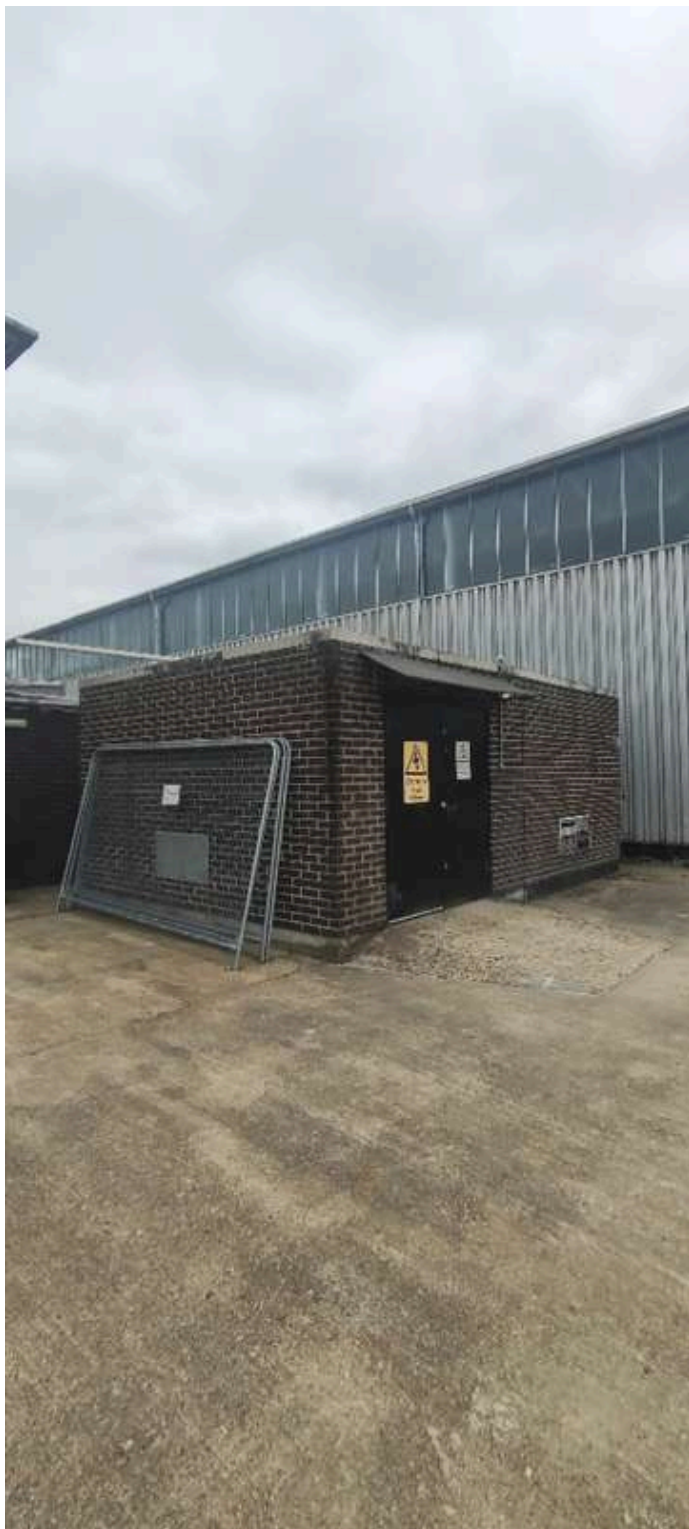
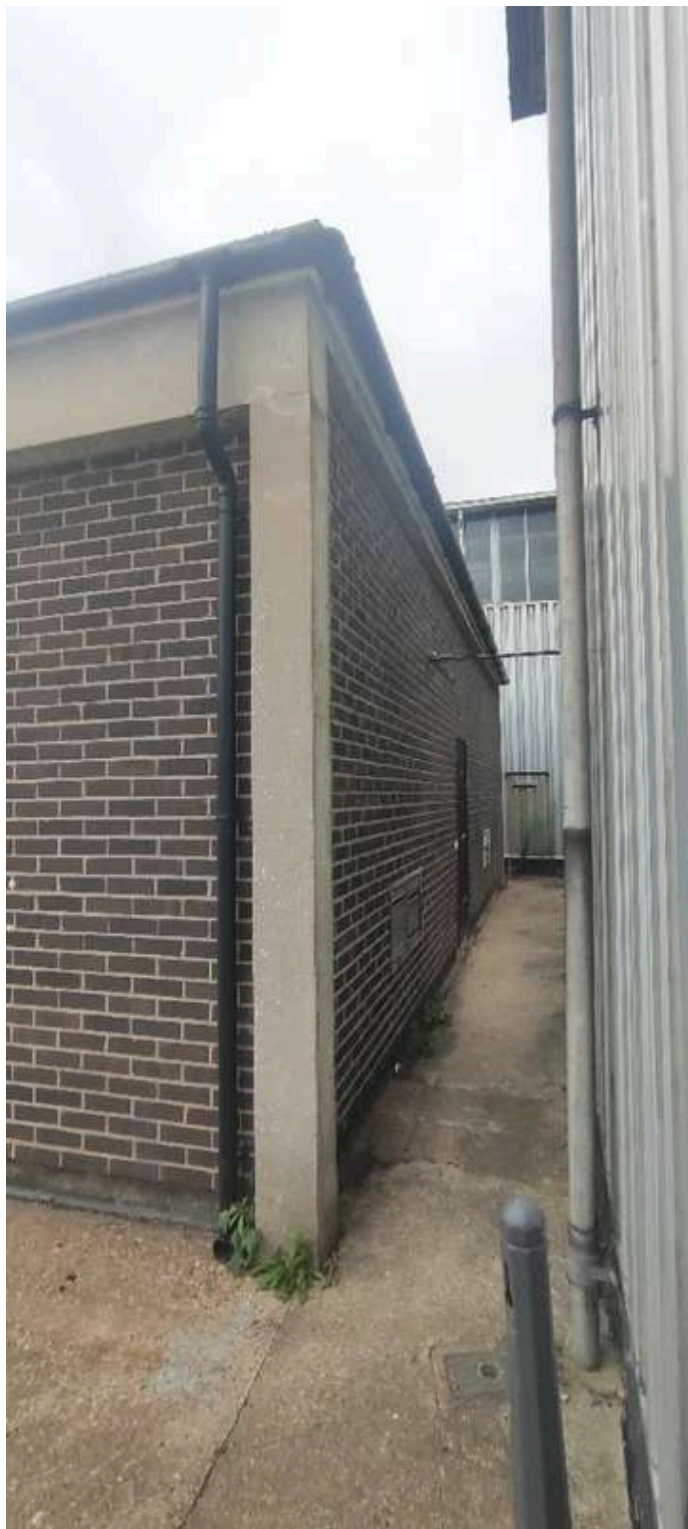
### External Photos

| <b>Further Notes</b> | Occasional gaps are present where vents are installed, but fast moving fans within these likely prevent bat or bird access. |

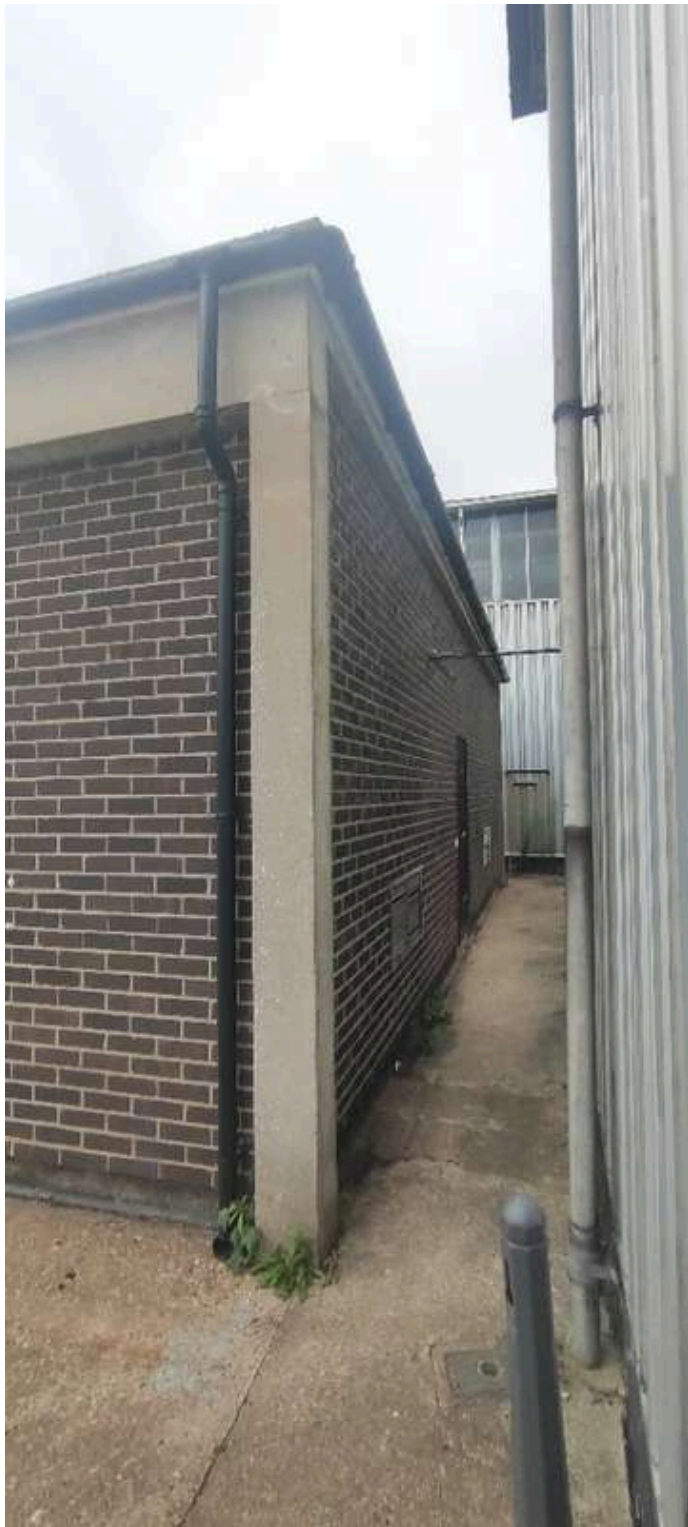
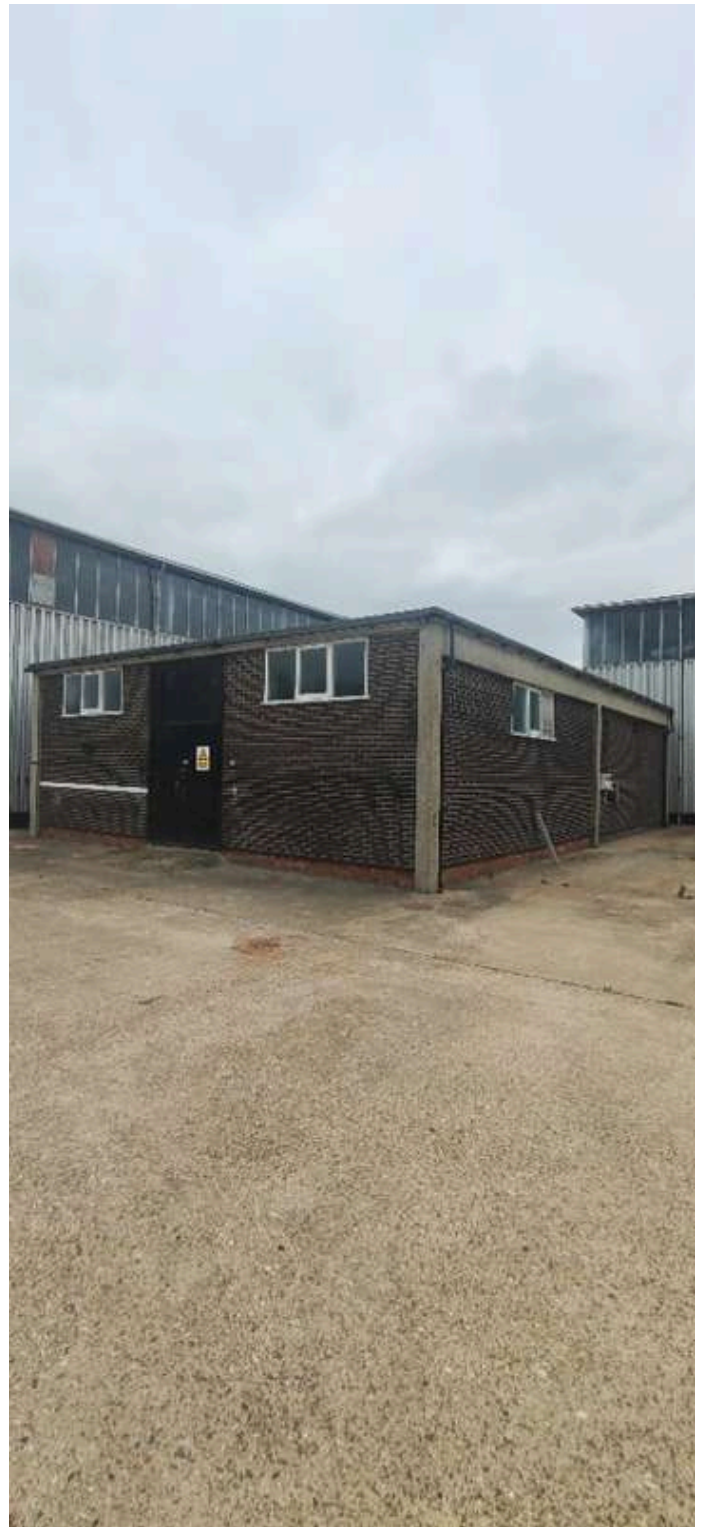
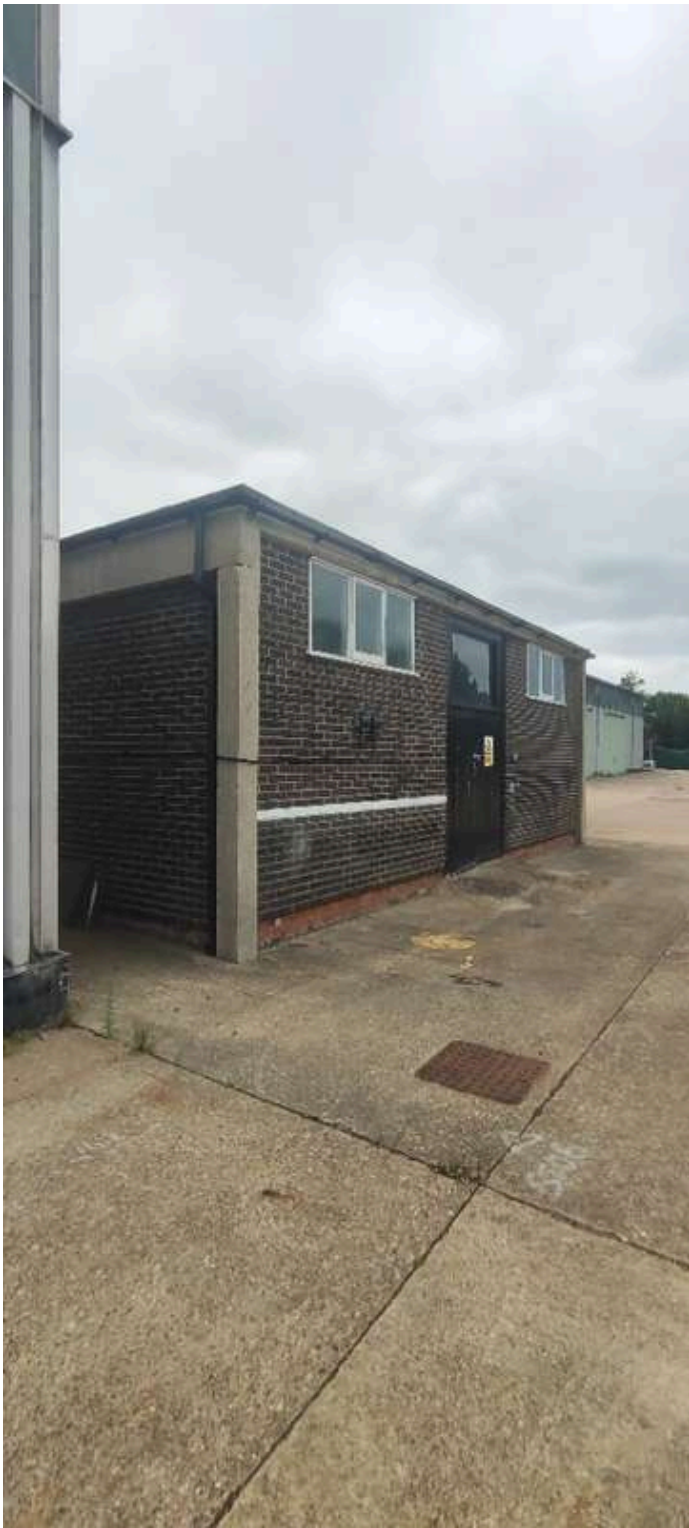
Ther are occasional gaps where the vents are installed, some contain fast moving fans but potential access points are present where fans are not present. No internal access given.

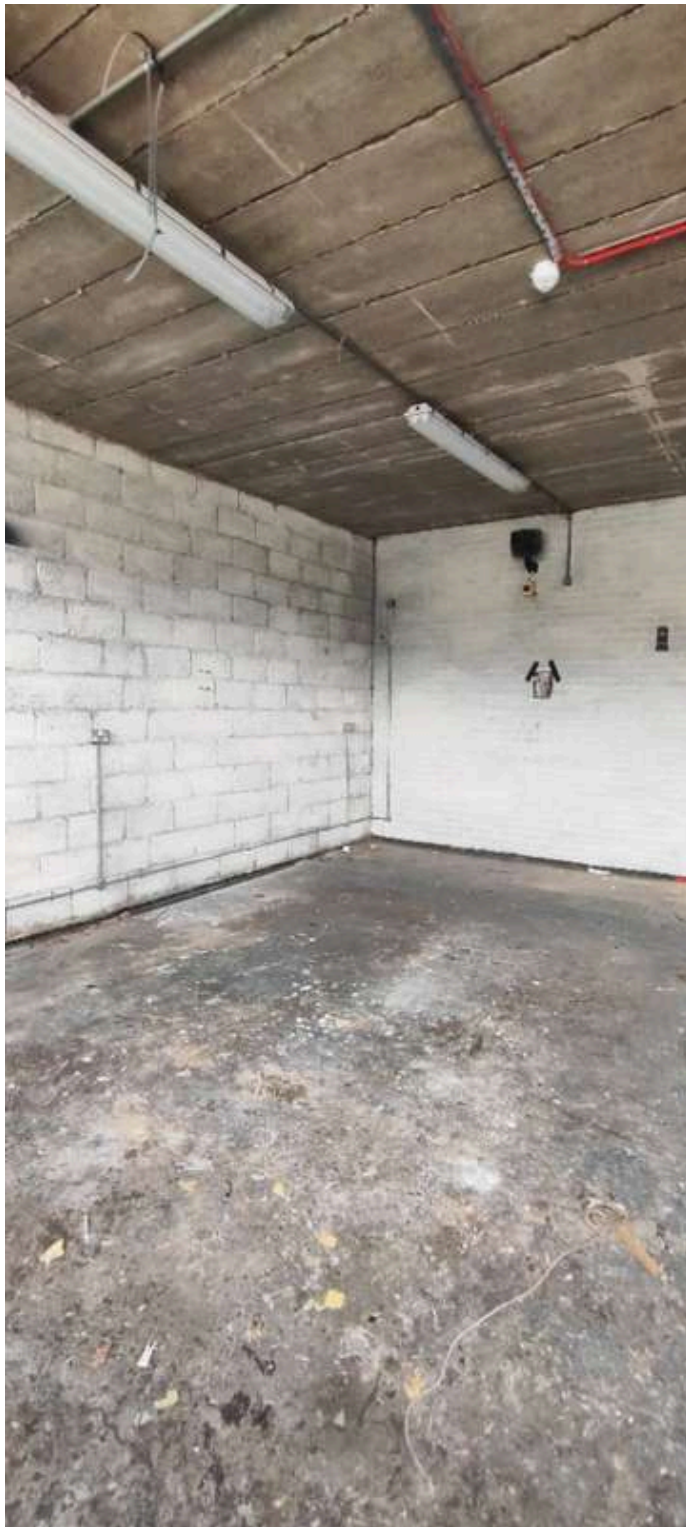
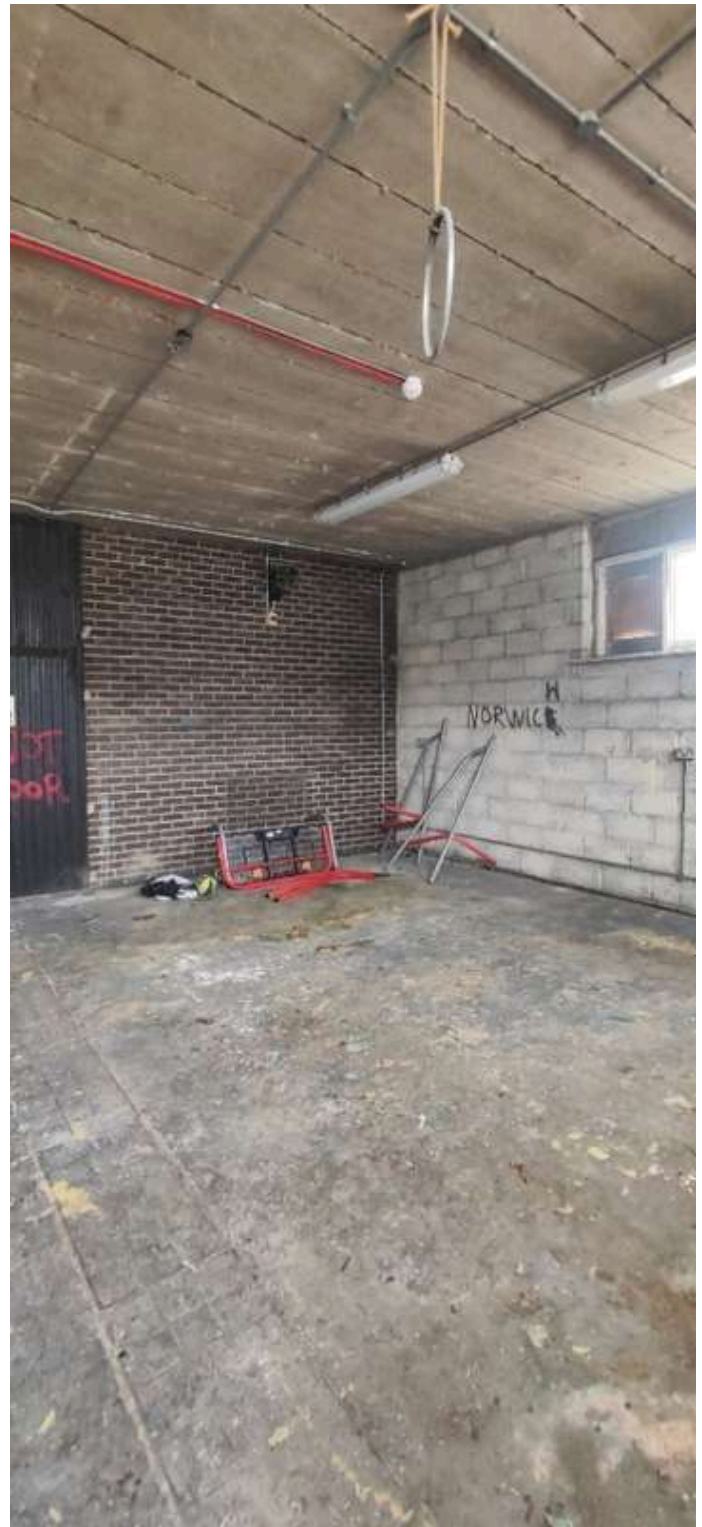
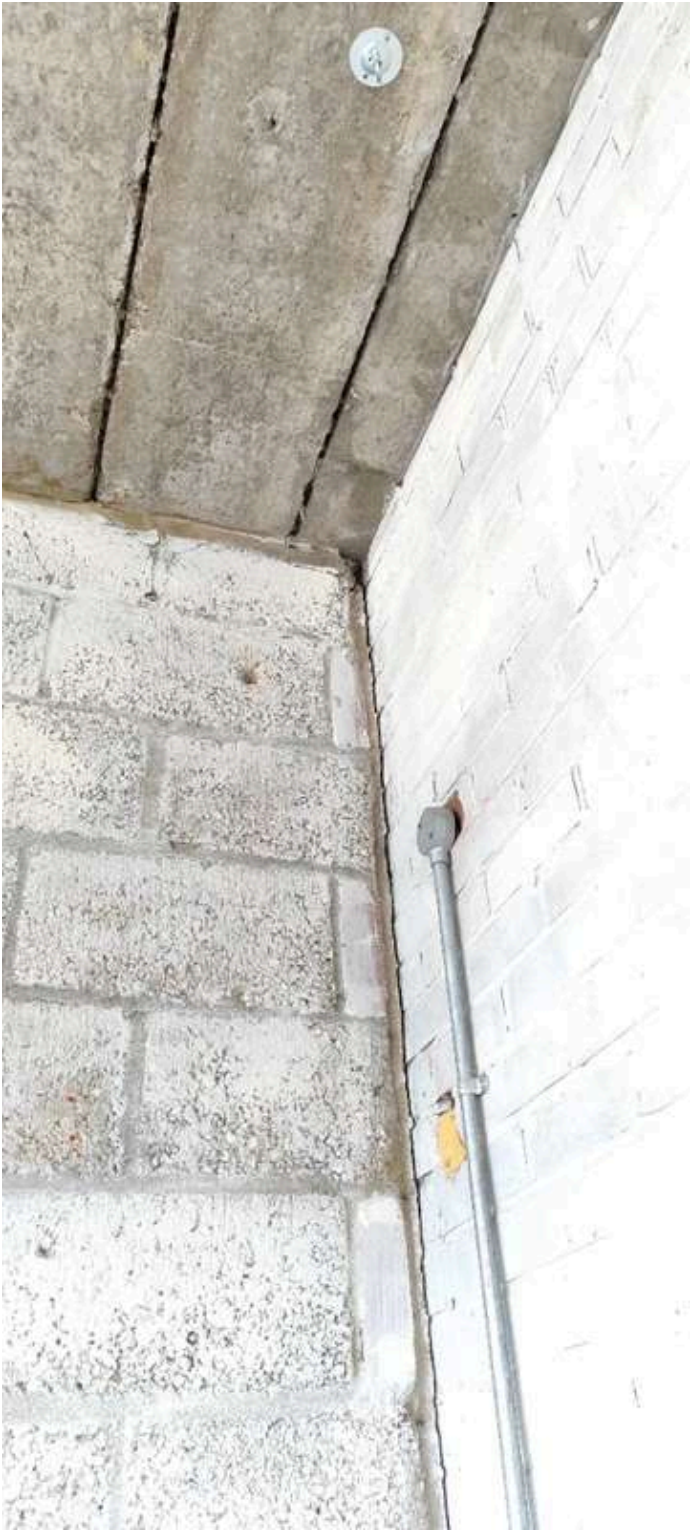
| <b>Description of Bat Evidence</b> | 6 droppings in the back left corner of the room and a single one found along the east wall. |

Droppings located in the building likely over a year old.

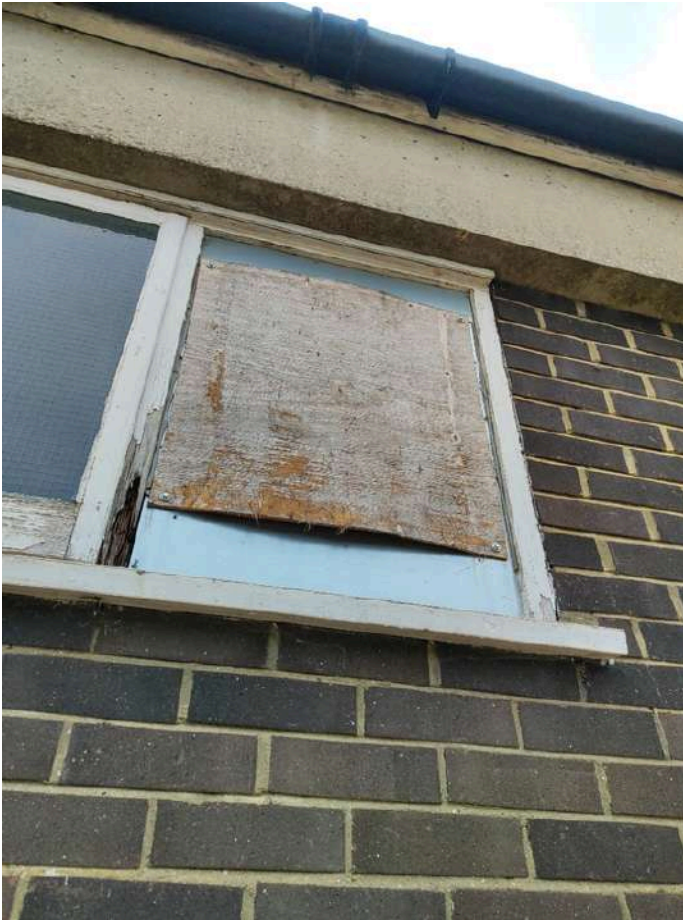
PRF - A

| Description | A window sealed by board with a gap at the base. |

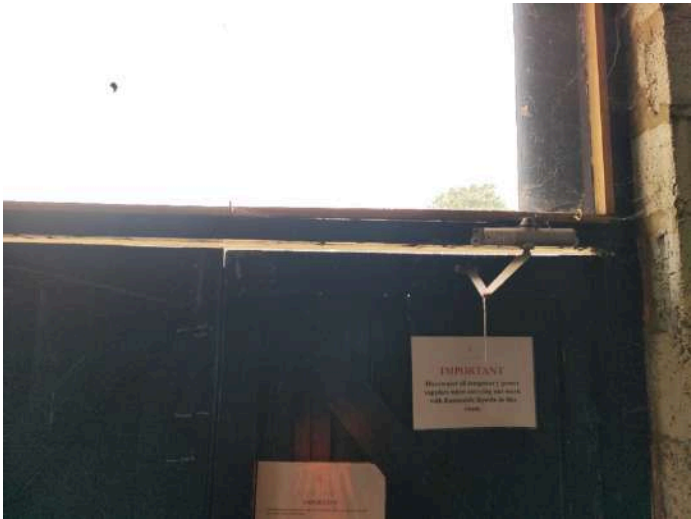
| Description | Gaps are present around the access door, providing potential bat access to internal space. |

| <b>Bat Roosting Potential</b> | Confirmed Roost |

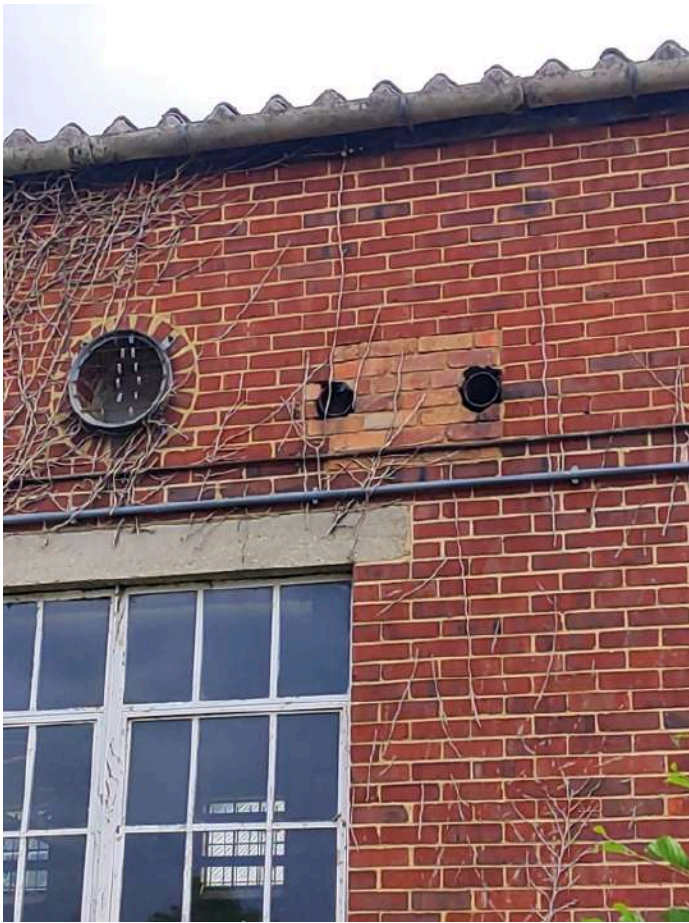
PRF - A

| Description | 2 pipes exiting through the brickwork with gaps around them. |

| Bat Roosting Potential | Low |
