# **Preliminary Roost Assessment**

Former Arborfield Studios  
(Parcels W, Y and Z)

**Report on Behalf of:**  
Crest Nicholson Operations Ltd.

**PEG659-02C**

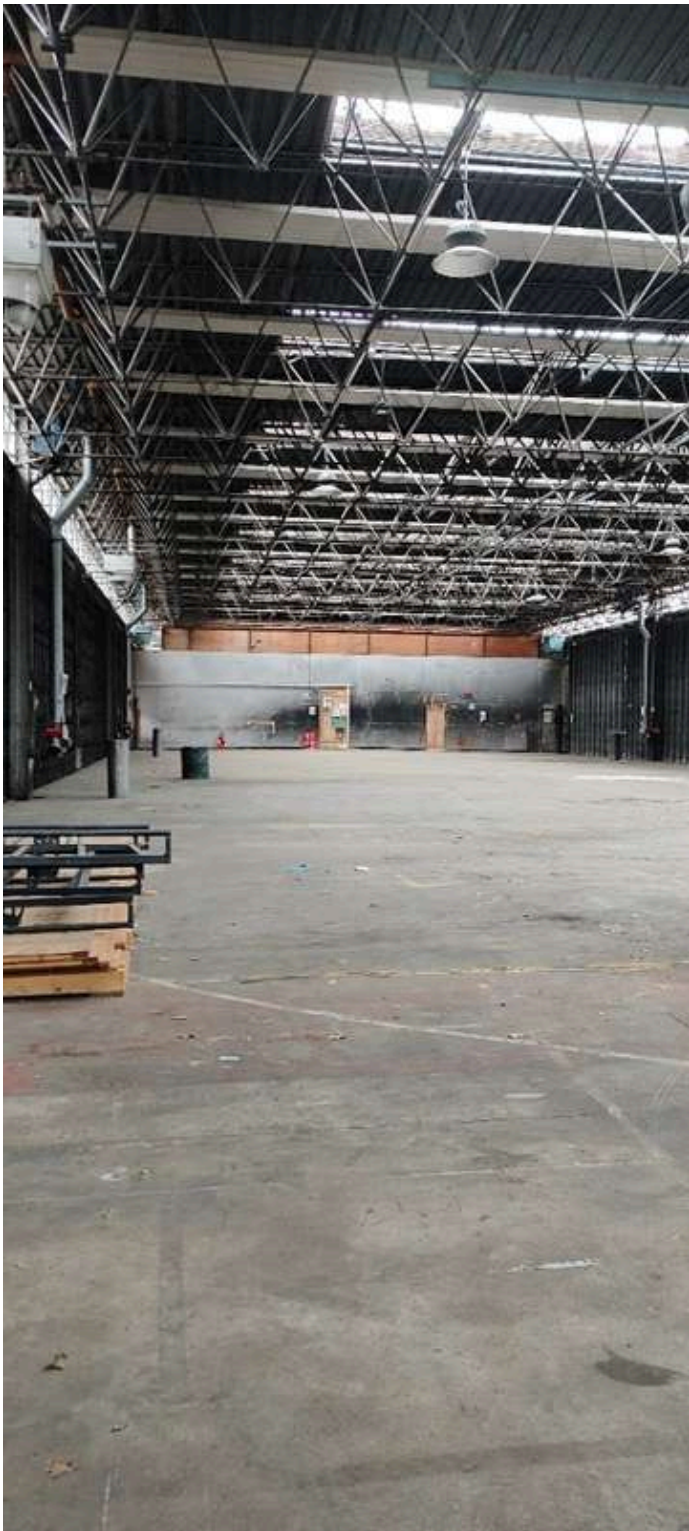
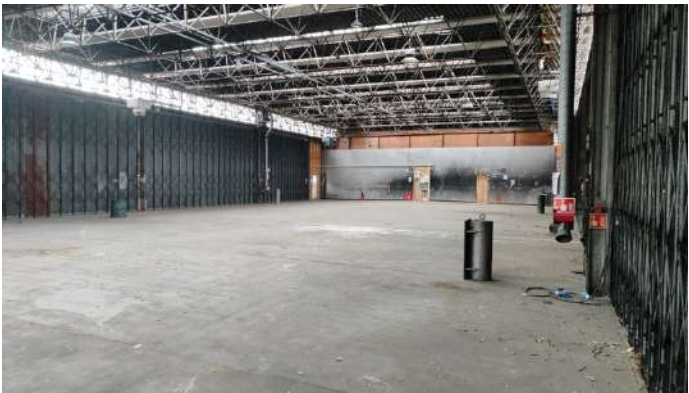
| <b>Description of Internals</b> | A large single open space internally with no roof void present. Broad daylight conditions present due to windows and rooflights throughout. The structure has no suitability for roosting bats. |
| <b>Further Notes</b> | No evidence of and no suitability for roosting bats. |

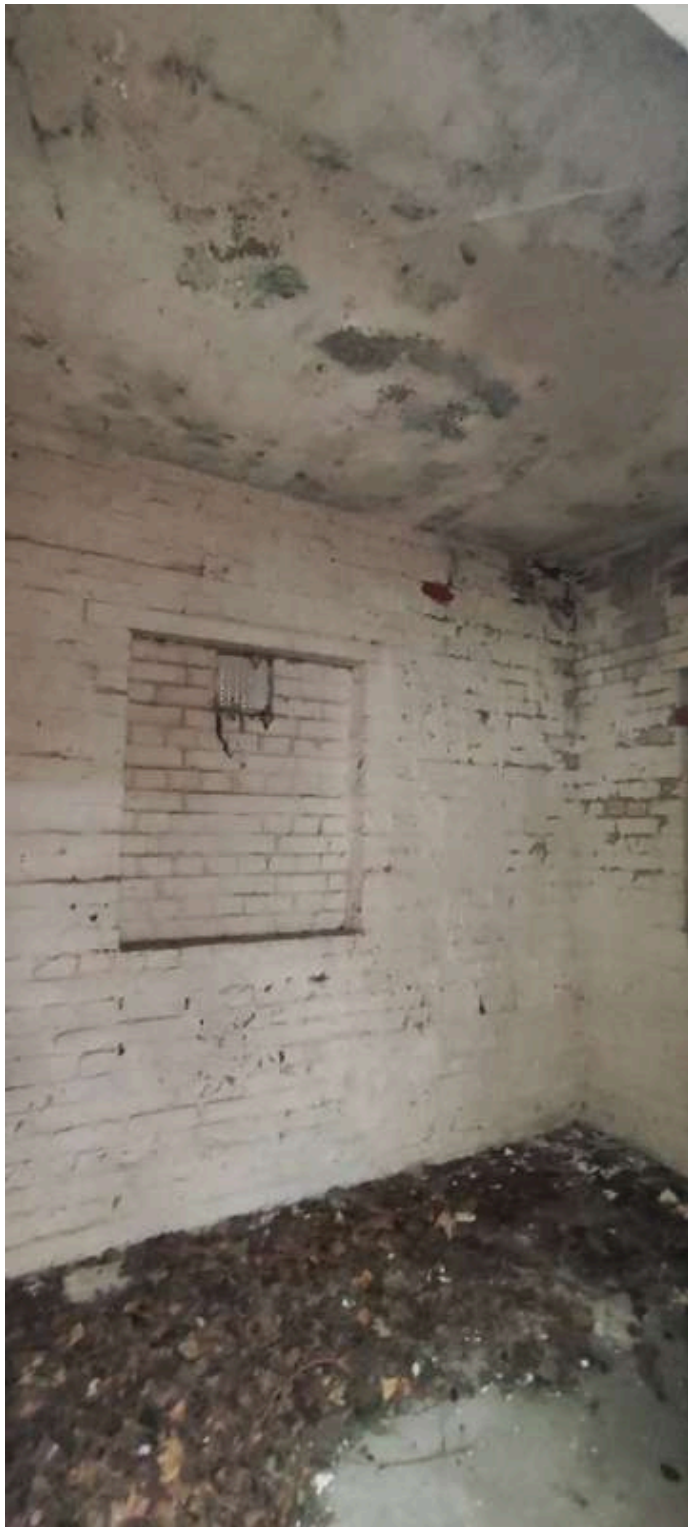
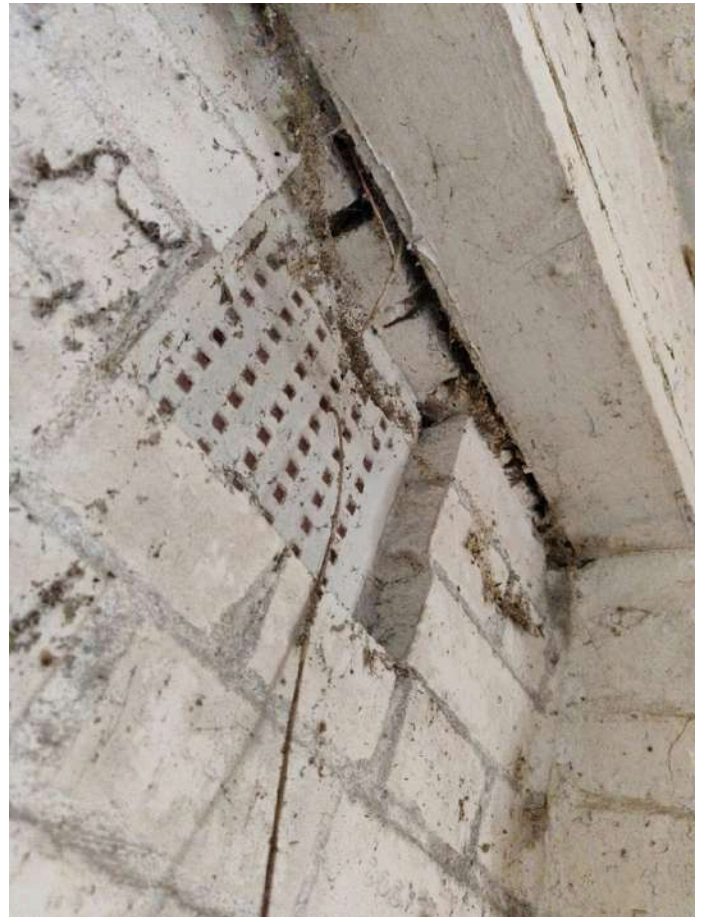
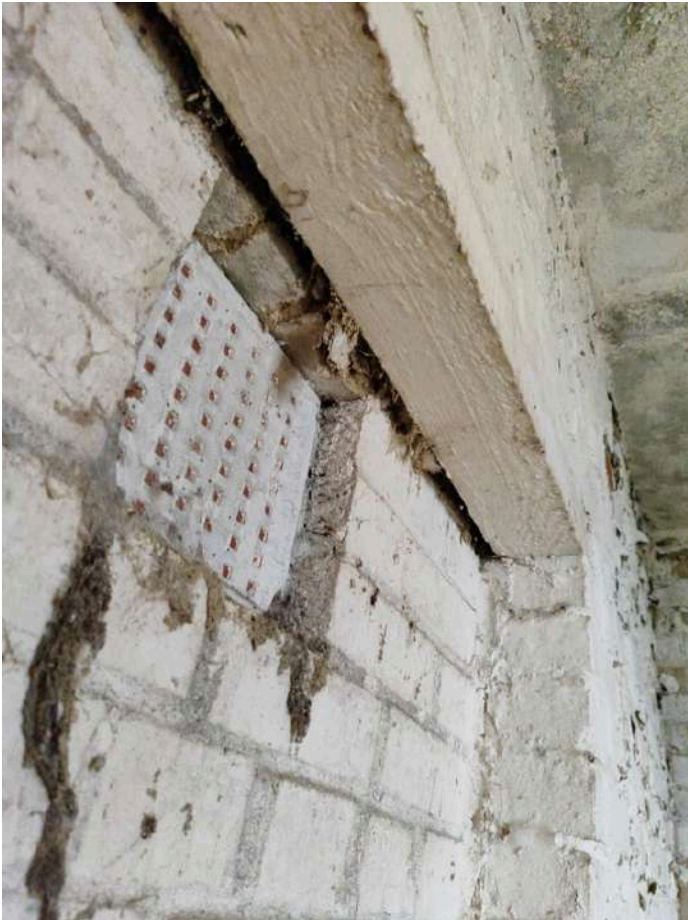
| Description of Bat Evidence | 4 old droppings were found on the windowsill beneath a sealed window. |

| Further Notes | Droppings located beneath window. |

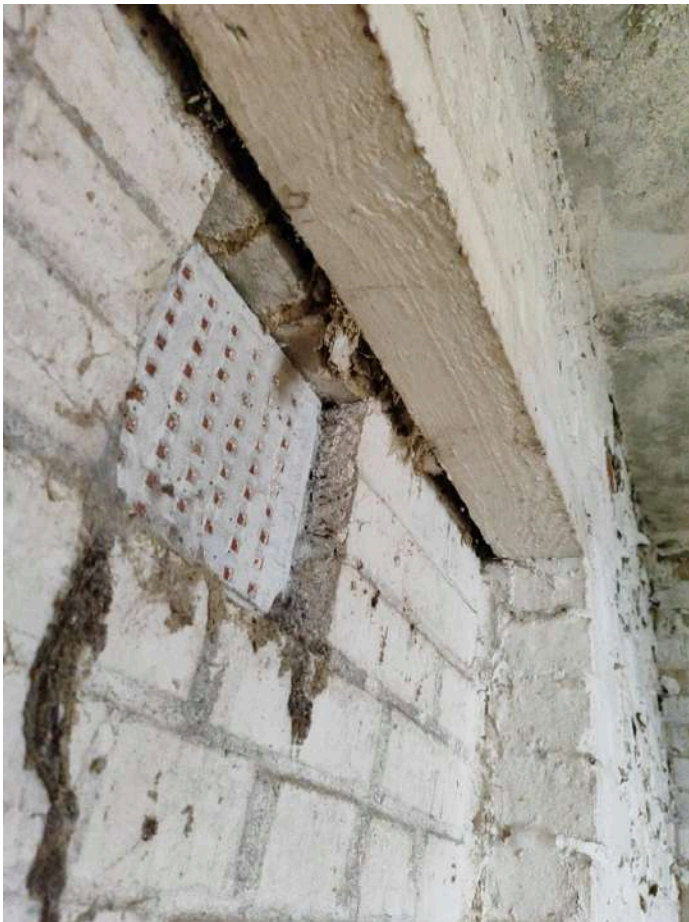
| Description | An internal gap above a blocked window leading to cavity wall. |

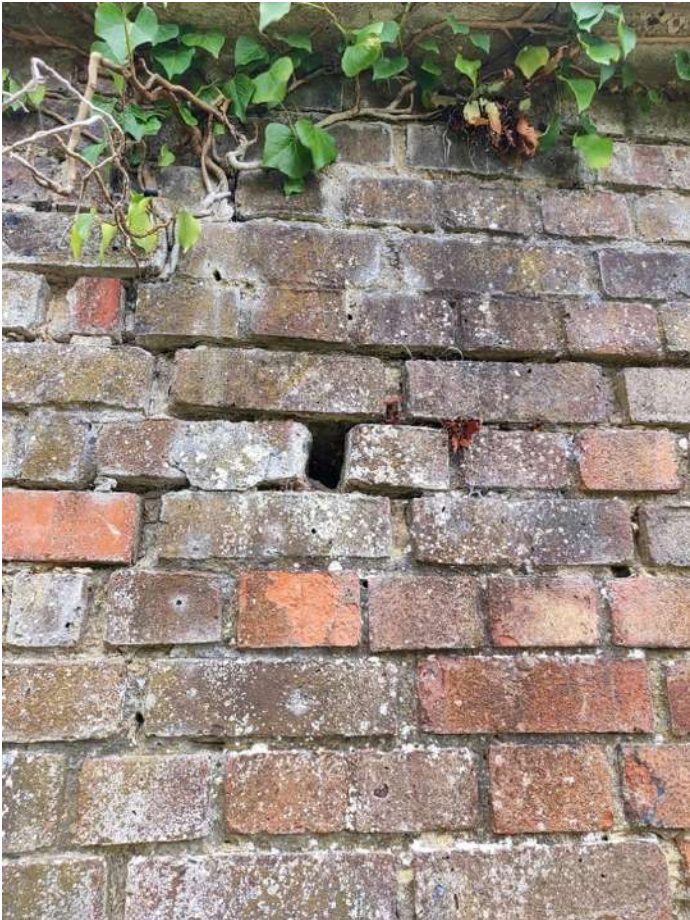
PRF - C

| Description | A gap in the mortar on the northern external wall. |

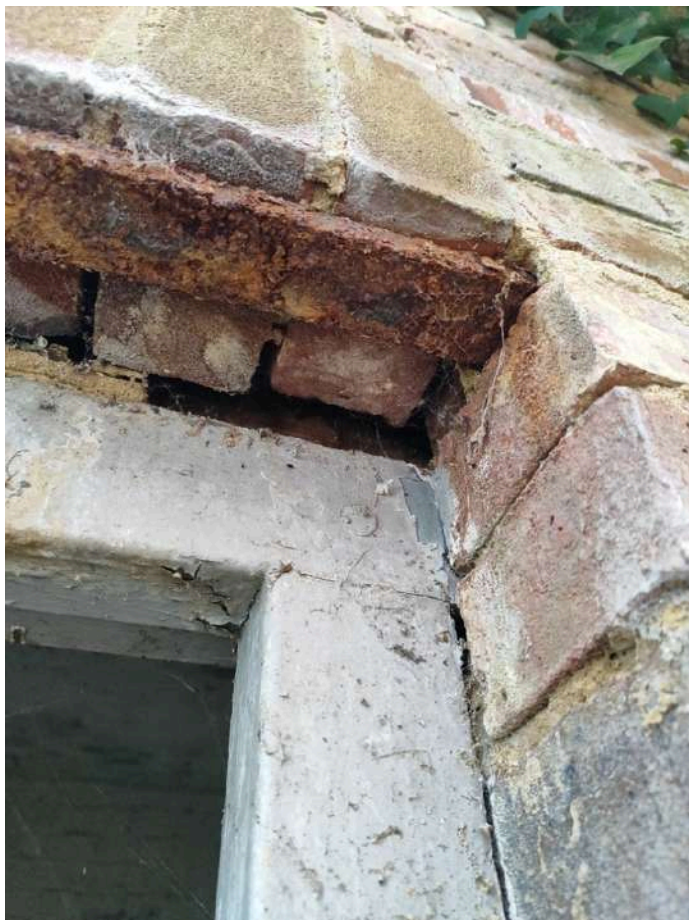
PRF - D

| Description | A gap above the doorframe on the external side. |

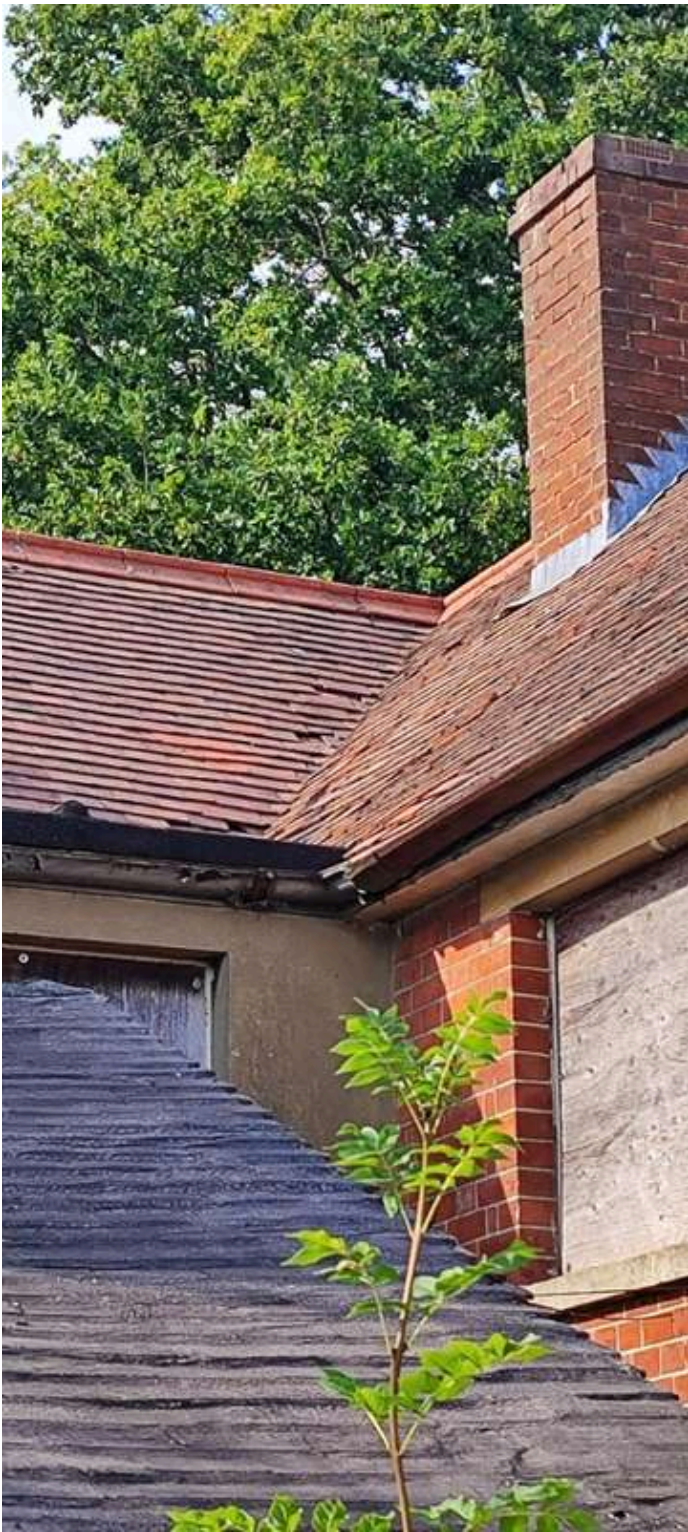
| Description | There are missing roof tiles throughout the property |

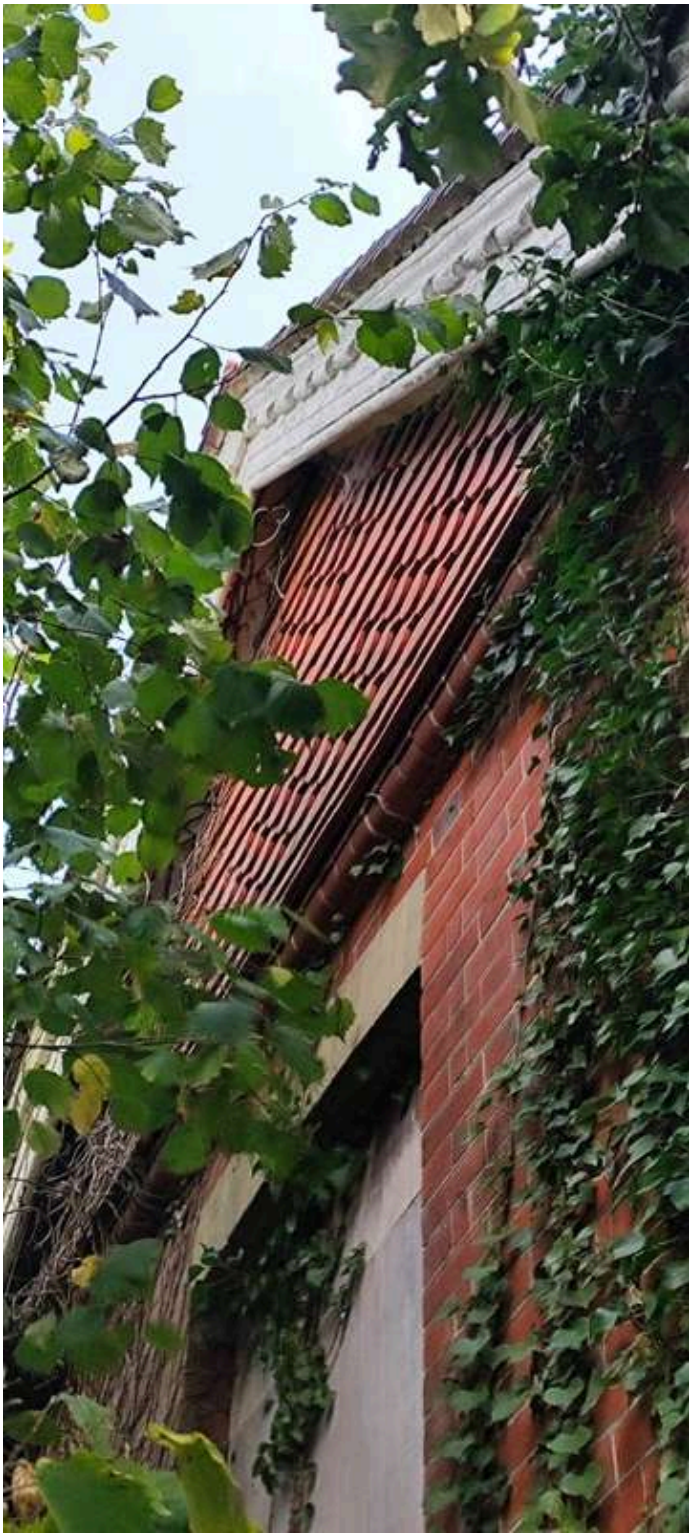
PRF - B

| Description | Gaps in the cladding tiles are present on all relevant gables. |

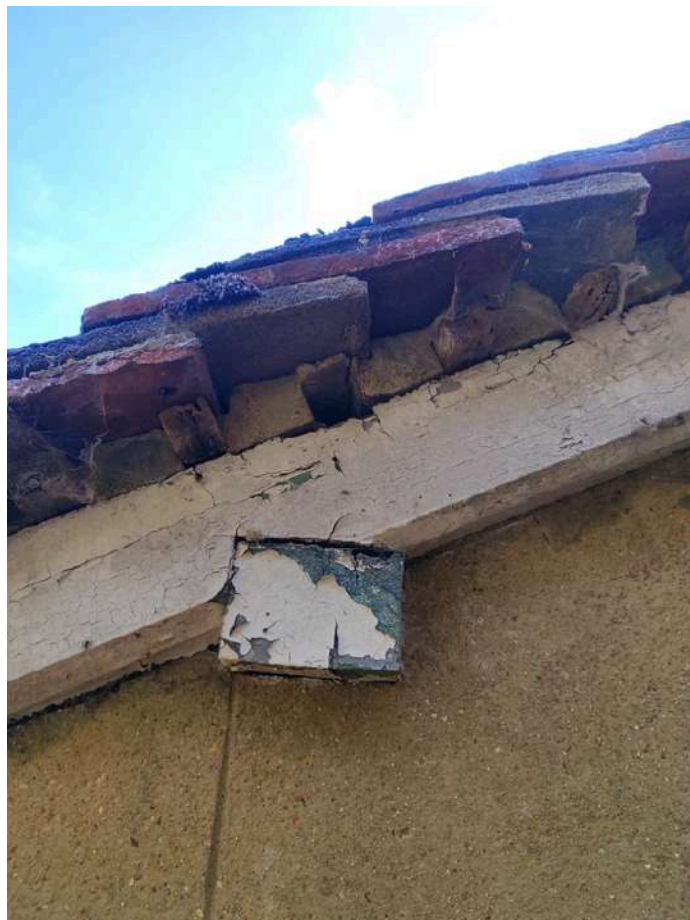
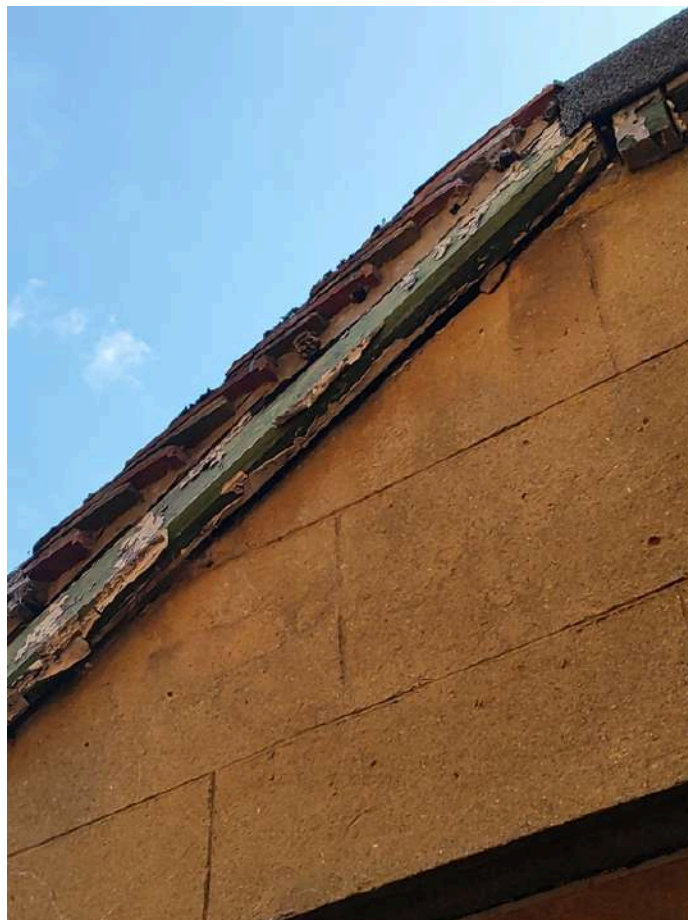
PRF - C

There are multiple gaps in the mortar rakes on the single storey section.

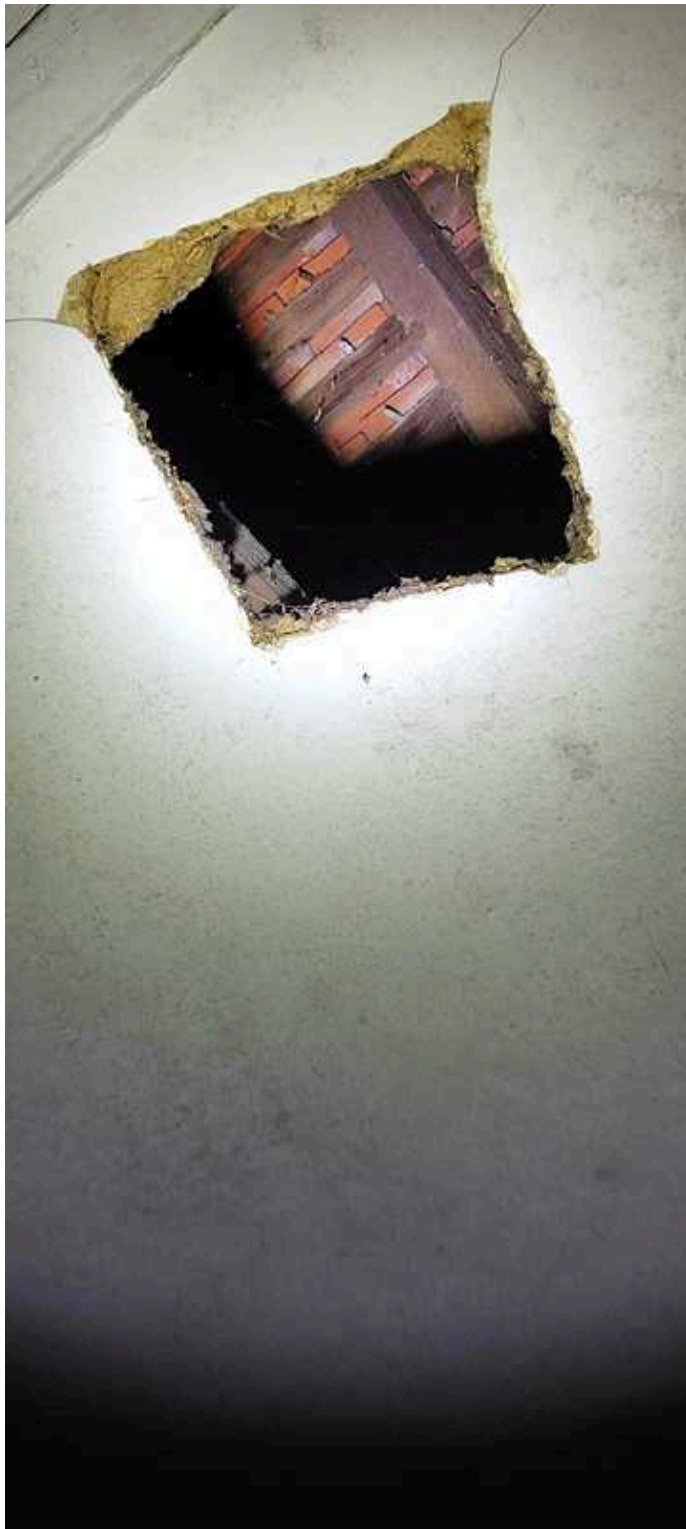
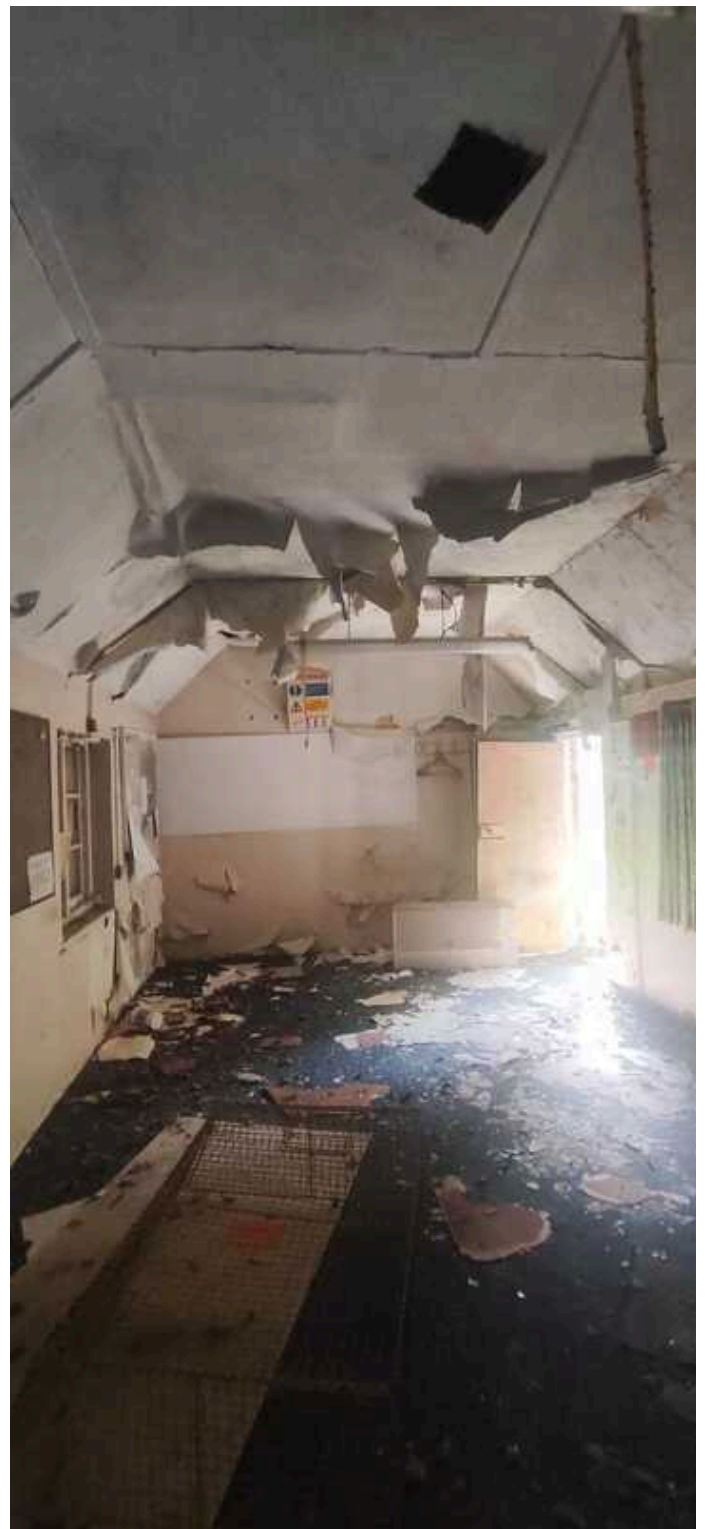
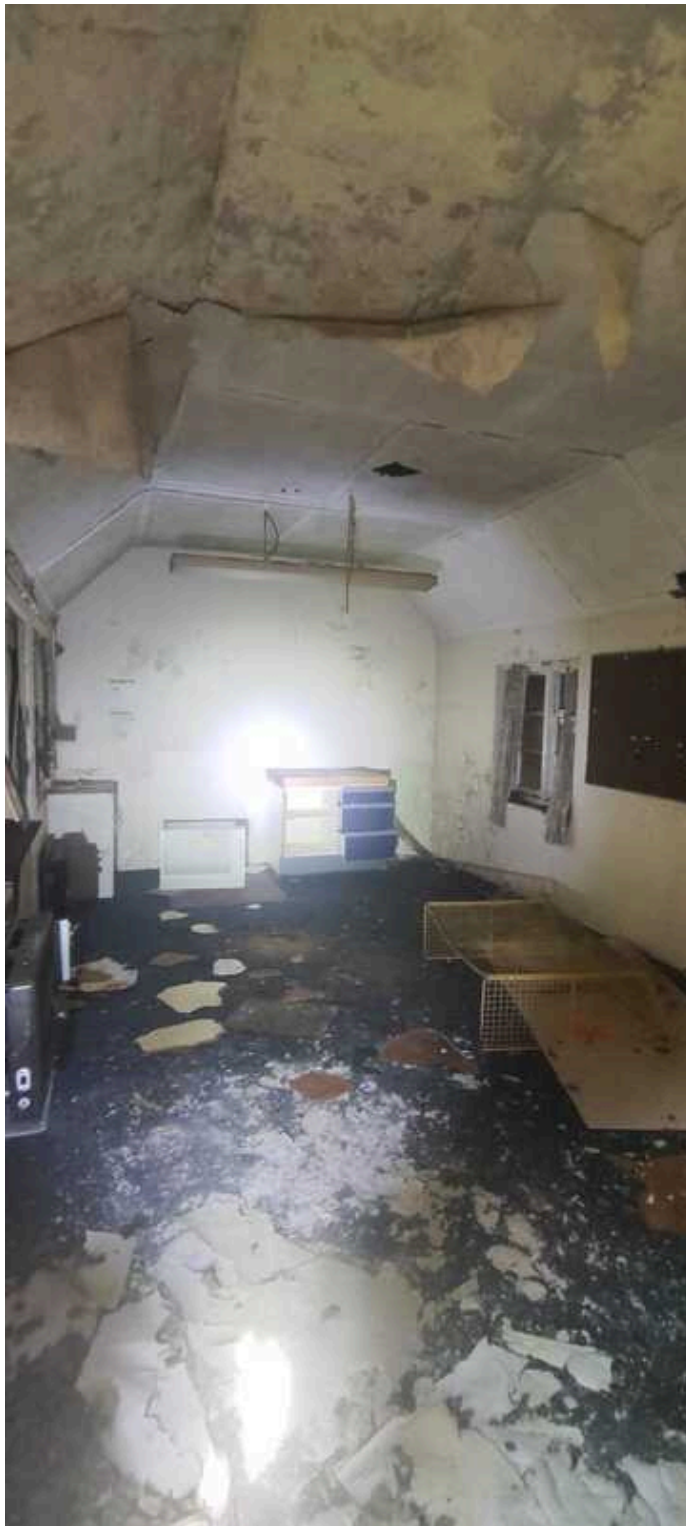
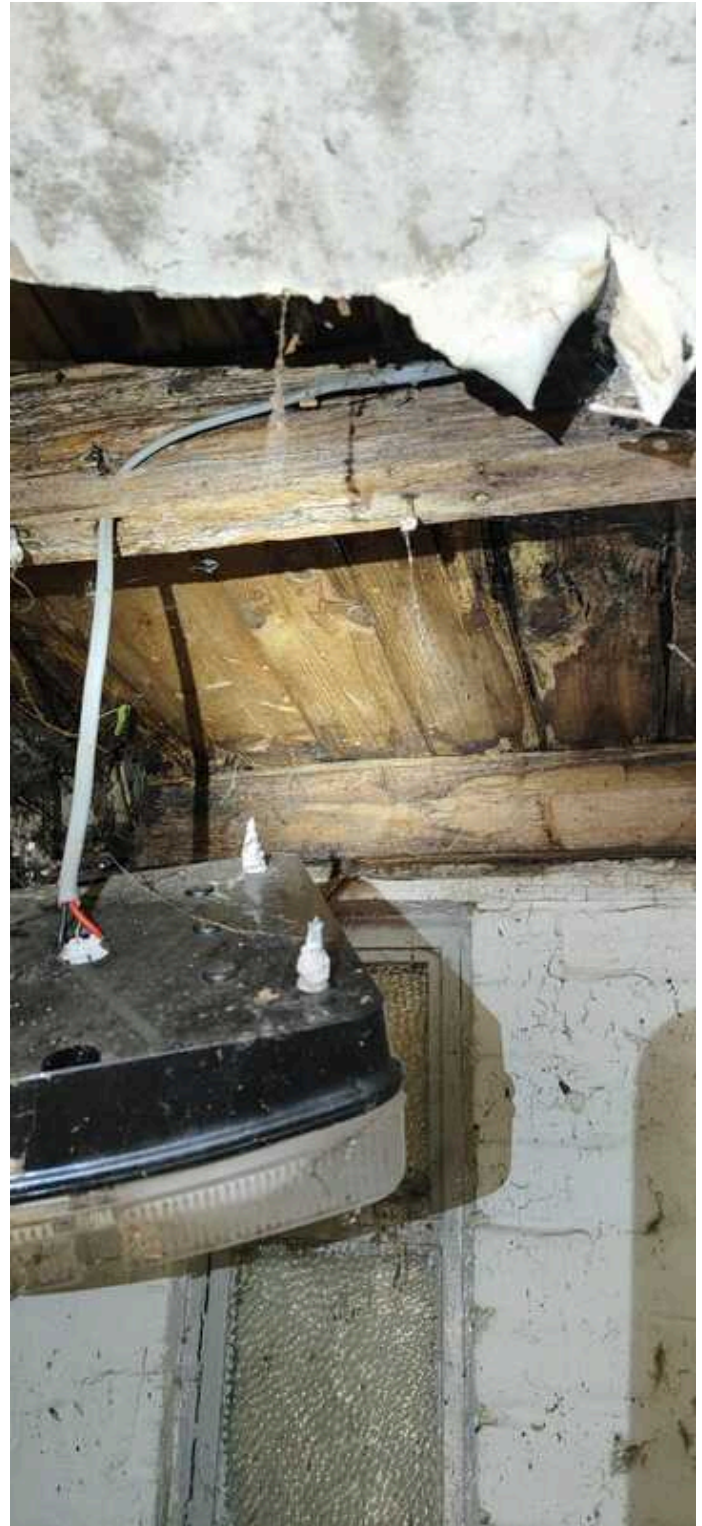
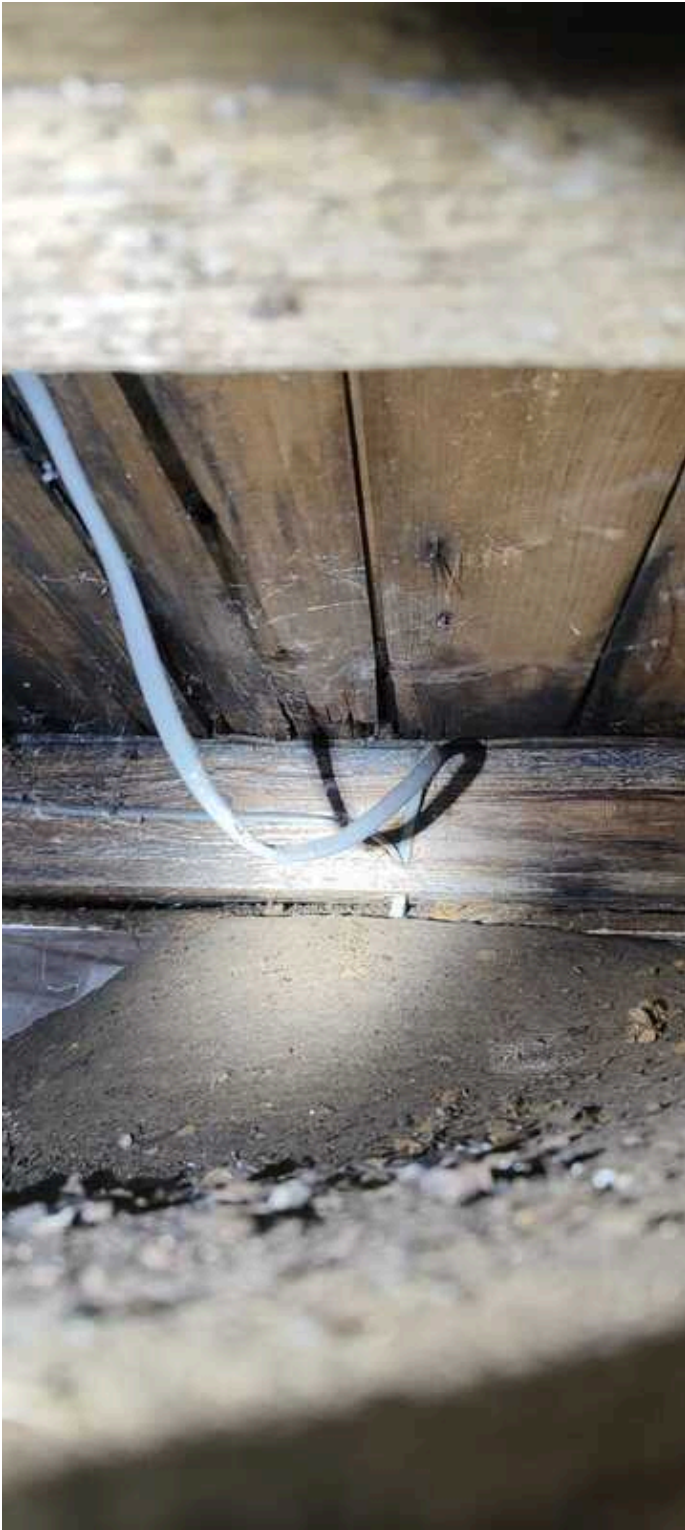
| <b>Description of Internals</b> | Single small room with plastered walls and ceiling. Mouldy and rotten with holes in the ceiling, but not access hatch. Structural concerns with the state of the building. All windows boarded but doors open or missing.<br>Flat roofed section has 2 outhouse rooms with timber roof and no underlining or insulation. |
| <b>Further Notes</b> | No bat or bird evidence but no access to roof space possible. |

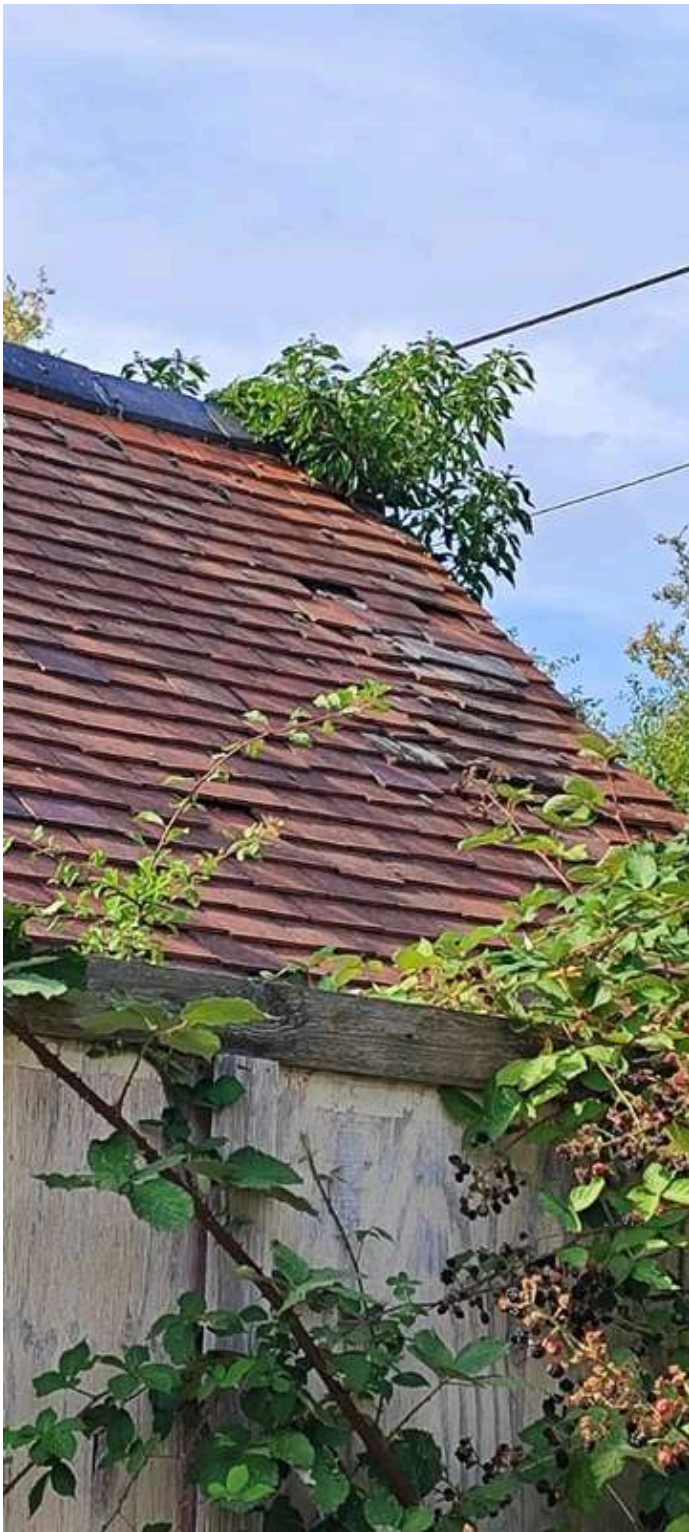
| Description | Missing or slipped roof tiles are present throughout the roof, giving access to the roof space. |

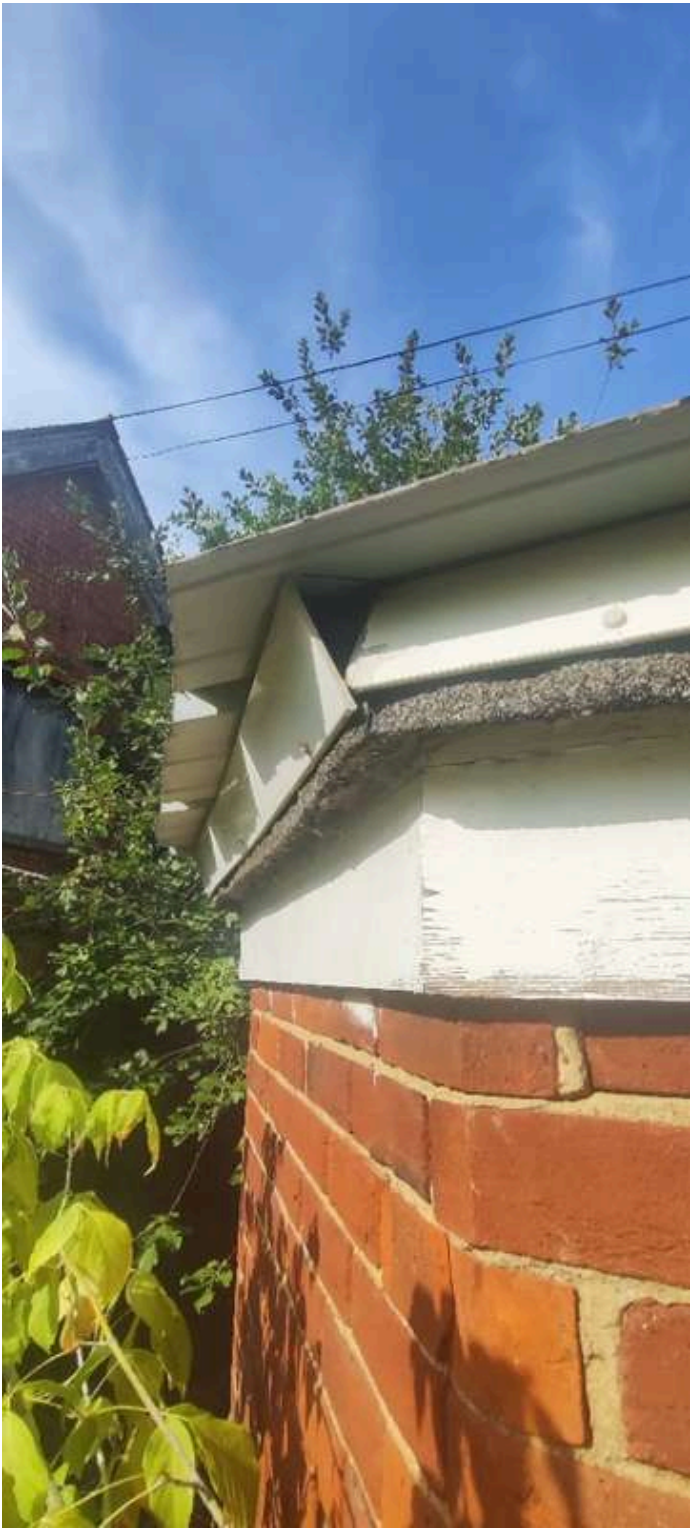
PRF - B

| Description | Gaps are present behind the plastic flashing that is nailed onto felted roof on the flat roofed section to the west. |

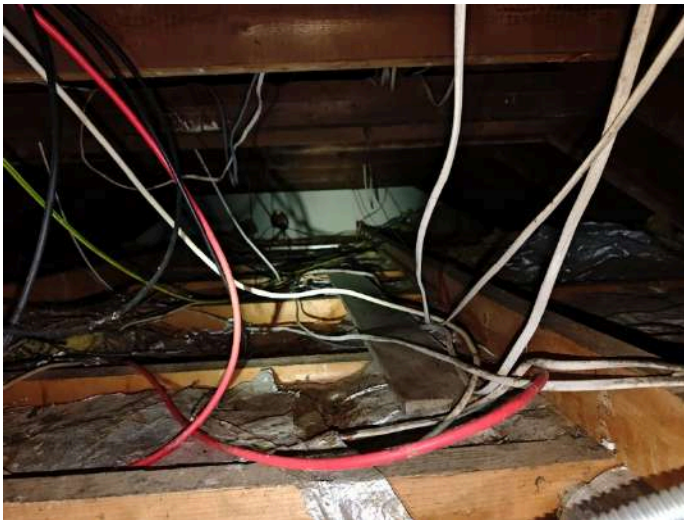
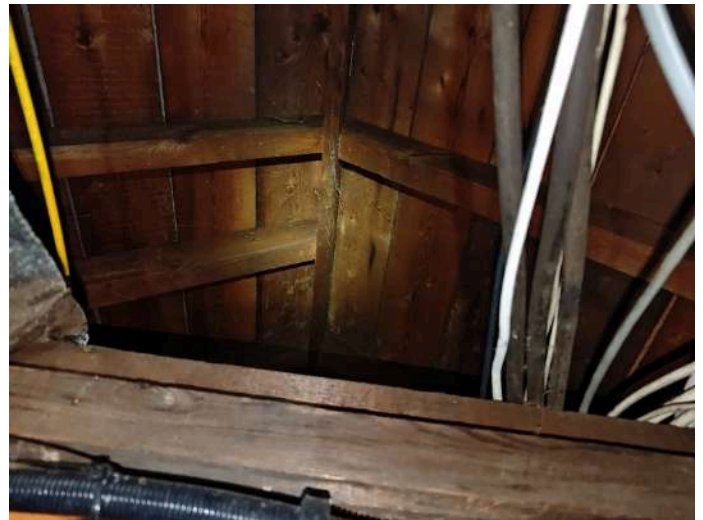
Internal Description - B11 - Void 1

| <b>Further Notes</b> | No evidence of bats identified. |

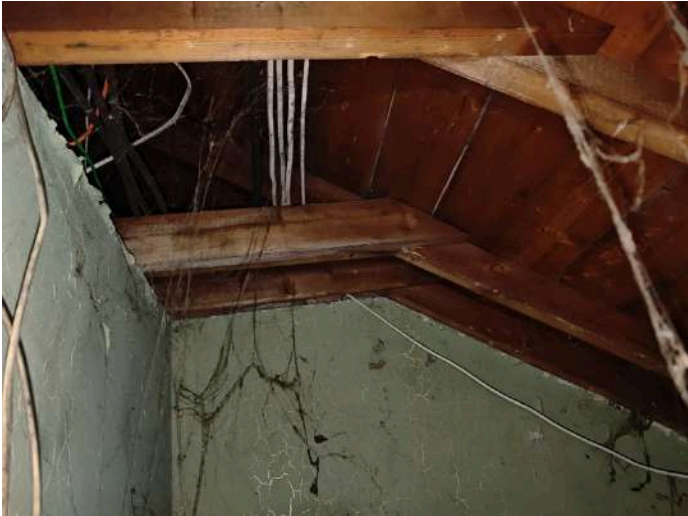
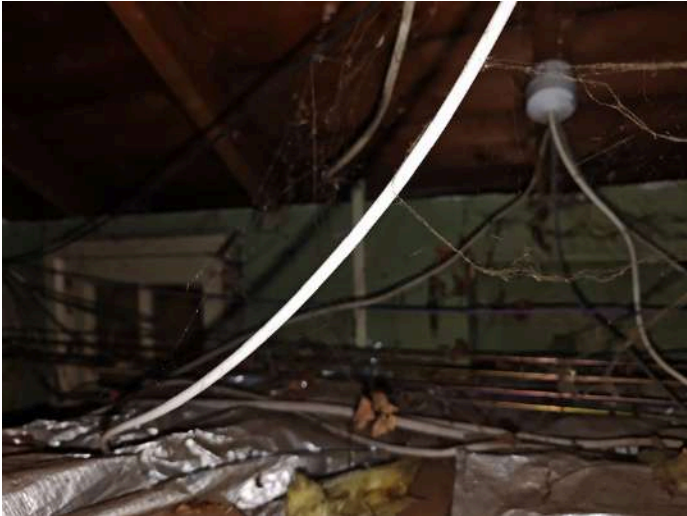
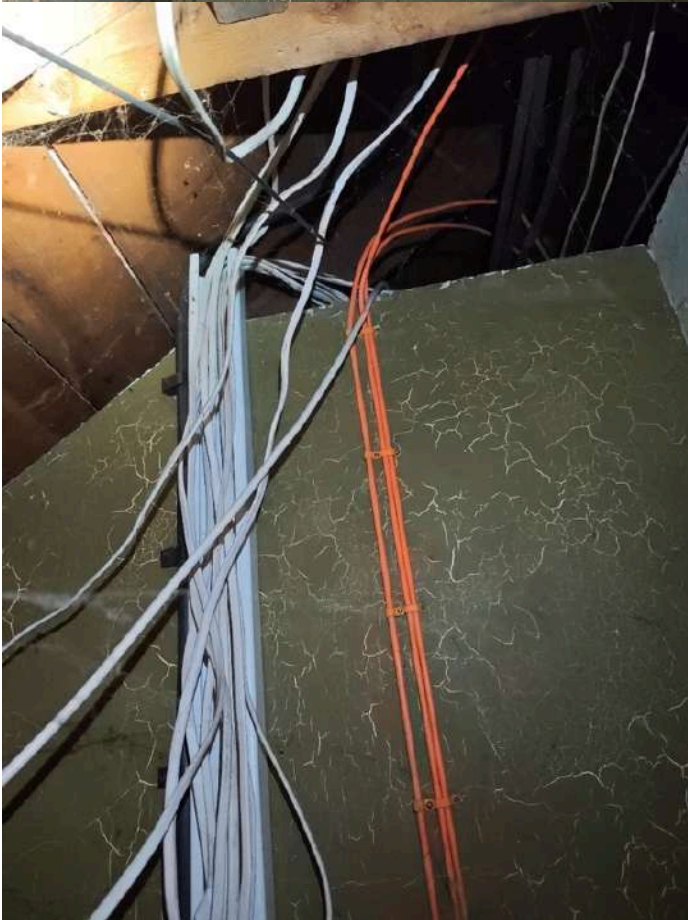
### Internal Description - B11 - Void 2

| Further Notes | A small space. The gaps in the partitions link to other sections. No evidence of bats found. |

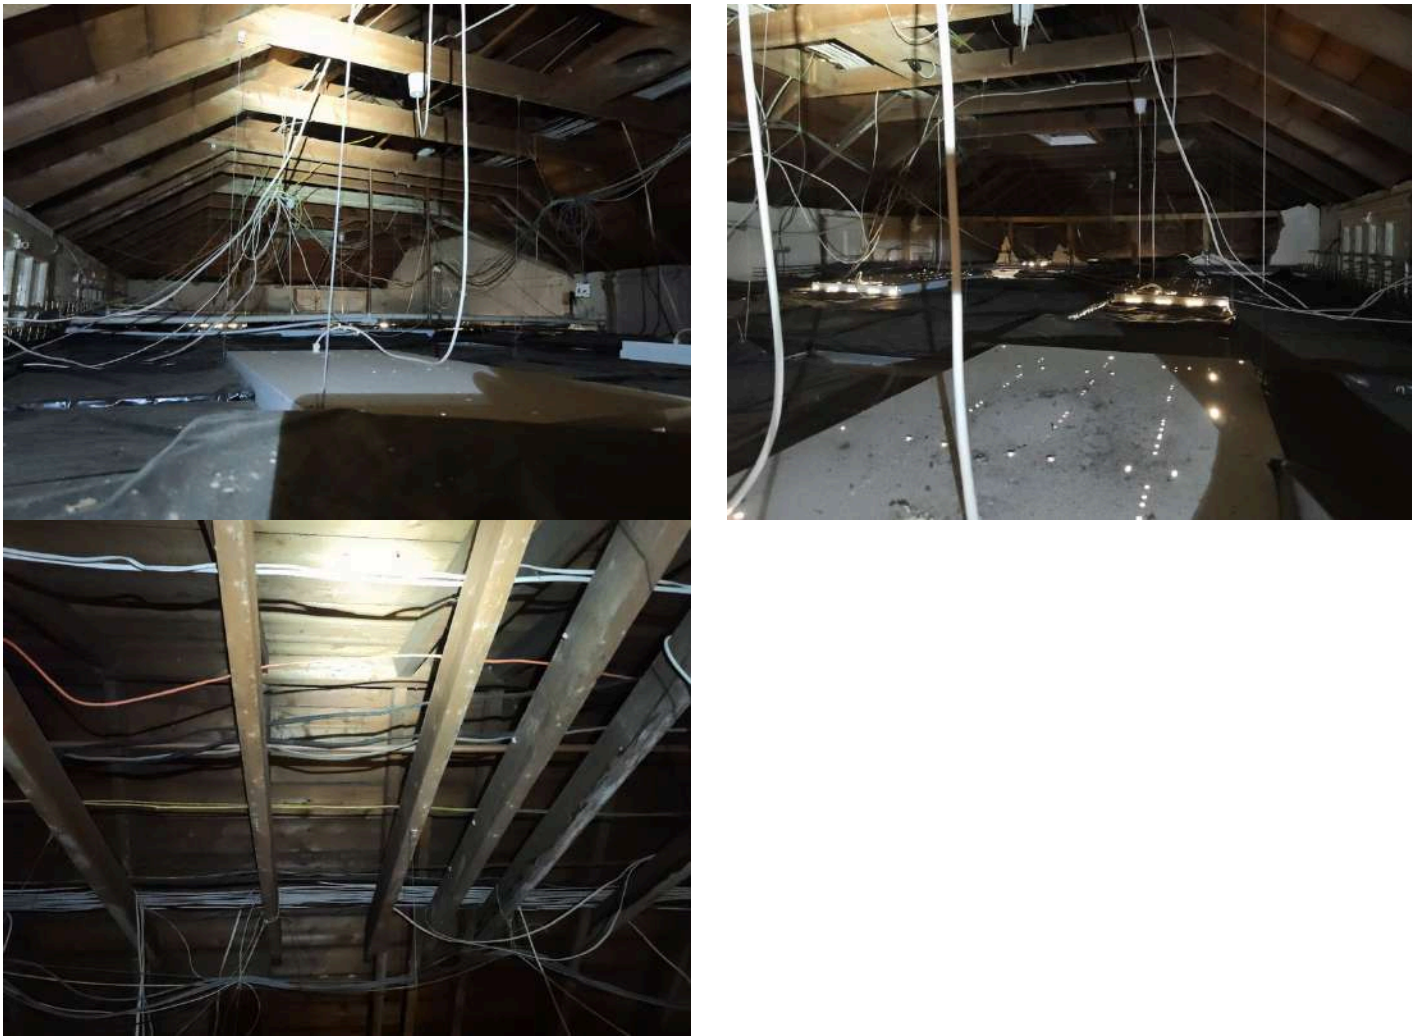
## Internal Description - B11 - Void 3

| <b>Further Notes</b> | No evidence of bats. |
