# **Preliminary Roost Assessment**

Former Arborfield Studios  
(Parcels W, Y and Z)

**Report on Behalf of:**  
Crest Nicholson Operations Ltd.

**PEG659-02C**

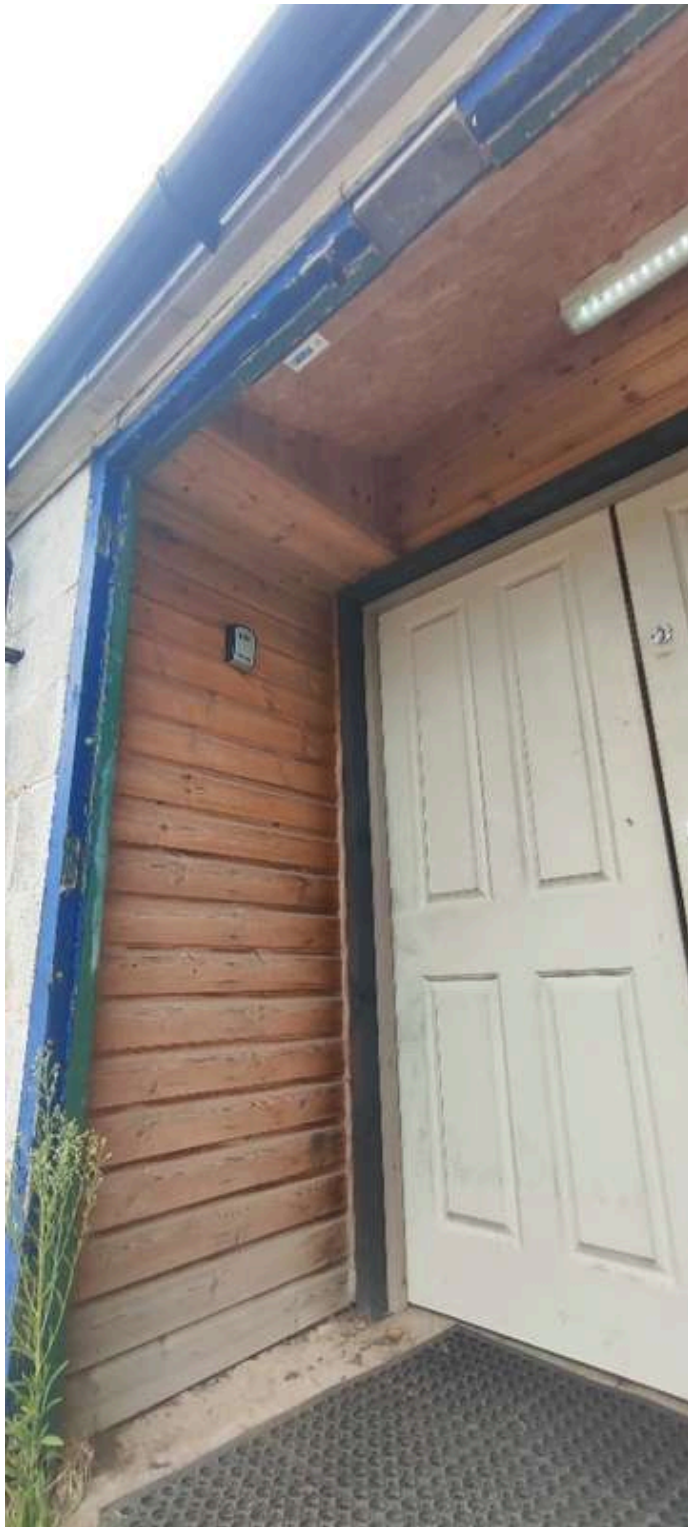
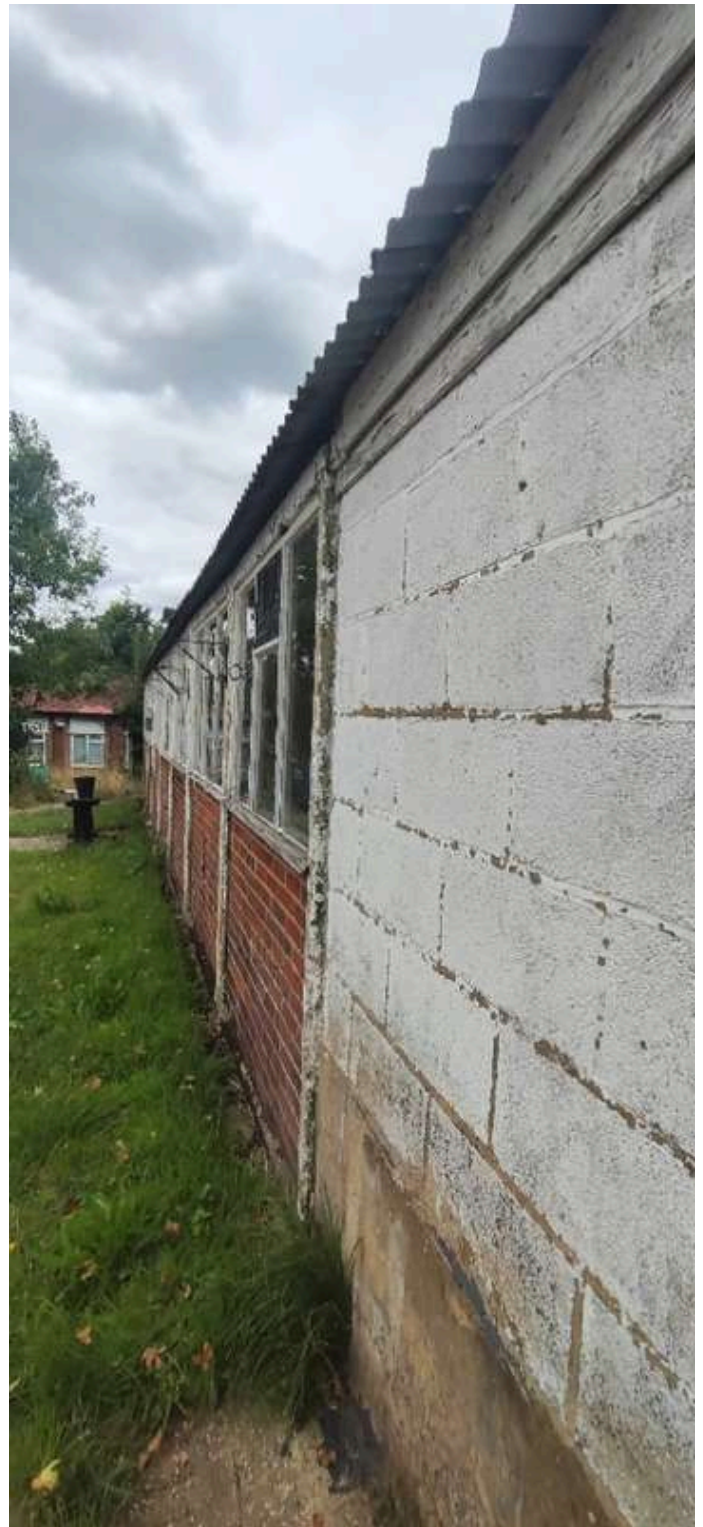
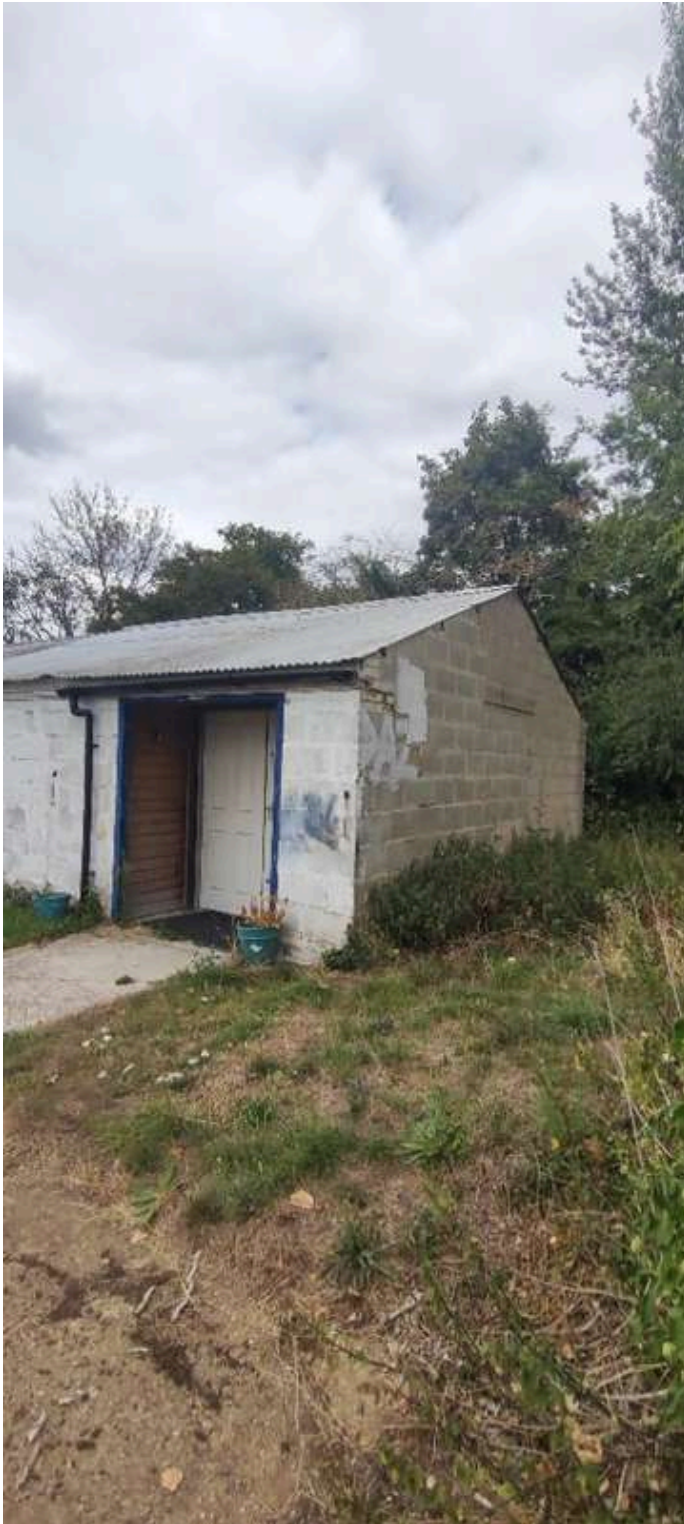
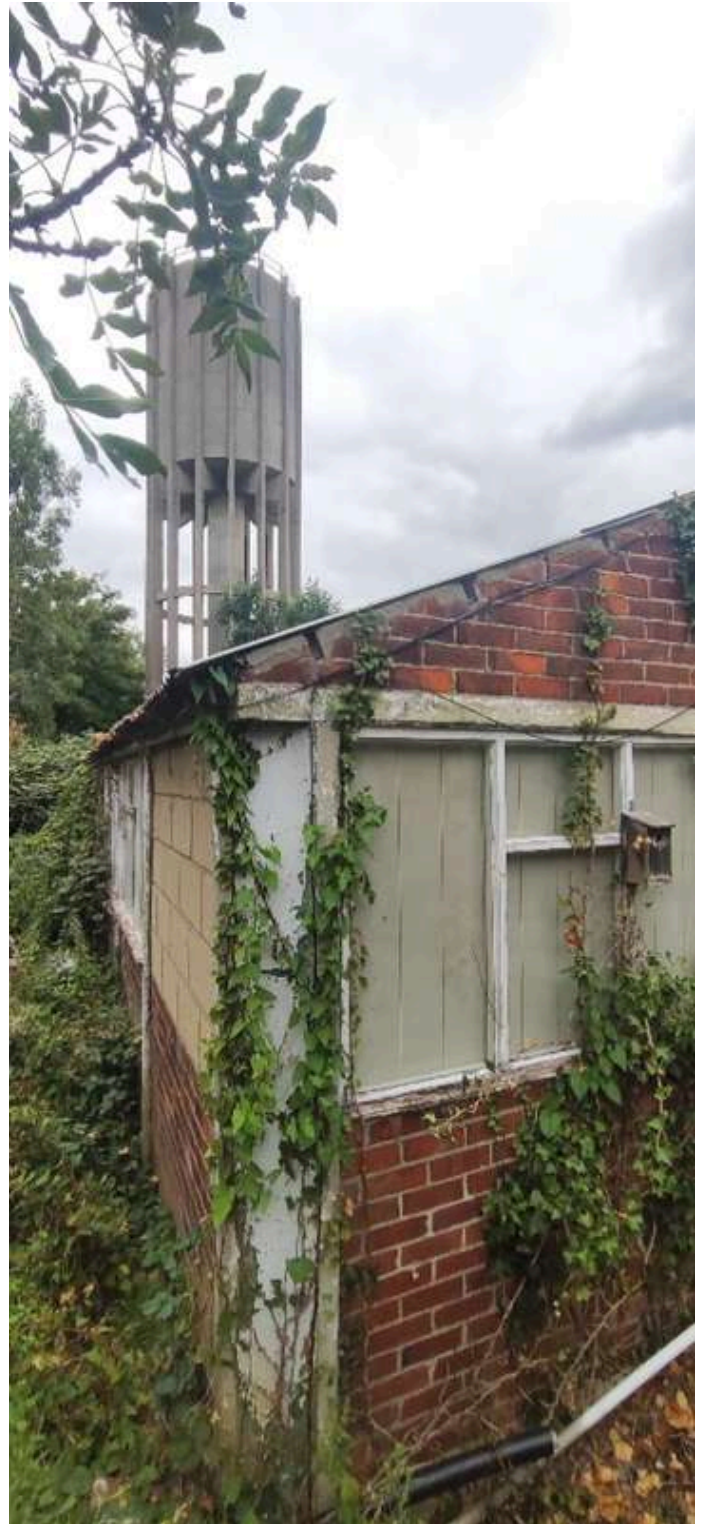
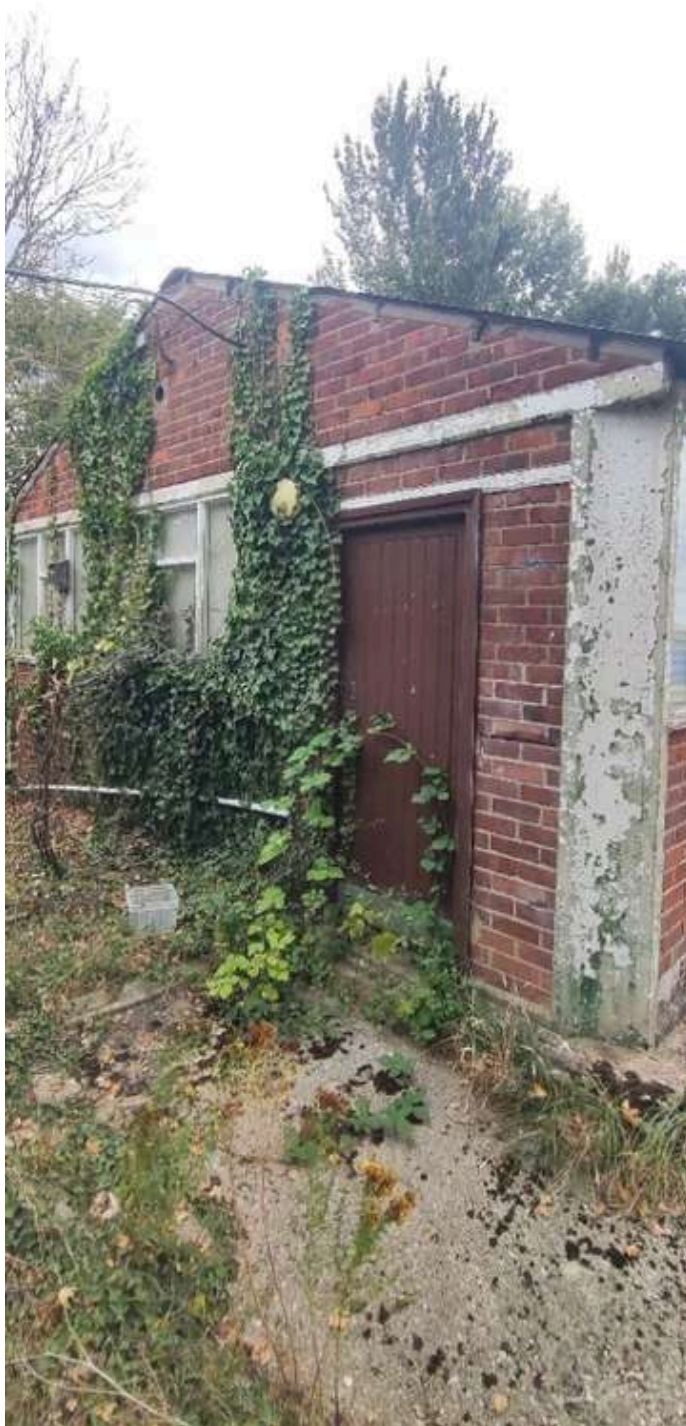
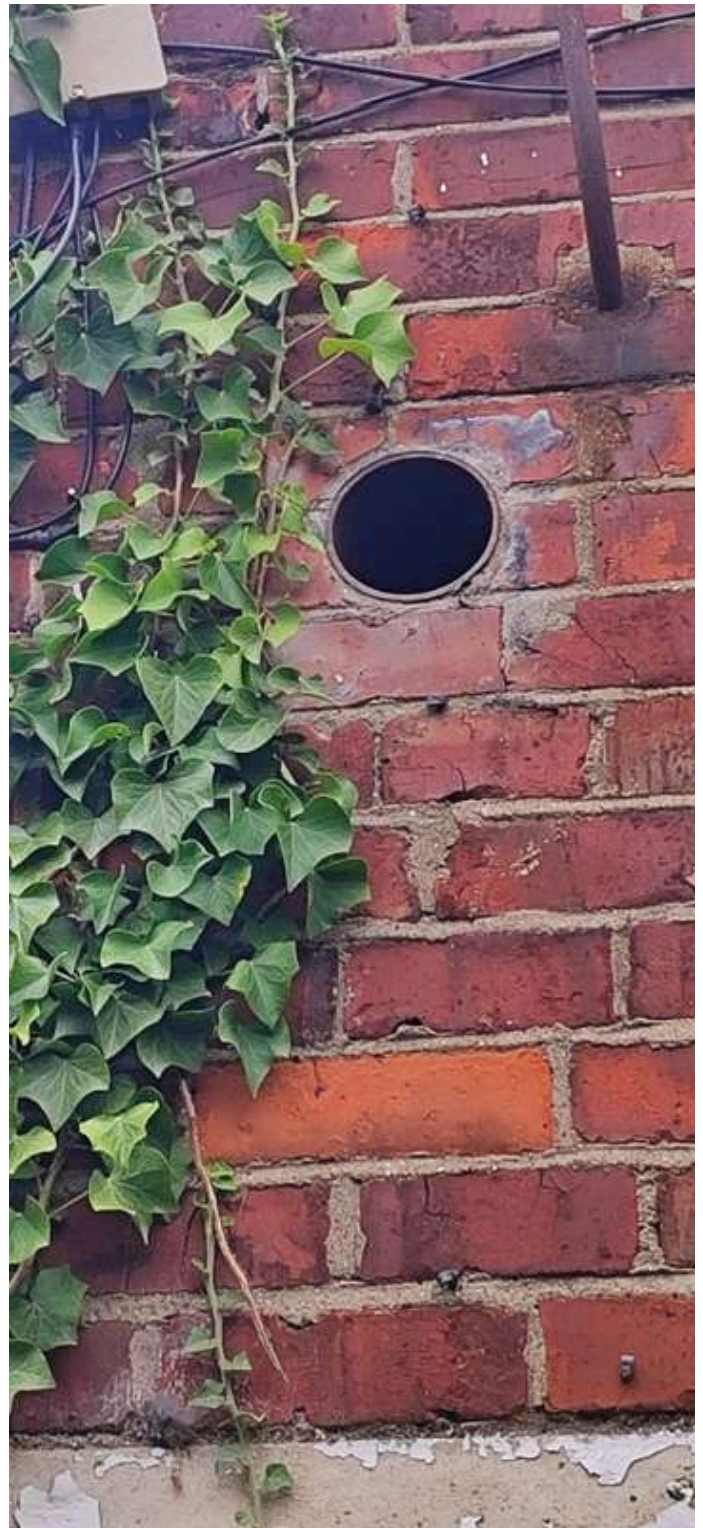
| <b>Mortar Condition</b> | Gaps Present |

**Further Notes** The building was locked at the time of survey so no internal assessment was undertaken.

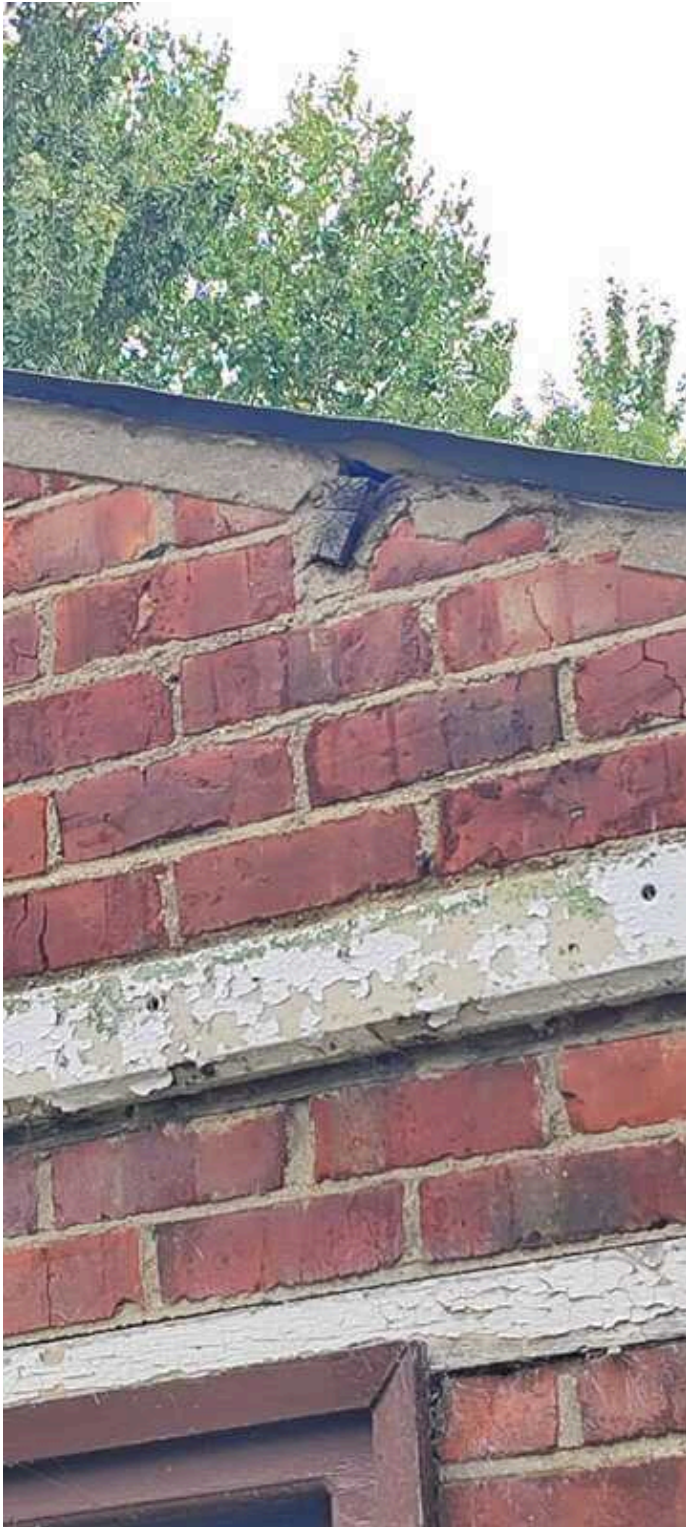
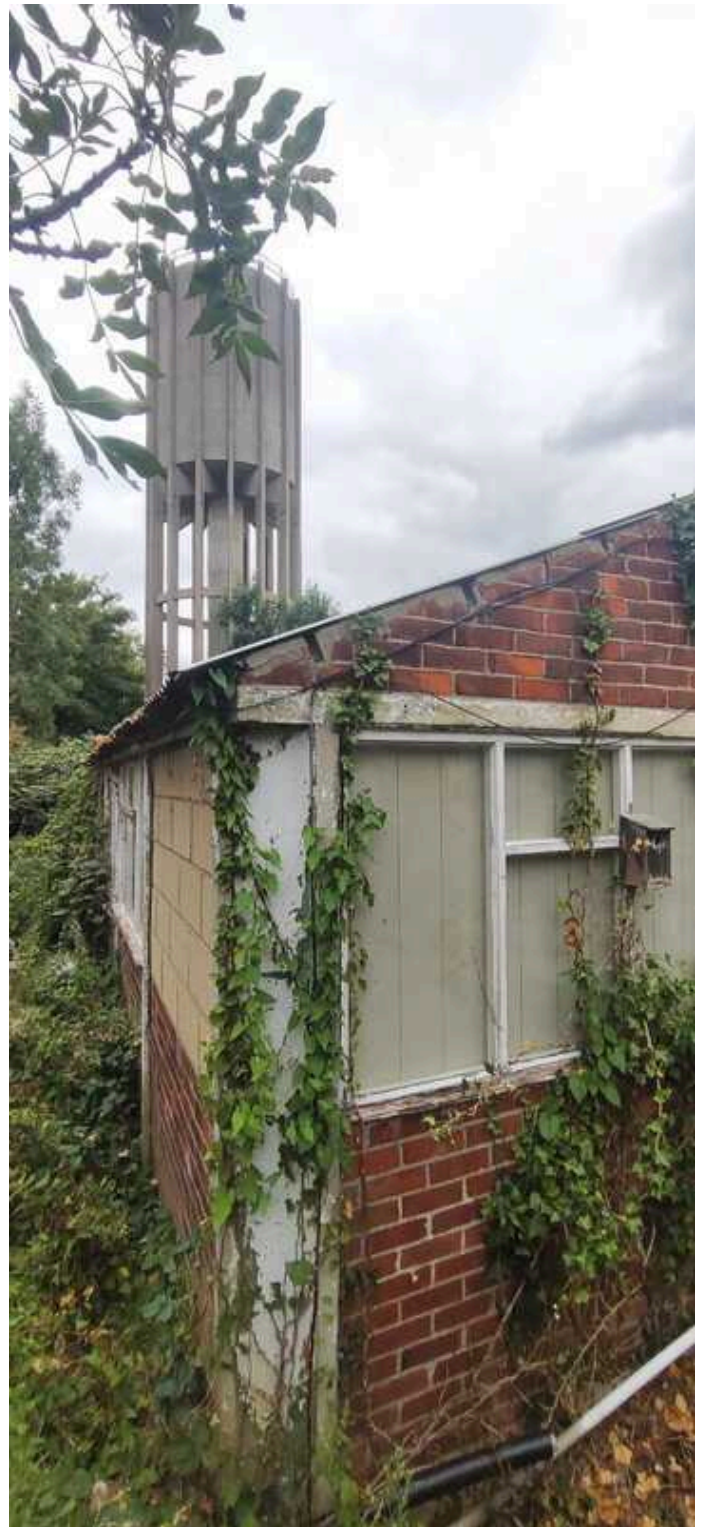
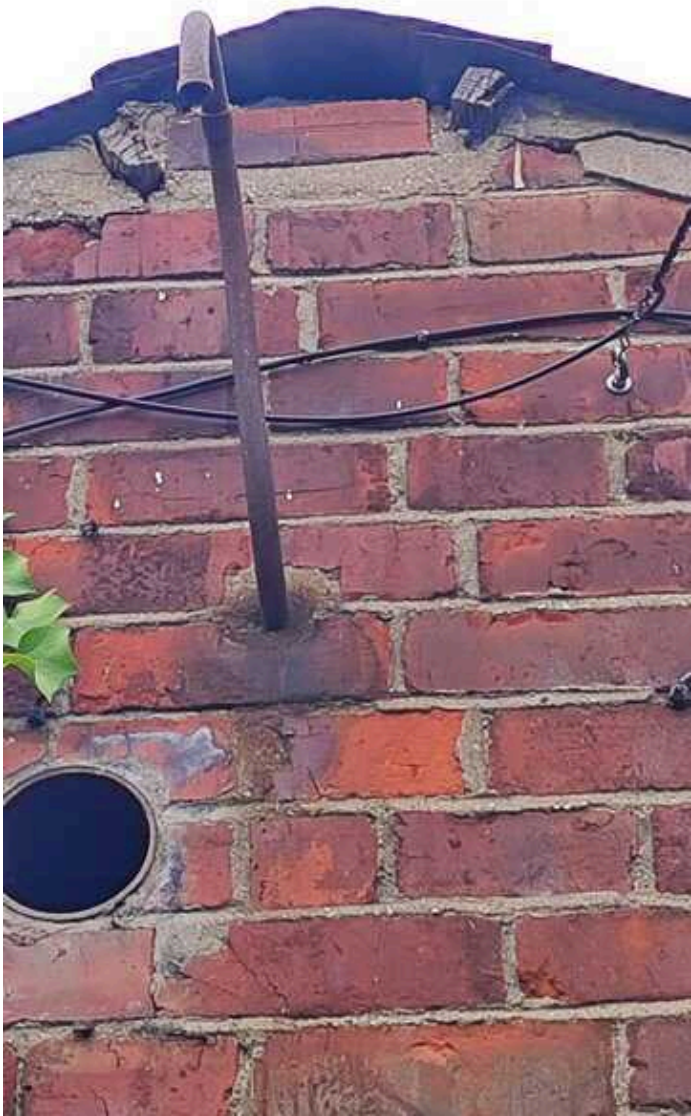
| <b>Description</b> | Gaps in the mortar on the gable rakes at each end. |

| Bat Roosting Potential | Moderate |

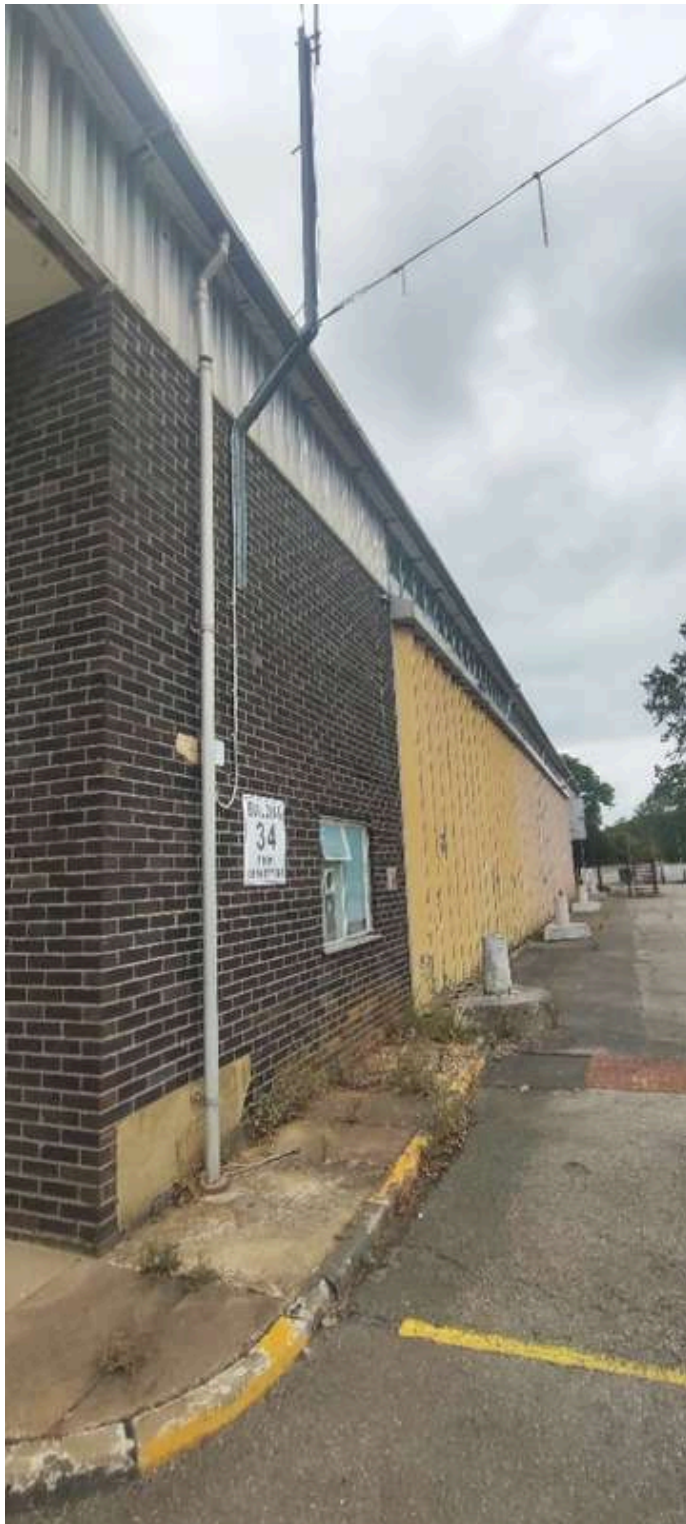
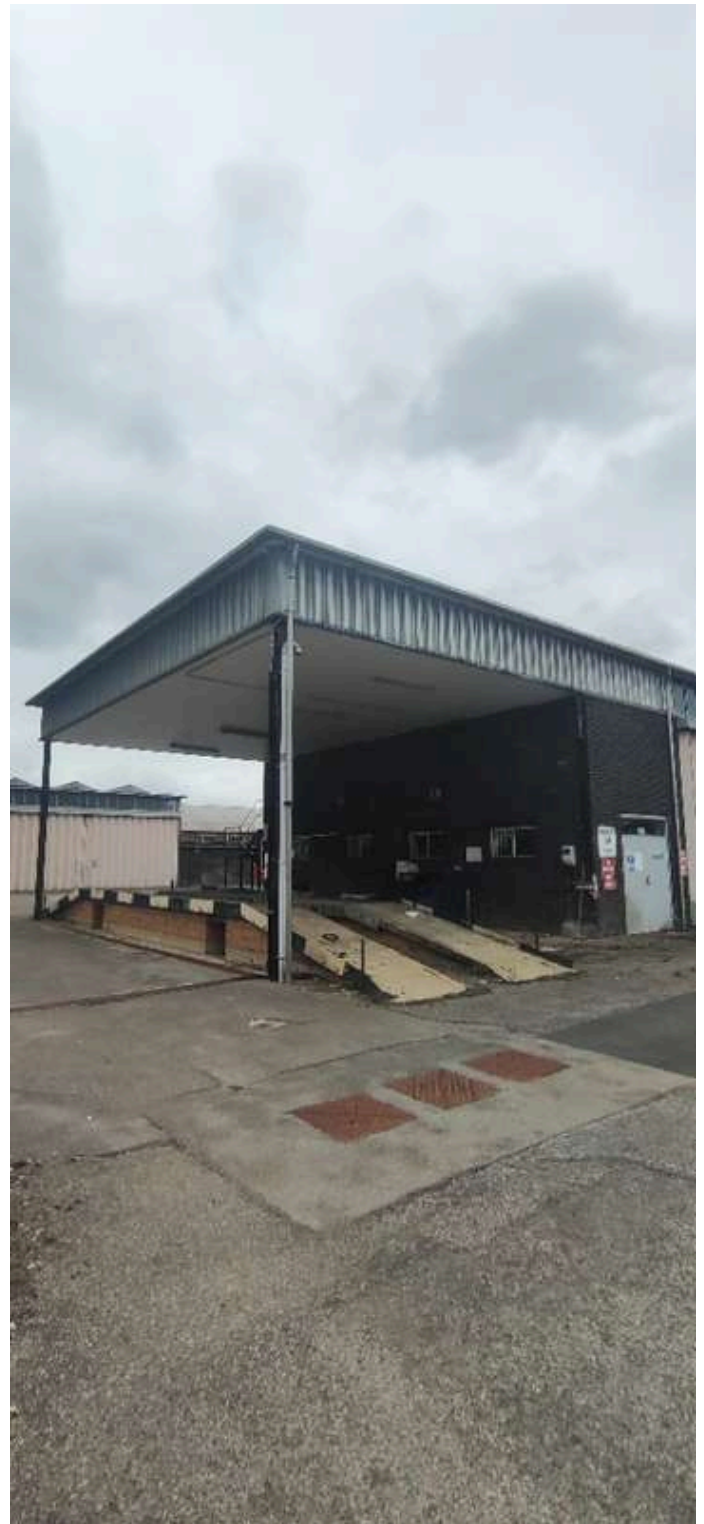
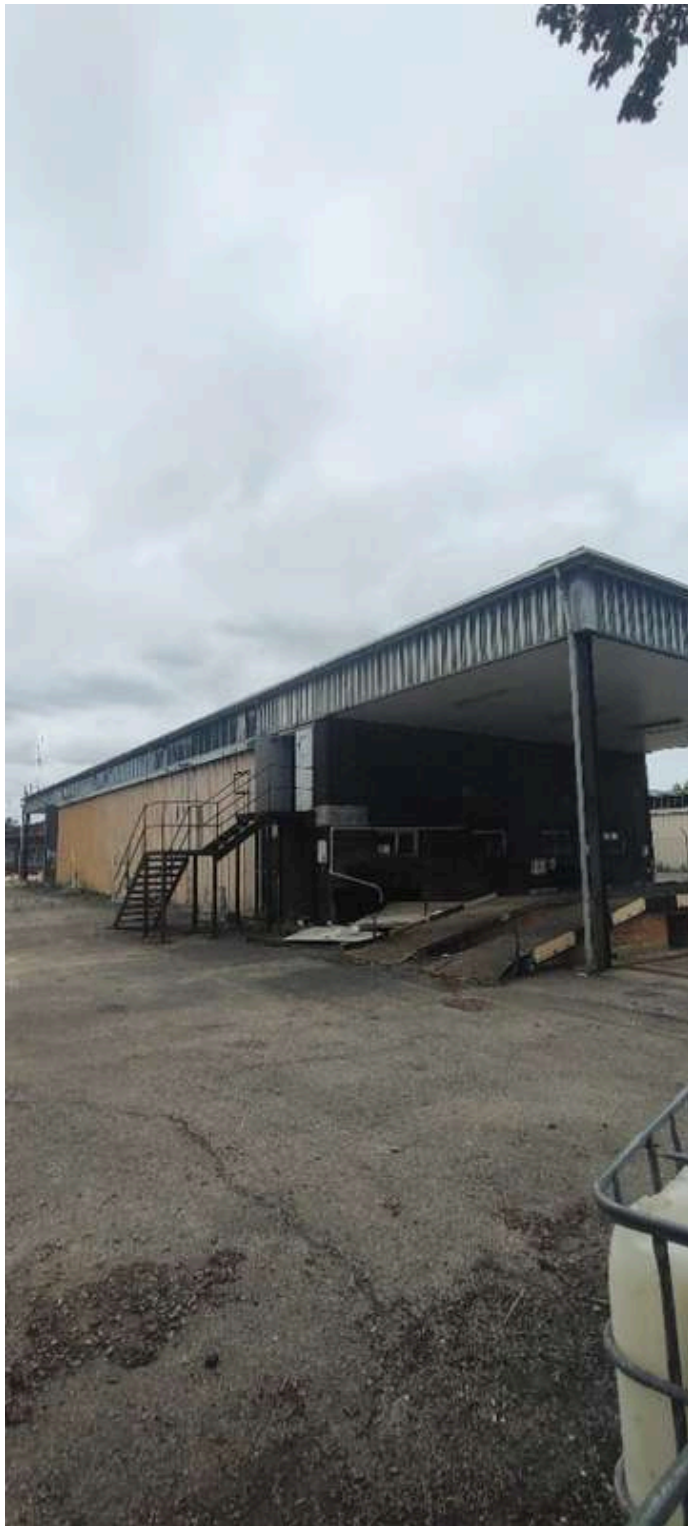
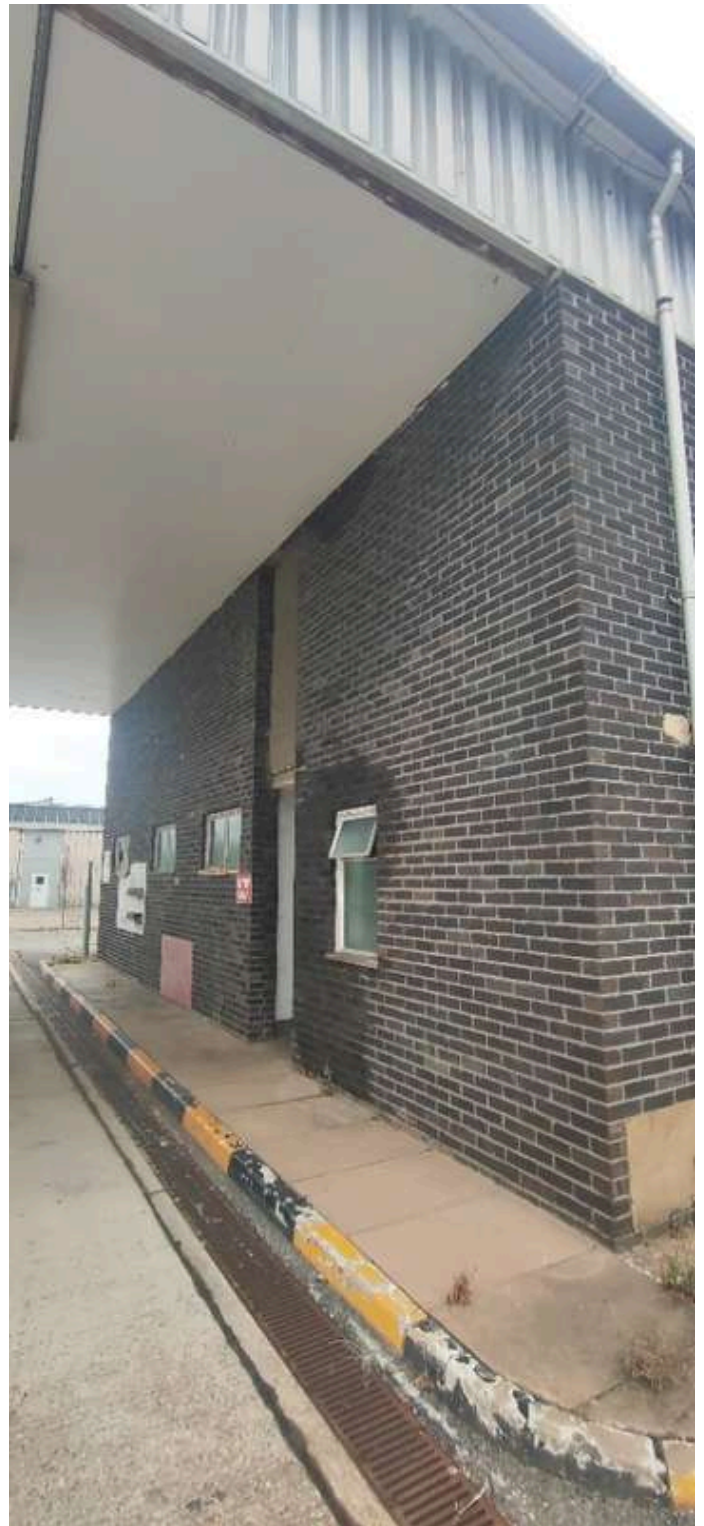
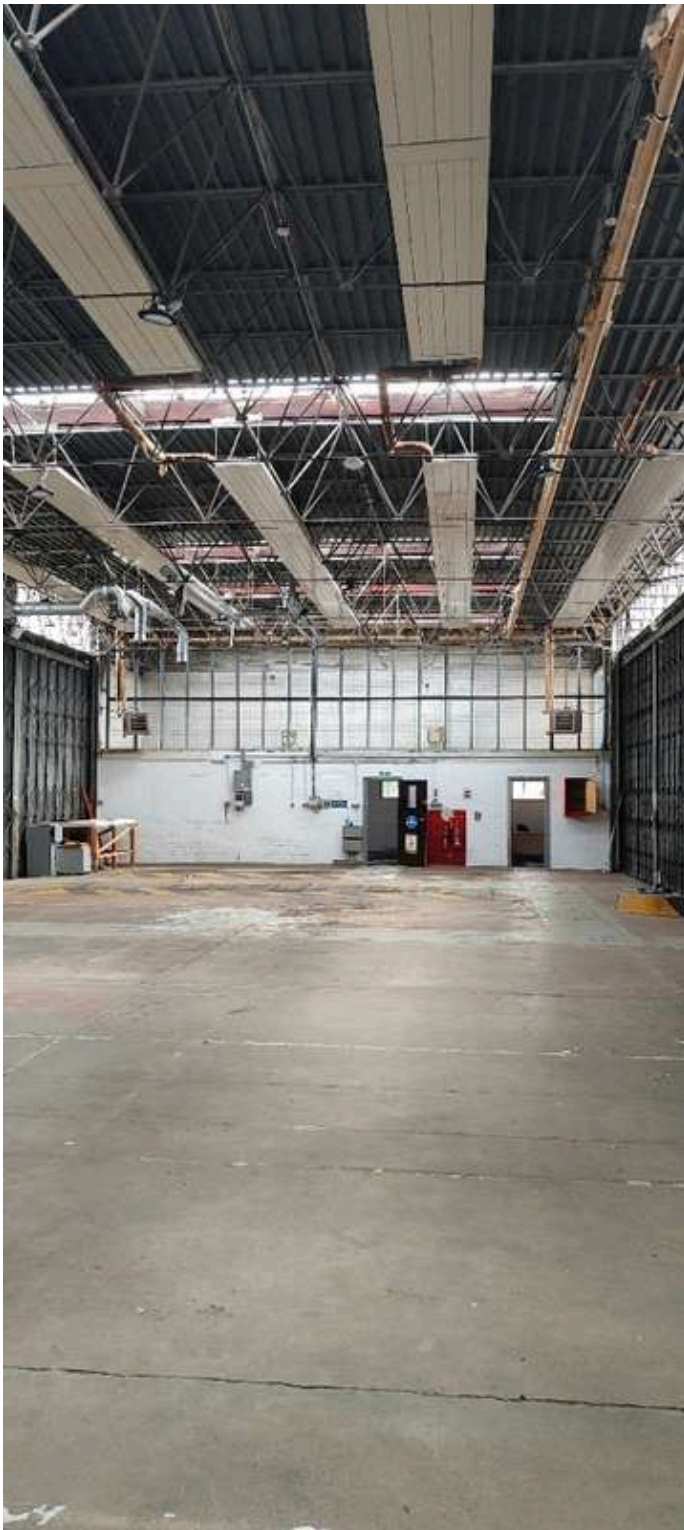
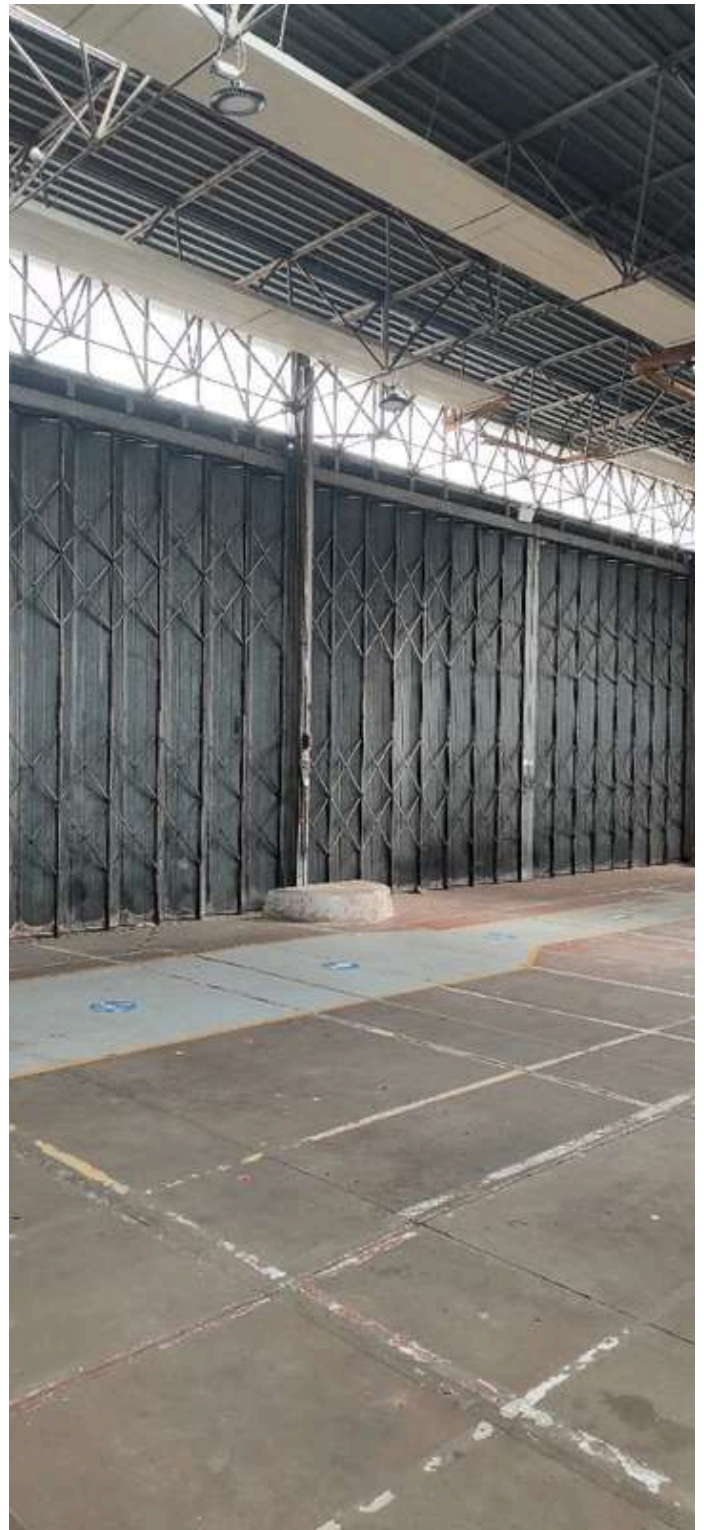
There are no visible PRFs, and the internals are unsuitable for bat roosts.

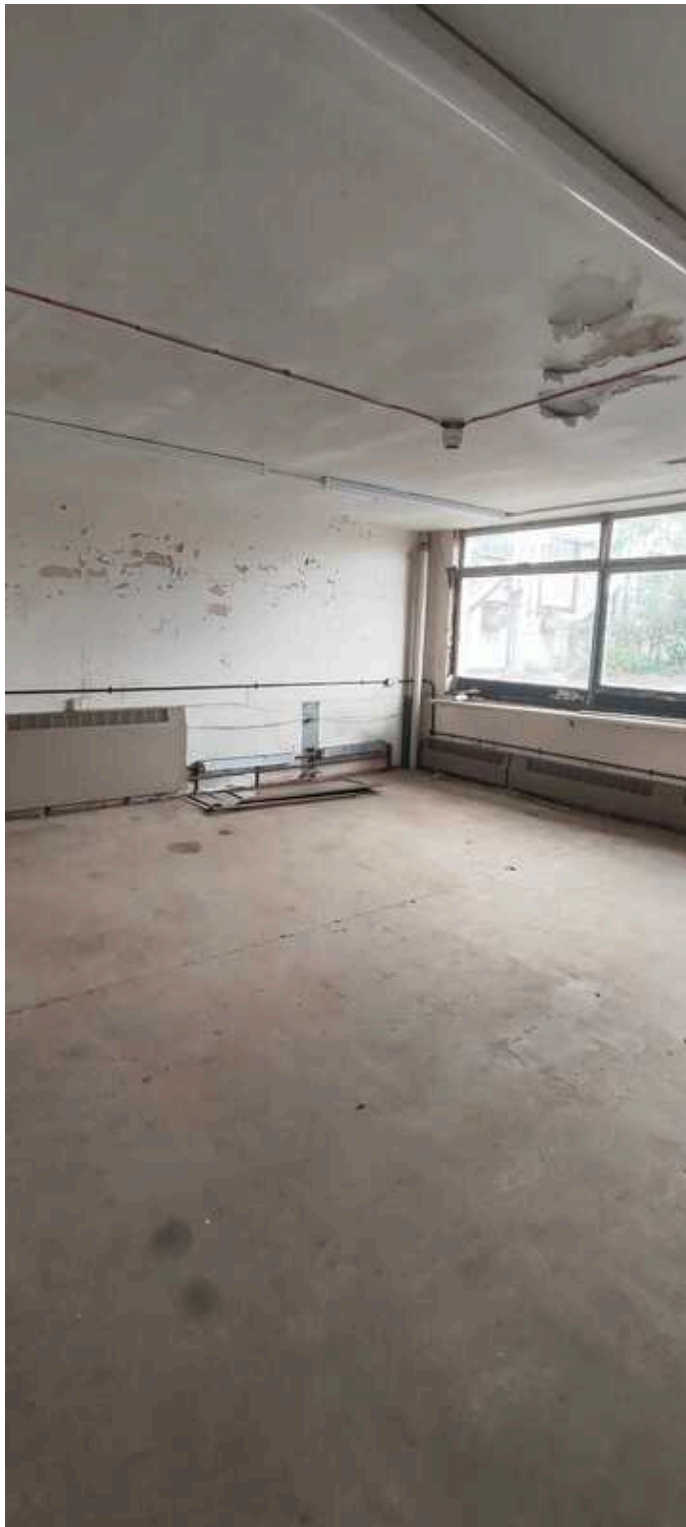
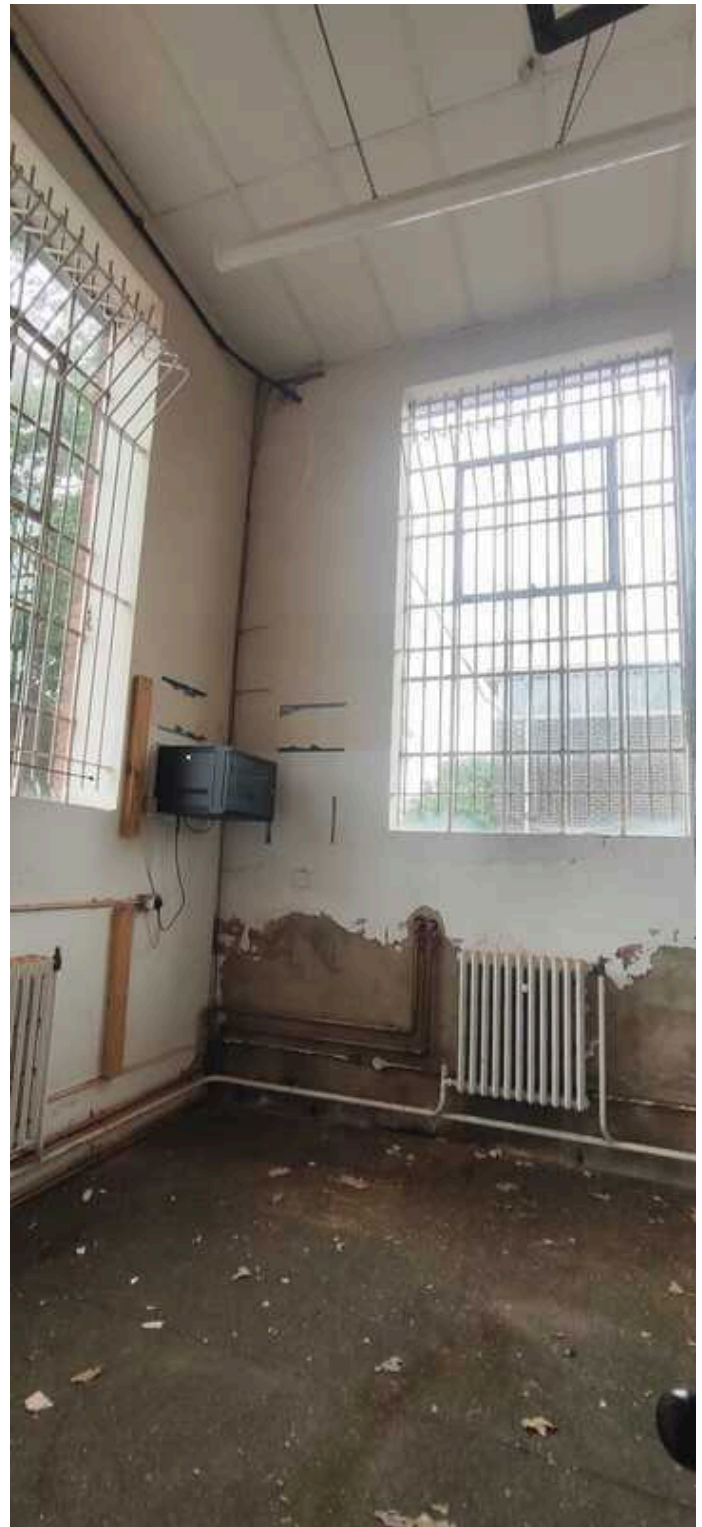
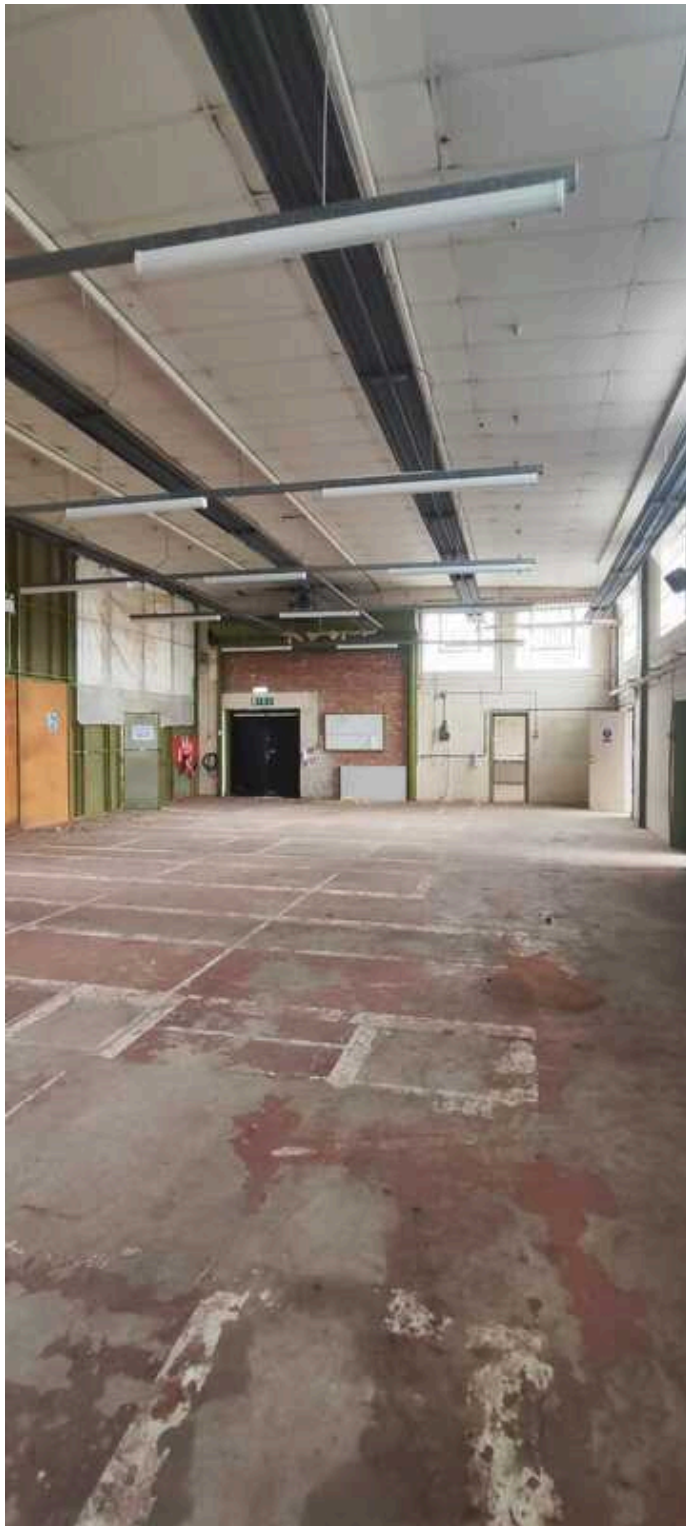
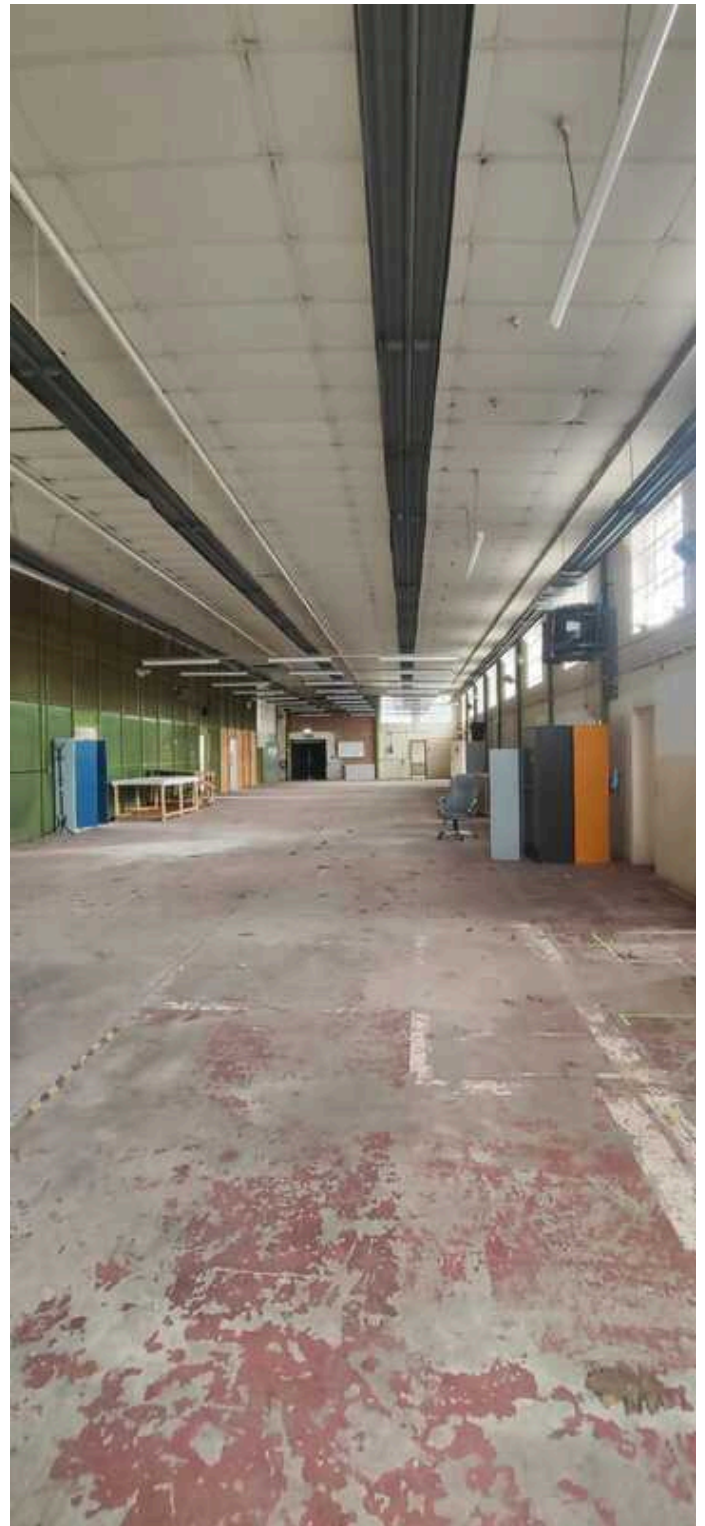
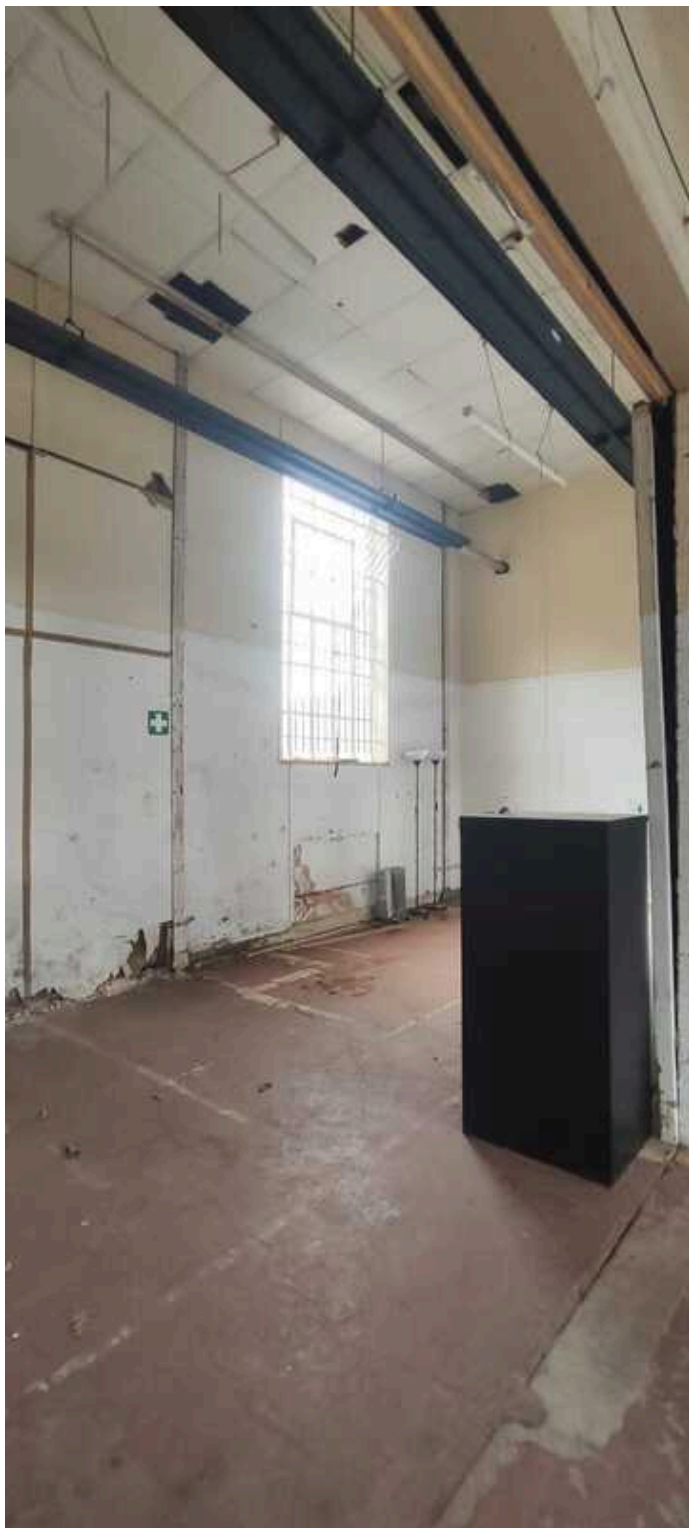
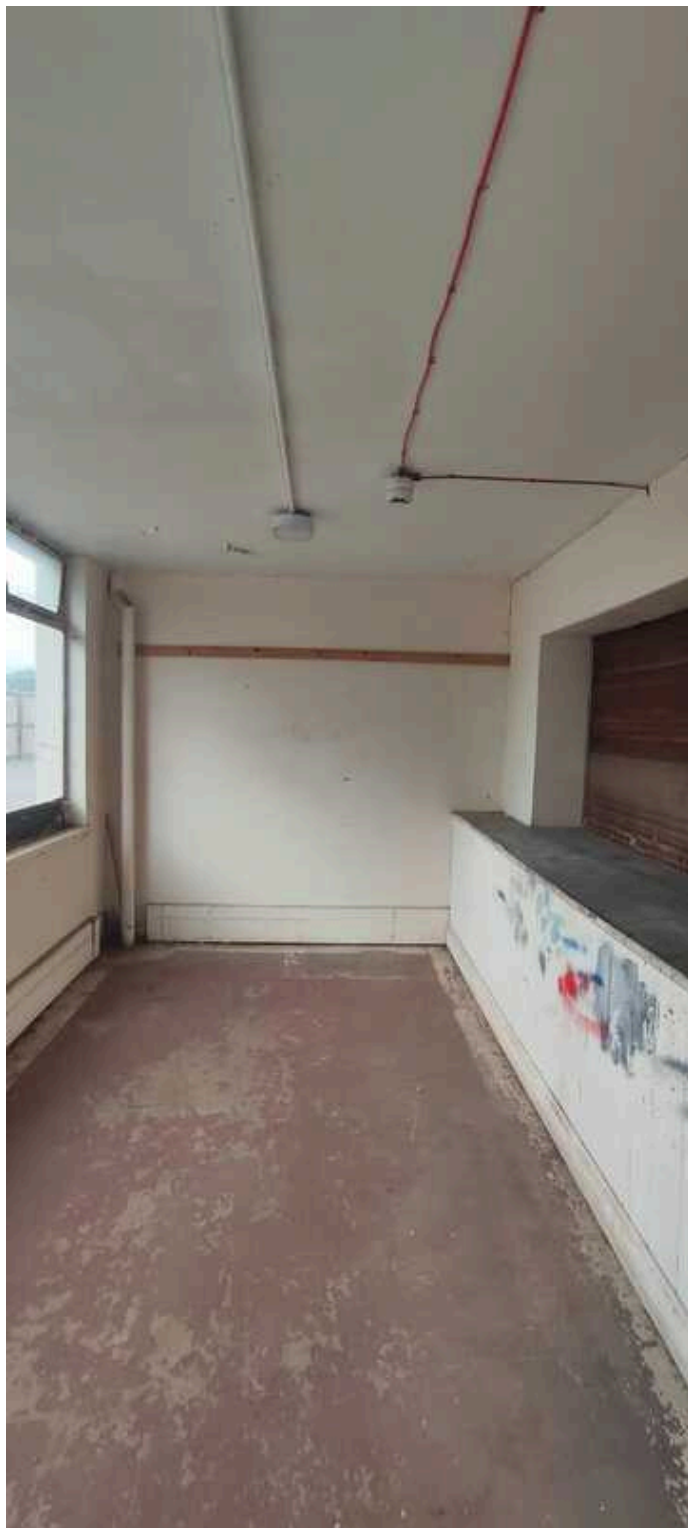
| <b>Further Notes</b> | False ceiling present throughout. No bat evidence, no access above false ceiling. |

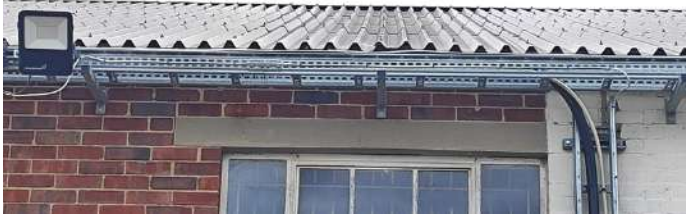
| <b>Description</b> | Gaps are present under the corrugated roof sheet along the north and south aspects may provide suitable cavities for roosting bats. |

| <b>Bat Roosting Potential</b> | Low |
