# **Preliminary Roost Assessment**

Former Arborfield Studios  
(Parcels W, Y and Z)

**Report on Behalf of:**  
Crest Nicholson Operations Ltd.

**PEG659-02C**

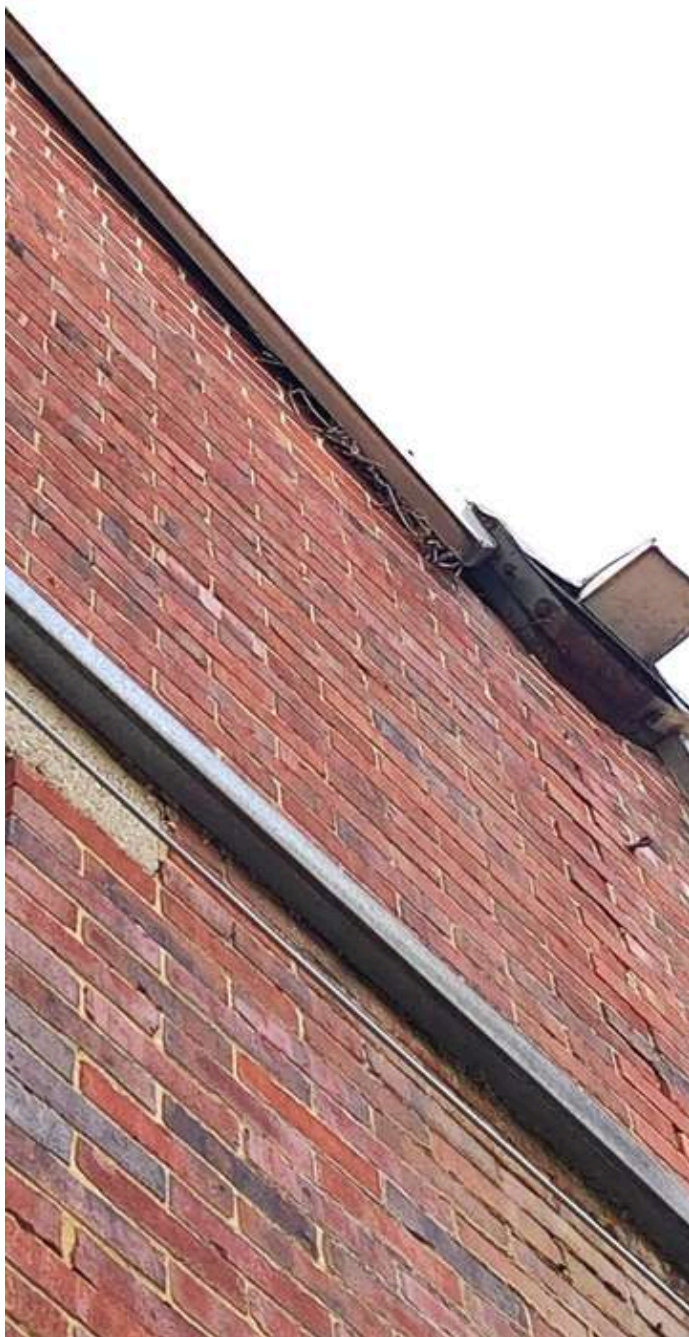
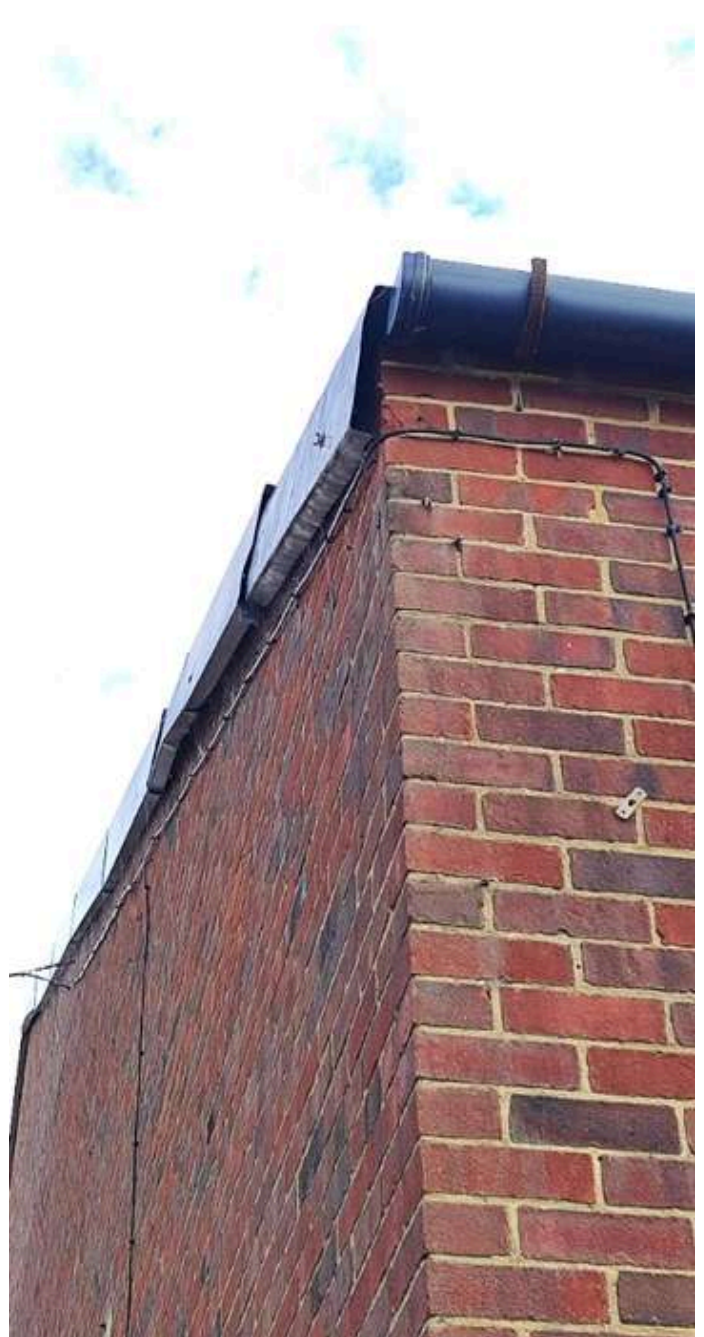
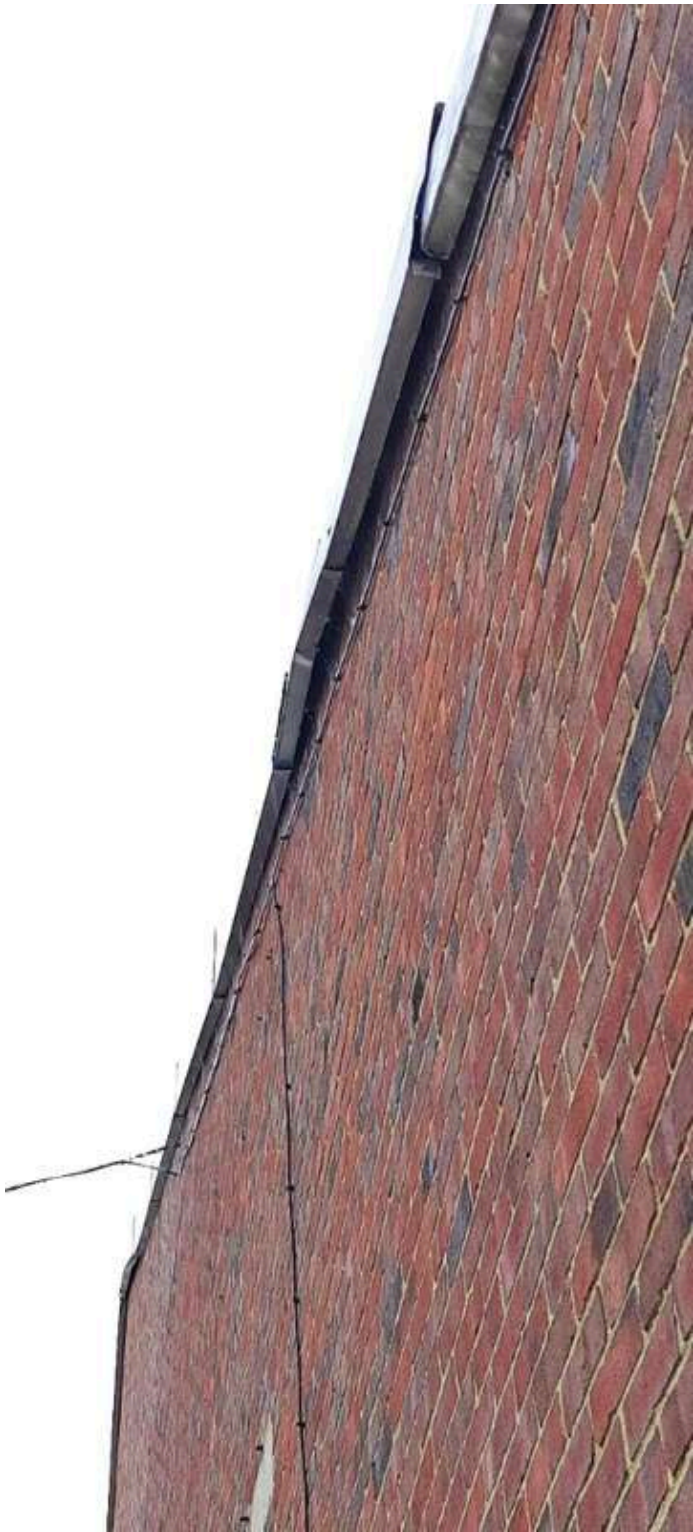
### PRF - A

| Description | There are gaps behind the barge boards along much of each end of the structures. There is potential for bat access and use by crevice roosting species. Evidence of birds nesting in places was present. |

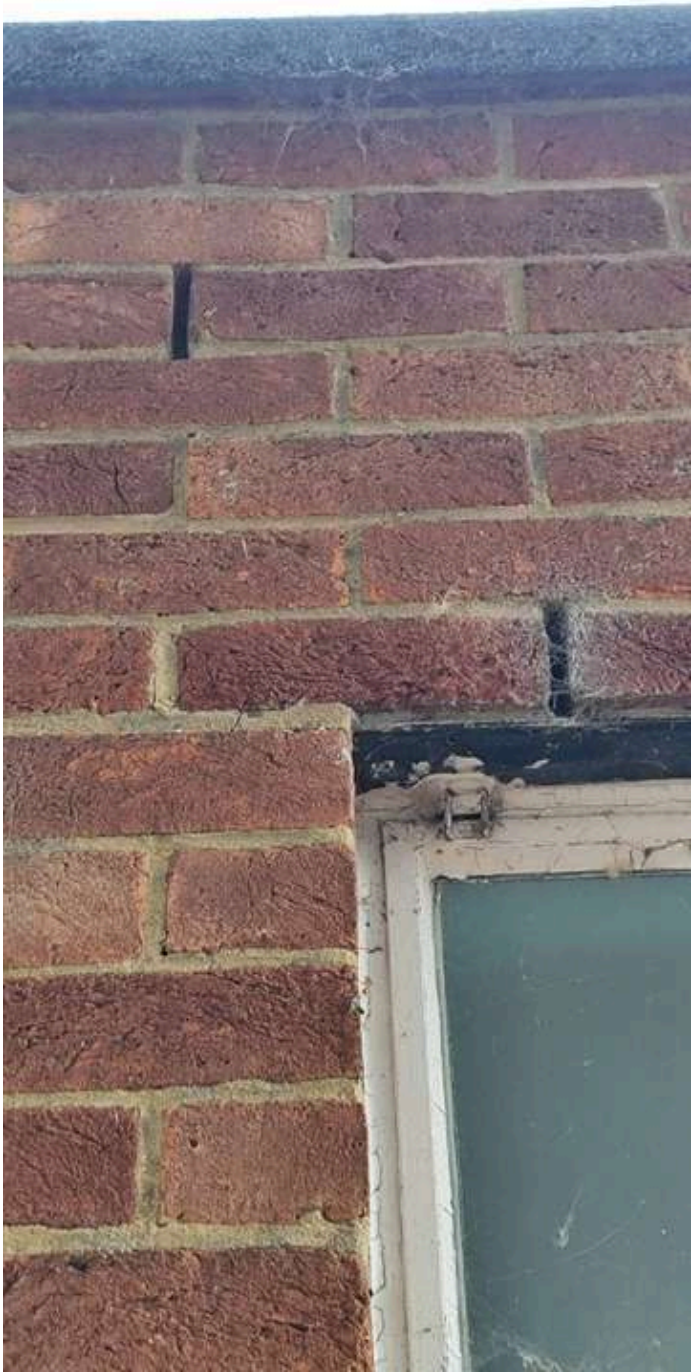
PRF - B

| Description | Weep holes are present in the mortar on B16a providing potential for crevice roosting species. |

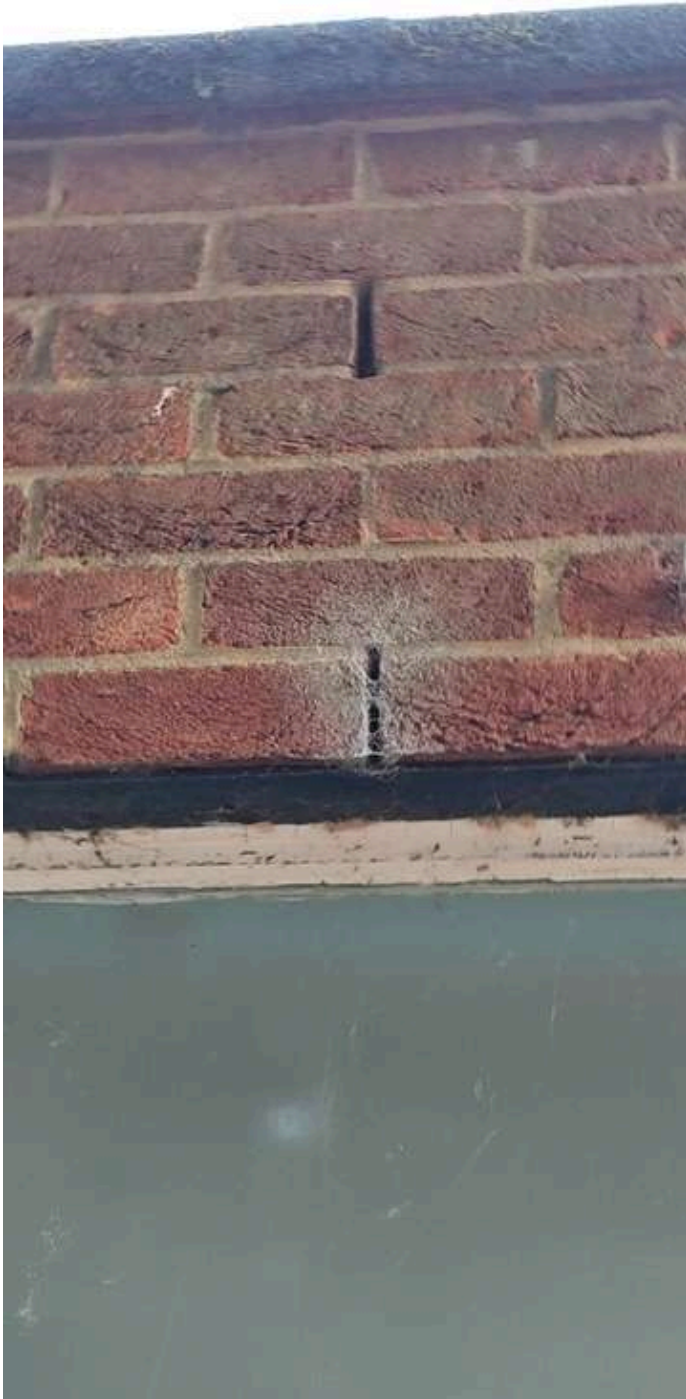
PRF - C

Weep holes are present in the mortar on B16b providing potential for crevice roosting species.

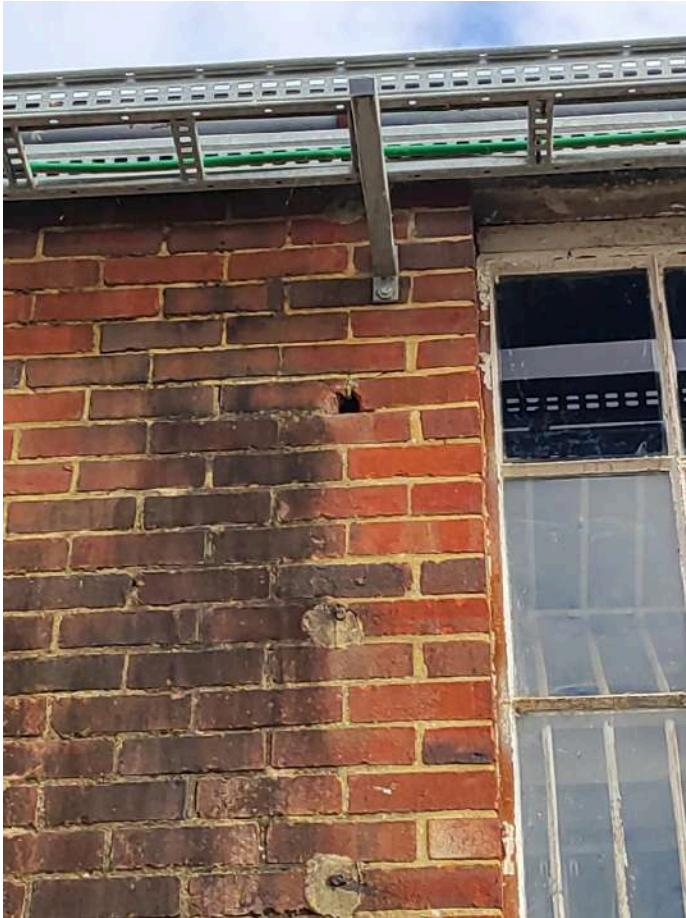
**PRF - D****Feature Letter**

| <b>Description</b> | A gap in the brickwork on the southern aspect where fitting may have been. There is potential access to cavity wall. |

| <b>Bat Roosting Potential</b> | Low |

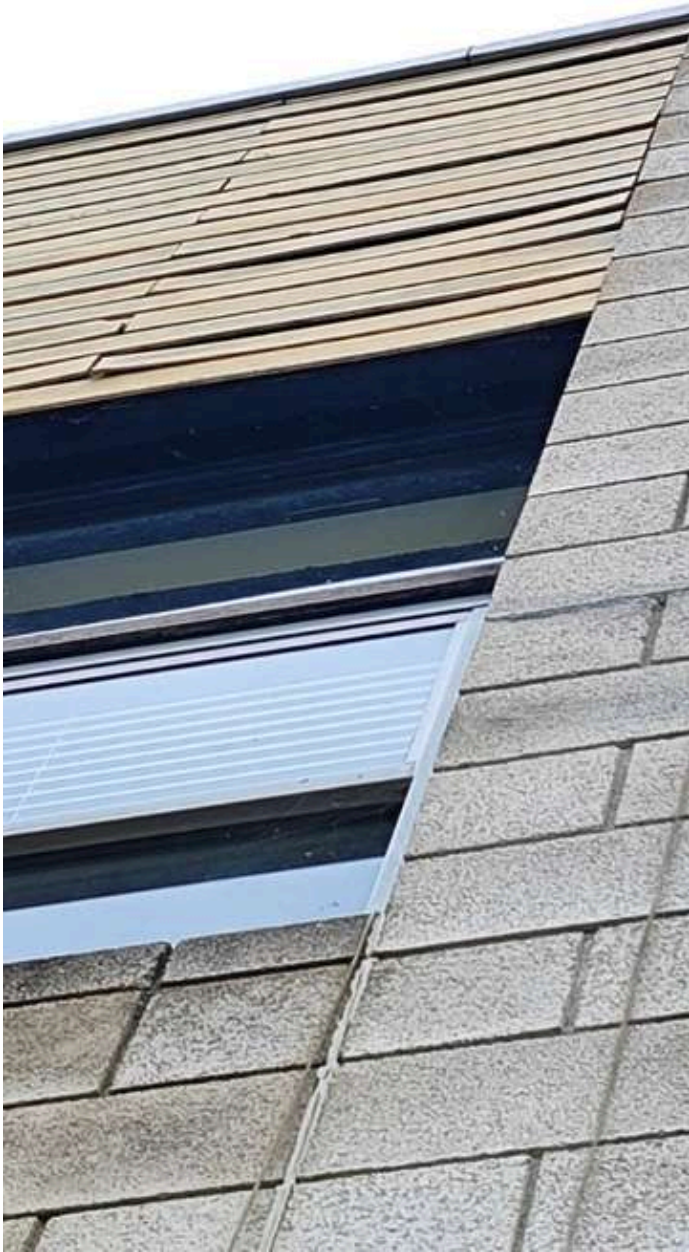
| Description | There are gaps in cladding along the east and west aspects of the building. |

| Bat Roosting Potential | Low |

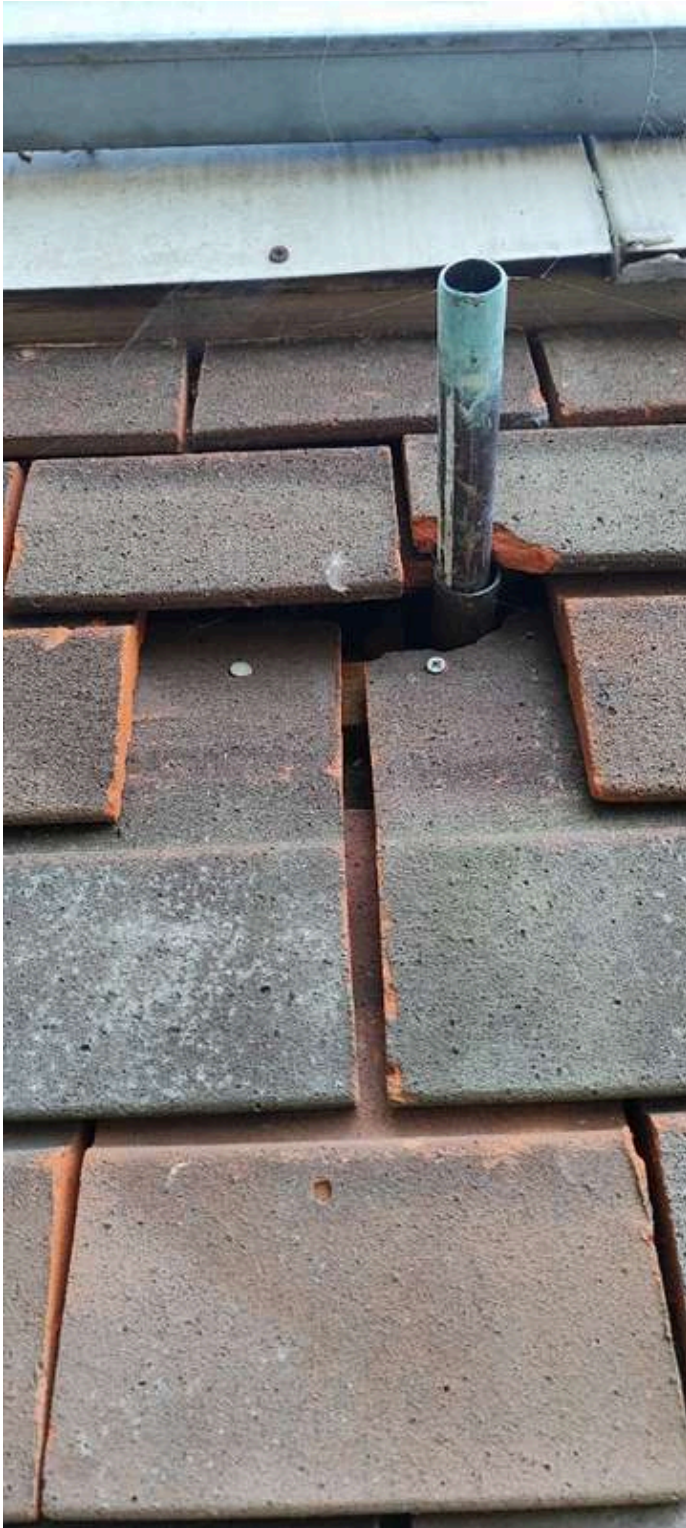
| <b>Description</b> | Tile cladding on walls on all aspects provide gaps and crevices for potential bat use. |

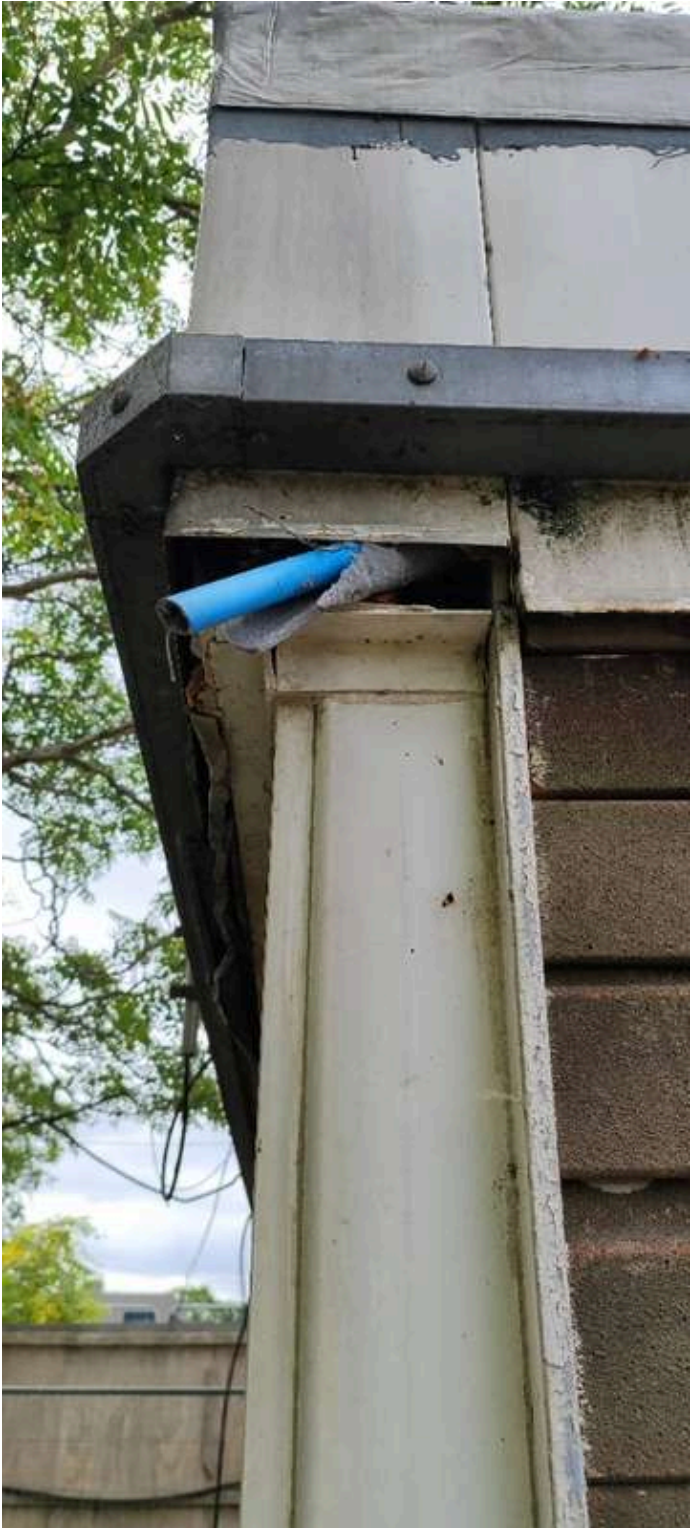
**PRF - B**

| Description | Gaps in soffits provide potential bat access to flat roof and length of soffit space. |

| Bat Roosting Potential | Moderate |

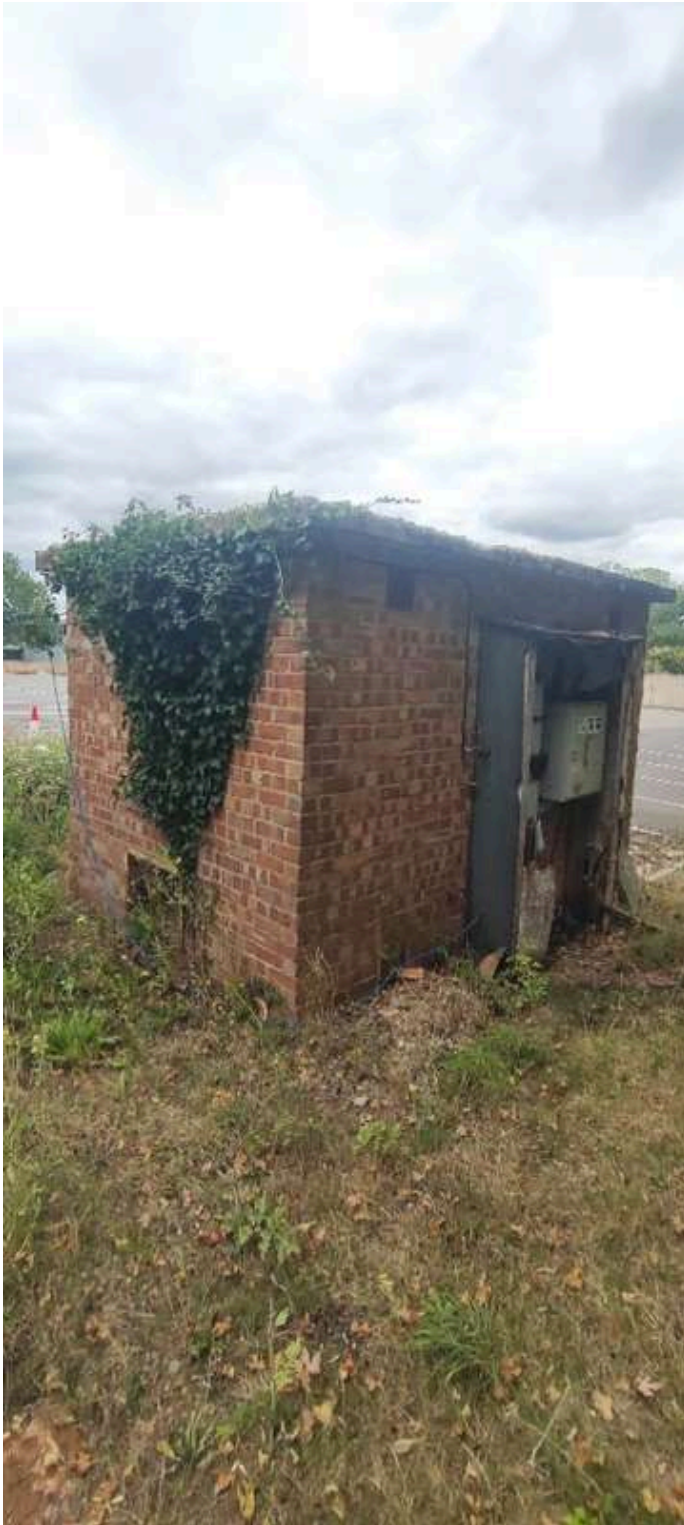
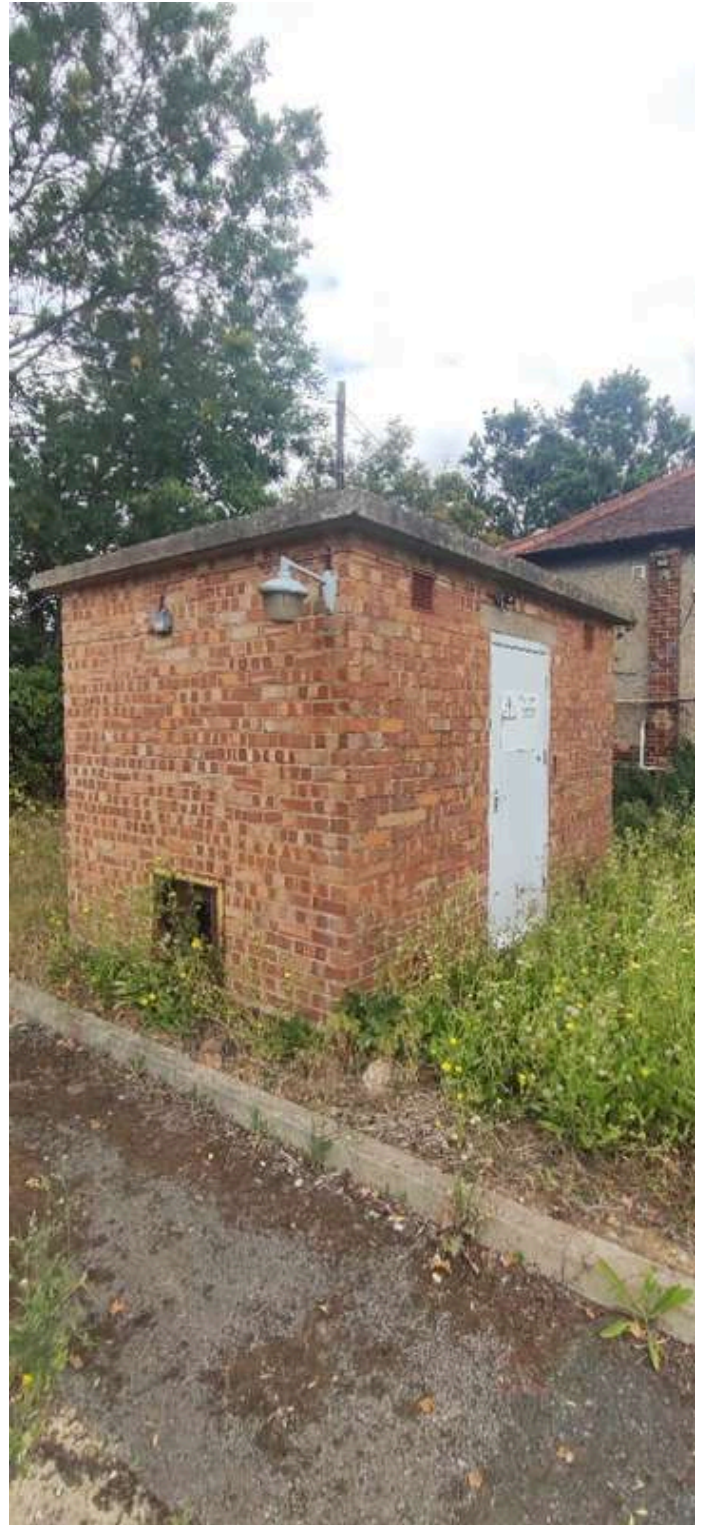
**Further Notes** | No internal access was possible. The building shows no suitability to support roosting bats.

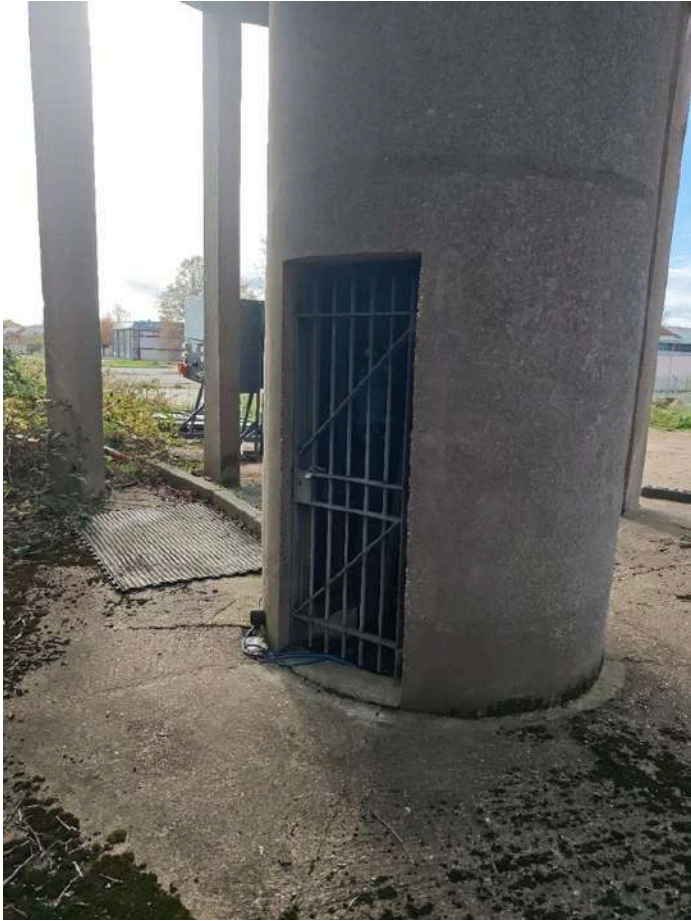
Internal Description - B24 - Internals

No access to the tower.

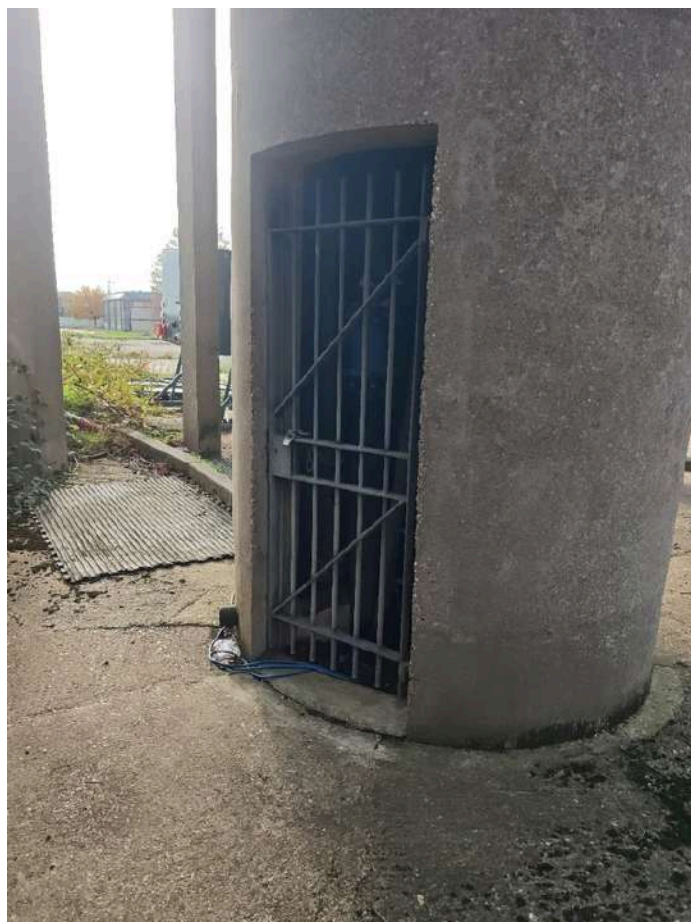
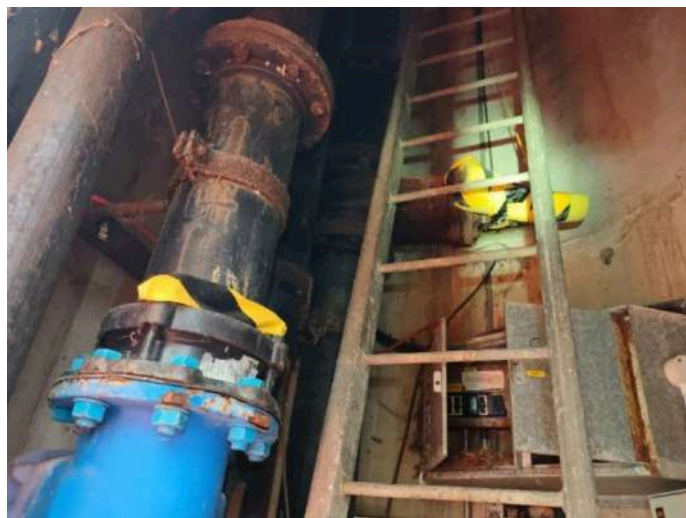
PRF - A

| Description | The door way at ground level leads to a central ladder access shaft up the tower. There is a dark space inside that could support roosting bats. Some drafts are present but the features within this space are unknown as access was not possible. |

| <b>Bat Roosting Potential</b> | Low |

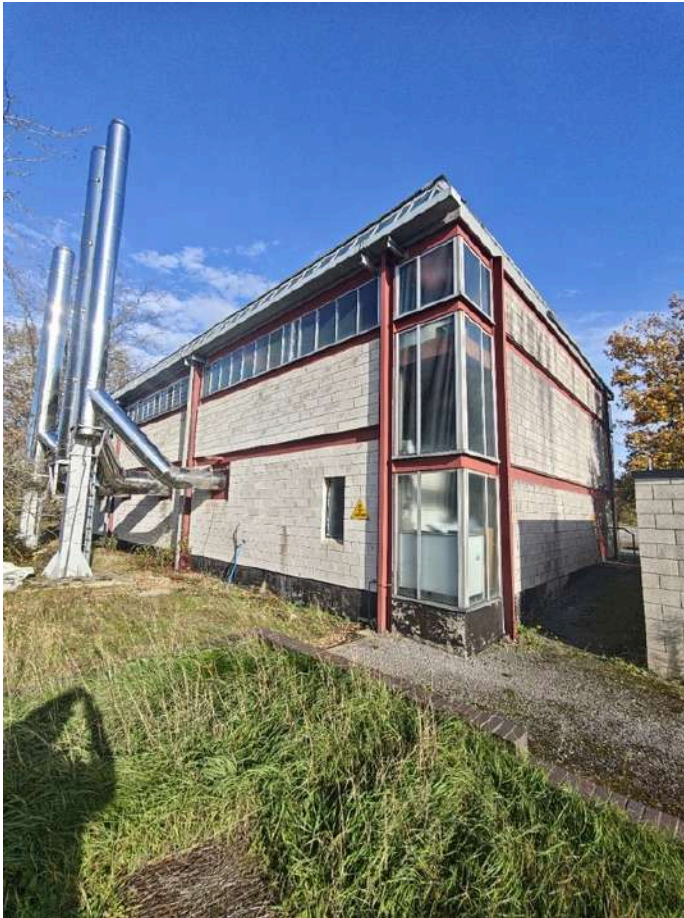
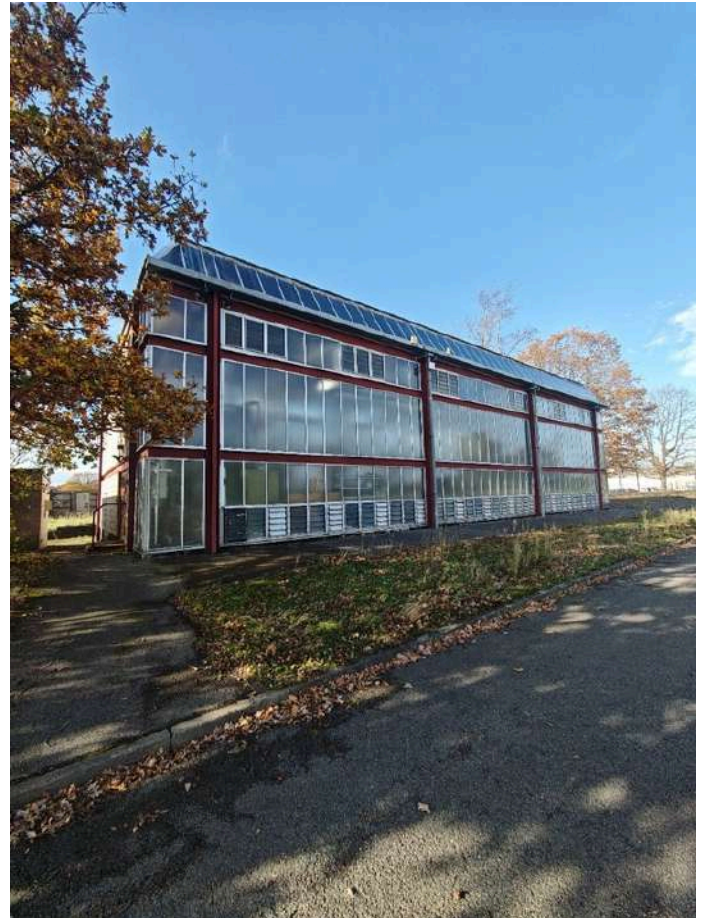
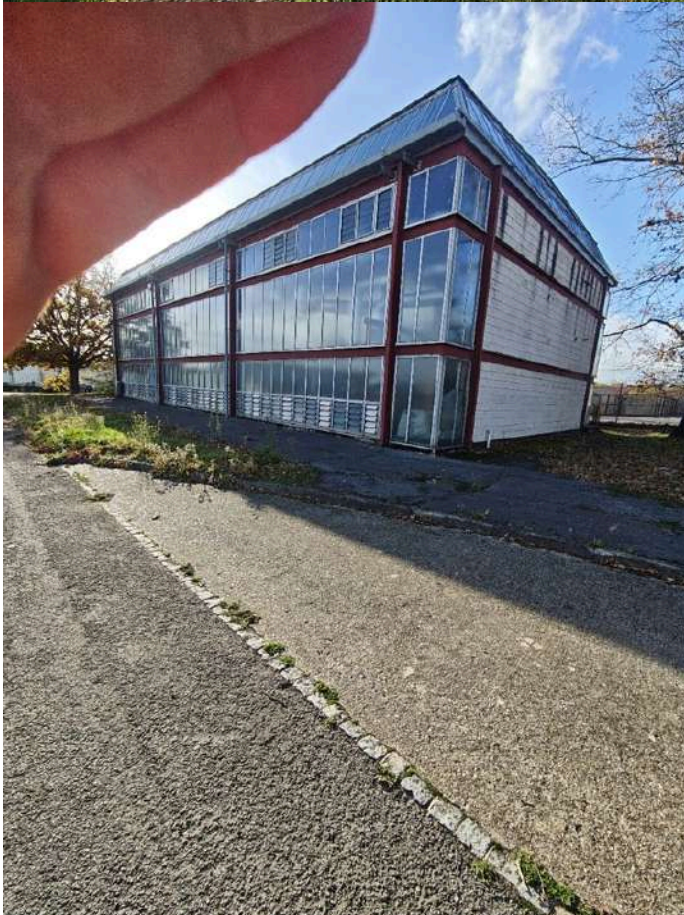
| <b>Further Notes</b> | No internal access was possible due to health and safety. Visible from through the glass door. The space inside is completely light with glass windows on all aspects. |

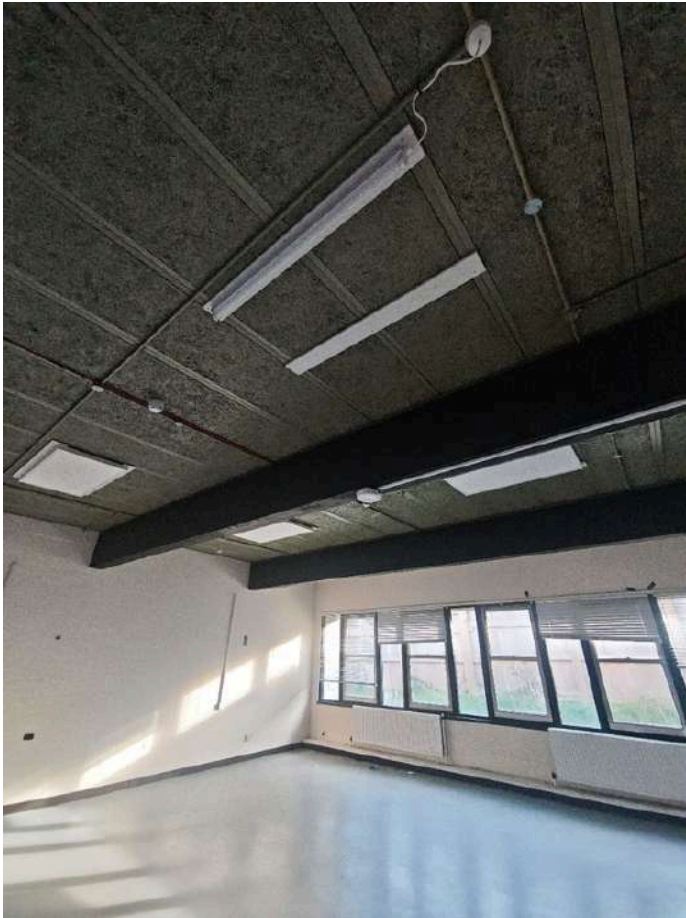
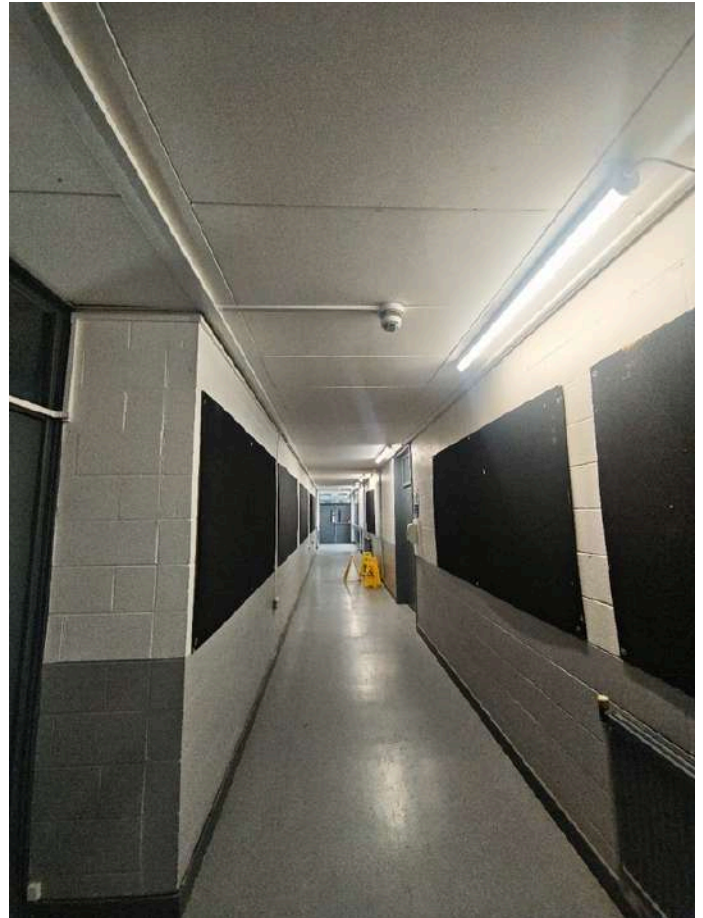
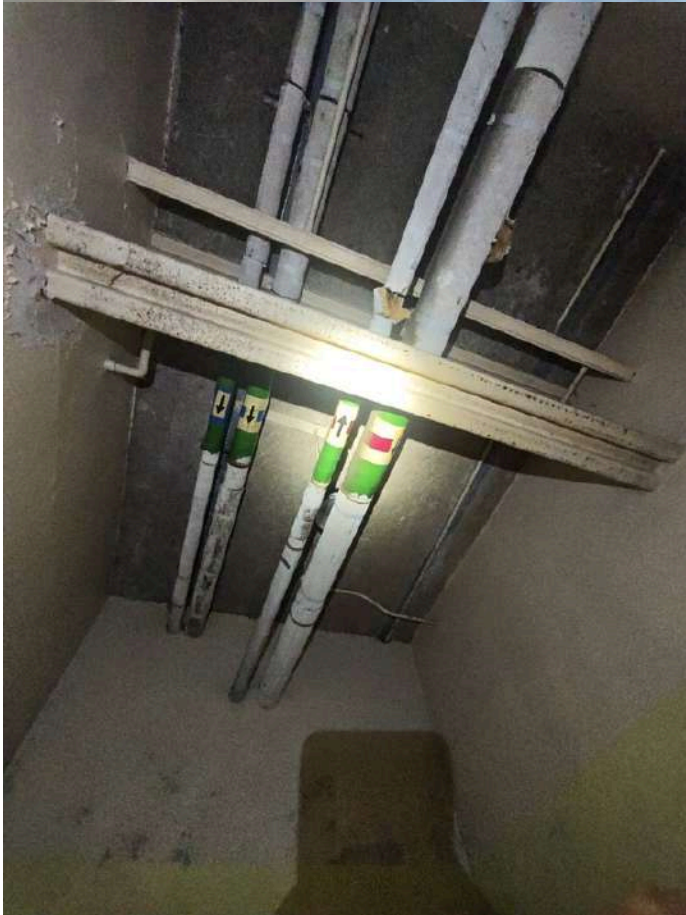
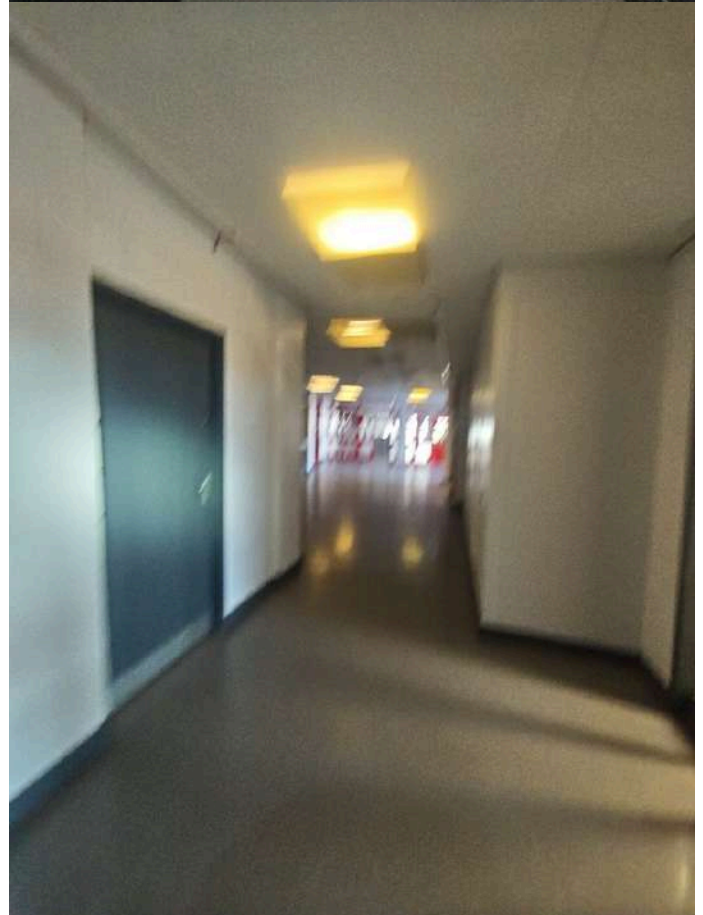
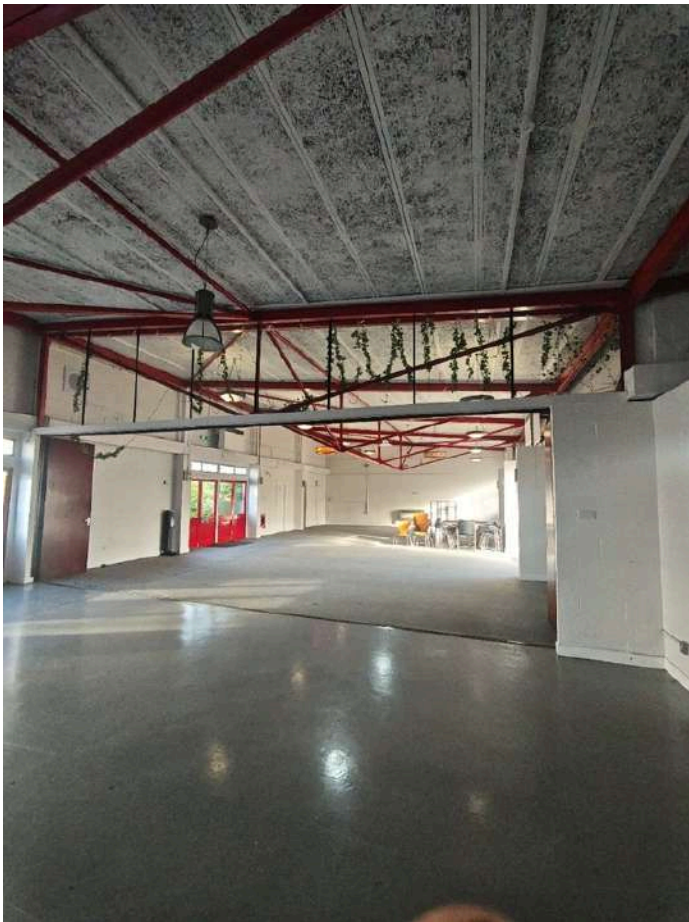
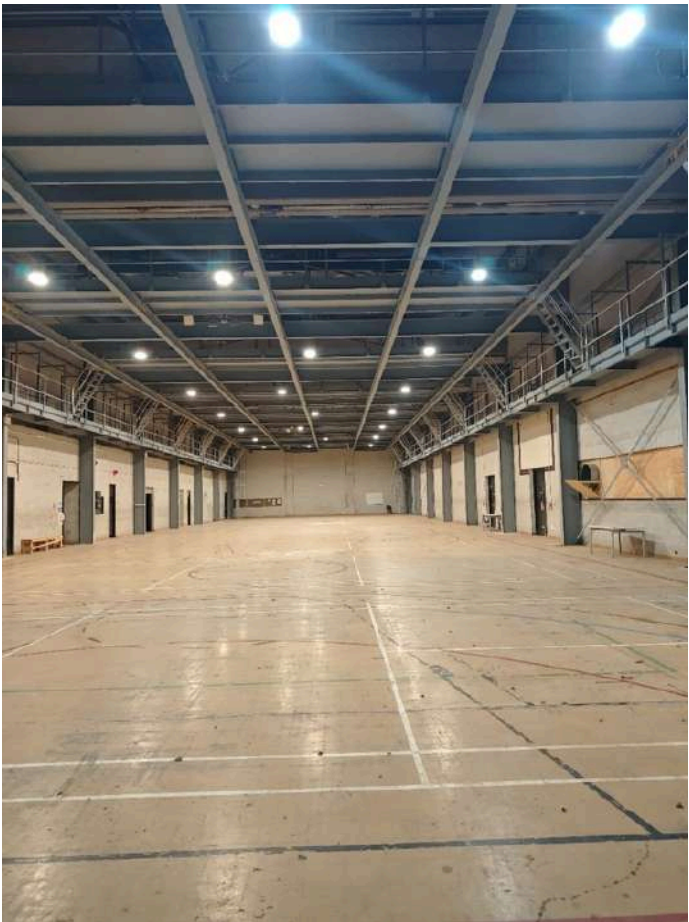
## Internal Description - B27 - Internals

| <b>Further Notes</b> | Access was available to all rooms. No roof voids were present. Several rooms had false ceilings with a small voids above containing pipework. However, as these areas were located centrally within the building beneath a flat roof, no external access to the voids was possible. |

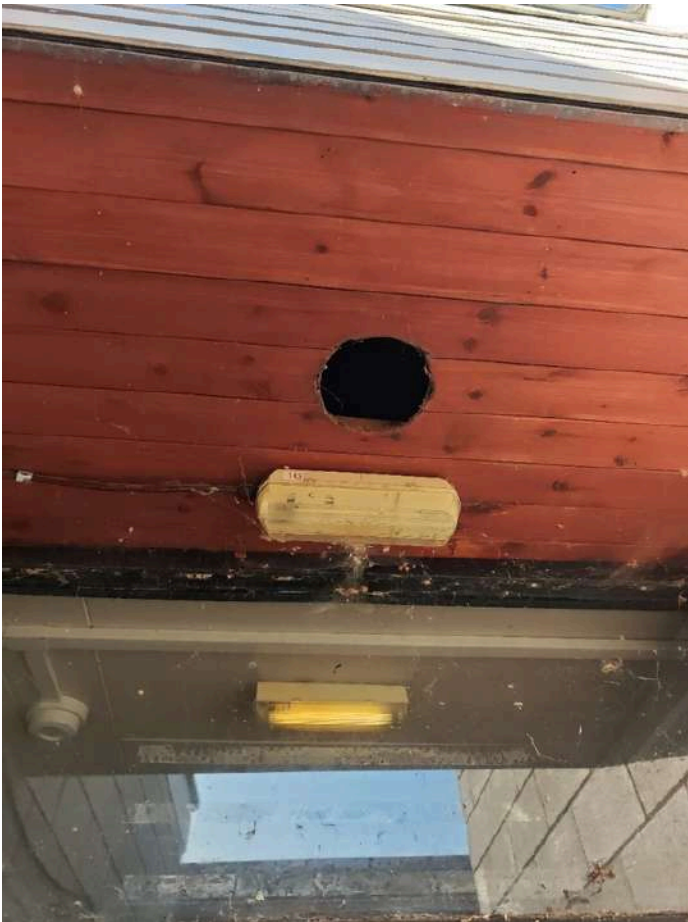
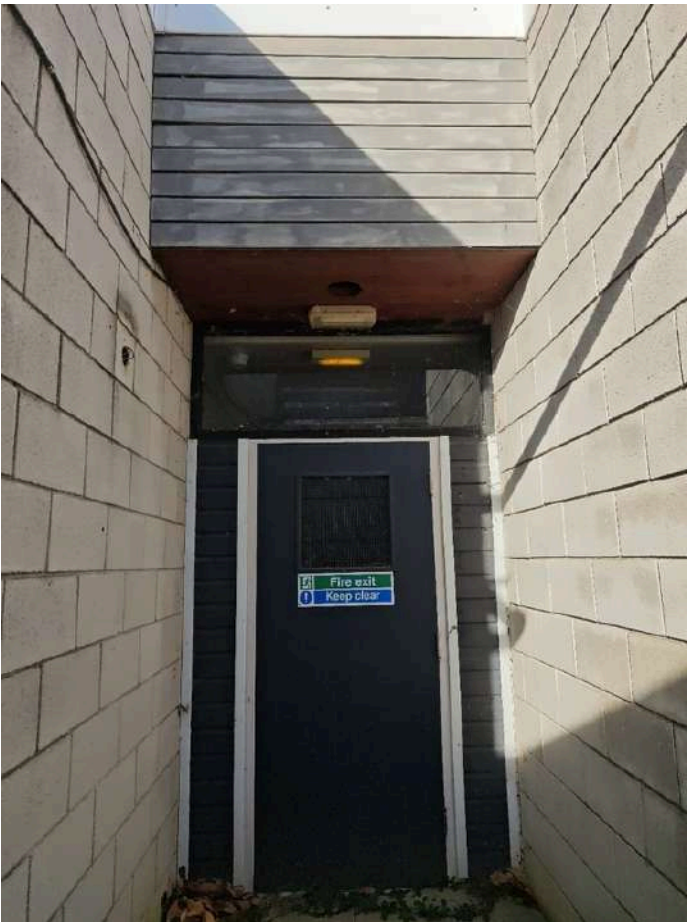
PRF - A

| Description | A hole in a boxed soffit above a rear emergency exit. |

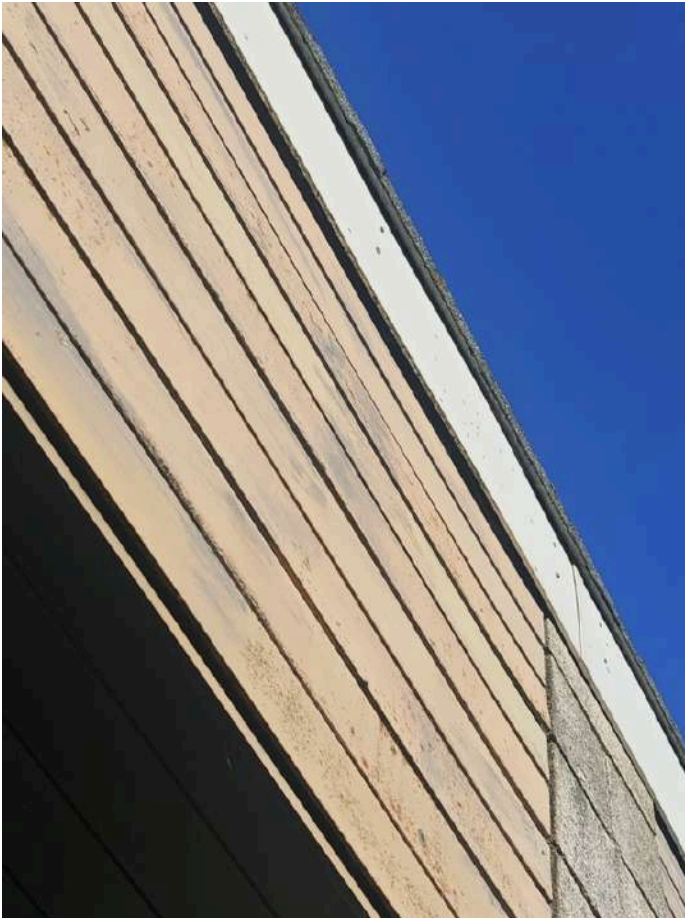
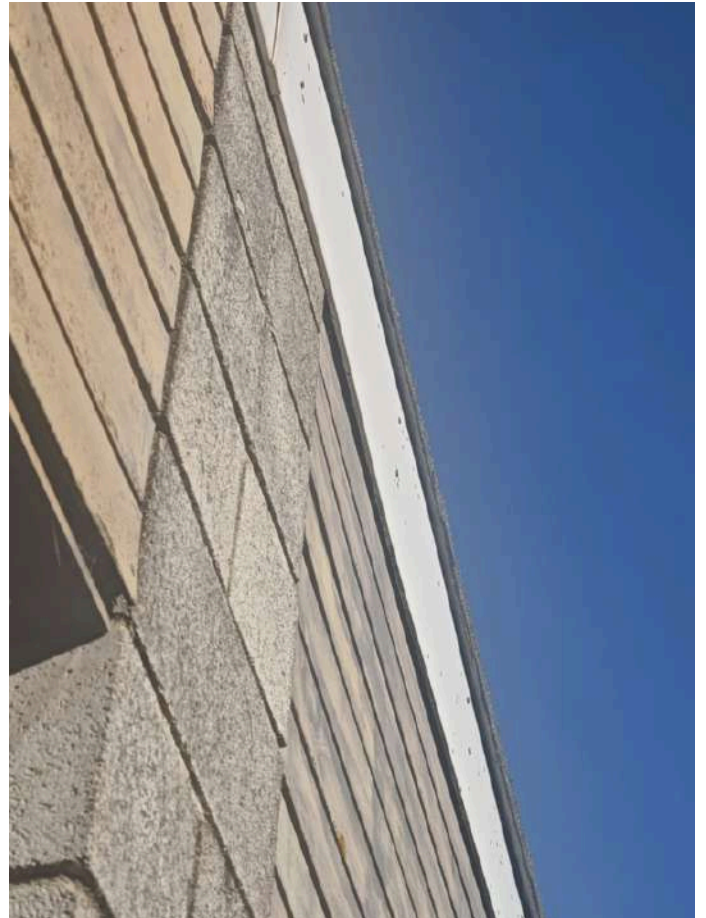
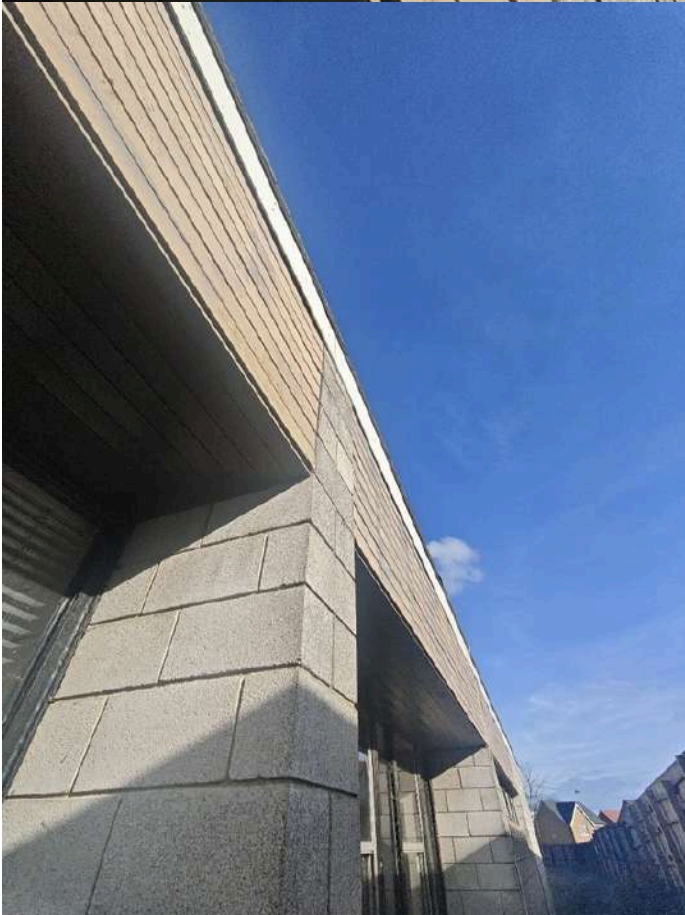
| <b>Description</b> | Multiple gaps are present along the side and rear fascia. Fully cobwebbed at the time of survey, however could support the occasional bat. |
