# **Preliminary Roost Assessment**

Former Arborfield Studios  
(Parcels W, Y and Z)

**Report on Behalf of:**  
Crest Nicholson Operations Ltd.

**PEG659-02C**

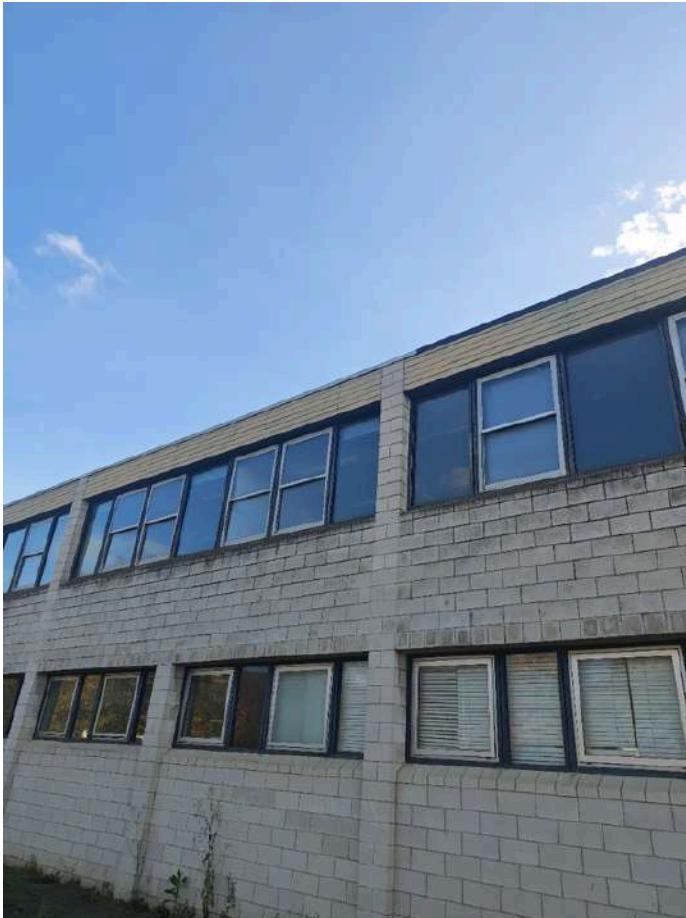
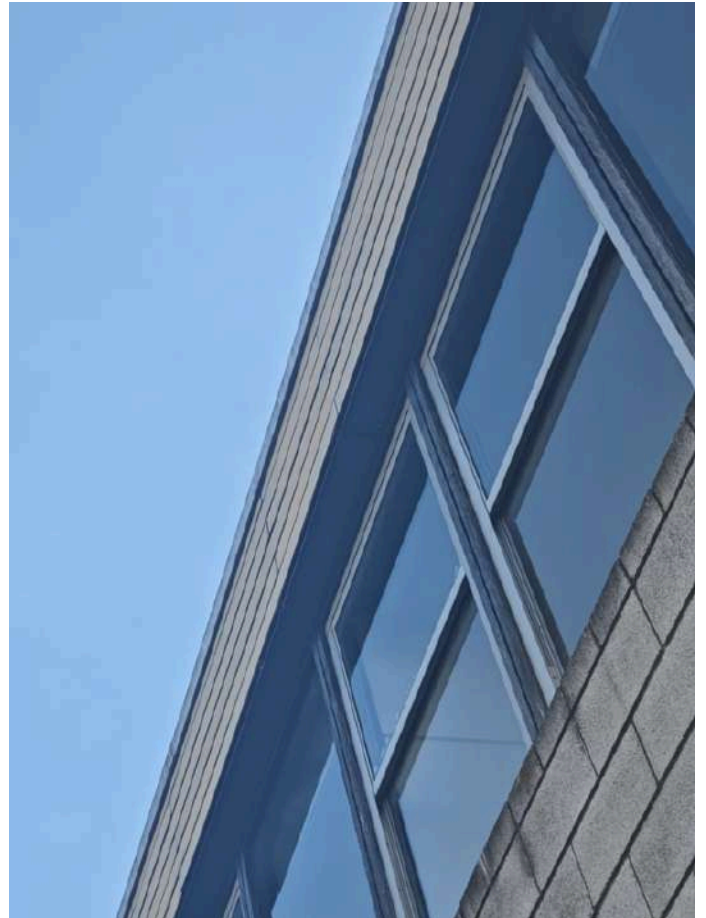
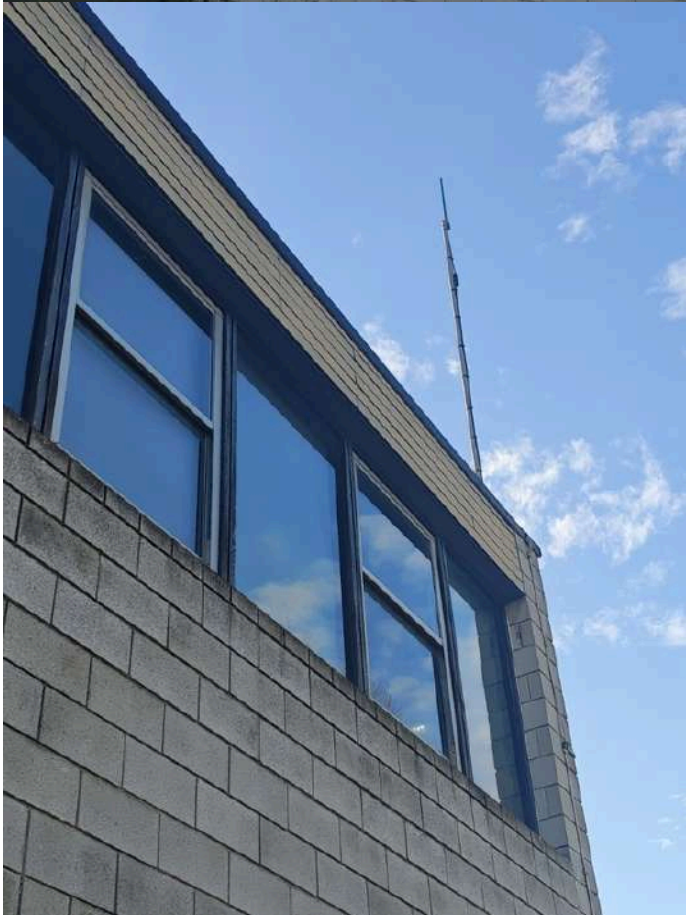
PRF - D

| Description | Slightly lifted cladding is present near the roof. Surveyor was unable to see sufficiently from the ground. |

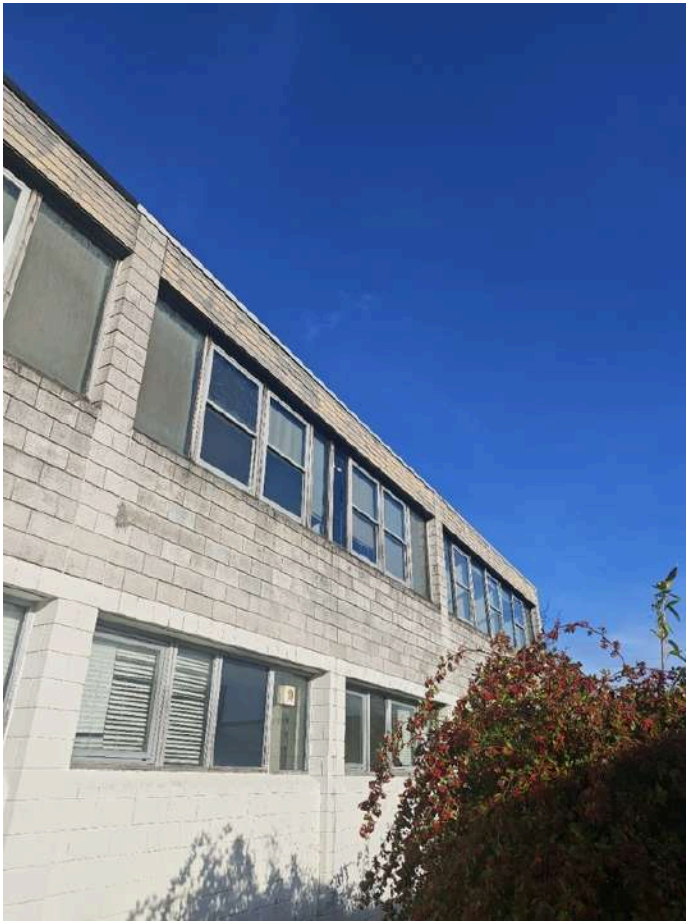
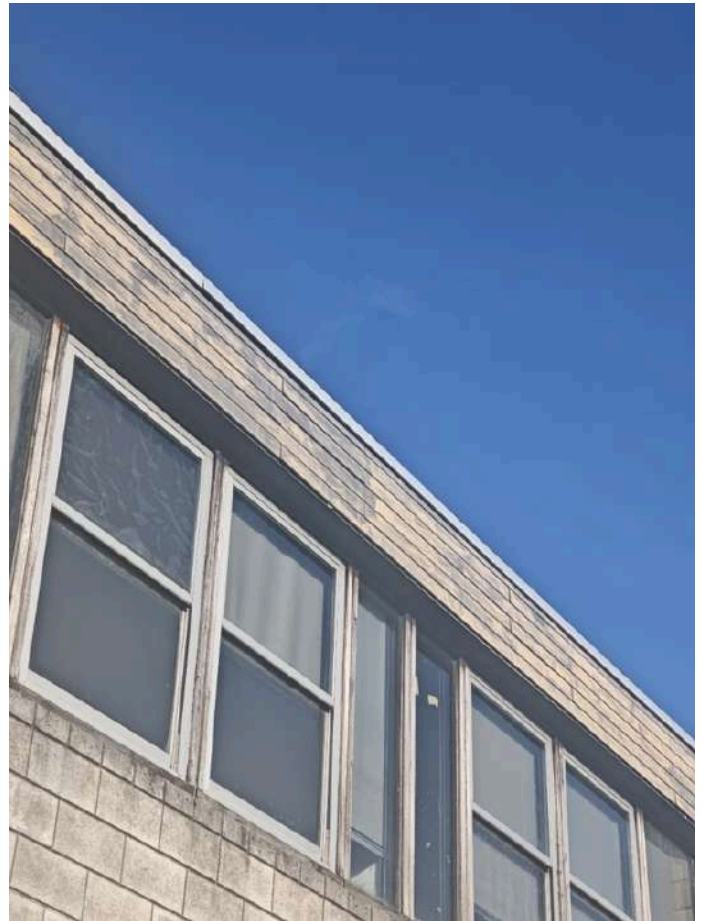
**PRF - E**

| <b>Description</b> | The same as feature D but on the opposite side. Slightly lifted cladding is present near the roof. The surveyor was unable to see sufficiently from the ground. |

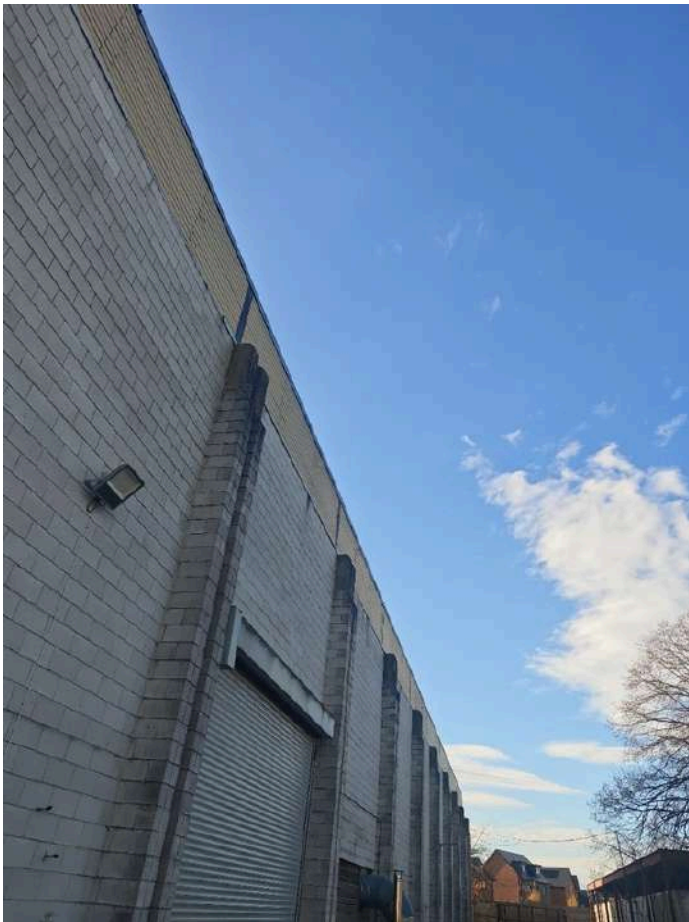
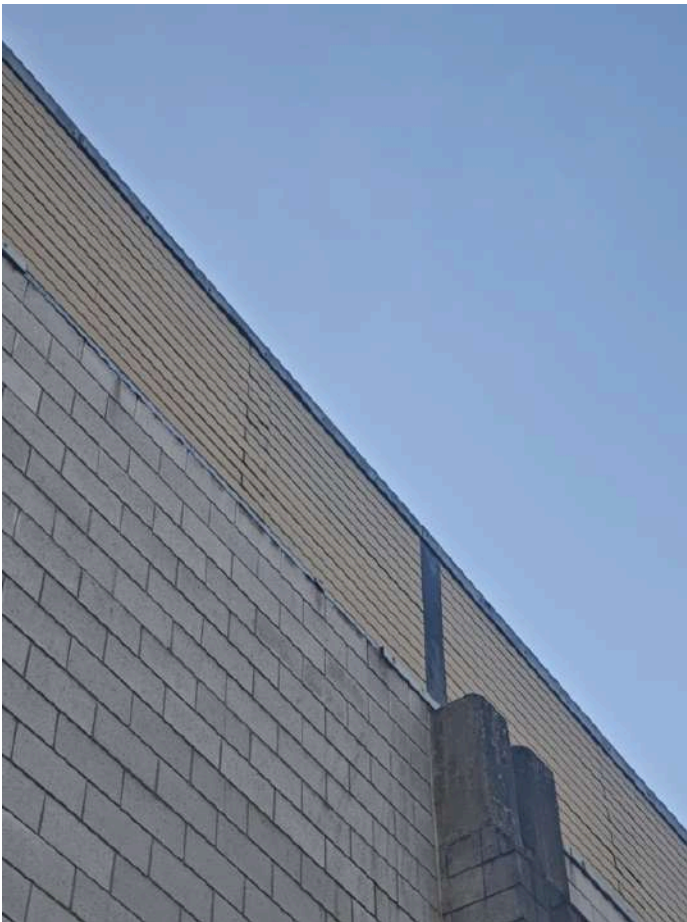
| Description | Multiple gaps along the fascia at the buildings frontage. |

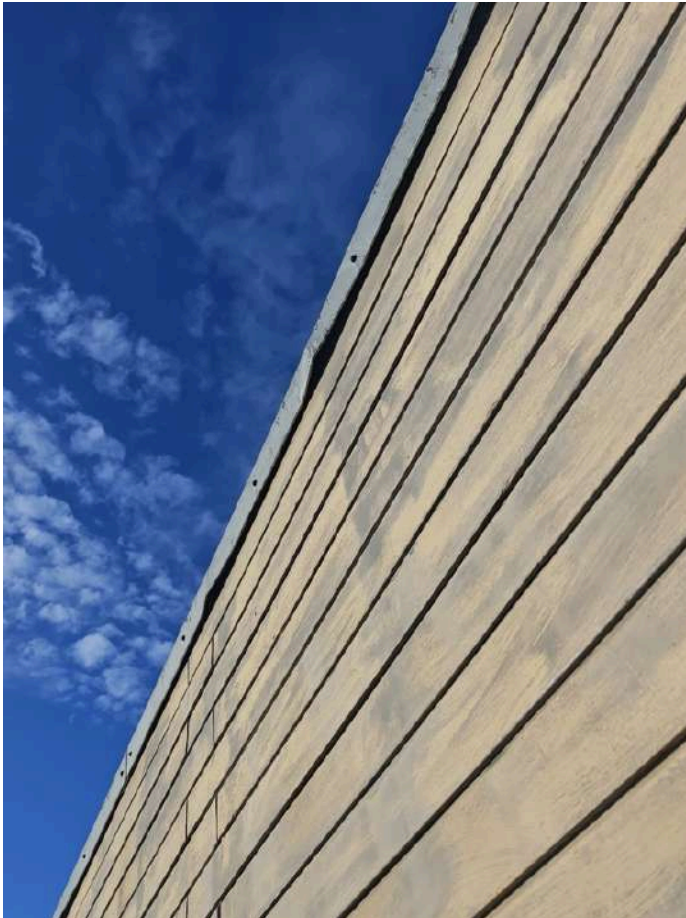
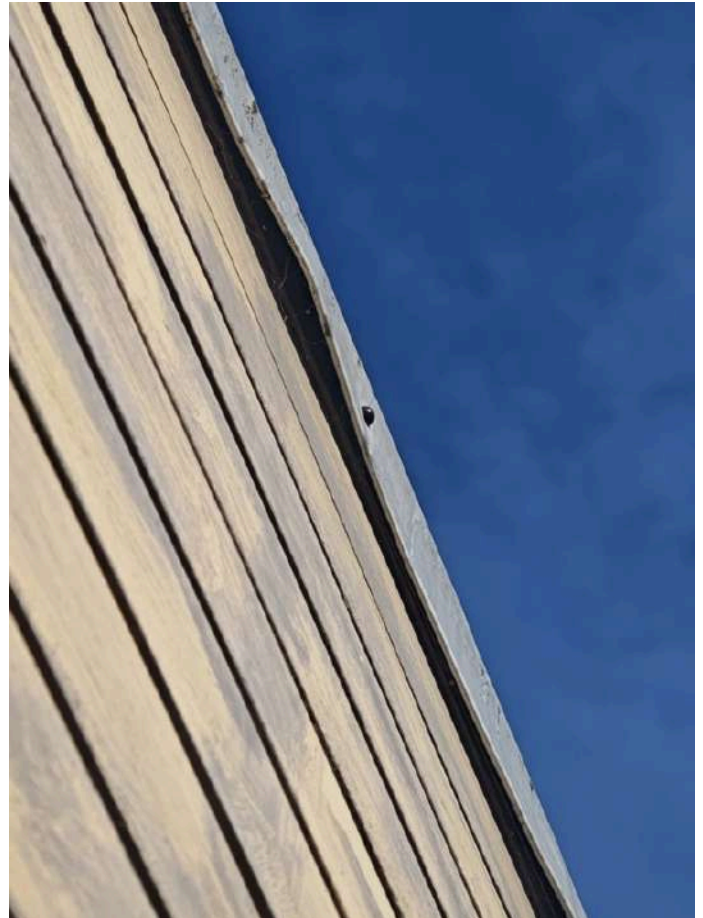
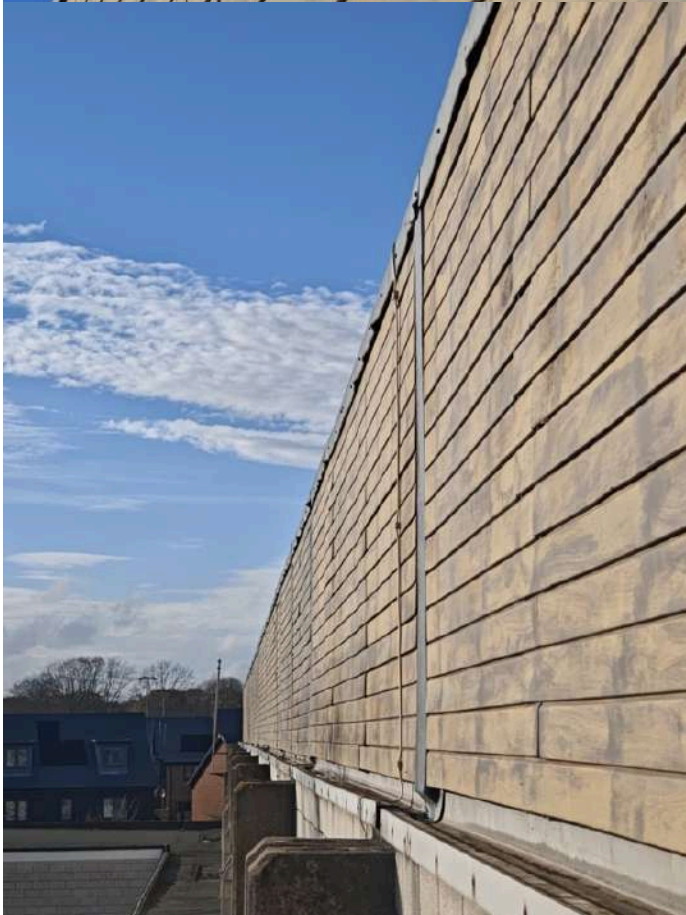
PRF - H

| Description | Multiple areas of lifted metal fascia on the rooftop. |

| <b>Bat Roosting Potential</b> | High |

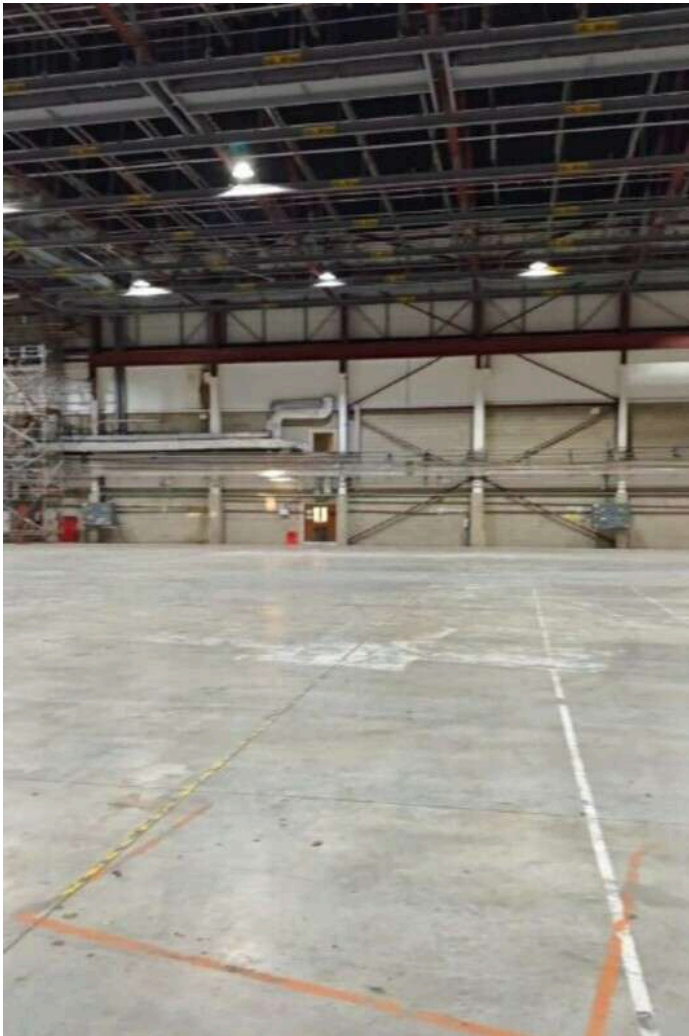
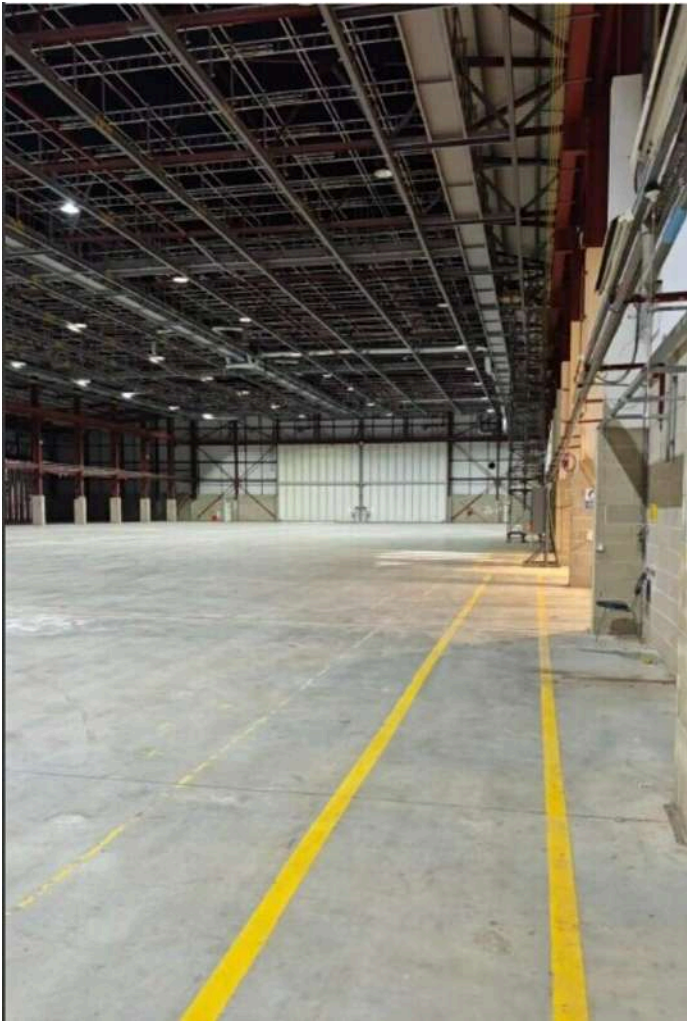
| <b>Further Notes</b> | The office spaces contained windows along one edge creating a bright space. The main hangar was dark when all doors were closed. no potential access points of PRF's were identified. |

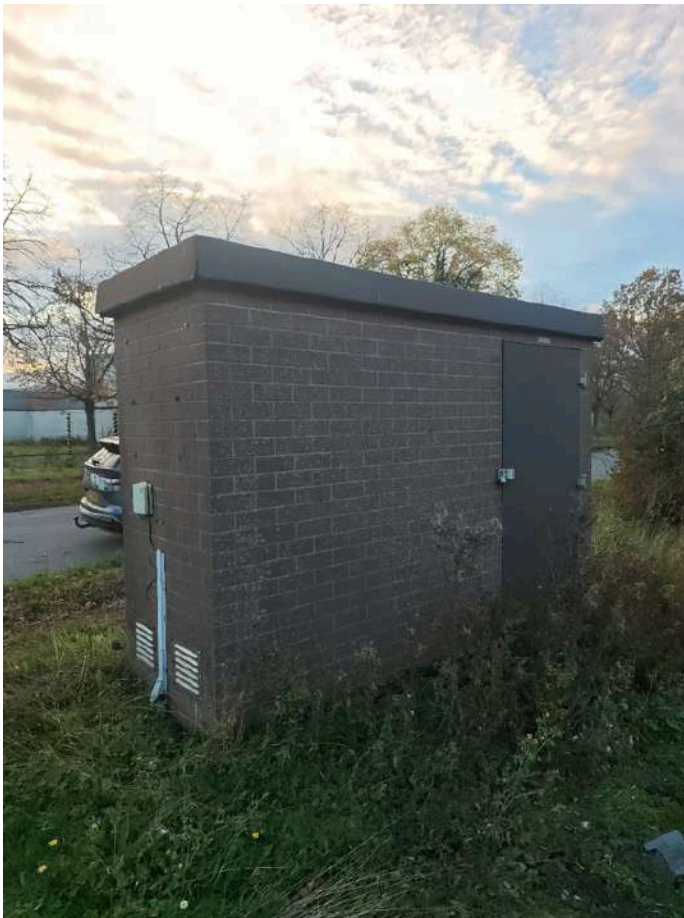
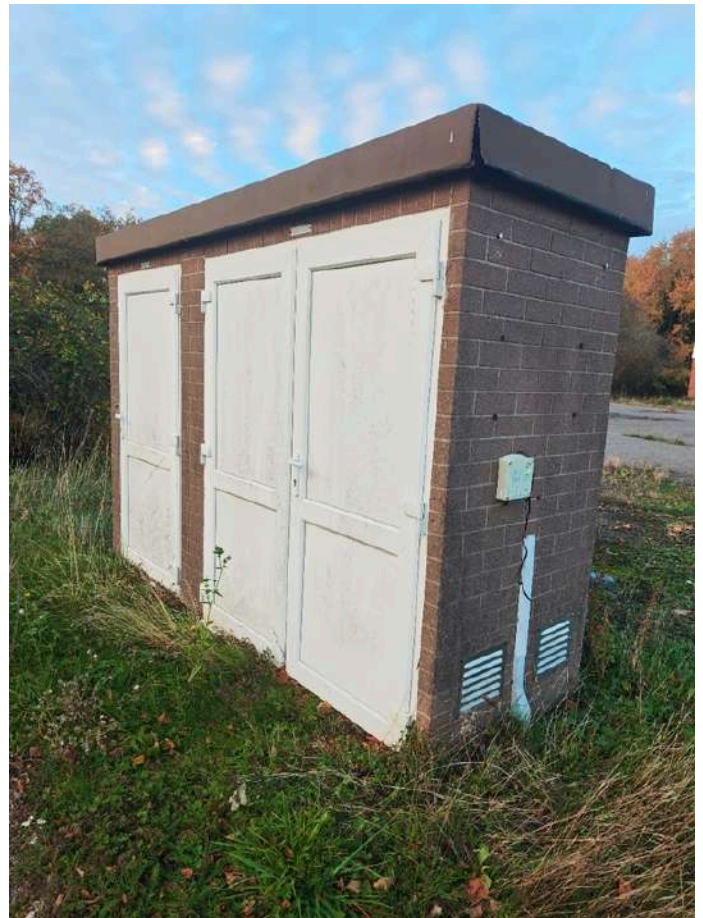
**Further Notes** | No PRFs

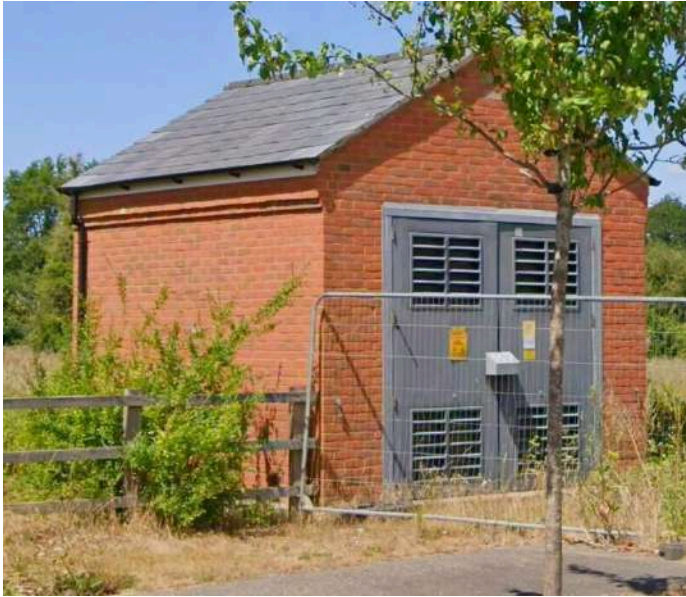
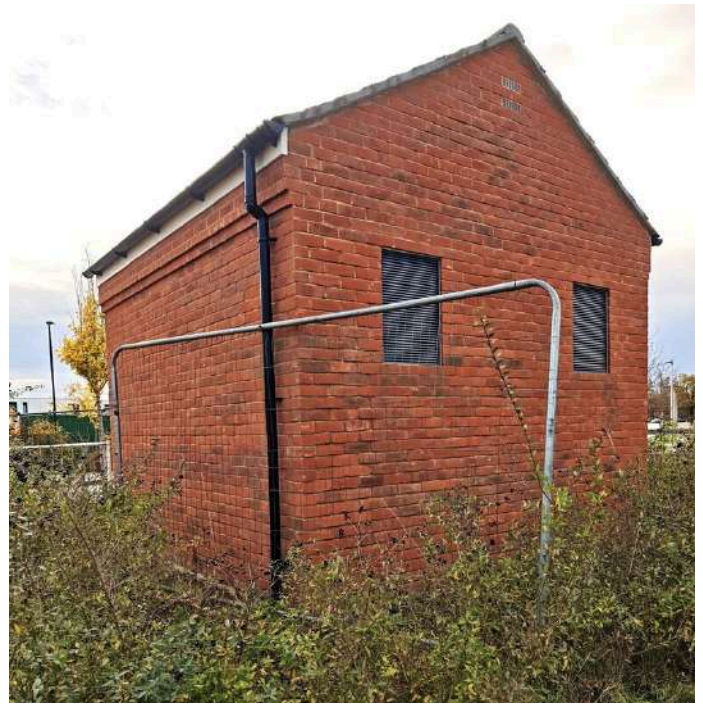
| <b>Further Notes</b> | No PRF's and no potential bat access points identified. No internal access possible. |
