# Tree Management, Duty of Care Report©

Site: Woodley Rectory, 36 Church Road, Woodley, RG5 4QJ

Client: Oxford Diocese    Date: 24/04/25    Surveyor: Danny Konstantinidis

## HERITAGE TREE SERVICES ABORICULTURAL DUTY OF CARE & MAINTINANCE SURVEY

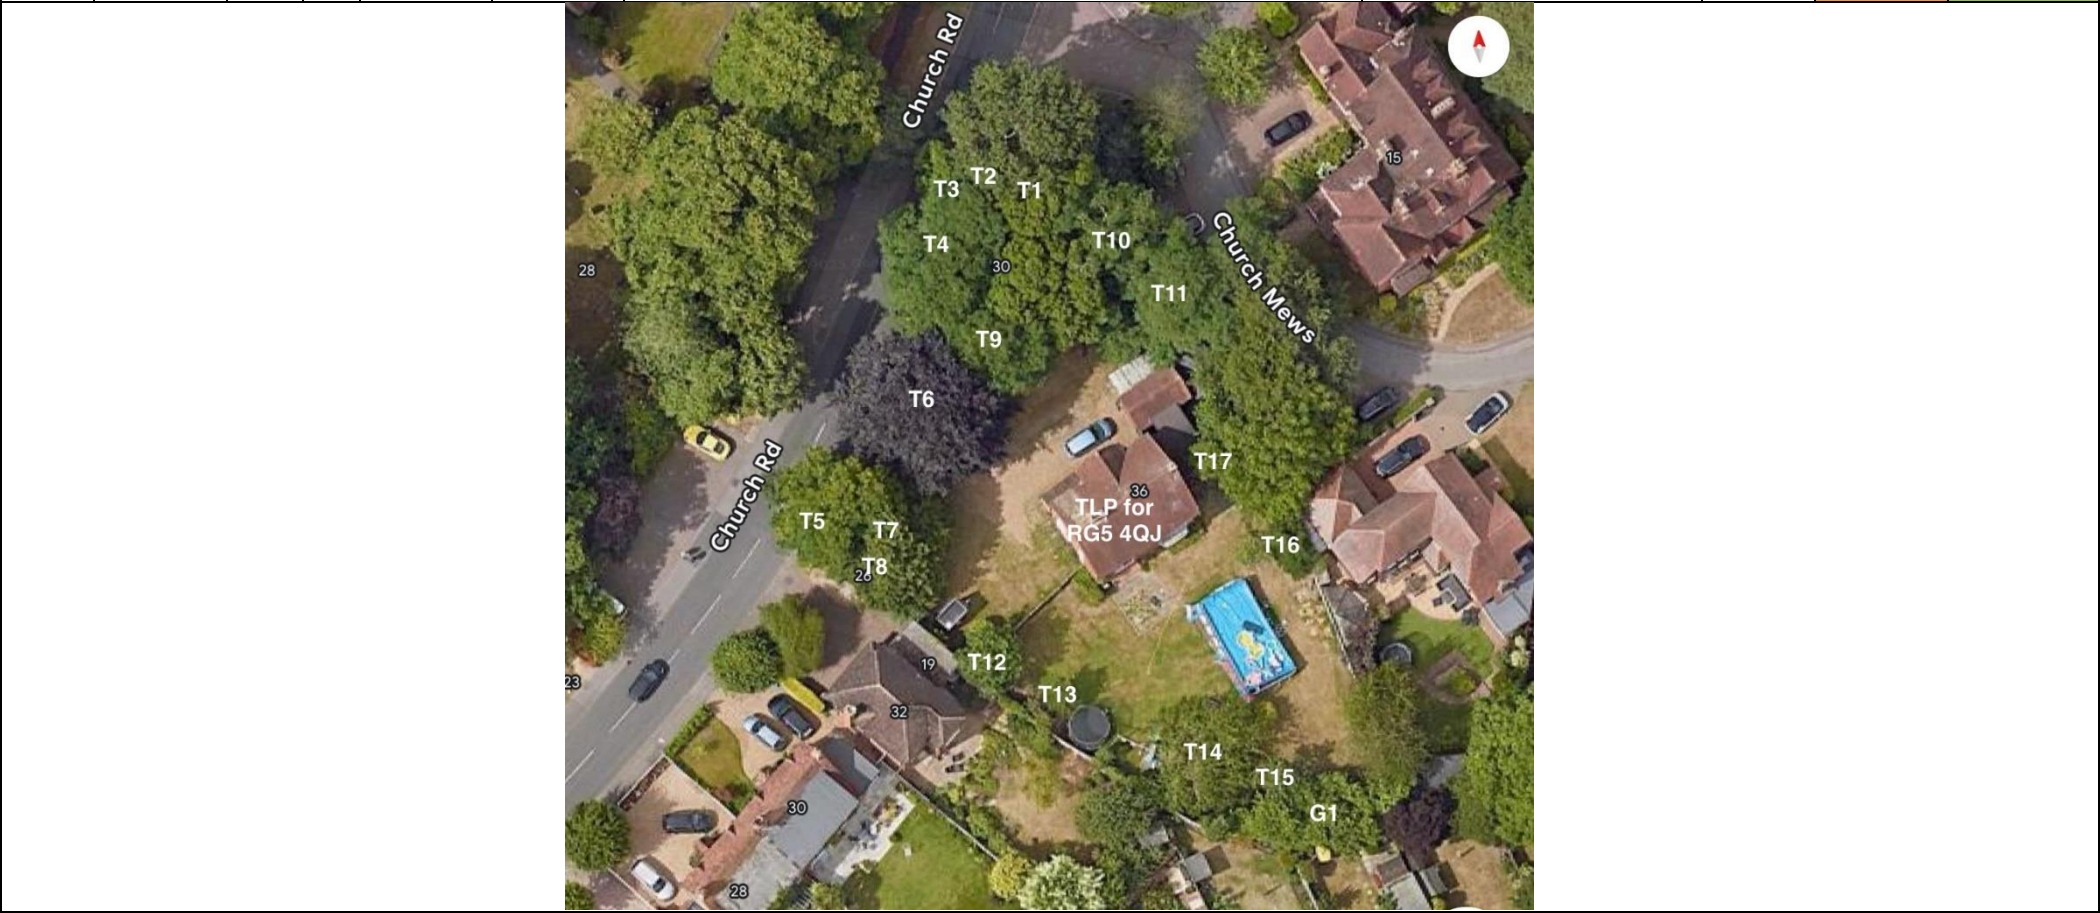
| T17<br>No<br>tag | Tree of<br>Heaven | Sm | M | G | G | Likely a sucker from roots of neighbouring tree.<br>Invasive species.<br><br>Growing next to boundary fence. | Remove to approximately<br>50mm from ground level. | 2<br>1<br>3 | 6 | B |
