# Hartley Court House

DESIGN & ACCESS, AND HERITAGE STATEMENT

LISTED BUILDING CONSENT

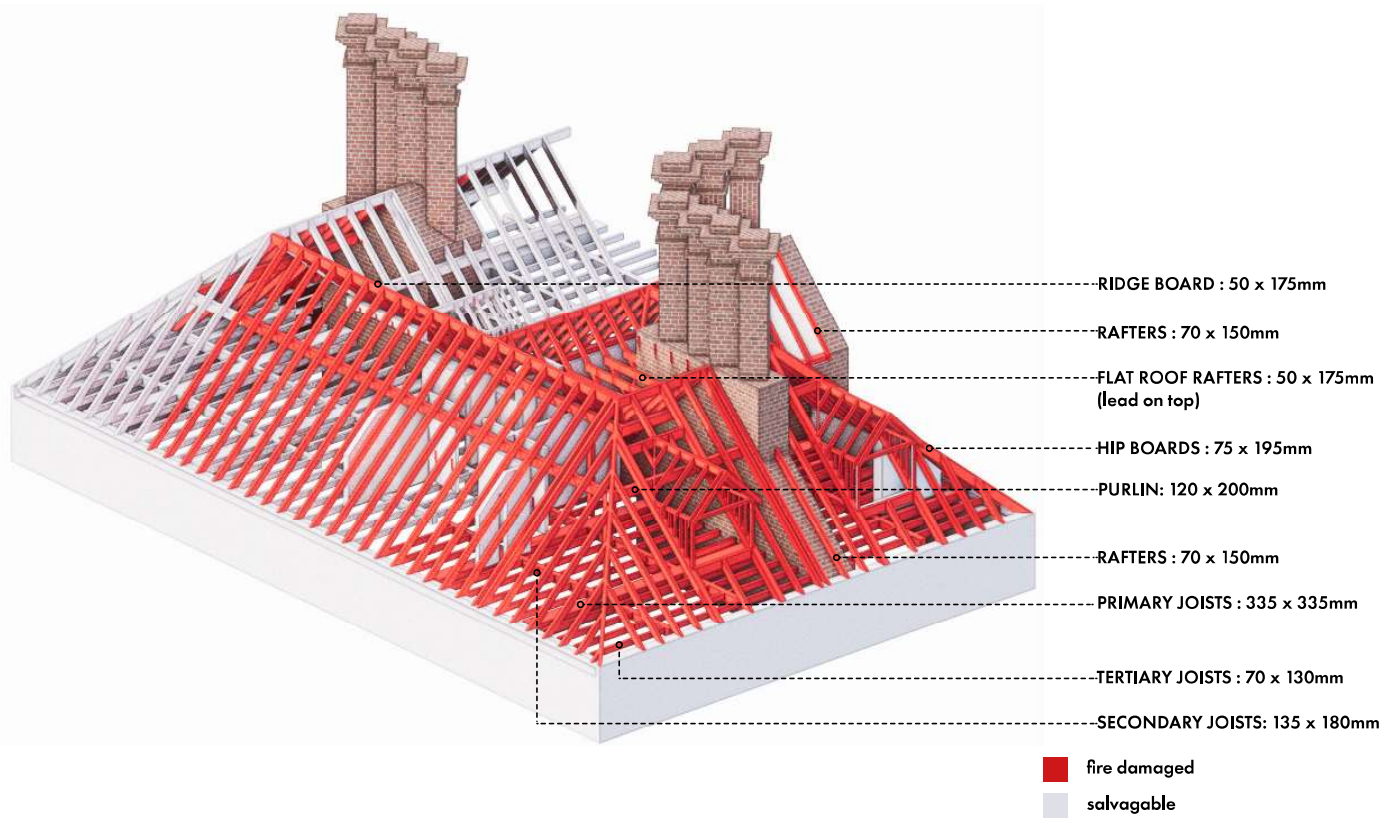
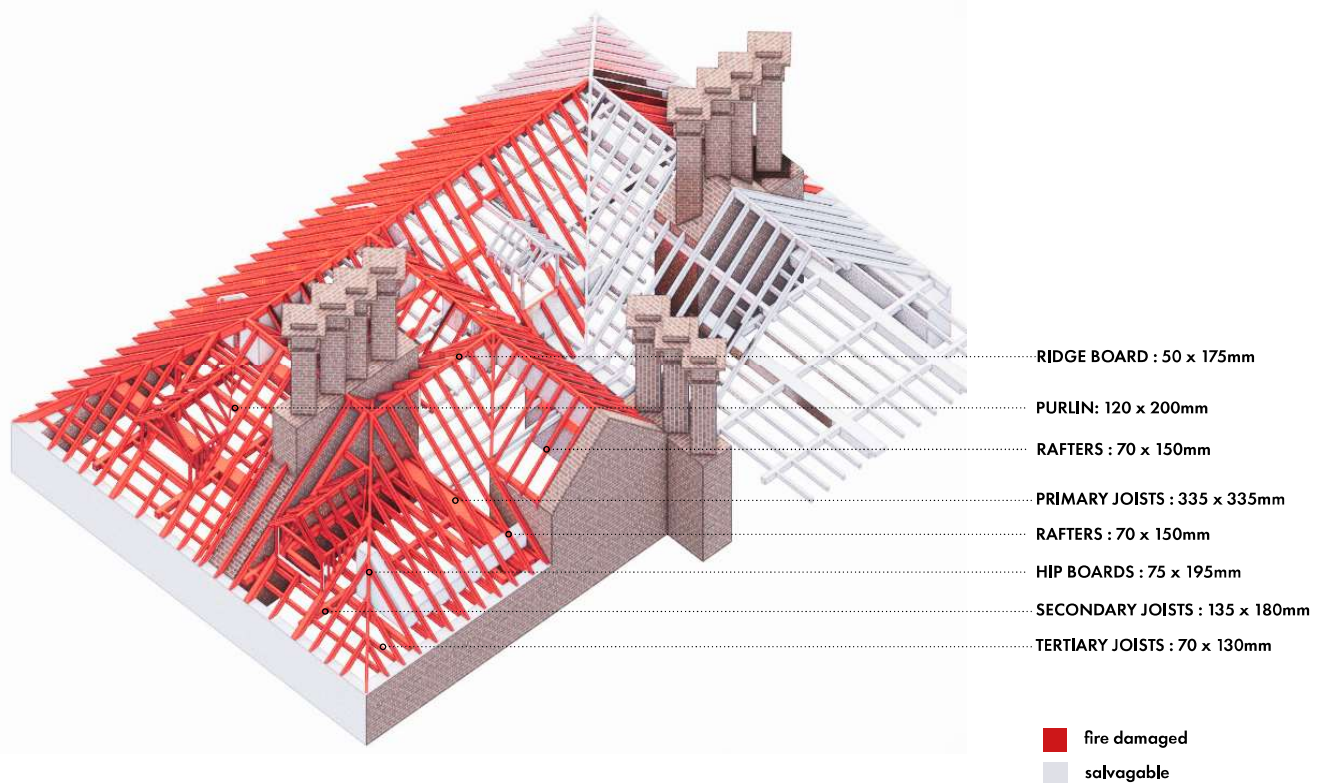
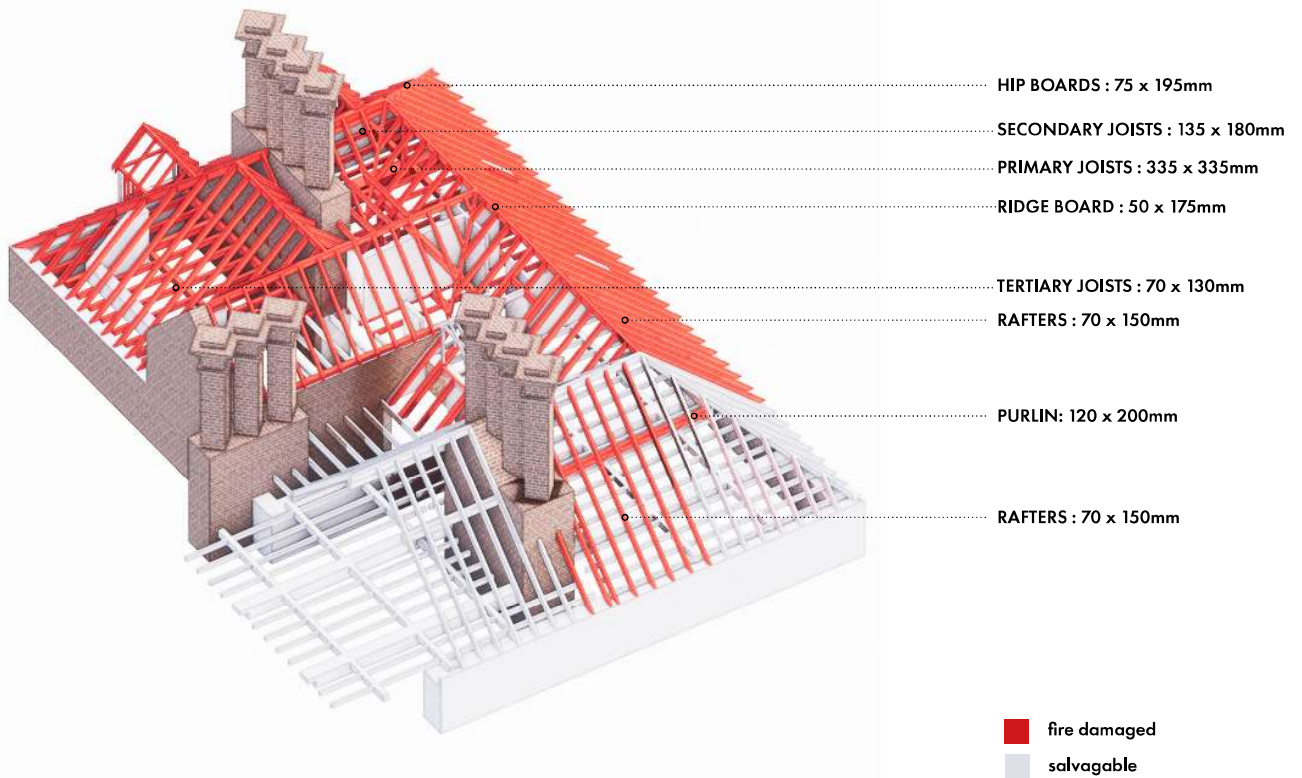
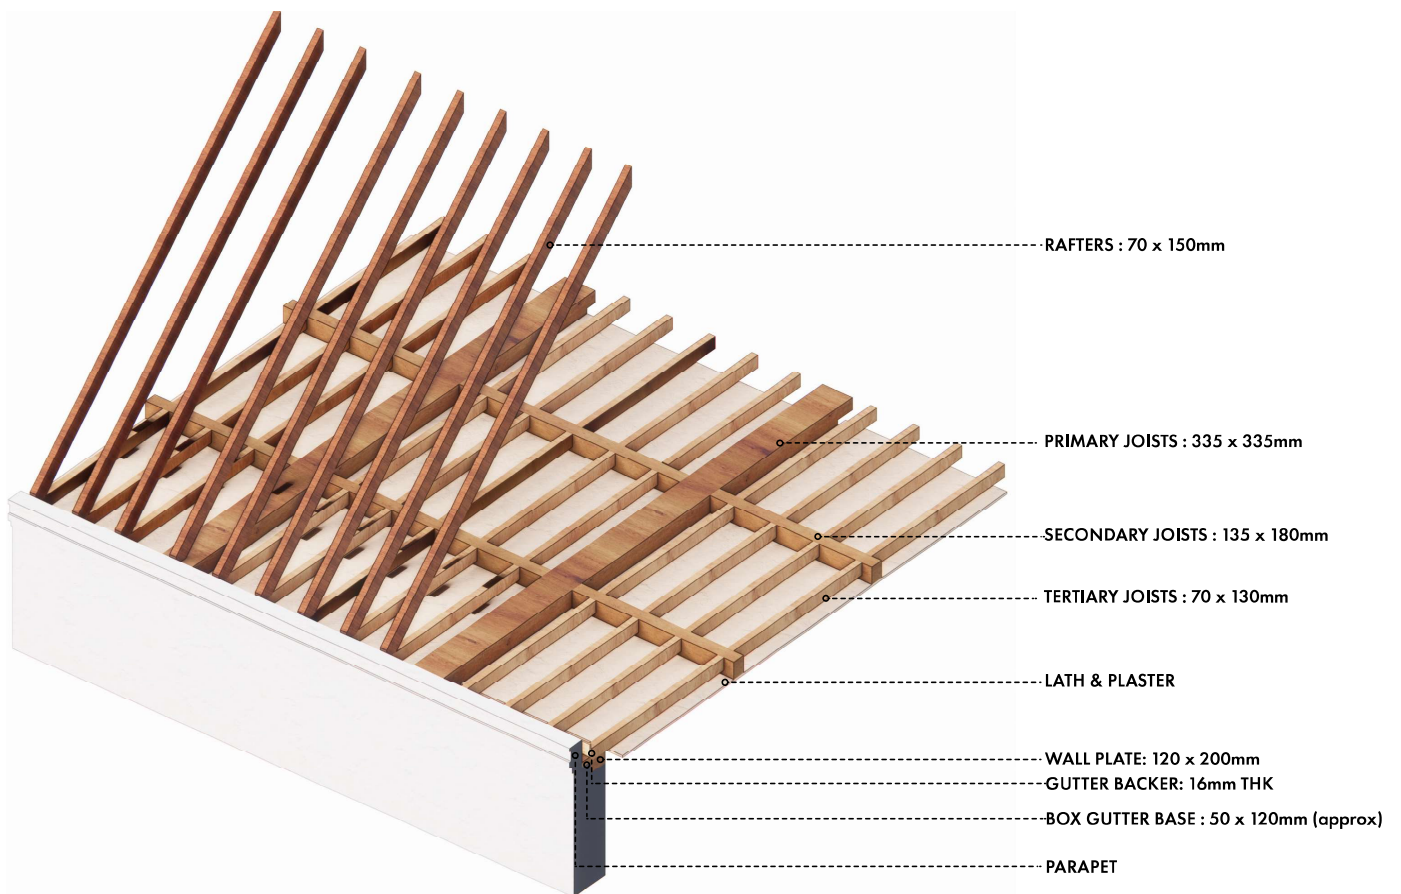
These images demonstrate the roof structure and how it will be rebuilt in the same style as the original roof. There will be a combination of timber framing and beams for the floor of the loft space and cut rafters for the roof. The image top left notes the sizes of the timbers that were measured on site. The image bottom right indicates how the flooring and rafters span onto the external wall. Note the parapet with gutter detail.

The primary and secondary joists have been sized based on the existing joists, however these will have final approval via the structural engineer.

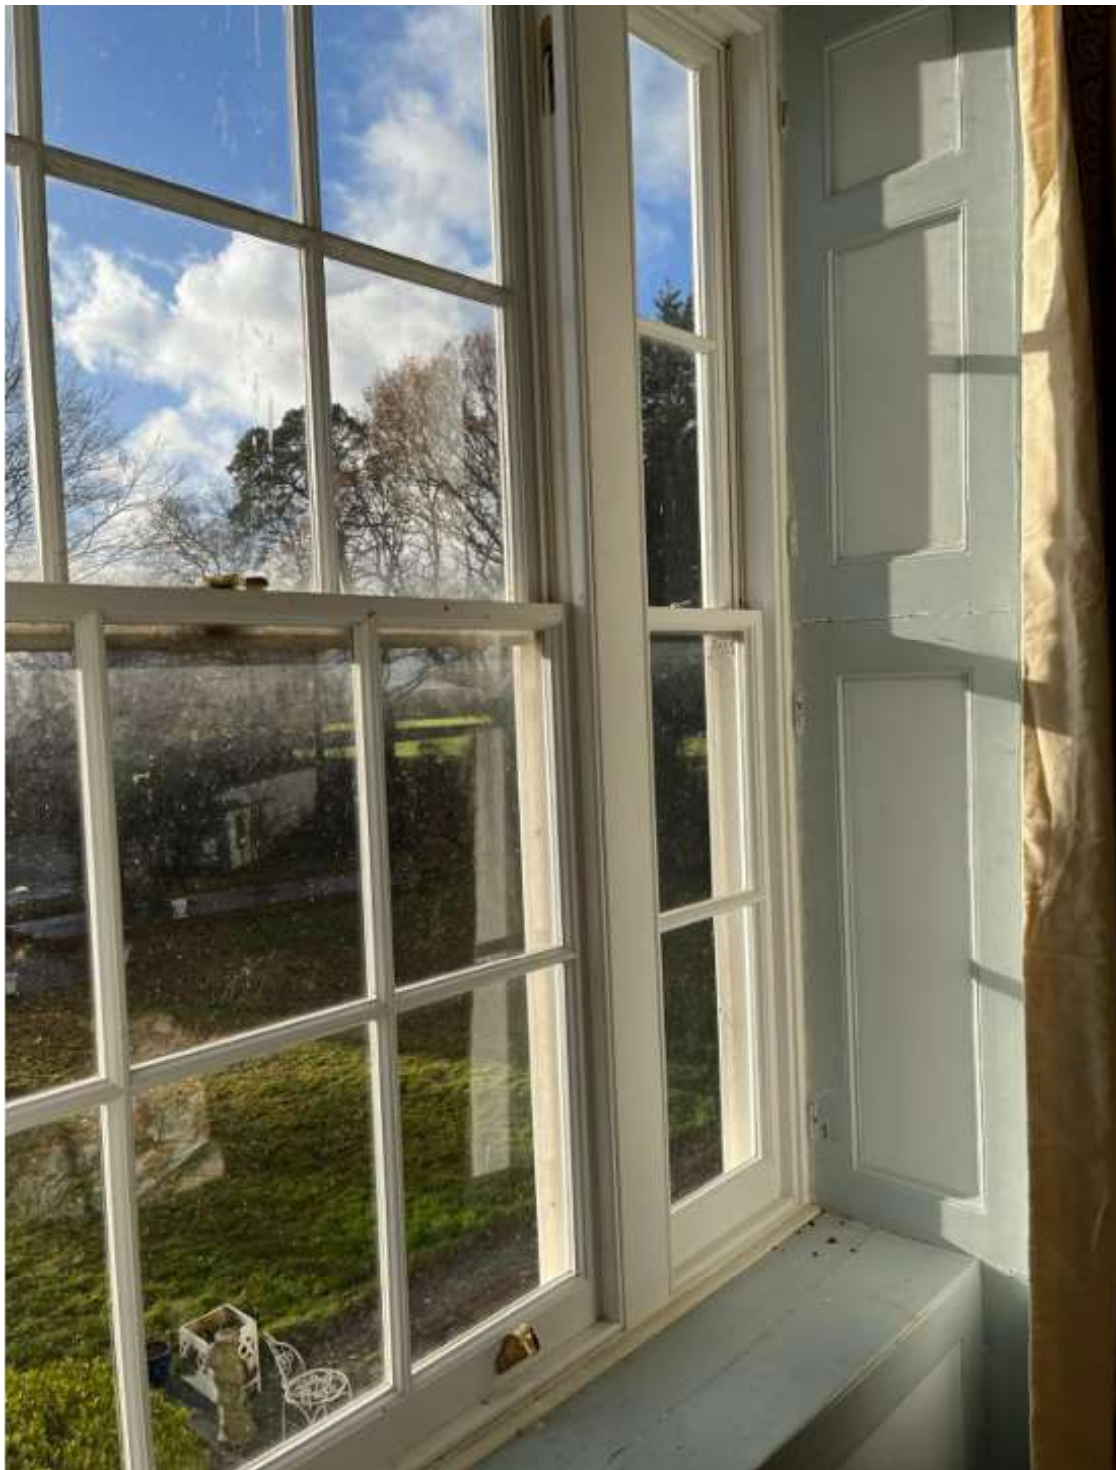
The image to the right is of the window to room FF4 which was replaced previously by Leigh Joinery.

Figure 9. Previously restored window to toom FF4

In 2017 a number of windows were replaced and subsequently approved under a previous planning application. These were to rooms GF9, GF10, GF11 and FF4 and were accepted by the previous officer Giles Stephens. They were templated and constructed by Leigh Joinery, who would be appointed again to use their previous templates to create copies of the originals for all the windows that need replacing.
