# Arboricultural Consultancy for Aviva

## 1. Case Details

| Insured | | Address | 5 Sharphorpe Close, Lower Earley, Reading, RG6 4DB | | |

**Scope of Report:** To survey the property and determine significant vegetation contributing to subsidence damage, make recommendation for remedial action and assess initial mitigation and recovery prospects. The survey does not make an assessment for decay or hazard evaluation.

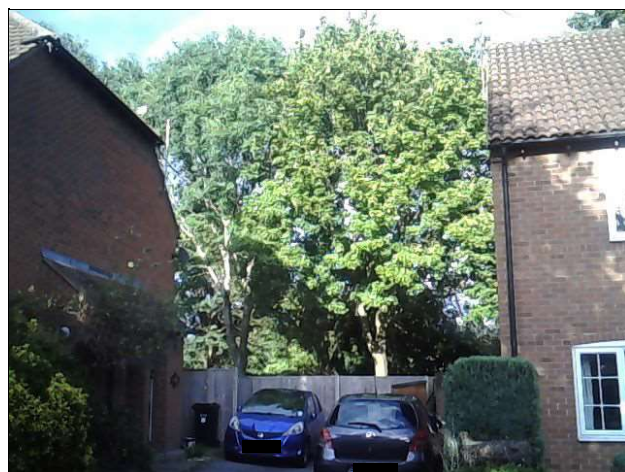
General view looking towards T4 & T5
