## The Swan, Three Mile Cross

## Drainage Strategy

September 2024

241836/DS/AG/KBL/01

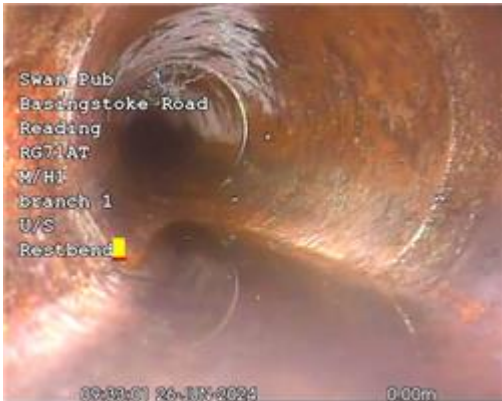
| Pos | Video Ref | Code | Description | Image |
|---|---|---|---|---|
| 00.00m | | MH | Start node type, manhole<br>MH1 B1 U/S | Image Provided - Ref: 0_0<br> |

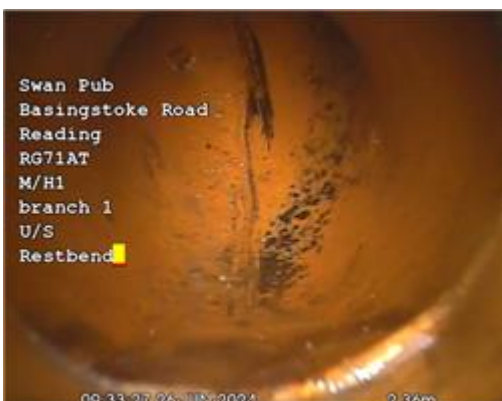
| Pos | Video Ref | Code | Description | Image |
|---|---|---|---|---|
| 02.36m | | OCF | Finish node type, other special<br>chamber<br>ENTERS RESTBEND | Image Provided - Ref: 0_9999<br> |

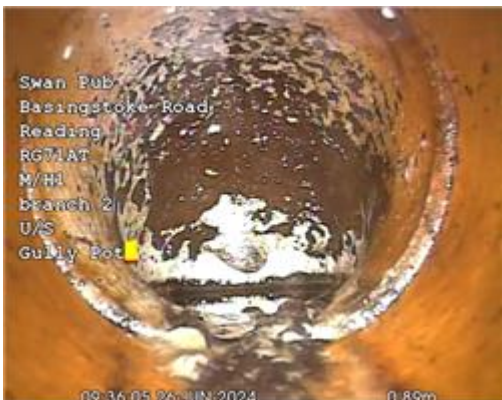
| Pos | Video Ref | Code | Description | Image |
|---|---|---|---|---|
| 00.90m | 0:00:11 | JDM | Joint displaced medium -<br>Severity 3<br>Displaced Joint identified, with<br>no evidence to suggest that<br>this is resulting in any issues at<br>present however the condition<br>of this may deteriorate over a<br>period of time. | Image Provided - Ref: 1_2<br> |

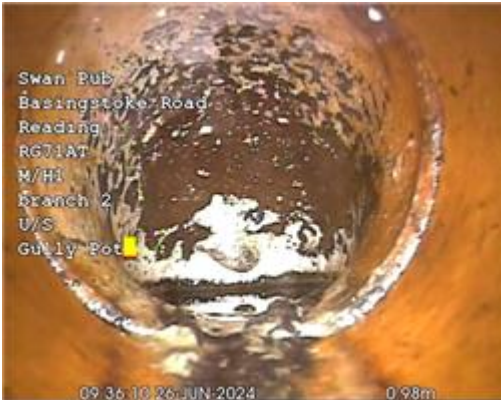
| Pos | Video Ref | Code | Description | Image |
|---|---|---|---|---|
| 01.10m | | OCF | Finish node type, other special chamber<br>ENTERS GULLY POT | <div>Image Provided - Ref: 1_9999</div> |

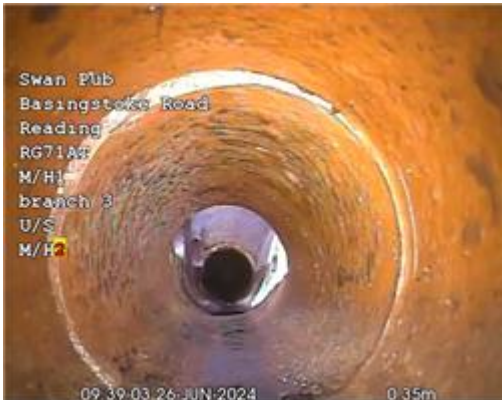
| Pos | Video Ref | Code | Description | Image |
|---|---|---|---|---|
| 00.40m | | JDM | Joint displaced medium -<br>Severity 3<br>Displaced Joint identified, with<br>no evidence to suggest that<br>this is resulting in any issues at<br>present however the condition<br>of this may deteriorate over a<br>period of time. | Image Provided - Ref: 3_1<br> |

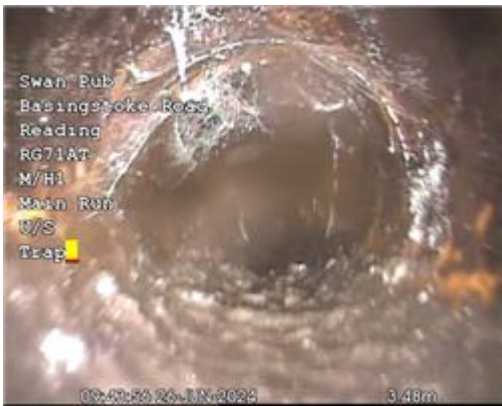
| Pos | Video Ref | Code | Description | Image |
|---|---|---|---|---|
| 03.48m | 0:00:19 | REM | General remark<br>ADVISORY - CLEANING<br>WORKS REQUIRED IN THIS<br>LOCATION | Image Provided - Ref: 4_3<br> |

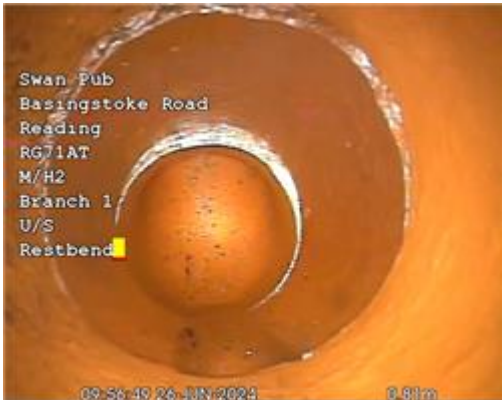
| Pos | Video Ref | Code | Description | Image |
|---|---|---|---|---|
| 00.80m | | JDM | Joint displaced medium -<br>Severity 3<br>Displaced Joint identified, with<br>no evidence to suggest that<br>this is resulting in any issues at<br>present however the condition<br>of this may deteriorate over a<br>period of time. | Image Provided - Ref: 6_1<br> |

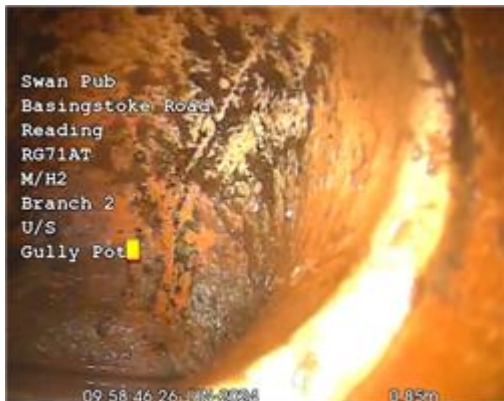
| Pos | Video Ref | Code | Description | Image |
|---|---|---|---|---|
| 00.85m | | GYF | Finish node type Gully<br>ENTERS GULLY POT | <p>Image Provided - Ref: 7_9999</p> <p>Swan Pub<br/>Basingstoke Road<br/>Reading<br/>RG71AT<br/>M/H2<br/>Branch 2<br/>U/S<br/>Gully Pot</p> <p>09:58:46.26 09/09/2024 0.85m</p> |

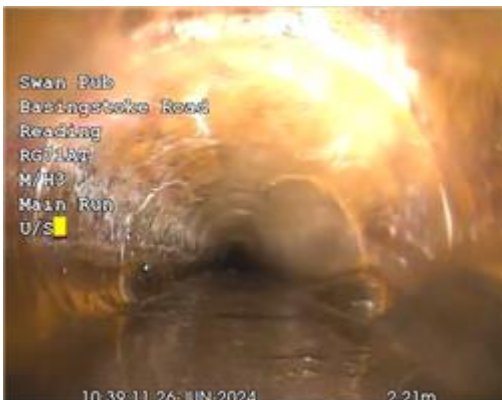
| Pos | Video Ref | Code | Description | Image |
|---|---|---|---|---|
| 02.21m | 0:00:18 | WL | Water level: 50%<br>Height/Diameter<br>WATER RETENTION<br>IDENTIFIED | Image Provided - Ref: 11_3<br> |

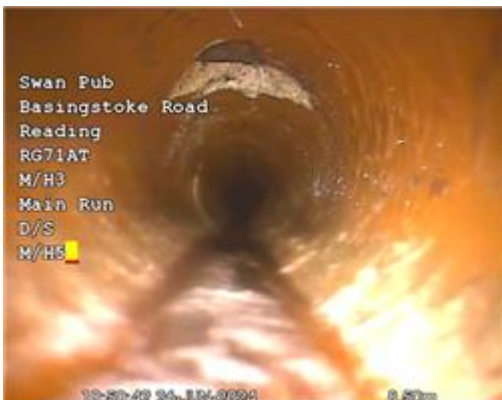
| Pos | Video Ref | Code | Description | Image |
|---|---|---|---|---|
| 08.50m | | B | Broken pipe from 11 o'clock to<br>01 o'clock - Severity 4 | Image Provided - Ref: 13_1<br> |

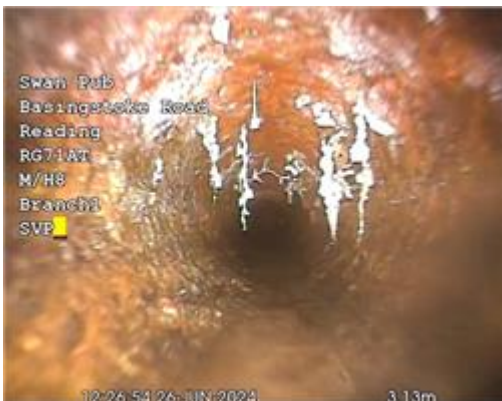
| Pos | Video Ref | Code | Description | Image |
|---|---|---|---|---|
| 03.13m | | REM | General remark<br>ADVISORY - CLEANING<br>WORKS REQUIRED | Image Provided - Ref: 21_1<br> |

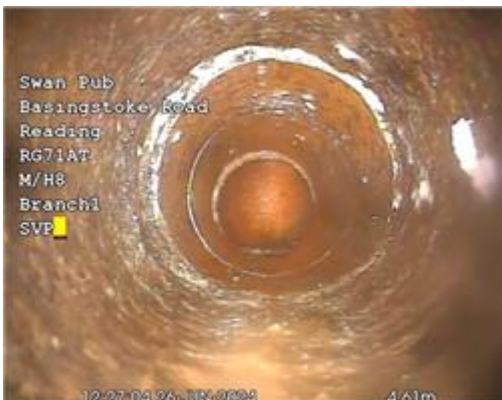
| Pos | Video Ref | Code | Description | Image |
|---|---|---|---|---|
| 04.60m | 0:00:21 | JDM | Joint displaced medium -<br>Severity 3<br>Displaced Joint identified, with<br>no evidence to suggest that<br>this is resulting in any issues at<br>present however the condition<br>of this may deteriorate over a<br>period of time. | Image Provided - Ref: 21_2<br> |

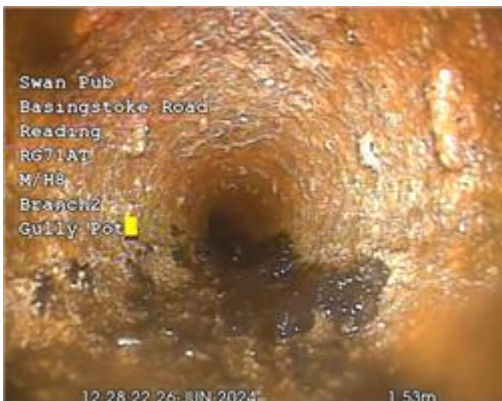
| Pos | Video Ref | Code | Description | Image |
|---|---|---|---|---|
| 01.53m | | REM | General remark<br>ADVISORY - CLEANING<br>WORKS REQUIRED | Image Provided - Ref: 22_1<br> |
